Chemical contamination of a coral reef by the grounding of a cruise ship in Bermuda

Ross J Jones *

Bermuda Institute of Ocean Sciences (BIOS), 17 Biological Lane, Ferry Reach, St. George's GE01, Bermuda

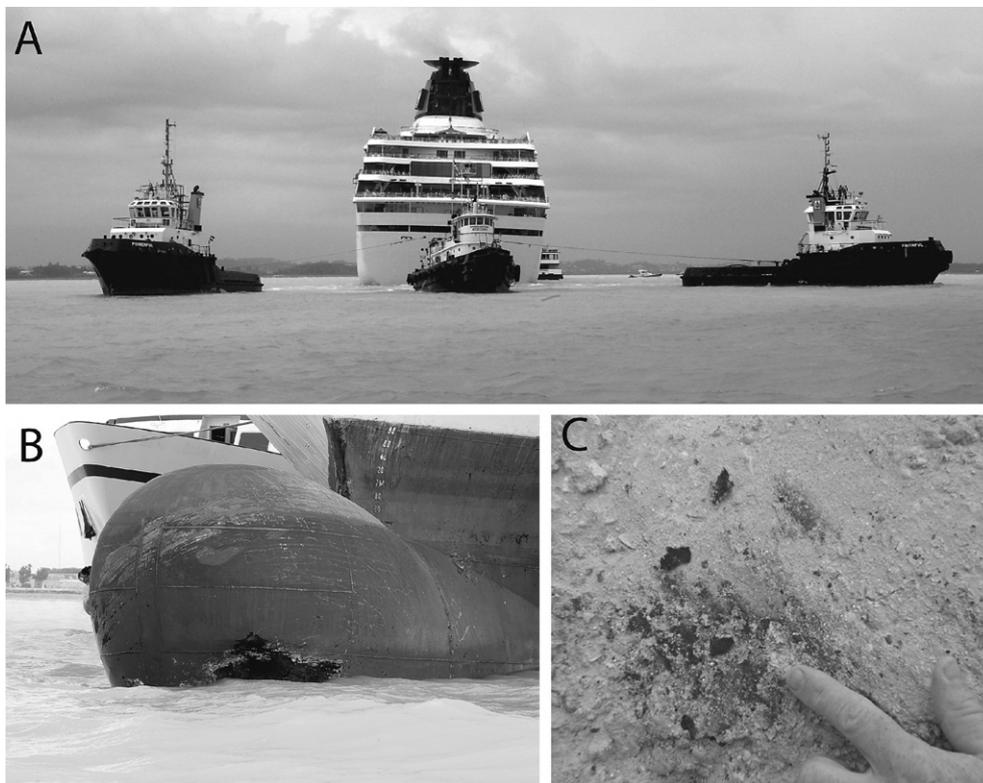
The result of the grounding was an impact scar in the form of a ~120 m long trench (furrow) in the carbonate sediments. Either side of the impact scar, berms of displaced sand and coral rubble were formed. Several deep craters were also caused by the ship's propellers close to the edge of the shipping channel. The ship eventually came to rest on a small patch reef at the head of the impact furrow, causing the reef matrix to shatter, generating large amounts of coral rubble, and causing extensive structural damage including splitting the reef in several large (>1 m wide) fracture zones. Flakes of large (>1 cm) red AF paint were observed adhered onto broken coral heads on the forward port side of the impact furrow. Approximately 20–50 m from where the bow came to rest patches of sediments on the western sides of the impact furrow were heavily compacted, i.e. firm to touch, impregnated with shells and coral rubble and pigmented reddish/pink with AF paint particles (Fig. 1C).

Fig. 1. (A) Initial, unsuccessful, attempts by three locally flagged tugs to pull the 188 m *Norwegian Crown* cruise ship off a patch reef in Bermuda. Note the starboard list. (B) Emersion of the ship's bulbous during the refloating attempts. Note the impact scarring and excoriation of the antifouling paint from the vessel's hull. (C) Interspersion of antifouling paint flakes with sediment. Images (A) and (B) courtesy of David Skinner.

Some of the contaminated samples collected from the grounding site were pigmented, and large (>1 mm) red particles or 'chips' of antifouling paint could be observed while underwater. In self polishing copolymer AF paints, like

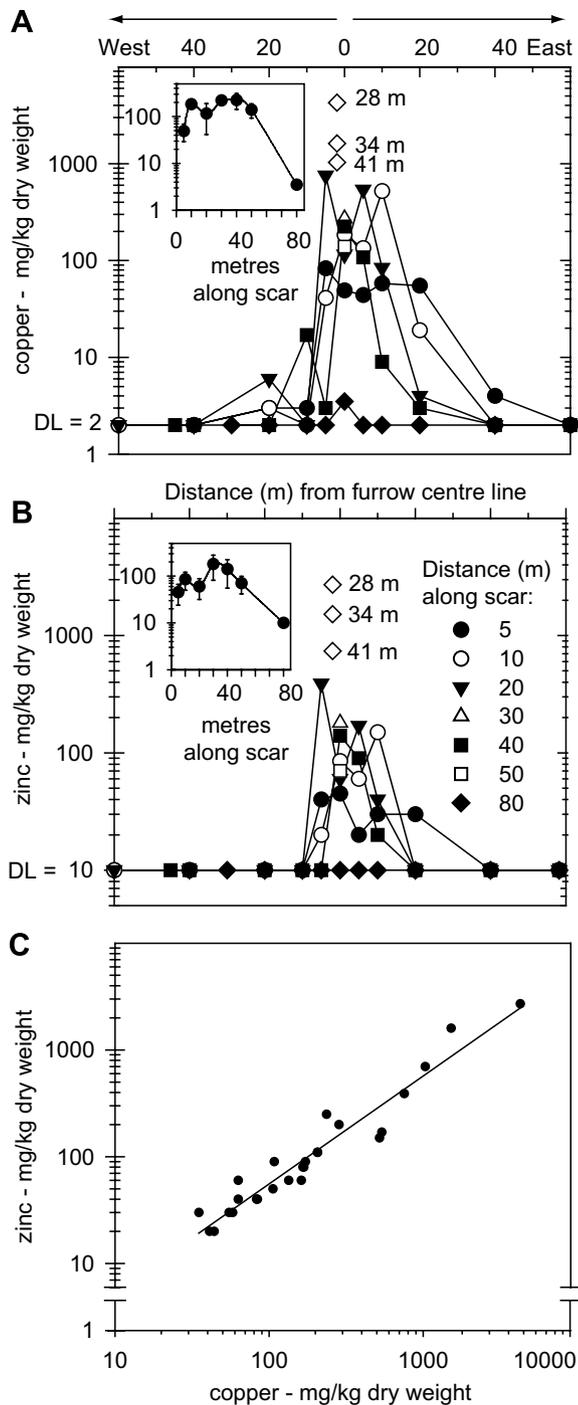
Of the metals tested copper and zinc levels were clearly elevated at multiple locations within and outside the impact scar (Fig. 3). Levels tended to be highest in the impact furrow, and decreased (1) with increasing distance at right angles away from the centerline of the furrow, and (2) down the length of the impact furrow (Fig. 3). In general metal levels also tended to be higher on the eastern side of the impact furrow (i.e. between the ship and the patch reef) than on the western side. The furthest distance contaminated sediments were detected from the centre line of the impact furrow (i.e. laterally) was 20 m, where elevated copper concentrations were detected in the forward part of the furrow on the eastern side (Fig. 3). The highest copper and zinc values (4270 and 2710 mg/kg dry weight respectively) were recorded on the western side of the impact furrow 28 m from the where the bow came to rest (Fig. 3). This sediment was intentionally sampled as it appeared obviously pigmented with AF paint and the metal values were anticipated to be high. Of the sediment samples collected in which there was no visible pigmentation by AF paint (i.e. samples were collected because they were located under the sampling grid), the highest values were 754 and 390 mg/kg dry weight for copper and zinc respectively (Fig. 3). Samples taken 40 m and 60 m east and west of the centre line of the impact scar were below the detection limit (2 mg/kg dry weight for copper and 10 mg/kg dry weight for Zn).

Fig. 3. (A) Copper and (B) zinc concentration (mg/kg dry weight) in sediments collected from the *Norwegian Crown* grounding site impact scar and surrounding areas. Duplicate samples were taken on the centreline of the impact scar at 5, 10, 20, 40, and 80 m from where the bow came to rest (data shown as means of 2 samples). Single samples were then taken at 5, 10, 20, and where possible, 40 and 60 m east or west of the sampling points in the impact scar. Additional samples (white diamonds) were taken at 28, 34 and 41 m where sediment was clearly contaminated with antifouling paints (i.e. the sediments were pigmented red or pink). Note the log scale on all y-axes. Inset figures represent the mean (\pm SD) of duplicate samples taken on the centreline of the impact scar. (C) Correlation curve between copper and zinc concentration (mg/kg dry weight) in sediments collected from the *Norwegian Crown* grounding site impact scar where values for both copper and zinc exceed the analytical detection limits ($r = 0.87$). Note the log scale on both axes.

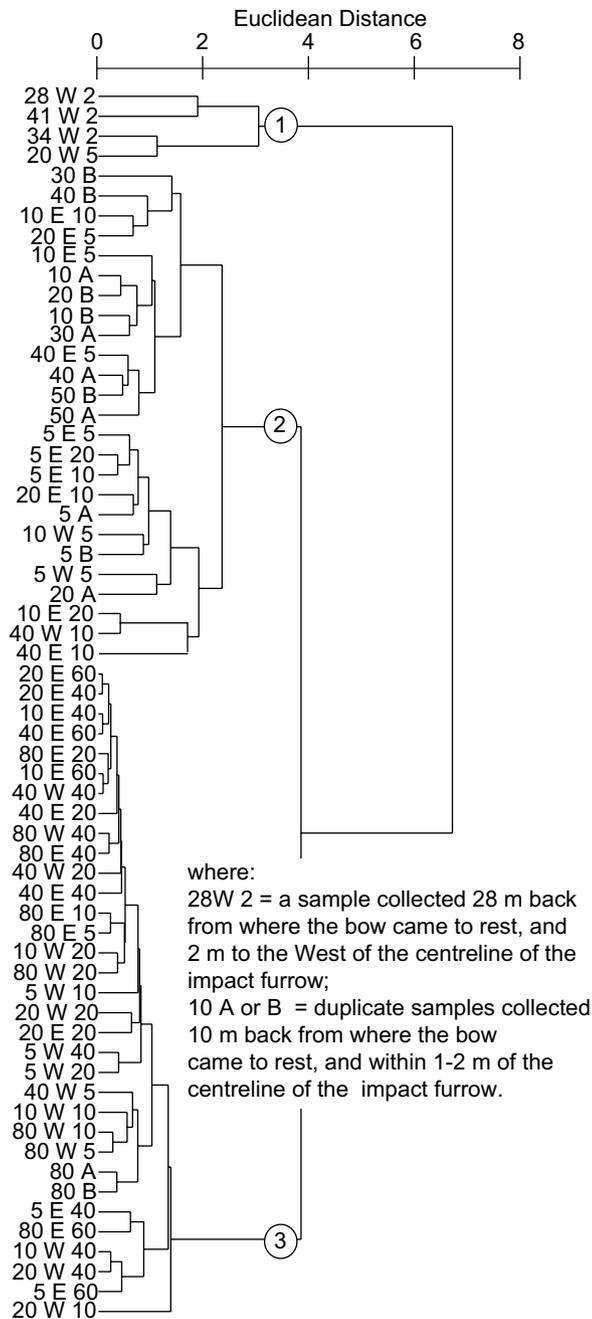
ilar samples spaced farther apart (Fig. 4). Several clusters can be identified, including samples taken of the pigmented (clearly contaminated) sediments (cluster 1), sediment samples collected close (i.e. less than 20 m) to the centreline of the impact furrow and close to where the bow came to rest (cluster 2), and the remaining samples (cluster 3).

Fig. 4. Dendrogram for hierarchical clustering (using group-average linking) for surficial sediment samples taken from the grounding site of the *Norwegian Crown* cruise ship, calculated on a Euclidean-distance similarity matrix from log transformed metal data.

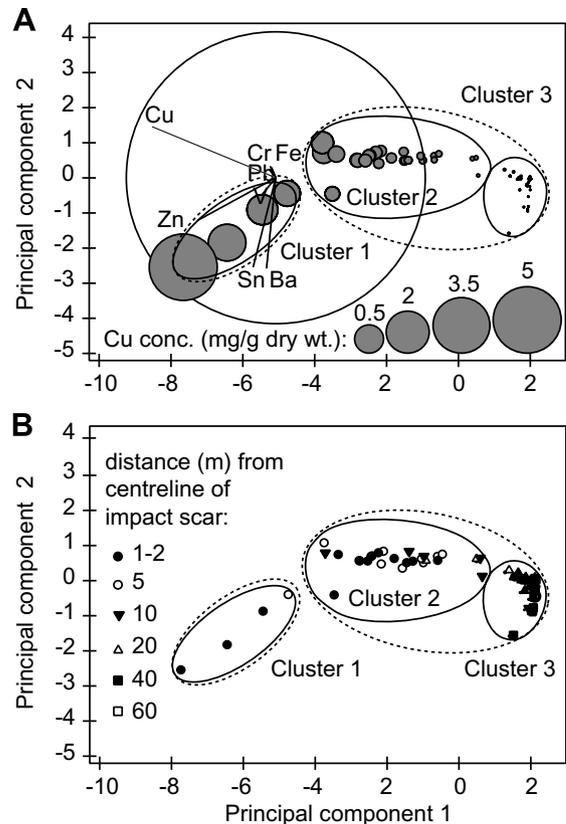
Principle component (PC) analysis (PCA) was performed on a table of sample sites and metals levels. Fig. 5 shows the relationship between the first 2 Eigen vectors. The PCA plot indicates a progression from heavily contaminated samples on the left hand-side, through moderately contaminated sediments in the middle, to uncontaminated sediments on the right-hand-side. PCs are products of the eigenvalue and the corresponding eigenvector. The total variance that can be explained by a PC is reflected in the eigen value and in this instance, a significant 87.9% of the total variability is accounted for by PC1 with only a further 5.6% by PC2 (cumulative value = 93.5%). This indicates that the 2-dimensional ordination is likely to be highly representative of the true order of the matrix in multidimensional space. Eigenvectors are composed of coefficients that reflect the contribution of their respective variables to the variance of that PC. The first PC had highest coefficients on copper and then zinc (data not shown).

Fig. 5. (A), (B) 2-Dimensional Principal Component Analysis (PCA) ordination of sediment metals levels using group averaged clustering from Euclidean-distance similarities on $\log(x)$ transformed metal concentration data superimposed with similarity levels (see Fig. 4). In (A) bubble plots of copper abundance data are superimposed, where the width of each 'bubble' is proportional to the metal concentration in the respective sediment sample (in mg/g dry weight). In (B) the symbols represent the distance in meters east or west of the impact furrow at which samples were taken and the numbers above the symbols represent the distance along the impact furrow.
