Long-Term Management Strategies for USS ARIZONA, A Submerged Cultural Resource in Pearl Harbor

NATIONAL PARK SERVICE
SUBMERGED RESOURCES CENTER

SEPTEMBER 2008
THIS REPORT IS APPROVED FOR PUBLIC RELEASE

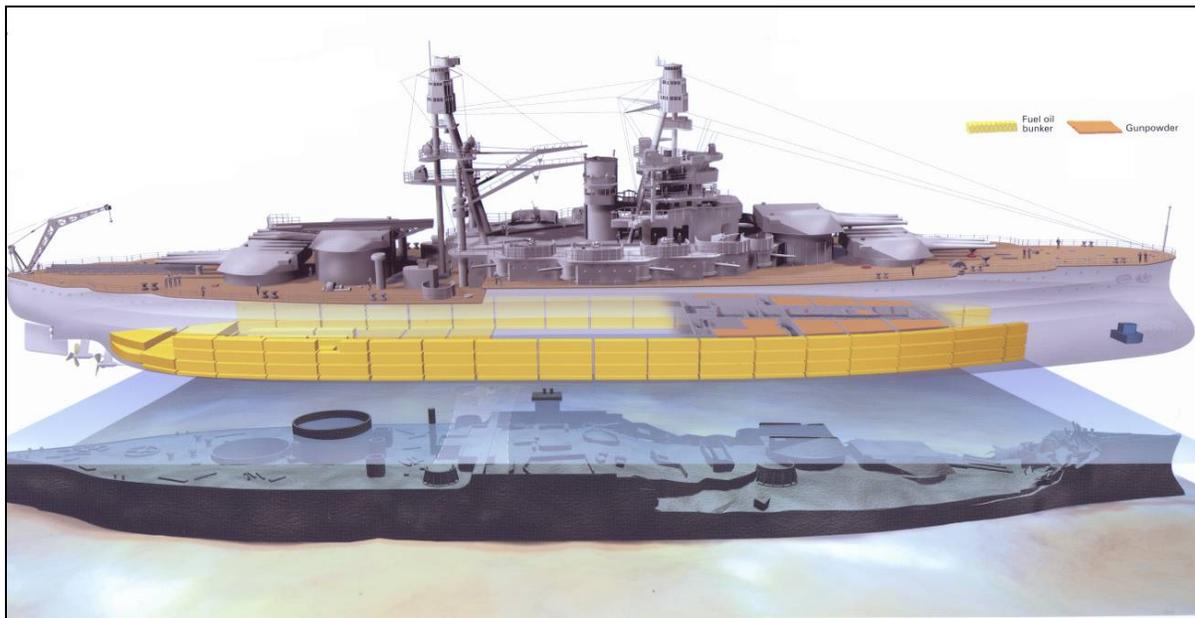
Figure 3.3. Graphic of Arizona showing oil bunker and forward magazine locations in relation to hull damage mapped by SRC in the 1980s (Graphic by National Geographic Society).

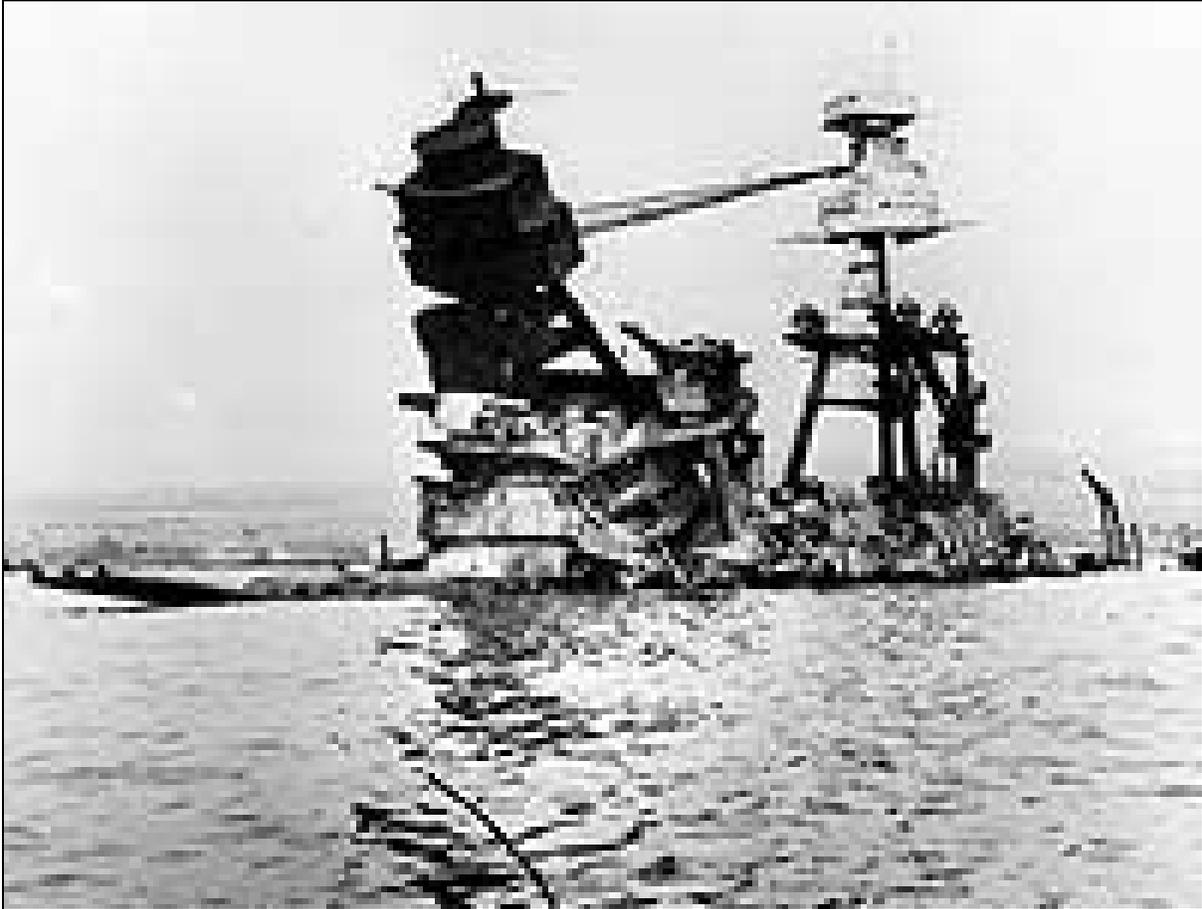
Figure 3.5. *Arizona* damage soon after fires were extinguished December 10, 1941 (USS *Arizona* Memorial Photo Archives).

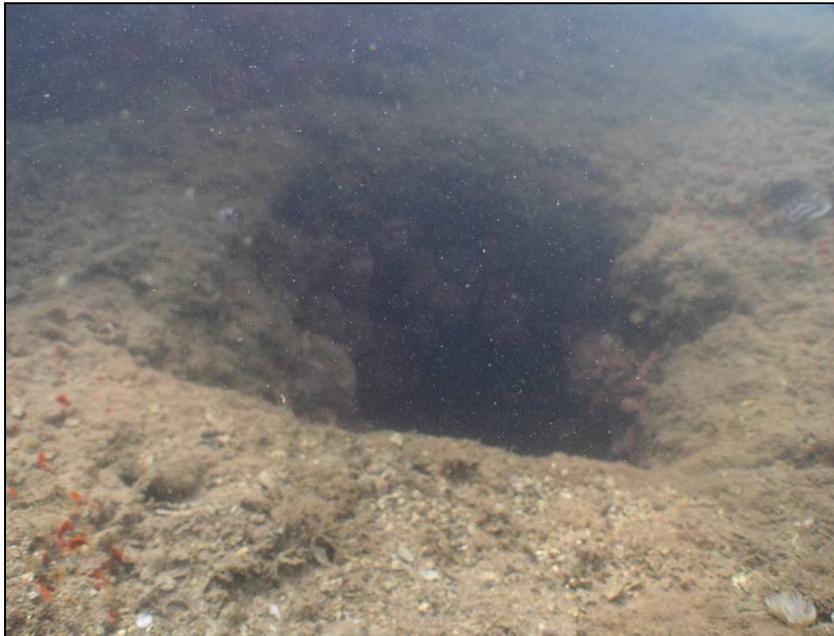
Figure 3.6. Bomb hole, forward of the galley, port side, near frame 78 (NPS Photo by Patrick Smith).

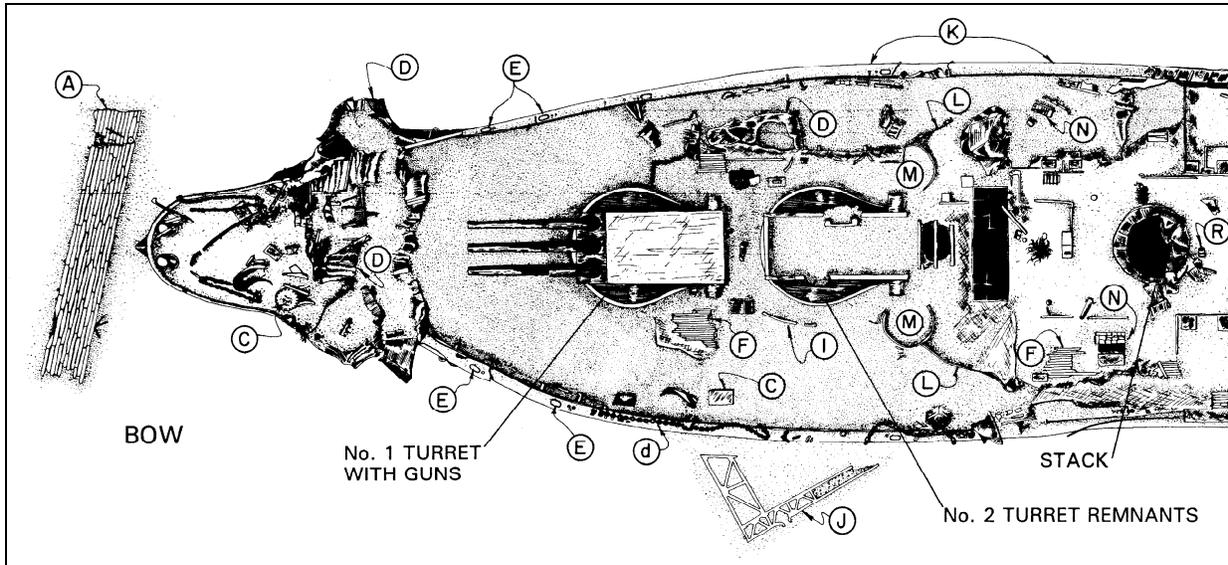
Figure 3.8. Planimetric view of *Arizona* bow damage (Drawing by NPS-SRC).

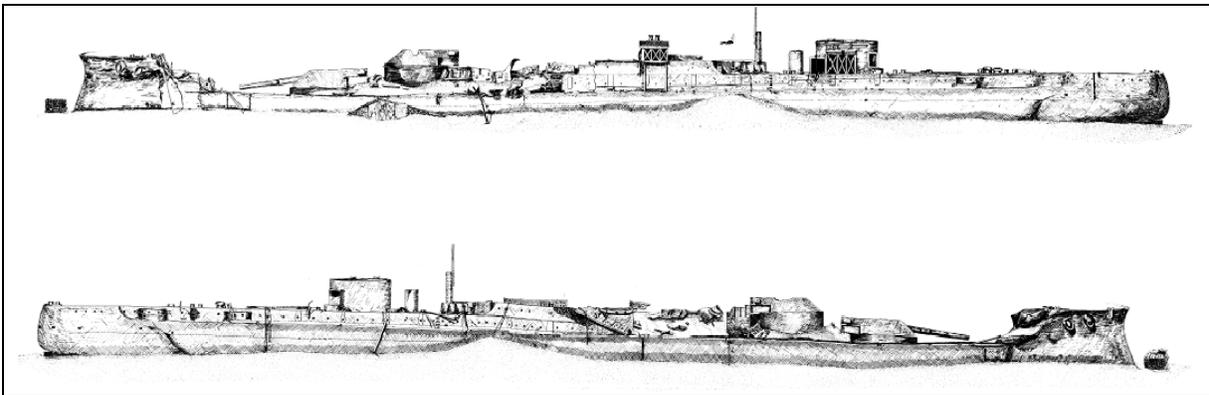
Figure 3.9. *Arizona* profile views port and starboard depicting current condition (Drawing by NPS-SRC).

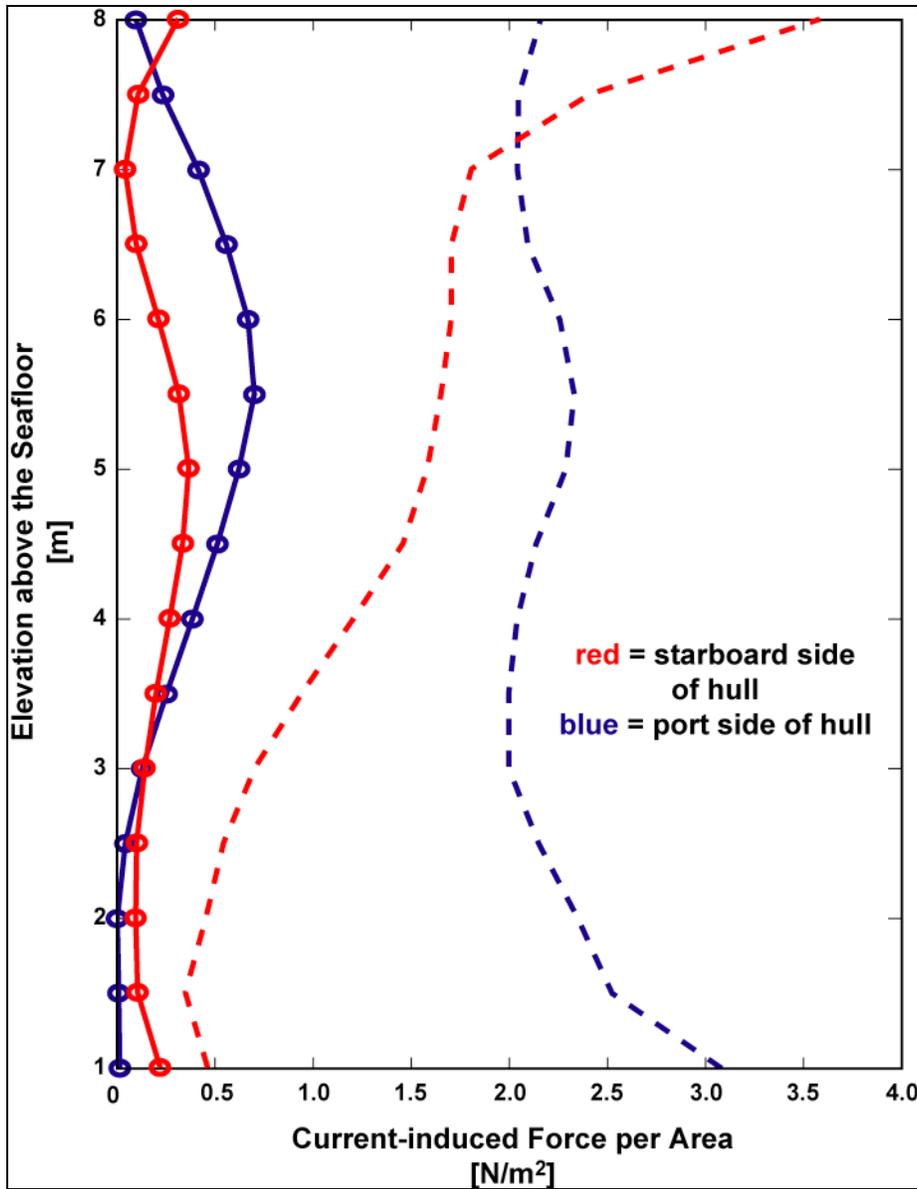
Figure 4.7. Vertical profiles of the current-induced force on the USS *Arizona*'s hull. Dashed lines are ± 1 standard deviation. Note that the force generally is at a maximum 6 m above the seafloor (4 m below the surface).
