Lead Exposure at an Indoor Range

LCDR Kimberly Chesteen, MPH
USCG Safety & Environmental Health Officer
Miami, FL

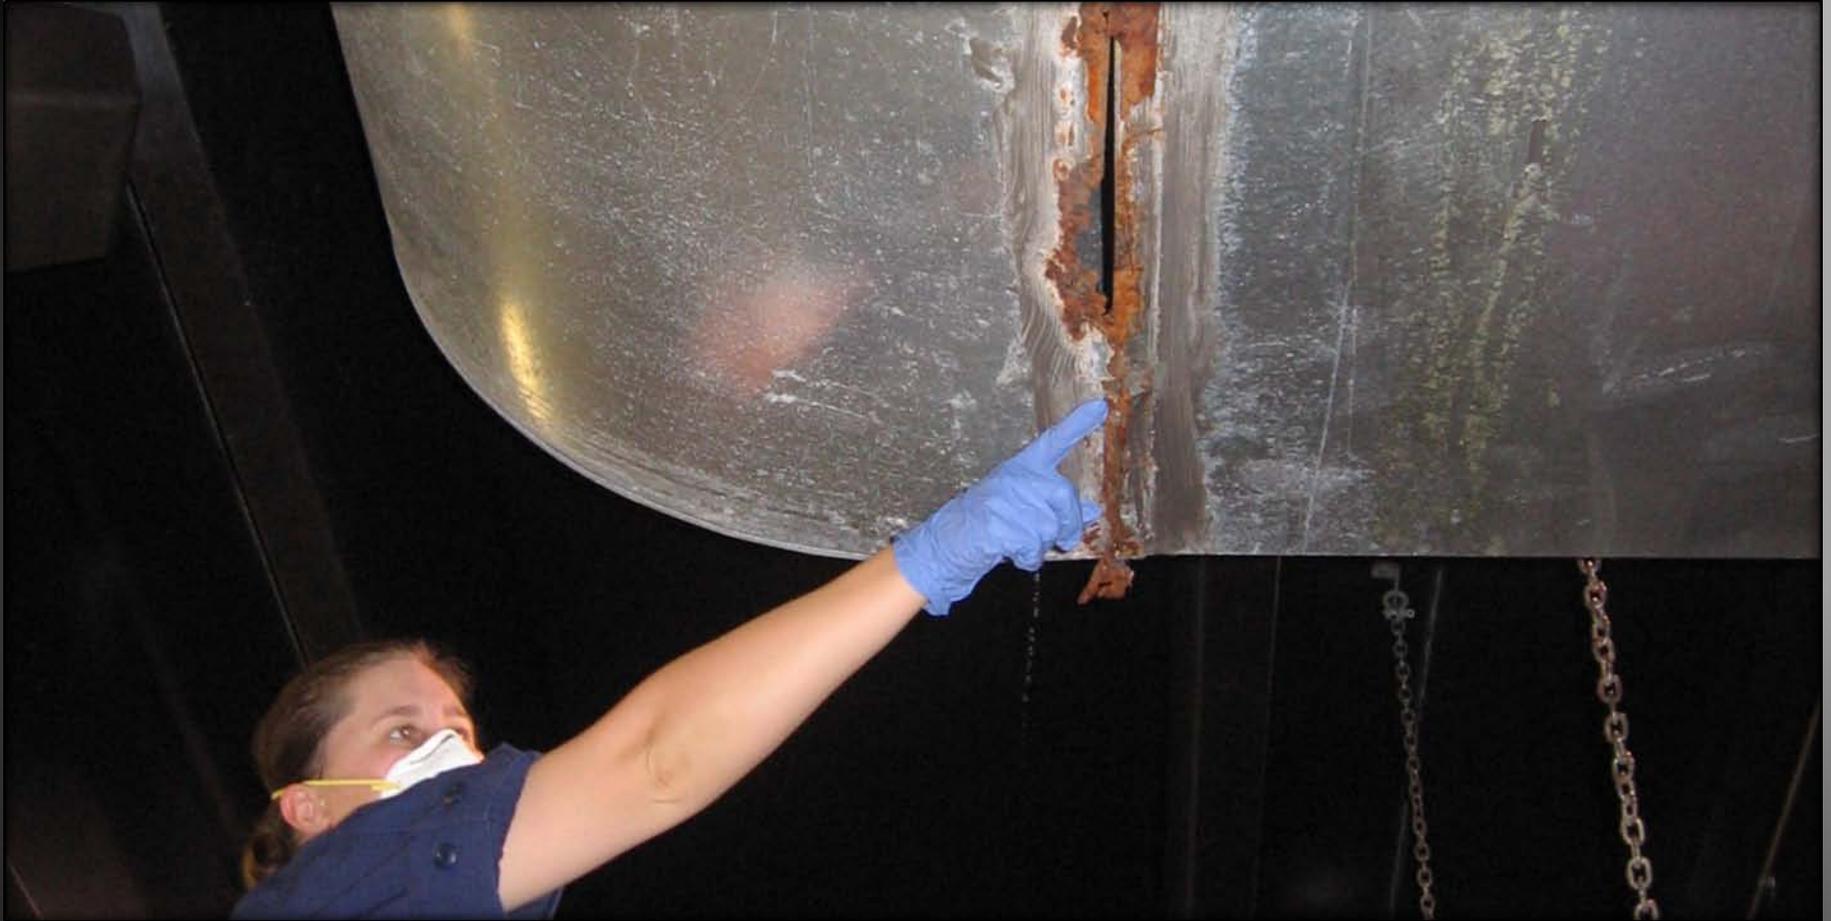
Deteriorated Supply Ductwork >>

- ▶ Visible eddies with smoke tests
- ▶ Positive pressure
- ▶ Structural defects in ductwork
- ▶ Inadequate exhaust system
- ▶ Numerous airflow impediments

Forced vertical air curtain disrupting linear air flow downrange

- Worked with Facilities Engineers
 - Repair ductwork & exhaust fan
 - Installed visible alarms for ventilation system
 - Installed pressure gauges across filter banks
- Medical monitoring enforced
 - Enrolled range staff in OMSEP – annual blood Pb test
- Contracted cleaning
 - Post cleaning surface dust range 11 – 176 $\mu\text{g}/\text{ft}^2$
- Safe work practices
- Training – include personal hygiene practices

- ▶ Redesign of supply ductwork
 - New supply air wall to distribute more uniform air curtain
 - New exhaust fan and system upgrade to maintain negative pressure

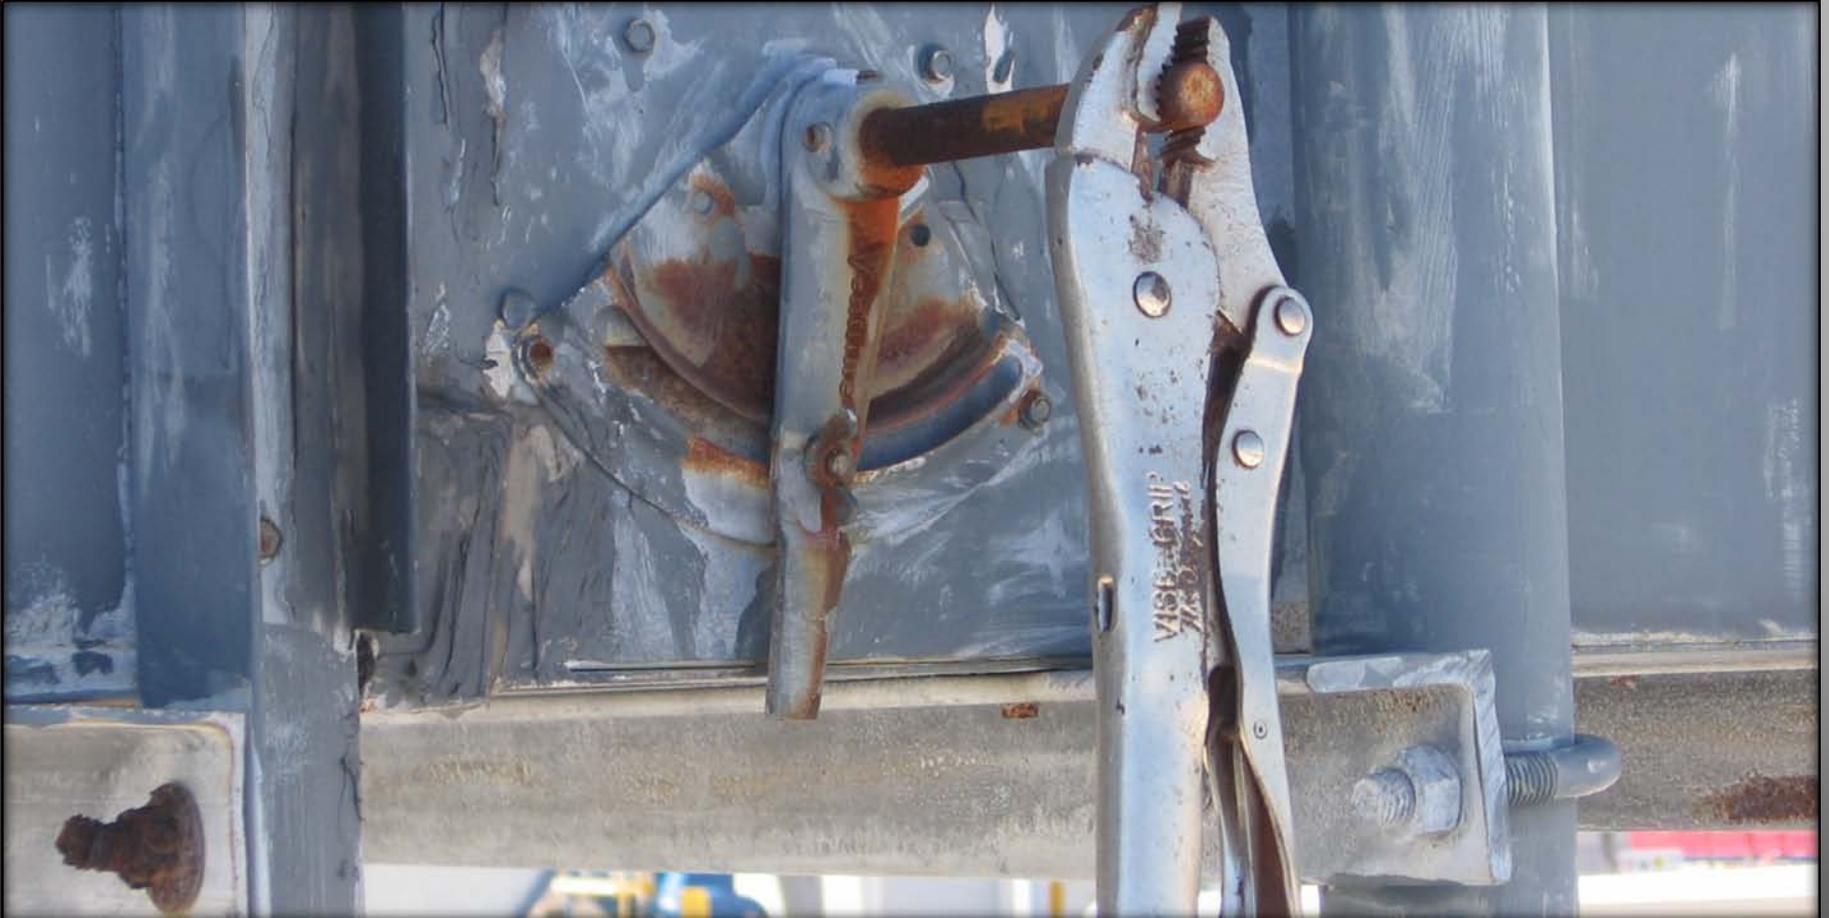
Ventilation System >>

Dampers rusted shut

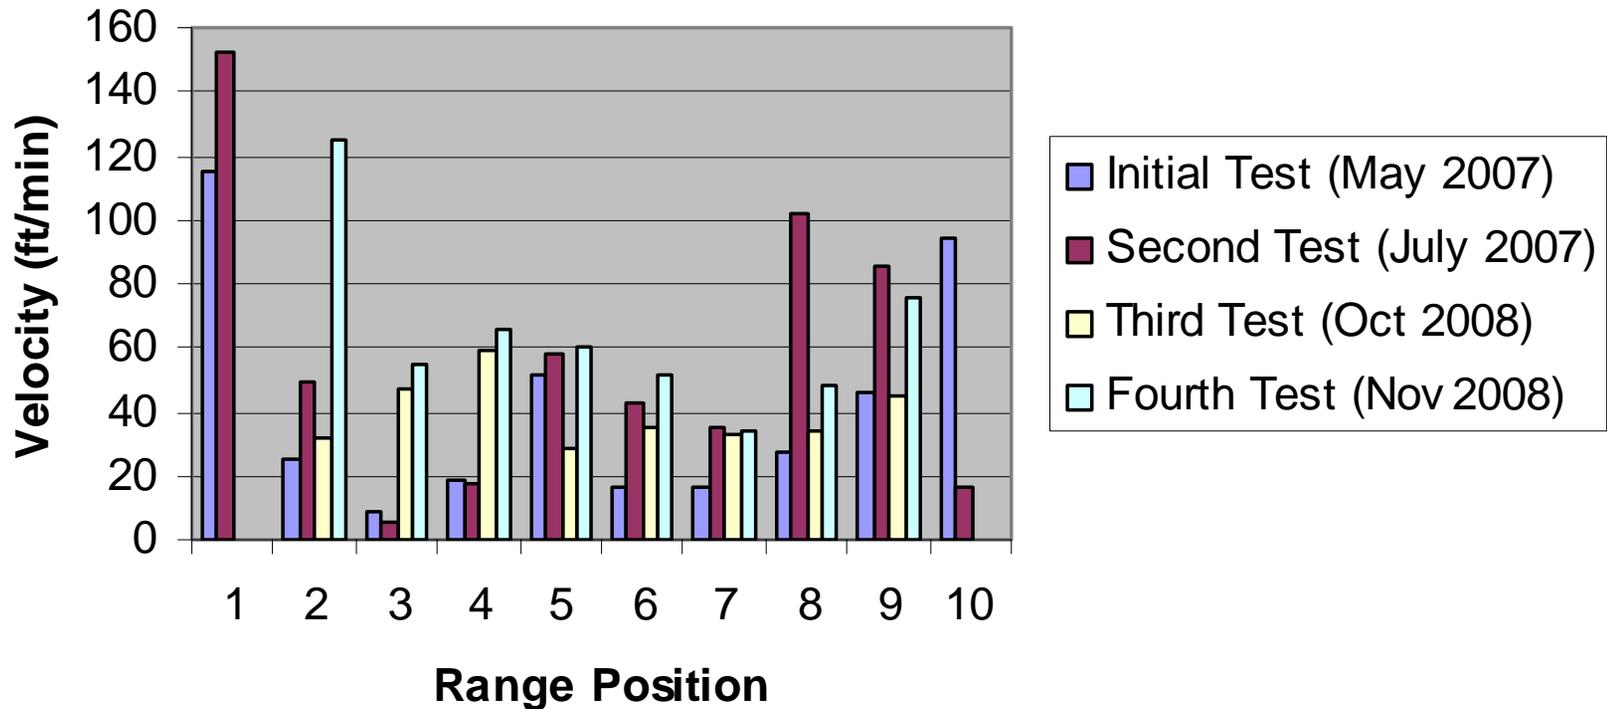
Comparison of Velocities at Breathing Zone >>>

Note: Initial test showed 6 range positions that did not meet minimum requirements

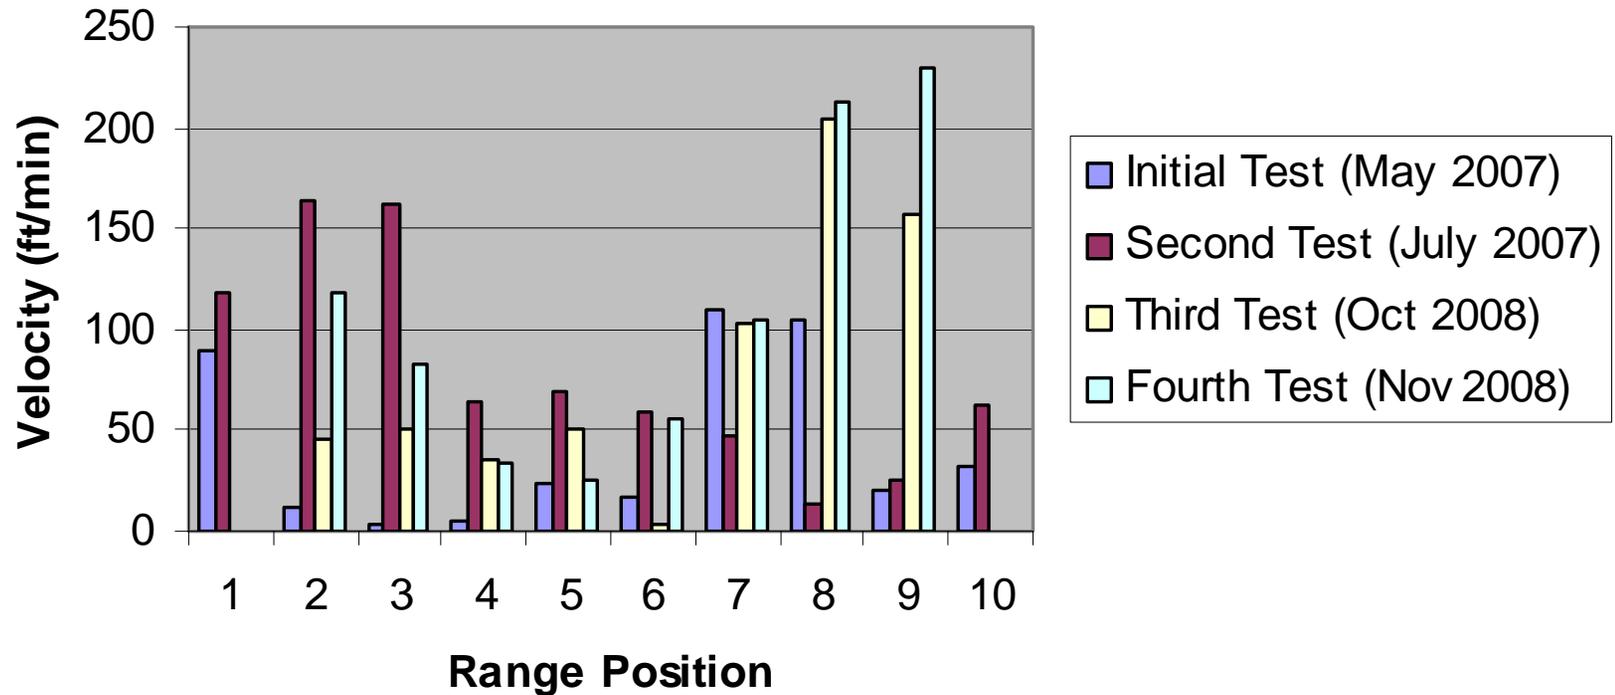
Velocity Comparison at Prone Position >>>

Note: Initial test showed 7 range positions that did not meet minimum requirements
