**FINAL REPORT**  
**with Management Plans**  
**Funding Document Reference #W9132T-10-2-0049**  
**Legacy Projects #10, 11, 12-142**

# Subterranean Survey of Kirtland Air Force Base, New Mexico

A report on the bat survey of 58 abandoned mine features, caves, and other underground structures located on Kirtland Air Force Base, New Mexico.

June 2014

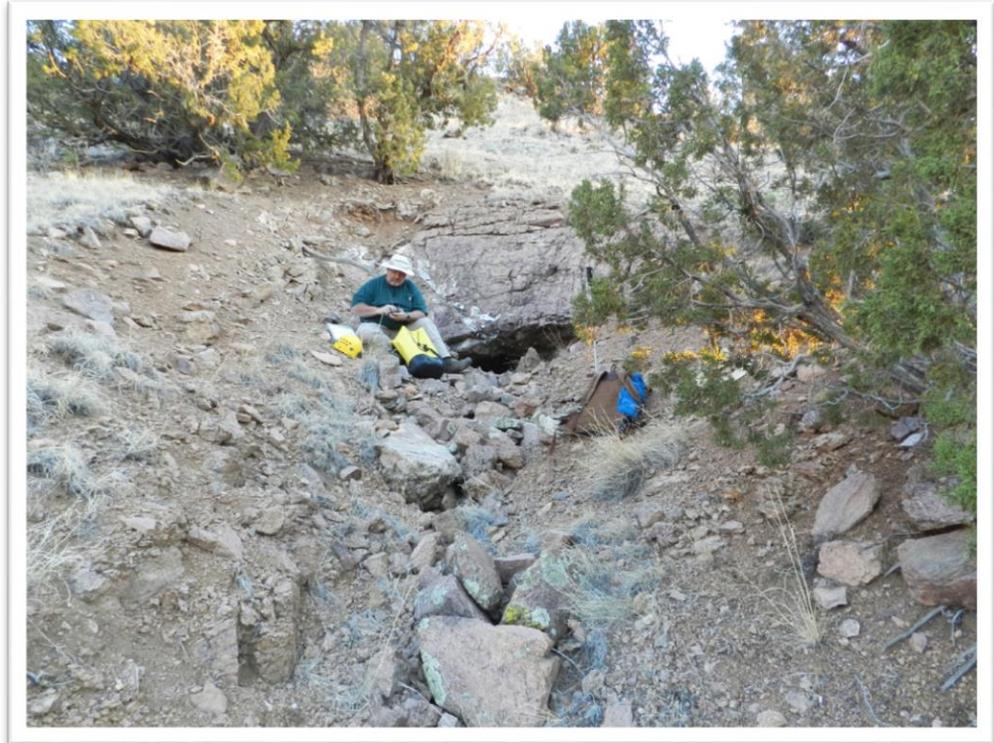
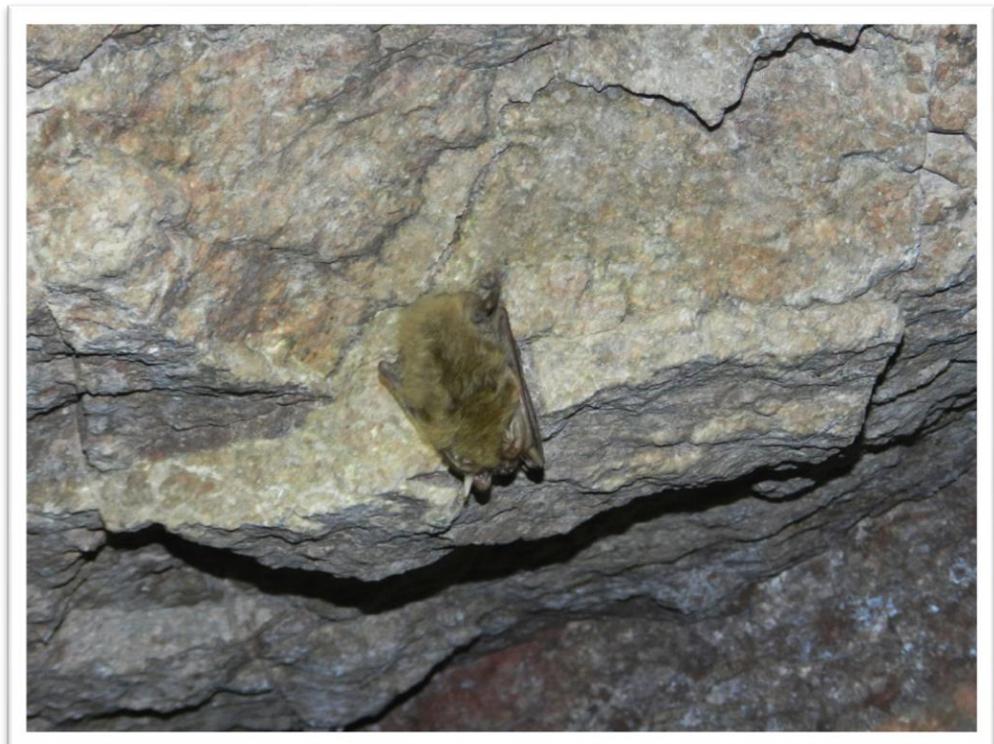
KL26 Adit

Date: 11.29.12  
Bat Count: 0

This small adit only extends underground for 13 feet. The entrance has a dangerous rock barely wedged over the portal. Ceiling staining and small amounts of scattered guano confirm this site as a summer roost. No bats were present during our winter survey.

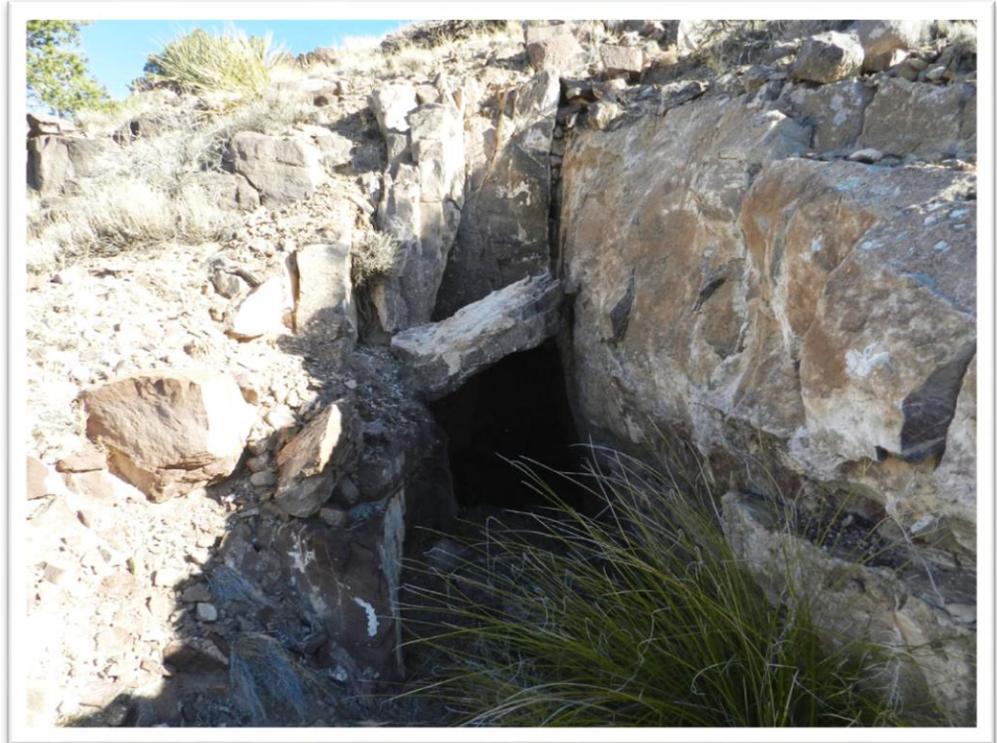
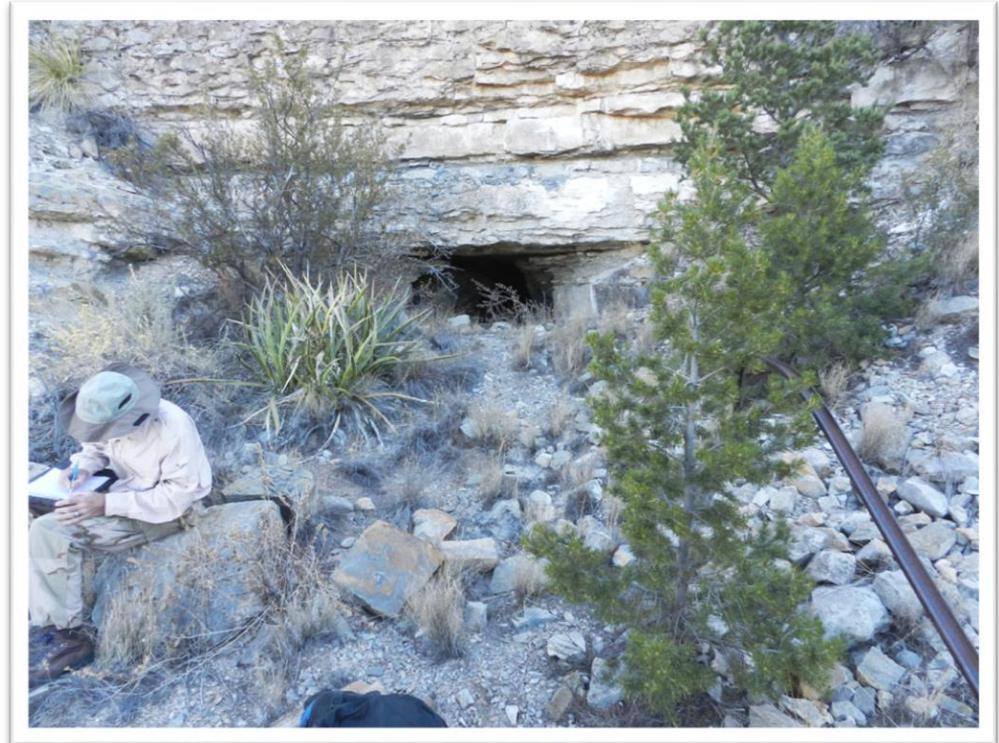
KL31 Adit

Date: 11.29.12

Bat Count: 1

This linear adit extends 730 feet underneath a thick layer of horizontally bedded limestone. This site is a winter bat hibernaculum, and only contained a single Townsend's big-eared bat (*Corynorhinus townsendii*). The floor of the mine is very level and contains the remnants of a mine cart rail and ties. Our survey did not observe any guano or other bat sign commonly found in summer roost sites.

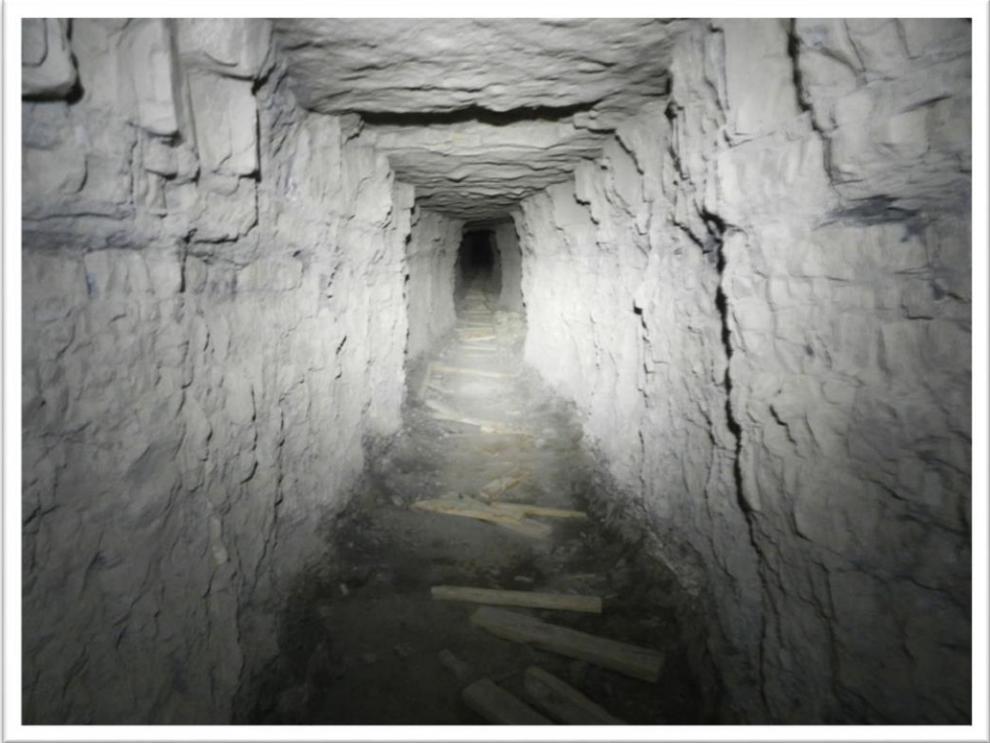
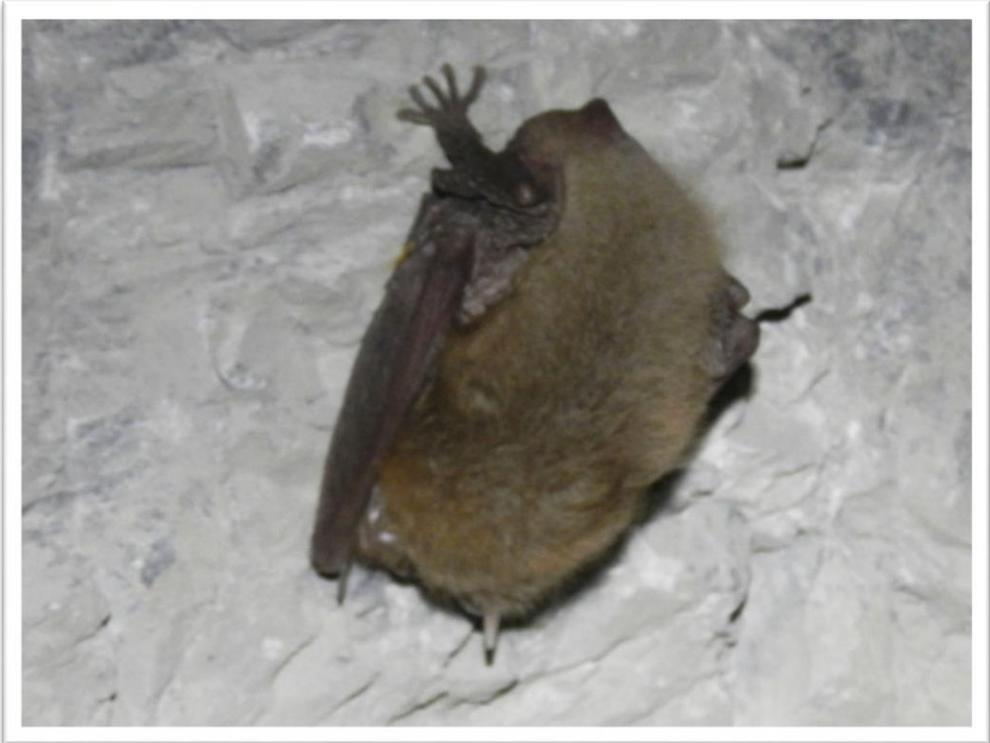
KL47 Adit

Date: 11.30.12

Bat Count: 1

This horizontal adit extends 30 feet into the hillside following a pink quartz vein. The site is a winter bat hibernaculum, and only contained a single Townsend's big-eared bat (*Corynorhinus townsendii*). The floor of the mine did not contain any guano or other bat sign commonly found in summer roost sites. Odd mining tools are at the adit end.

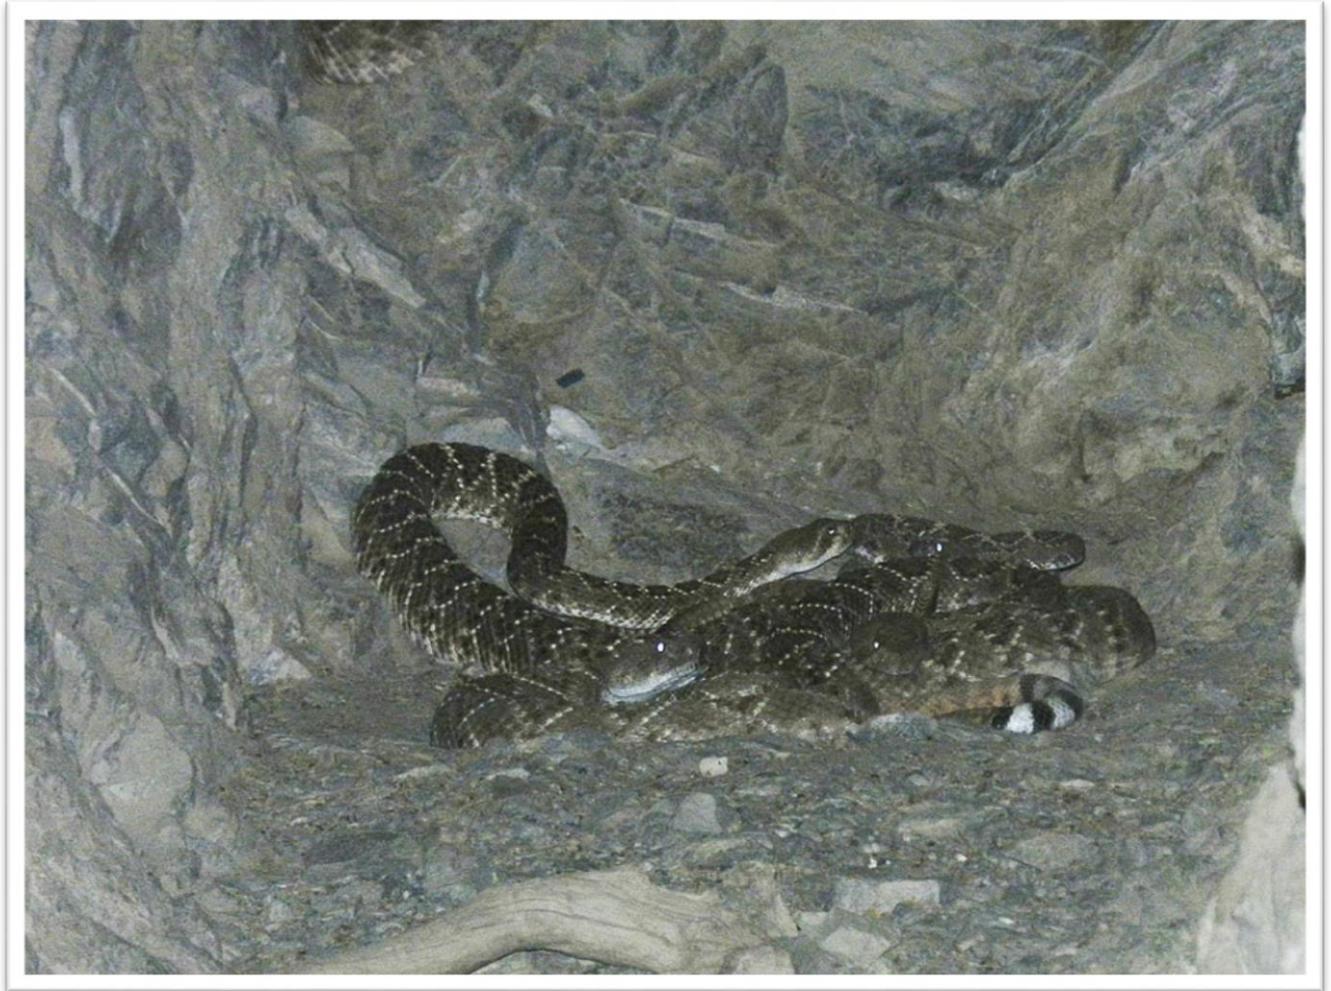
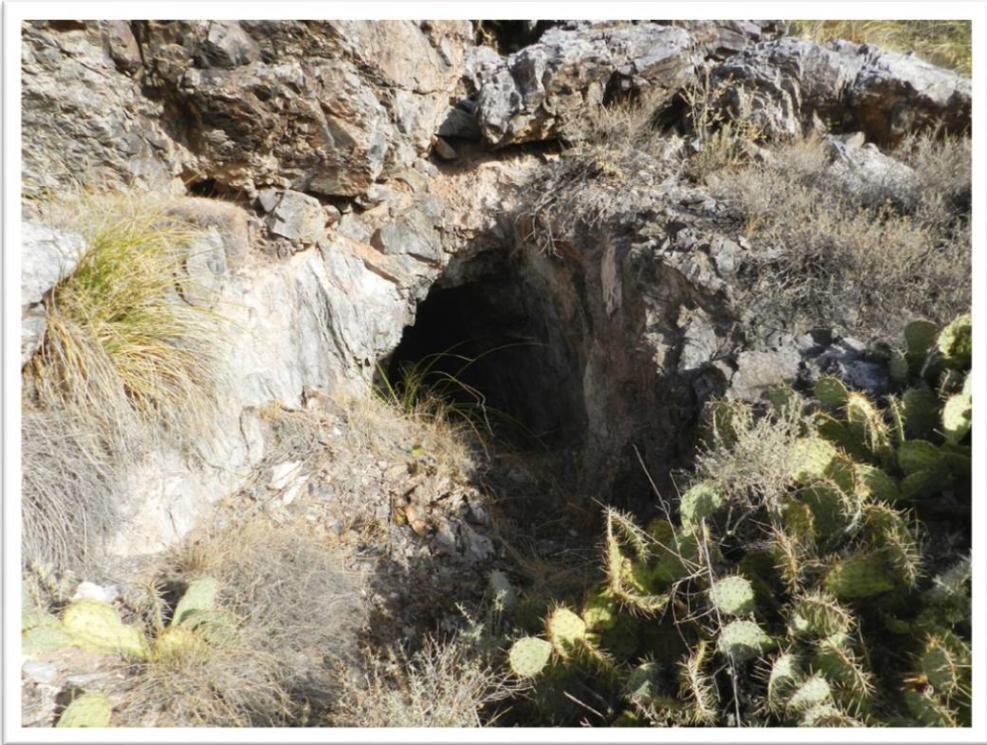
Date: 11.30.12  
Snake Count: 6+

This horizontal adit was biologically interesting as it is a rare winter rattlesnake hibernaculum. At least six Black-tailed Rattlesnakes (*Crotalus molossus*) were noted at a point 170 from the entrance, at the back of the mine.

The snake winter hibernaculum at KL37 Adit is a rare habitat site and should be protected. A large cluster of Black-tailed rattlesnakes (*Crotalus molossus*) also offers significant risk to the unwary human visitor and further supports protecting of this unique site. At a minimum, basic fencing and signage would be appropriate for a remote site such as this. If the area becomes more heavily traveled, or it is decided that the site should be further protected, then we would suggest installing a bat and snake-friendly steel adit gate.

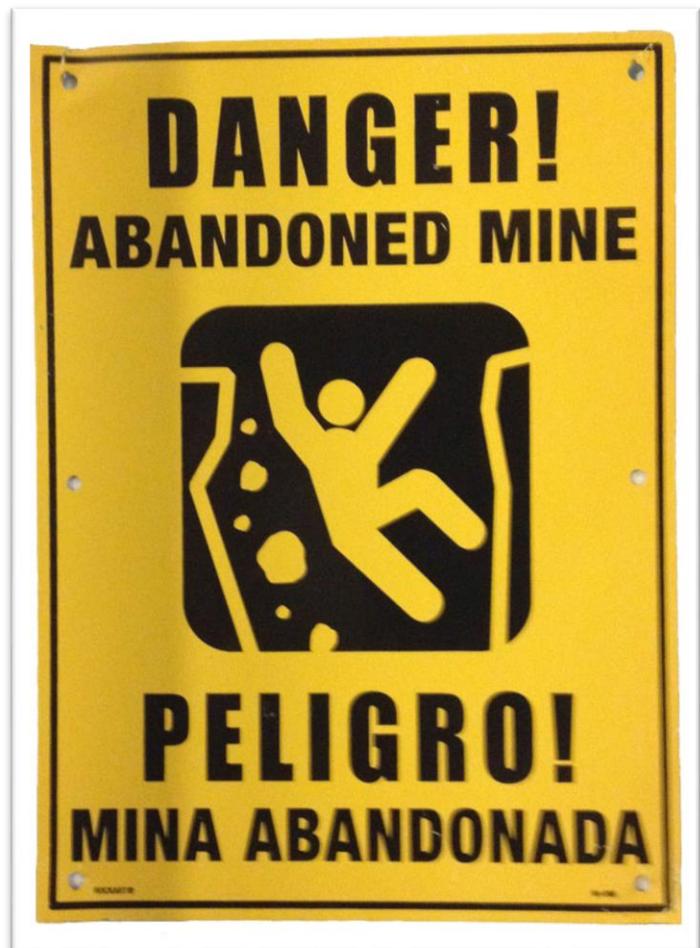
As a general guideline we recommend that nearly all vertical shafts should minimally have a fence around the site. Note that a person can be killed falling down a 20 ft. shaft, or a 200 ft. shaft so all of these features should be approached with caution. Safety signs on these fences offer good and bad results. For informational and liability reasons these signs are good to install. The drawback of these signs is that they attract curious people to these dangerous sites, and since the signs are interesting looking they are often stolen from the site. A possible solution would be to mount the signs just inside the feature so that they are not visible from afar, but still readable when the feature is approached.
