# Strategies for Greening Historic Properties Study

Department of Defense  
Legacy Resource  
Management Program

Project No. 09-452

# **A Short Guidebook for Greening Historic Properties**

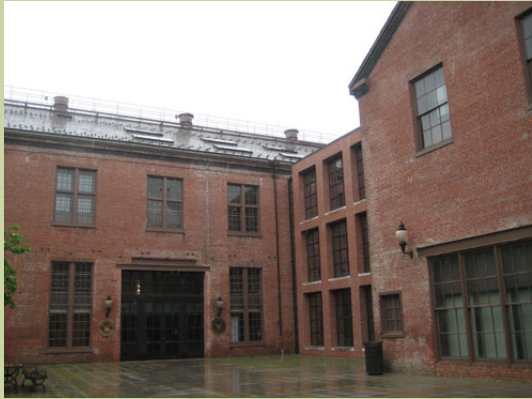
*One of the approaches adopted for "greening" the Washington Navy Yard was the addition of structures and techniques used to reduce stormwater runoff that otherwise contributed to localized soil erosion and added pollutants to the Anacostia River watershed. Innovations such as permeable paving in parking areas, street tree filters, street sweeping to remove contaminants and sediments, and the diversion of roof rainwater into soil and rain barrels, contribute to a reduction of contaminants and promote bioretention, whereby contaminants in the water are removed by passing through media or through natural biological filters (plants) in rain gardens. Installation of these measures had little or no effect upon Building 33's historic architectural characteristics.*

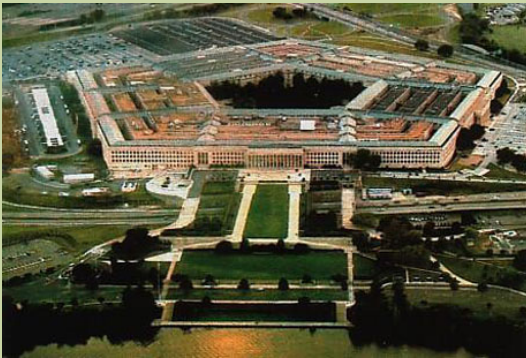
The Pentagon was built in 1943 to consolidate the widely scattered offices of the War Department (today the DoD) in the District of Columbia. Upon its completion it was the largest office building in the world, covering 29 acres and consisting of 17.5 miles of corridors. Built of reinforced concrete, it consists of five concentric five-story pentagons connected by radiating corridors, all centered on a six-acre interior courtyard. Working under

conditions of wartime building supply shortages, the Pentagon's builders substituted concrete ramps for passenger elevators and concrete drainpipes in place of metal drainpipes. At that time it was the largest office building in the world, covering 29 acres and consisting of 17.5 miles of corridors. As of 2010, Pentagon architects were attempting to achieve LEED certification with its Wedge renovations. Sustainable features and principles that have been incorporated into the Pentagon during its recent, ten-year renovation period have included public transportation, energy efficiency measures, lighting, water efficiency, envelope insulation, recycled materials, construction waste management, and indoor environmental quality.

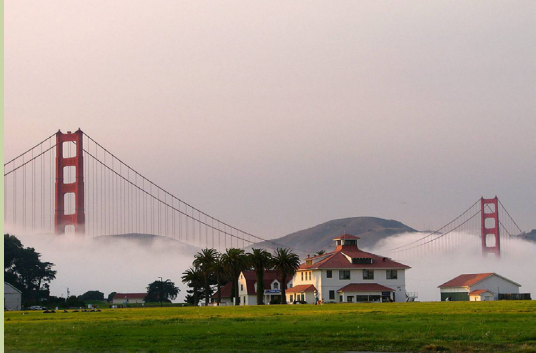
To reduce the environmental impact of old building materials, the Presidio in San Francisco uses recycled building products whenever possible. At the Thoreau Center for Sustainability, these products include: sustainably harvested EcoPanels from Architectural Forest Enterprises, and maple veneers from the Menominee Tribe; formaldehyde-free medium density composite fiberboard panels manufactured from recycled wood; fiberboard panels made from 100% recycled wood; rest room tiles made with recycled windshield glass; nontoxic, water-based tile adhesives; linoleum flooring; and other recycled and sustainable products. All remodeling projects strived to maintain the buildings' historic characteristics.

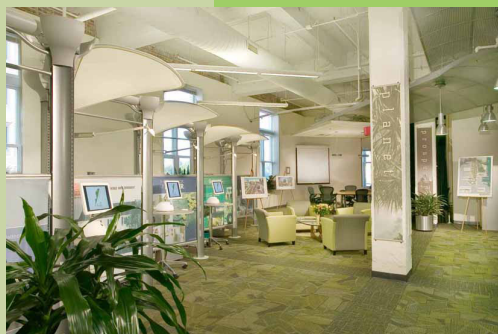
*Building 7 uses energy efficient approaches to its HVAC system. The system operates only in occupied interior spaces, and the heating and cooling of some spaces is accomplished with an efficient central chilled water system. In addition, open spaces are kept cool with large, twelve-foot diameter ceiling fans to provide constant airflow during summer months, while suspended radiant heaters are hung in key locations for special events during cooler months. All equipment is hidden on the building's exterior, minimizing visual impacts to the building's historic architectural character.*

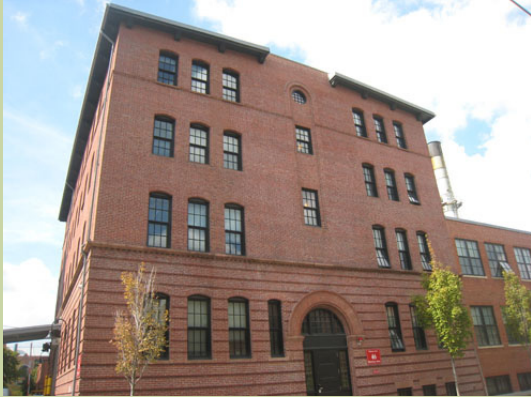
46 Blackstone South used commissioning, measurement, and verification techniques to help monitor energy use in the rehabilitation project. The building is metered to monitor energy use, while UOS simulates energy use of a baseline building and compares actual energy use data gathered with metering to calculate energy savings. Metering is used for lighting systems and controls, constant and variable motor loads, variable frequency drive operation, chiller efficiency at variable loads, cooling load, air distribution static pressures and ventilation air volumes, building-specific energy efficiency systems and equipment, and indoor water risers. Metering of operational systems usually has no effect on a building's historic features.

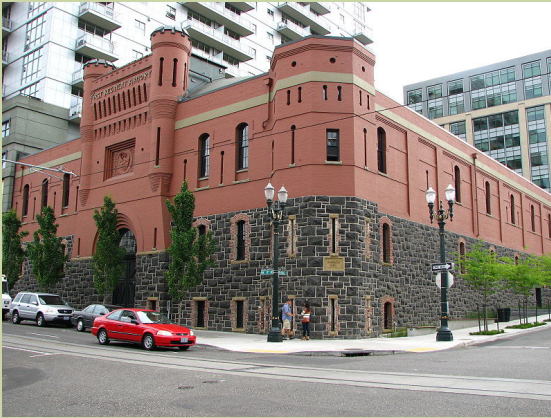
The Portland National Guard Armory Annex was constructed in 1891, enlarging the original 1887 Armory building of the Oregon National Guard. A 2002-2006 renovation converted the building into a space for the Gerding Theater. The original armory building was torn down in 1968, but the Annex remained, and the Guard sold the building to a brewery in 1996. After the brewery closed, the building was sold to the Gerding/Eden Development Company, which renovated and converted the building into a 600-seat theatre space.

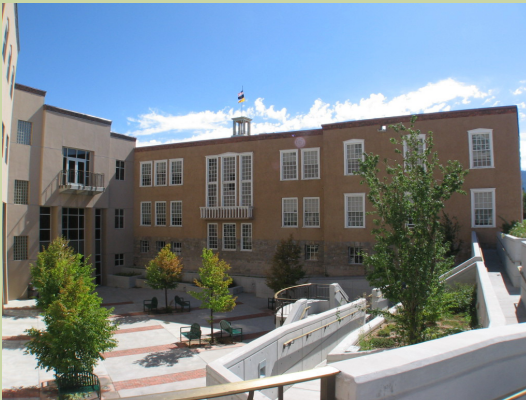
*The New Mexico Villagra Building has optimized energy performance by installing R-30 insulation in the roof, adding two inch (R-14) insulation to the top floor ceiling interior; installing R-11 insulation to the interior surface of exterior concrete walls, which was then covered in gypsum board; and by enhancing the performance of the historic windows with ceramic film applications and making them operable as originally designed. These measures had no appreciable impact upon the building's historic character.*
