# An Archaeological Curation-Needs Assessment for the Legacy Resource Management Program

Archaeological Curation-Needs Assessment Technical Report No. 15

U.S. Army Corps of Engineers St. Louis District

Mandatory Center of Expertise for the Curation and Management of Archaeological Collections

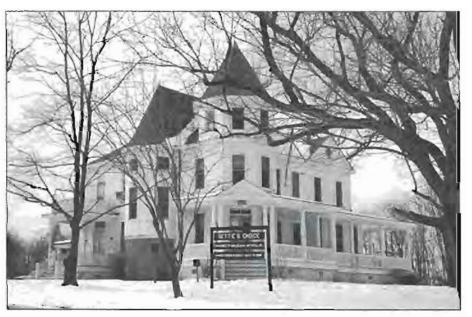
The Malcolm Mitchell House has been renovated to contain offices and exhibit areas managed by the Directorate of Safety, Health, and Environment. The foundation of the building is granite, the roof is imitation-slate tile, and exterior walls are Victorian-style wood clapboard. There are three floors aboveground and one belowground. Interior and exterior renovations are numerous. Walls and ceilings have been repaired and repainted. The gutter system, front porch ceiling, front porch pillars, and floor joints are all either additions or major modifications. The current roof is 15 years old. Overall, the structure is solid, with no cracks or leaks. There are multiple windows in the structure,

Figure 1. Exterior of the repository on Aberdeen.

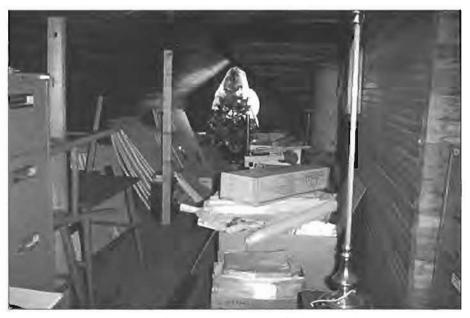
Figure 2. The collections storage area is located in the attic of the Aberdeen Cultural and Natural Resource Visitor/Learning Center.

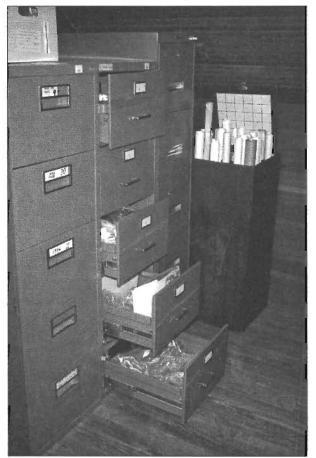
Figure 3. Some artifacts found on Aberdeen are stored in the drawers of metal file cabinets.

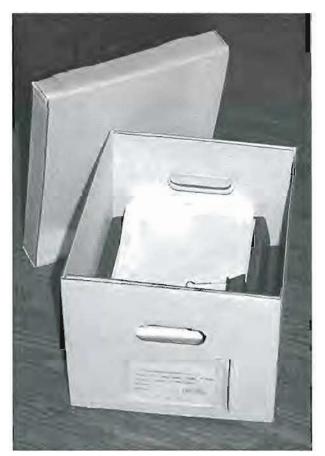
There are 12.5 linear inches of paper records, including excavation records, field notes, and artifact inventories. Primary containers consist of acid-free Hollinger boxes, labeled directly in marker with project, site number, contents, and box number (Figure 4). Secondary containers consist of acid-free envelopes and vinyl threering binders. Some paper stacks not enclosed in secondary containers are bound by metal clips, but are not labeled. Acid-free envelopes are not labeled. Vinyl binders are labeled with rub-on letters, covered with tape. Label information consists of project, contents, and copy number. Records are arranged by document type.

Figure 4. Paper records are stored in cardboard boxes on Aberdeen.

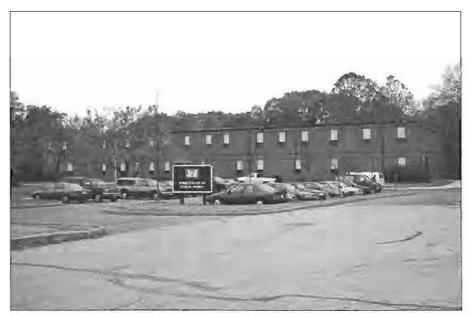
Figure 5. View of the DPW building that houses associated records and reports from Fort Belvoir.

The Directorate of Public Works (DPW) on Fort Belvoir is located in an administrative office building on the Fort Belvoir military installation (Figure 5). Only associated records and reports are stored in the offices of the DPW.

The office building in which the DPW is located encompasses approximately 26,400 ft<sup>2</sup>. The structure, which is approximately 30 years old. has a concrete foundation and brick exterior walls. The roof is built-up asphalt, with instances of leaks and cracking having been reported in the past. The repository has a total of two floors aboveground. The collections storage area is on the first floor. Windows were upgraded to aluminum frames in 1985, and there is some indication that air leaks into the building through these windows. The collections storage area is an unused office currently storing office furniture and associated documentation. The floor is carpeted concrete. The interior walls are plasterboard, and the ceiling is suspended acoustical

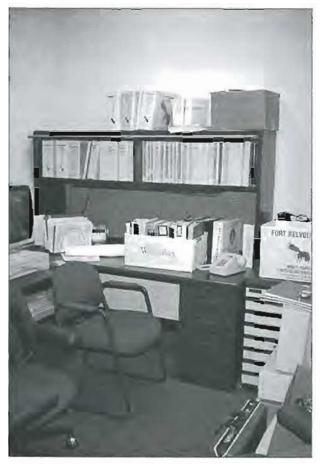
Approximately 4.6 linear feet of associated documentation from archaeological investigations conducted on Fort Belvoir are stored in an unused, approximately 10-x-10-foot ( $100-ft^2$ ) office at the DPW (Figure 6). All environmental controls for this room are the same as those for the remainder of the structure. There are functioning overhead pipes in this collections storage area that have leaked in the past. This collections storage area has no fire-suppression systems.

Figure 6. Associated documentation is stored in an extra office at the DPW.

2. Overhead pipes pose a potential problem; leakage in the collections storage area has occurred in the past.

2. Overhead pipes need to be protected and rendered more leak resistant.

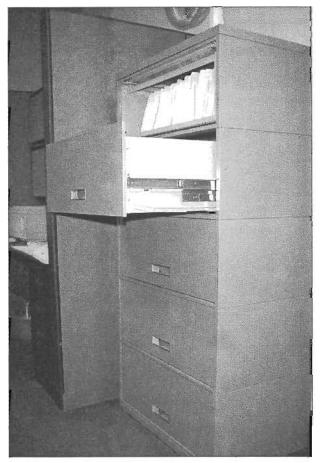
Figure 7. Active files are stored in hanging files in metal file cabinets at the DPW.

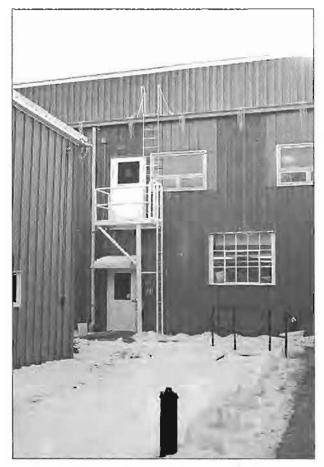
Building 201 was originally constructed in the 1930s (Figure 8). The foundation is concrete, and the approximately 5-year-old roof is builtup asphalt. Exterior walls are corrugated metal over asbestos board. Clay structural tile inside the exterior walls is also covered. The roof and foundation are solid, with no cracks or leaks.

Figure 8. Entrance to repository on Fort Detrick.

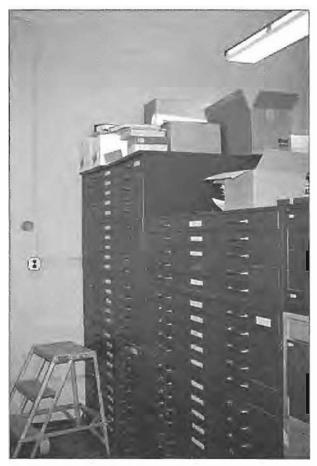
Archaeological collections are stored in a cardboard box located on the top of several 7-foot-tall, metal file cabinets in the rear of the collections storage area (Figure 9).

Artifacts are stored in one acidic-cardboard box with a volume of 1 ft<sup>3</sup>. The box has folded flaps, and is directly labeled "archaeological survey" in marker.

Figure 9. Collections are stored in a box on top of the highest of the flat map cabinets.

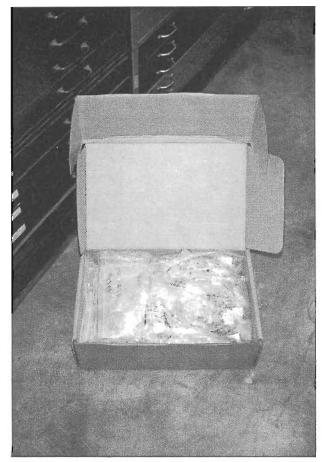
Figure 10. An open acidic-cardboard primary container reveals zip-lock plastic bags used as secondary containers on Fort Detrick.

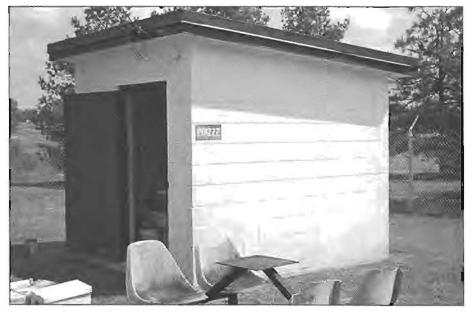
Storage Location 1, the well house, is a small stand-alone structure (Figure 11) associated with a much larger building housing offices and meeting space. It is located within a compound that is enclosed by a fence with barbed wire on its top. Approximately 20 years old, the well house

Figure 11. Exterior of Storage Location 1, the well house, on Fort A. P. Hill.

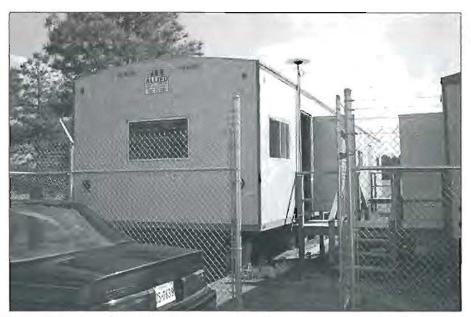
Storage Location 2 is a standard trailer-housesized structure made primarily of corrugated metal (Figure 12). It rests on concrete blocks. There is one floor, with a set of wood steps leading up to the two exterior doors. There are multiple

Figure 12. View of Storage Location 2, a rented trailer, where associated records are stored.

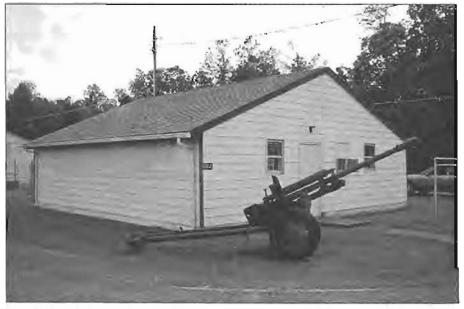
The Fort A. P. Hill Museum, Storage Location 3, is a small, one-room facility located in the main cantonment area of the installation (Figure 13). Although originally used as a Class 6 (liquor) store, it was later converted into a museum. The foundation is poured concrete and concrete block. Exterior walls are constructed of aluminum siding over wood. The roof, composed of shingles, is original to the building.

Figure 13. View of Storage Location 3, the Fort A. P. Hill Museum.

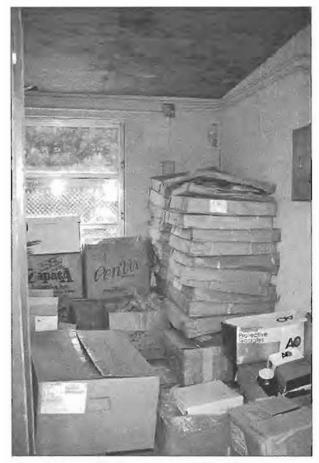
Boxes of artifacts are stacked on the concrete floor of Storage Location 1 (Figure 15). In Storage Location 3, artifacts are exhibited in a woodand-glass storage case measuring  $3.1 \times 1.1 \times$ 3.4 feet (w × d × h).

Figure 15. Damaged artifact boxes are stacked against the wall in Storage Location 1.

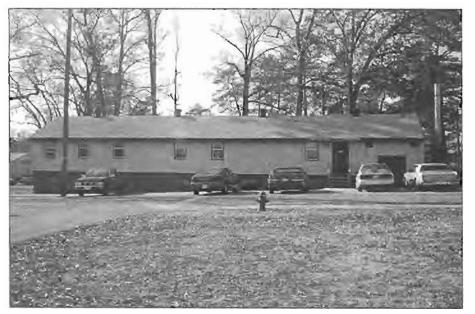
Building 239, which encompasses approximately 2,125 ft<sup>2</sup>, is not an official repository (Figure 17). Activity areas in the structure include offices, a reception area, a conference area, and rest rooms. Collections are currently being stored in the closet within one of the offices.

Figure 17. Exterior of Building 239, Fort Meade's environmental offices, where collections are stored.

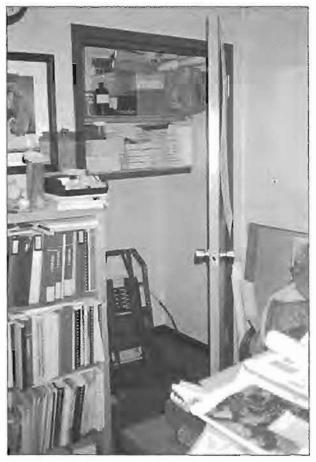
Artifacts and records are stored in a closet in William Harmeyer's office, in Building 239 (Figure 18). The 2-x-4-foot  $(8-ft^2)$  closet also contains personal items, office supplies, and field equipment.

Figure 18. Office closet used for the storage of artifact and record collections on Fort Meade.

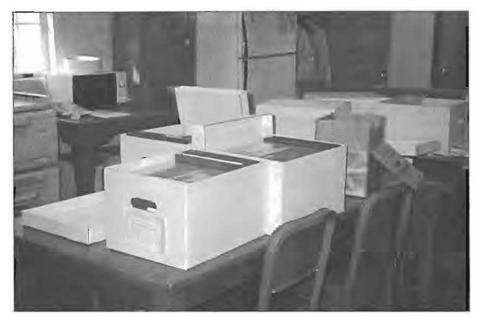
Approximately 3.4 ft<sup>3</sup> of artifacts recovered on Fort Meade are stored in acid-free Hollinger cardboard boxes with telescoping lids (Figure 19). These boxes are labeled with contents, site number and provenience. Labels are acid-

Figure 19. Cardboard boxes are used as primary containers for artifacts and associated documentation on Fort Meade.

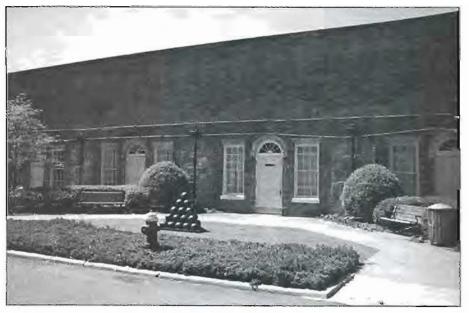
The original fortification dates to the period 1818-1834. The foundation and exterior walls are primarily composed of brick and stone. Bricks have been removed from several sections of the fortification roof and been replaced with poured concrete. On many original sections, however, roofing remains composed of bricks that are covered with earth. The museum has had multiple renovations and expansions since 1951, the latest during 1982-1983 when several rooms were added. There is only one floor for the entire fortification. Multiple windows are present in the inward-facing walls of the museum, and approximately one-third as many face outward to the fort's exterior. Windows and their frames were replaced approximately two years prior to the assessment team's site visit. The structure is solid, but there are multiple cracks in the brick walls and roofs. In addition, there is some water seepage from the brick roof, where it is overlain by earth.

Figure 20. Exterior of the Casemate Museum, Fort Monroe.

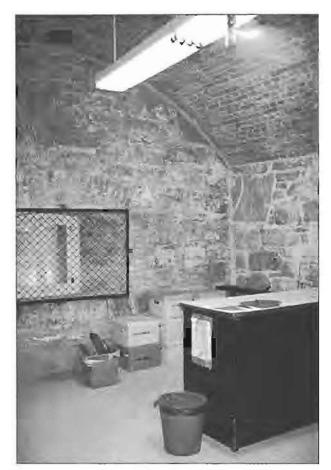
Figure 21. Collections storage area for arms within the Casemate Museum.

The collections storage area is a series of casemates separated from the offices and exhibit sections of the museum by a wood-panel door (Figure 21). Total space for collections storage measures 3,600 ft<sup>2</sup>, and includes four casemates and one arms room. The arms room is separated from the collections storage area by a metalpanel door. The interior sections of the collections storage area are divided by brick archways. There are four wood-panel doors in the collections storage area that open to the exterior of the museum. The collections storage area is filled to approximately 90 percent capacity with archaeological and ethnographic collections, each composing approximately one-half of the materials.

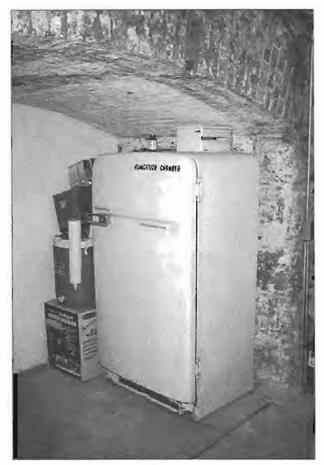
The Casemate Museum has an integrated pestmanagement program that includes monitoring and control (Figure 22). Sticky traps are the primary monitoring method. Pest control, usually in the form of sprays and "bombs," is conducted by the post entomologist. When needed, poisons are used in restricted areas. At the time of the site visit, the farmost casemate in the collections storage area had a serious problem, as birds had infiltrated the area, died, and were a health concern. An archway was covered and quarantined to protect against disease. It should be noted, however, that this was reportedly an isolated occurrence.

Figure 22. View of the fumigation chamber at the Casemate Museum.

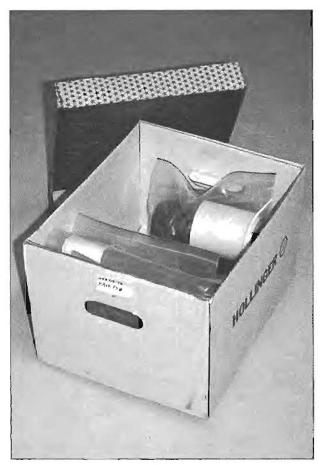
Figure 24. Cardboard boxes and zip-lock plastic bags are used to store artifacts on Fort Monroe.

Within the moat collection, secondary containers are either not present or consist of acidfree-construction-paper dividers or Styrofoam "peanuts." Secondary containers for the survey collection are either not present or consist of zip-lock plastic bags (Figures 24 and 25). The zip-lock plastic bags generally have interior, acidic-paper tags with provenience recorded in pen. Table 8 outlines the percentages of secondary-container types in the on-base collections.

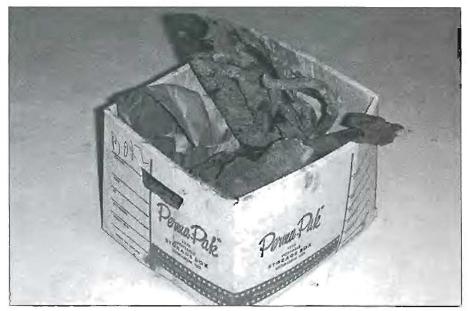
Figure 25. Oversized metal artifacts are stored loose within a cardboard box.

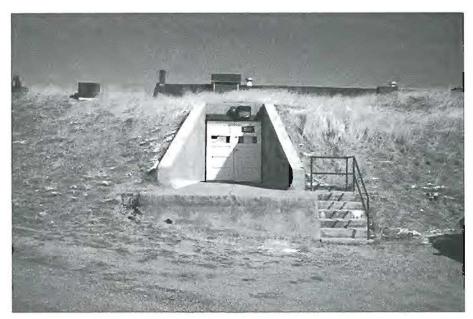
Figure 27. The entrance to Building 261, the curation facility on Warren AFB, appears to lead into a hill. Approximately 3 feet of earth cover this facility.

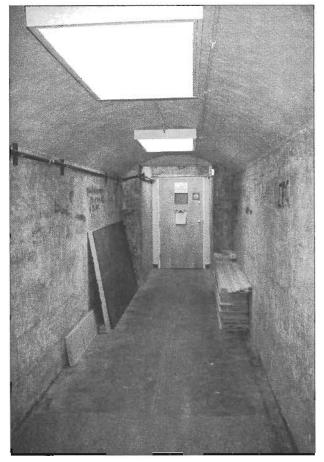
Figure 29. The exterior door of Building 261 leads into a concrete tunnel that has a second locked door securing entrance to the curation facility. The concrete walls have graffiti dating to 1907 that was discovered during the rehabilitation of the facility in 1992.

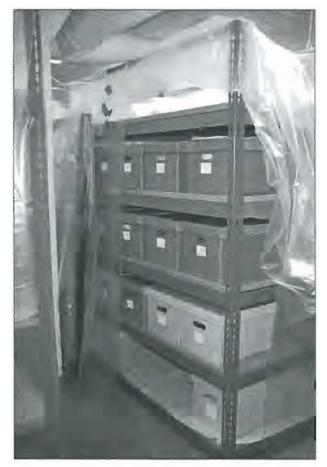
Figure 30. Collections are stored in cardboard boxes on metal shelving units in Collections Storage Area 2. Note that some of the shelves are lined with sheets of ethafoam and covered with heavy sheets of plastic to protect against dust.

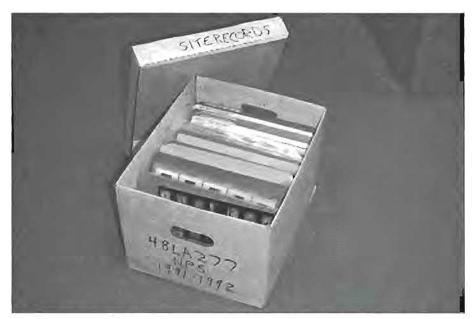
records, and field notes. Paper records are stored in acid-free boxes in Collections Storage Area 2 (Figure 32) and on wood shelves in Collections Storage Area 1. Boxed records are generally stored in manila files labeled with adhesive tags written on in marker. Some of the records not in files are bound together with rubber bands. Records in Collections Storage Area 1 are kept in plastic-covered, three-ring binders (Figure 33). Different types of records are separated with tabbed, labeled pages. Binders stand upright and are labeled and arranged by project. Artifact catalogs are filed in a standard, four-drawer, metal file cabinet. The acid-free files are labeled directly in red pencil.

Figure 32. Some of the associated records for Warren AFB have been placed in cardboard boxes and are stored on metal shelving units in Collections Storage Area 2.

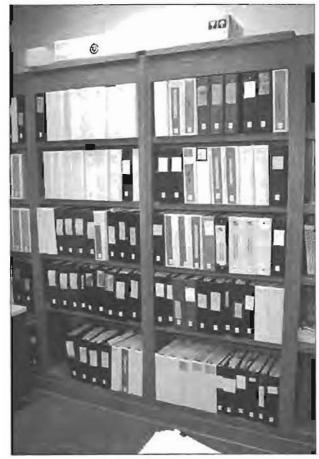
Figure 33. Associated documentation from projects conducted on Warren AFB is stored in plastic-covered three-ring binders on wood shelves in Collections Storage Area 1. Binders are numbered with white adhesive labels.

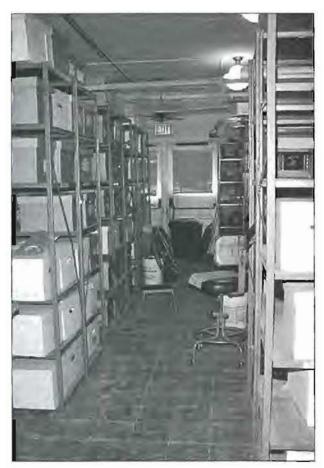
Figure 35. Collections Storage Area 1 is crowded with boxed collections and field equipment. A significant amount of dust covers the peeling asbestos floor tiles. The back, exterior door is kept locked.

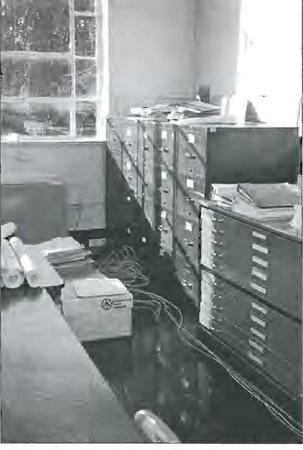
Prehistoric-site files are stored in a legalsized, metal file cabinet. Historical-period files are in a letter-sized cabinet (Figure 37). Labels on the secondary containers range from being directly written on in marker to adhesive labels with information written in pencil. Manila folders are used to file paper and photographic records.

Figure 37. Associated records for historicalperiod sites are stored in metal file cabinets located upstairs in an office and lab area (Collections Storage Area 3).

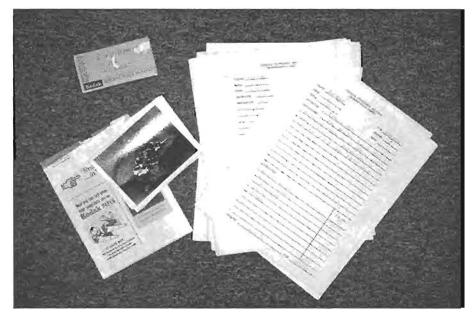
Figure 41. Associated documentation is kept in an acidic envelope that is stored in a file cabinet at FLSHA.

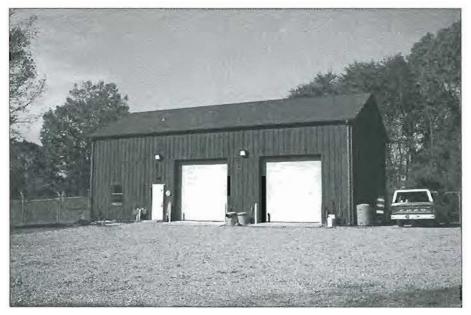
Storage Location 2, the maintenance building, was built in 1985 and encompasses approximately 2,500 ft<sup>2</sup> (Figure 42). The foundation is

Figure 42. Exterior view of Storage Location 2, the maintenance building, at FLSHA.

concrete block; the exterior walls are cinder block with wood siding. The shingled roof is original to the structure. No problems with water leakage through the roof have been reported. The single-story structure has a metal, cagedin loft that contains the collections storage area. The floor of the 125-ft<sup>2</sup> loft consists of steel beams with poured concrete. The ceiling is

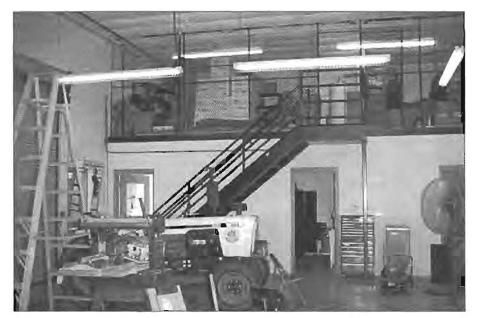
Figure 43. Artifact collections are stored on shelves in the loft of Storage Location 2.

Enameled-metal shelving units are used to store the archaeological collections in the loft of Storage Location 2 (Figure 43).

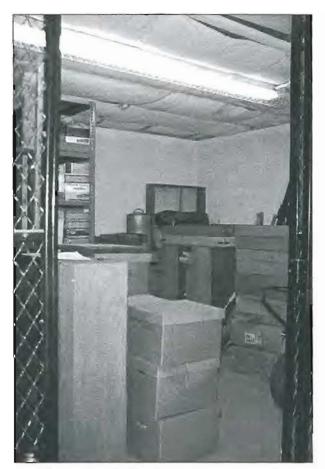
Figure 44. Collections storage area in Storage Location 2.

Acidic-cardboard boxes that are stapled, folded, and have removable, telescoping lids are used as primary containers (Figure 44). Labels are written directly on the boxes in marker. Boxes are very dusty; spider webs and insects were observed in the boxes. Water stains and tape are also on the boxes.

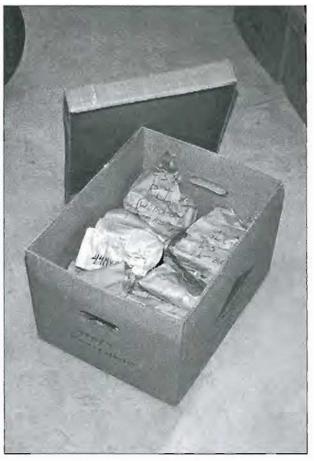
Figure 45. Cardboard boxes and paper bags are the primary and secondary containers used to store the artifact collections recovered from Radford.

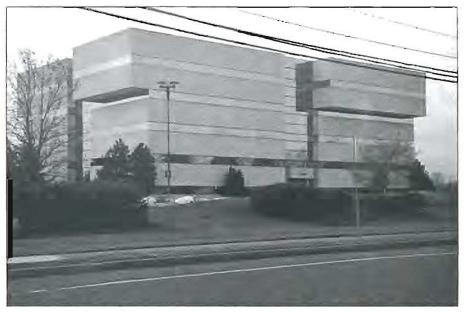
Figure 46. View of the office building where Foster Wheeler is located.

Storage Location 1, built in 1983, is a large office building encompassing 106,806 ft<sup>2</sup> (Figure 46). Foster Wheeler occupies approximately

58,000  $ft^2$  on the third, fourth, and fifth floors. The building has a poured concrete foundation, concrete block walls, and a flat roof that is original to the building's construction. The building is structurally solid, with no signs of cracks or leaks. There is a total of five floors, all aboveground, with bands windows on all four sides of the building.

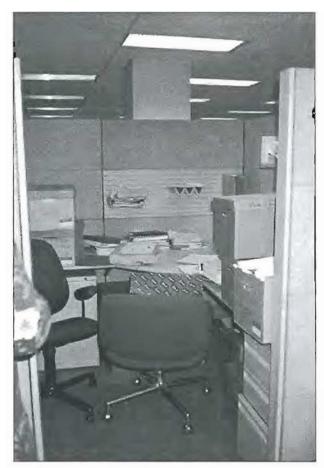
Figure 47. Associated records are boxed and stored in an extra office cubicle in Storage Location 1.

Records are stored by project. Associated records for the Adelphi Labs survey are stored in an acidic-cardboard box similar to the one used for artifact storage (Figure 47). The label is written directly on the box in marker (Figure 48). Records are filed in acidic, hanging files within the box. All of the records are in generally good condition; however, duplicate copies have not been produced. Some of the field notes still have dirt and dust on them, and contaminants (e.g., staples, paper clips, and rubber bands) are present on the original documentation.

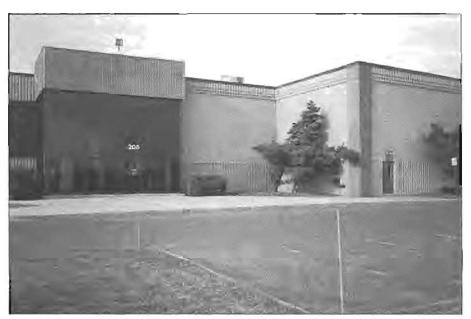
Figure 49. Artifact collections are temporarily stored in Storage Location 2. This office building is in the same office complex as Storage Location 1. The single door on the right is the only entrance to the Foster Wheeler collections storage area.

Storage Location 2 encompasses 151,705 ft<sup>2</sup>, and also has a poured-concrete foundation with concrete exterior walls and a flat roof that was recently replaced (Figure 49). Foster Wheeler

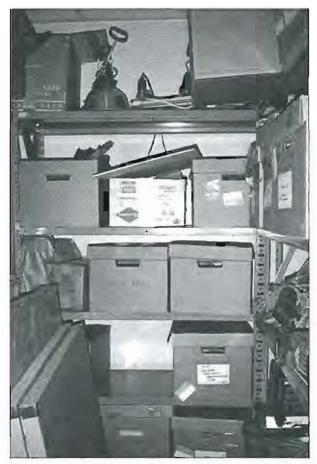
Figure 50. Metal shelving unit where artifact collections are temporarily stored in Storage Location 2.

Boxes of artifacts are stored on metal shelving units in a small room designed to be a temporary storage space in Storage Location 2 (Figure 50). During our site visit, however, three of the four boxes of artifacts—representing about 4.2 ft<sup>3</sup> of materials—recovered from Adelphi Labs were missing. Refer to Table 14 for the percentages of artifact material classes present in the single-box collection.

4. Two of the four boxes of artifacts recovered from Adelphi Labs are missing.

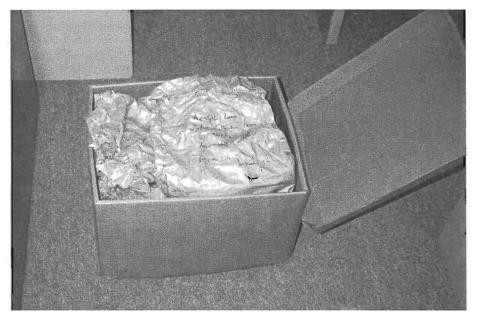
Figure 51. Artifacts from Adelphi Labs are stored in cardboard boxes and paper bags in Storage Location 2.

The primary container is an acidic-cardboard box with a telescoping lid (Figure 51). The box label was written directly on the box in marker. The box is slightly damaged and torn. One end of the box lid is held on with clear packing tape.

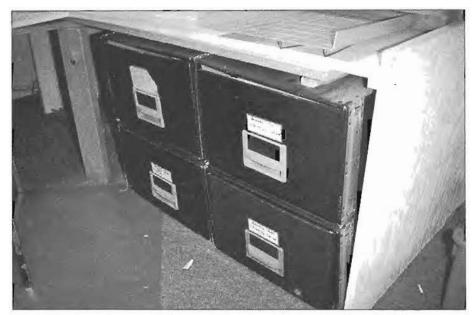
Figure 53. Cardboard storage units are used to house associated documentation at GRI.

The archaeological documentation associated with Bloodsworth Island NR and Blossom Point is stored in acidic-paper file folders and envelopes, which in turn are filed in stacked cardboard storage units that are sitting directly on the carpeted floor of the small storage room (Figure 53). Documentation totals 29.25 linear inches, of which 13.5 linear inches are associated with Bloodsworth Island NR, and 15.75 linear inches are associated with Blossom Point.

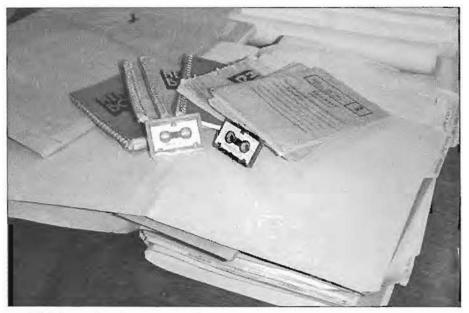
Figure 54. Field notebooks and audiocassettes are examples of the different types of associated documentation located at GRI.

excavation, and analysis records (Figure 54). There are approximately 5.75 linear inches of paper records associated with Bloodsworth Island NR, and 8.5 linear inches associated with Blossom Point.

Two microcassette audiotapes are included in the documentation collection (see Figure 54).

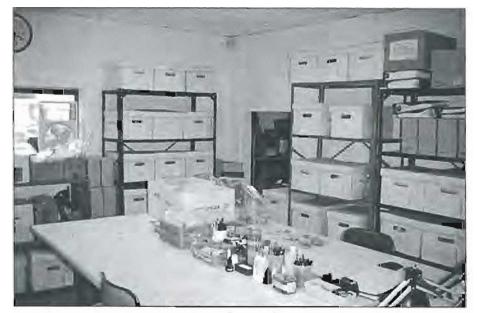
Figure 57. View of the collections storage area and laboratory at Goodwin. Boxed collections are stored temporarily on metal shelving units until they are sent to a permanent repository.

Archaeological collections and associated documentation are stored on standard enameledmetal shelving units (Figure 57) measuring approximately  $3 \times 1.3 \times 5.8$  feet ( $w \times d \times h$ ). Each unit is five shelves high, and boxes are stacked one to two high.

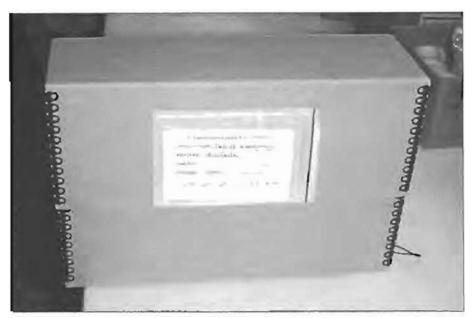
Figure 58. Acid-free primary containers are used to house artifacts recovered from an emergency project on Fort Detrick.

Except for one, primary containers are acid-free Hollinger boxes, with telescoping lids, and a capacity of 1.2 ft<sup>3</sup> each (Figure 58). They are constructed by folding and glueing. None of the boxes appears damaged. Each box is labeled with a preprinted, acid-free-paper tag placed in a zip-lock bag adhered to the front of the box (Figure 59). Pertinent information is written legibly on the label in black marker. Label information generally includes project name, contents of the box, bag numbers, site numbers, and remarks. The single non-Hollinger container is an acidfree envelope folder with a folding lid and a capacity of 0.5 ft<sup>3</sup>; labels and accompanying information is the same as for the Hollinger boxes. Collections are arranged by project on the storage units (e.g., Aberdeen, Fort Detrick).

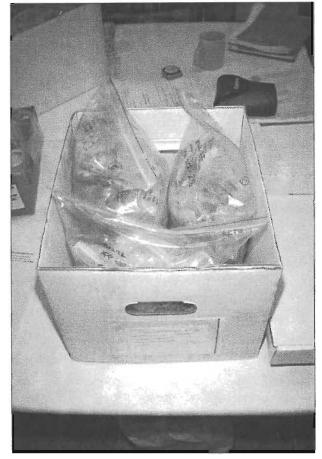
Figure 59. Zip-lock plastic bags labeled directly with black marker are used as secondary containers for the artifact collections at Goodwin. The box label is inside a zip-lock bag that is stuck to the front of the box.

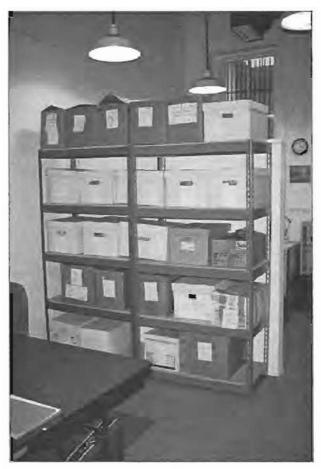
Figure 61. Temporary storage of materials awaiting processing at G&P.

Primary containers for artifacts are stored on two baked-enamel metal uprights with particleboard shelves (Figure 61). The shelves measure  $36 \times 18 \times 71$  inches (w x d x h) and are located in the collections storage area.

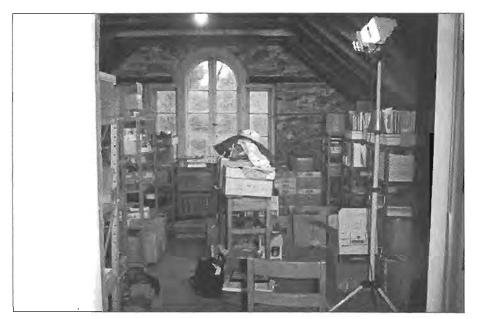
Figure 64. View of the mansion's attic where collections recovered from Aberdeen are stored. Note the borrowed, free-standing halogen lights used to help illuminate the room.

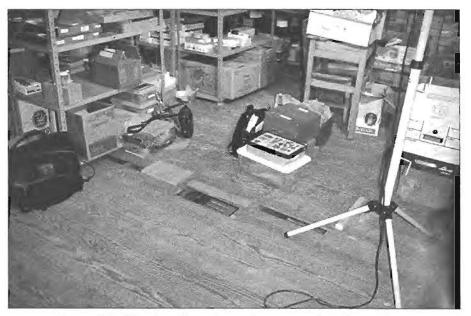
Figure 65. Missing floor boards are a safety hazard and the result of current repair work on the electrical system.

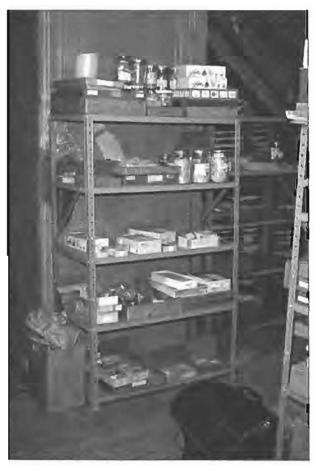
Figure 66. Metal shelving units are used to hold the variety of primary containers storing the Aberdeen collection.

Archaeological collections are stored on adjustable metal shelving units measuring  $3 \times 1.5 \times 5$  feet (w × d × h) (Figure 66). Shelves are not labeled.

Approximately 26 ft<sup>3</sup> of archaeological artifacts and human skeletal remains recovered from Aberdeen are stored in a variety of containers including acidic-cardboard boxes without lids, glass mason jars, plastic pencil boxes, wood cases, plastic vials with lids, and glass Riker boxes. The containers are arranged haphazardly on the shelves, making the identification of

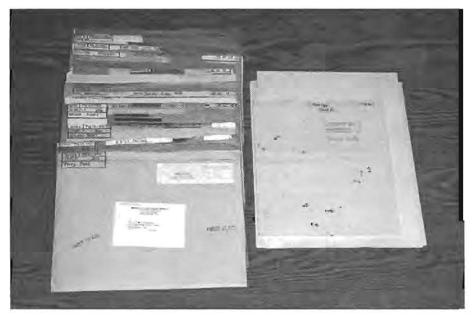
Figure 67. Original paper records associated with Aberdeen sites are filed in acidic envelopes and labeled with Cresthull's unique numbering system.
