Fort Leavenworth,  
Building # 1  
1 Scott Avenue  
Leavenworth  
Leavenworth County  
Kansas

HABS No. KS-53-K

HISTORIC AMERICAN BUILDINGS SURVEY

FORT LEAVENWORTH, BUILDING # 1

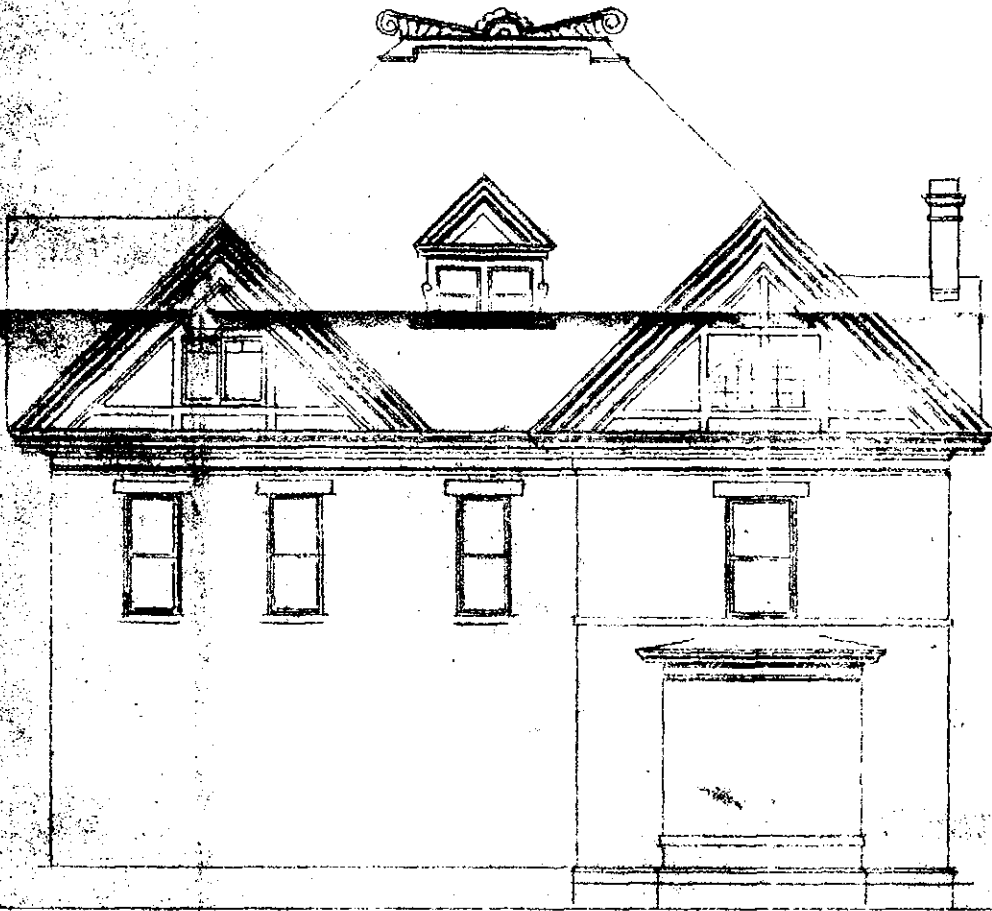
EAST FRONT

6. East front elevation

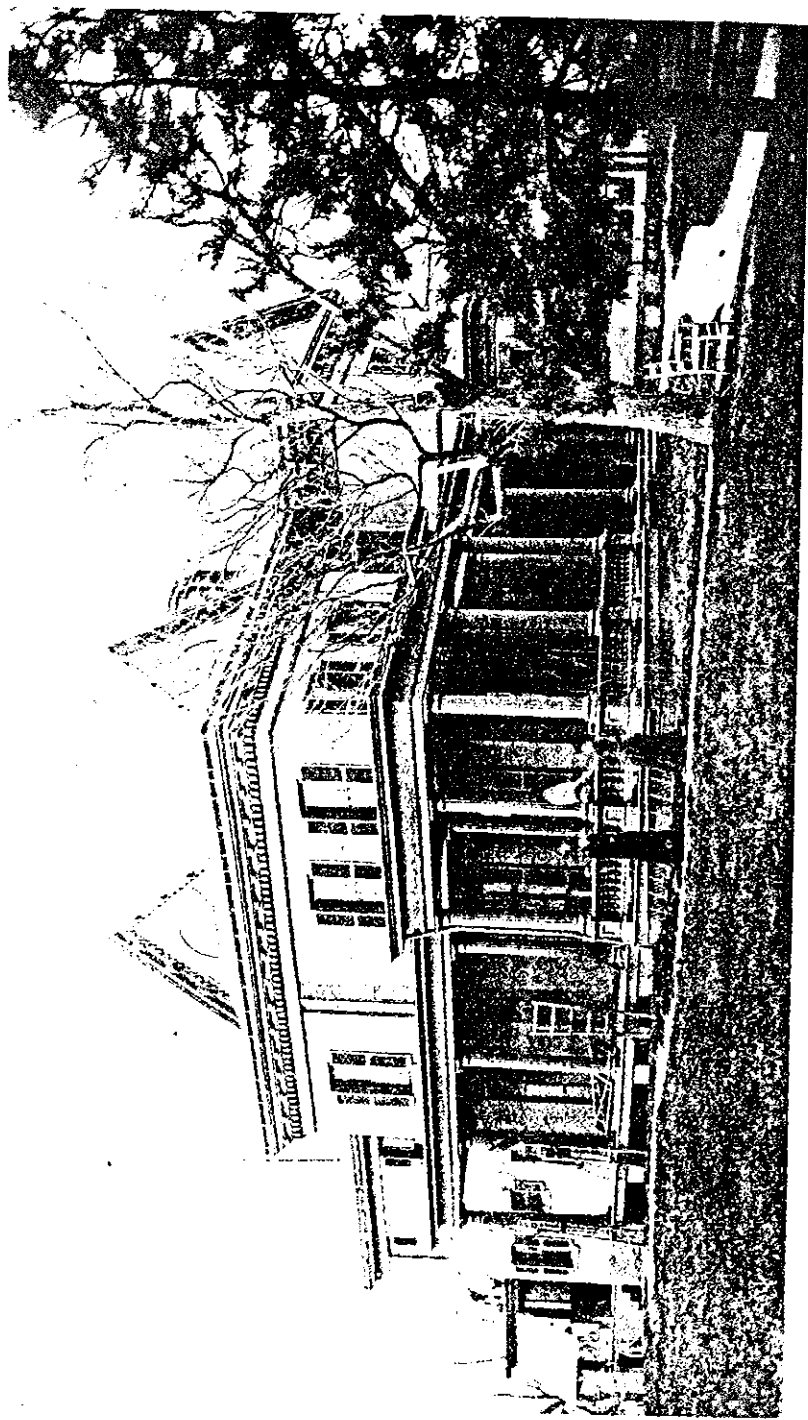
13. Photograph, east elevation from southeast corner, undated

The house has had no major alterations since 1906, however, between 1862, when the house was originally erected, and 1906 major changes occurred. The main block of the residence was originally designed as an asymmetrical, irregularly massed building with two bays across the south facade and a very shallow pitched roof. The general character of the residence reflected Italianate style, although the details were classical, including Tuscan porch columns, dentils and modillions on the horizontal cornice and lintel windows (see Supplemental Material # 11). A group of undated plans that appear to be proposals for enlarging the house, includes a plan illustrating the approximate present configuration. Excluded are two additions that occurred in 1887 and 1906. The proposed plan shows the main block enlarged to four bays on the south elevation. The remodeling occurred sometime before 1881 as Dammeier's "Bird's Eye View" illustrates a four bay south elevation of the main block (see Supplemental Material # 12). In 1887, drawings show the roof was altered and additions built into the service wing (R.G. Bow 92, Box 548). The house after the 1887 modification retained many classical features such as the modillions and dentils and porch columns. Other alterations include replacing windows on the east projecting bay and north wall with Queen Anne windows; altering the roof from low pitch to a steeply pitched one, with dormers that have half-timbering gable decoration and iron cresting on the ridge of the roof and finally, an elaborately decorated chimney constructed on the north elevation. By 1906 the irregular massing was all that remained of the original Italianate character, after the 1887 remodeling the residence was completely transformed to a very large residence with Classical and Queen Anne features (see Supplemental Material # 13).
