Archaeological Curation-Needs Assessment Technical Report No. 8

US Army Corps
of Engineers
St. Louis District

**AN ARCHAEOLOGICAL CURATION-NEEDS ASSESSMENT
FOR THE
LEGACY RESOURCE MANAGEMENT PROGRAM**

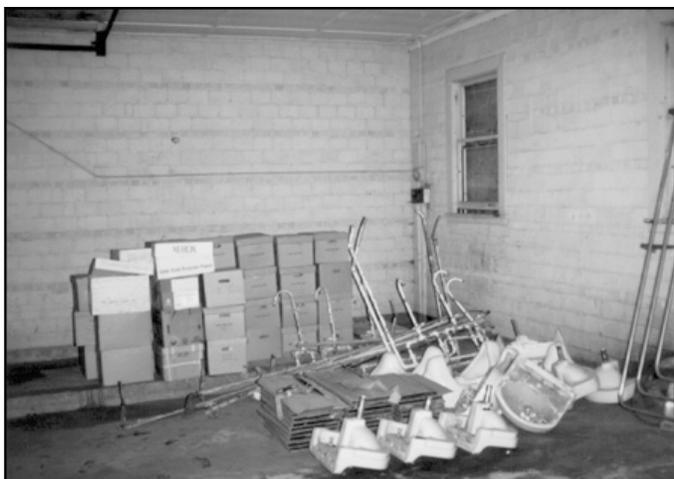
Figure 6. Fort Lewis collections stored on floor in Building T4294.

Approximately one half (55%) of the artifacts are clean. The majority (67%) of the artifacts are sorted by material class. Only 12% of the artifacts are labeled. Labeling consists of direct ink on correction fluid, sometimes covered with nail polish.

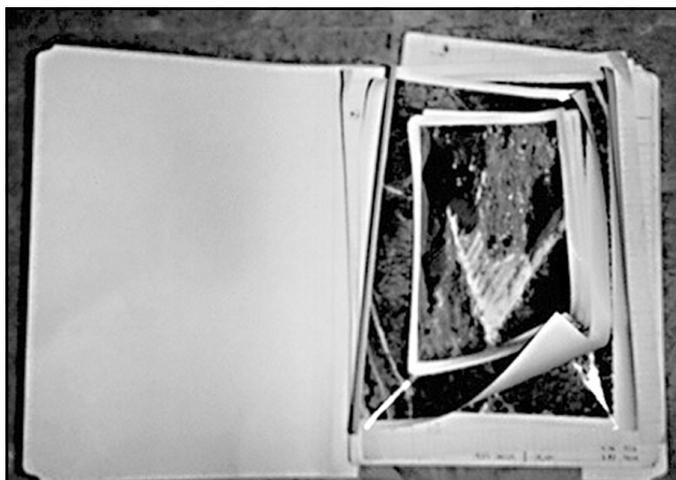
Figure 10. Condition of Fort Lewis photographic documents (note curling edges).

Several black-and-white, 4x6 inch and 8x10 inch photographs were found in a manila folder in an artifact box. The folder is labeled in pencil with the contents. The photographs, which are curling at the edges, are labeled with a stamp containing the date, the subject, and the photographer.

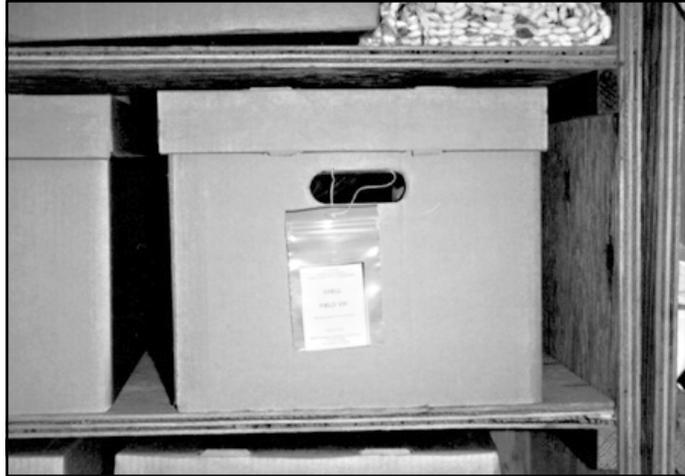
Figure 13. Type of box label used for NSB San Diego collections.

Box labels for material stored in the acidic cardboard boxes consist of acid-free tags inserted into polyethylene plastic zip-lock bags (Figure 13). The plastic label holders are affixed to the boxes by string looped through a hole in the lip of the bag and around the box handle. Label information, which is computer generated, consists of the site name, the general box contents, and the provenience. The wood boxes with architectural materials have computer generated labels affixed to the front of each box with cellophane tape. Label information consists of the site name, the contents, and a statement mentioning that these materials are in need of processing.

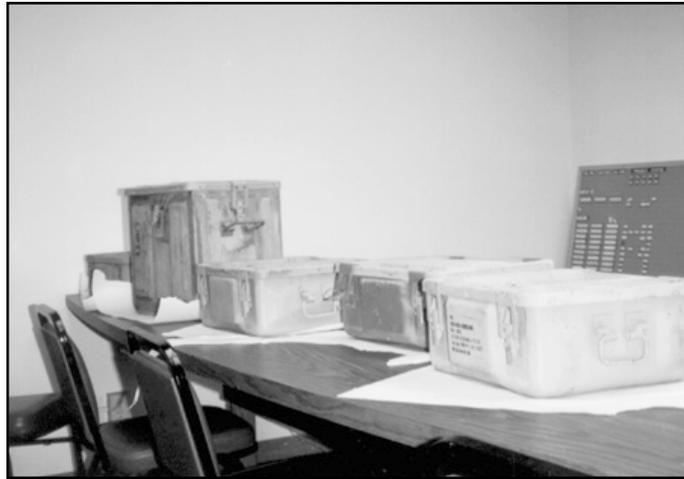
Figure 16. Type of primary containers used for collections in the storage locker.

Primary containers consist of five molded-metal ammunition containers with telescoping lids and fixed latches (Figure 16). Four of the containers have a volume of 0.6 ft³, whereas one has a volume of 1.4 ft³. Labels are stamped and contain information on the type of ammunition previously stored in them. One container is also labeled in marker with the word "artifacts" written on it. The primary containers are very dirty, a result of being placed in a storage locker with walls that do not meet the ceiling.

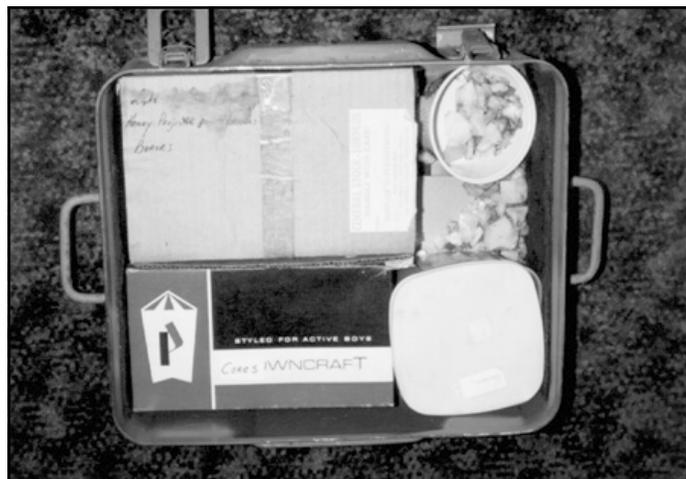
Figure 17. Types of secondary containers for collections in the storage locker.

Five types of secondary containers (Figure 17) are present (Table 15). The majority (60%) of the containers include adhesive labels written in marker and/or pen stating content information. All are either directly labeled or contain adhesive labels. The plastic bags with twist ties are punctured, allowing artifacts to spill out into the primary container, losing any provenience information.

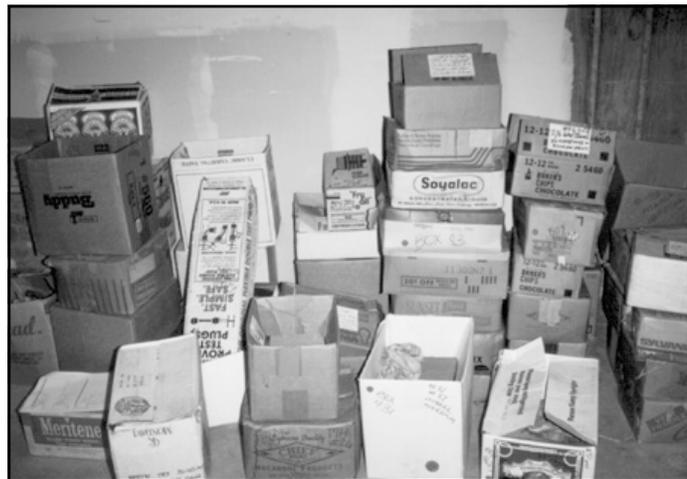
Figure 21. Admiral Baker Field collections in the library repository

The concrete slab floor serves as the storage unit. The archaeological materials from Admiral Baker Field are stored in boxes stacked three to seven high on the floor along the south wall of the collections storage area (Figure 21).

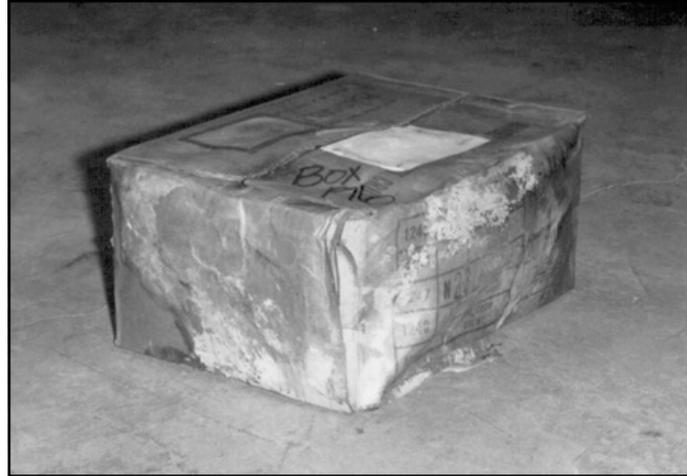
Figure 22. Example of water-damaged box in library collections area

The primary containers for archaeological materials from Admiral Baker Field consist of 152 various sized acidic cardboard boxes with either telescoping or flap lids. Box labels vary from paper tags stapled to the boxes, to adhesive labels, to boxes that are directly labeled. Label information included provenience and box contents, and was written in grease pencil or marker. Some boxes have been damaged by water and mold (Figure 22).

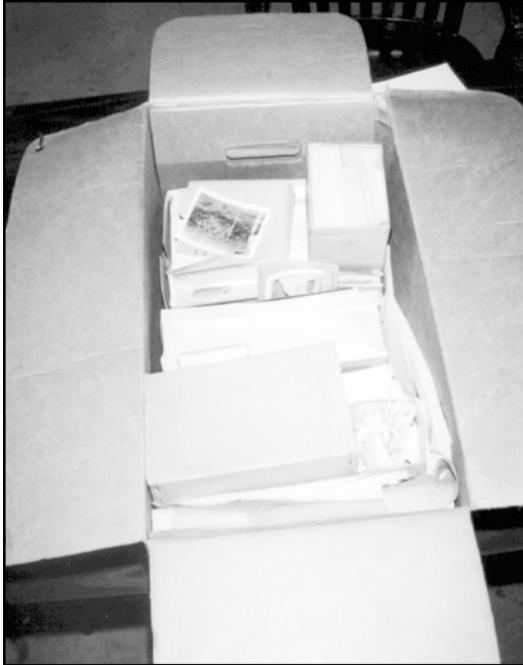
Figure 24. Types of secondary containers used for collections

A variety of secondary containers (Figure 24) are used to store the archaeological materials from Admiral Baker Field (Table 17). The majority (77.9%) of the secondary containers are not labeled. However, 21.8% are directly labeled with marker with the site number, provenience, and date information.

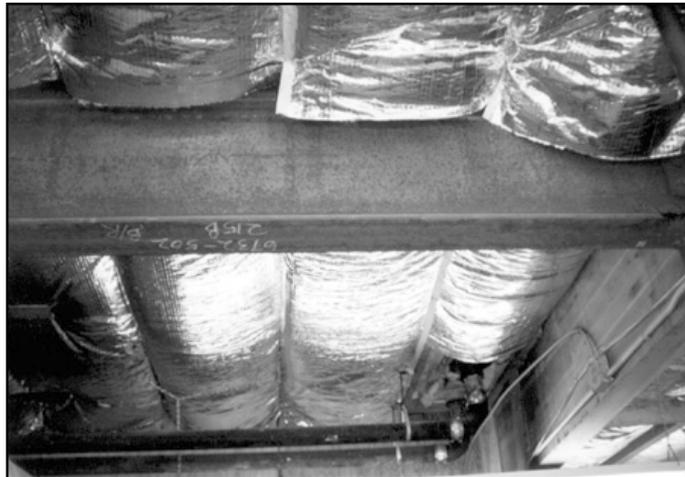
Figure 28. Ceiling beams and insulation in collections area

The storage area is composed of two rooms separated by a single panel wood door on the second floor of Building 5550. The interior walls are covered with sheetrock, but are unfinished. There are exposed steel and wood support beams in the ceiling overlaid with uncovered insulation (Figure 28). The floor is constructed of unsealed poured concrete. Tar, possibly from the roof, has permeated the ceiling around the joints in the support beams and hangs on the rafters. There are several places where large cracks exist in the concrete floor. The plumbing and electrical systems are original to the building. Overhead pipes that are connected with an exterior storm sewer system are in close proximity to archaeological materials. Additionally, ductwork for the heating and cooling system is clearly visible (Figure 29). There are numerous uncovered telephone panels and transformers on the south and east walls of the larger of the two rooms. Four doors are present in the two rooms: one in the “center” which separates the two rooms, two west-facing single wood panel doors each leading to Analytical Technologies, Inc. offices (one from each archaeological material storage room), and one north-facing single wood panel door that leads to a hallway and to the outside.

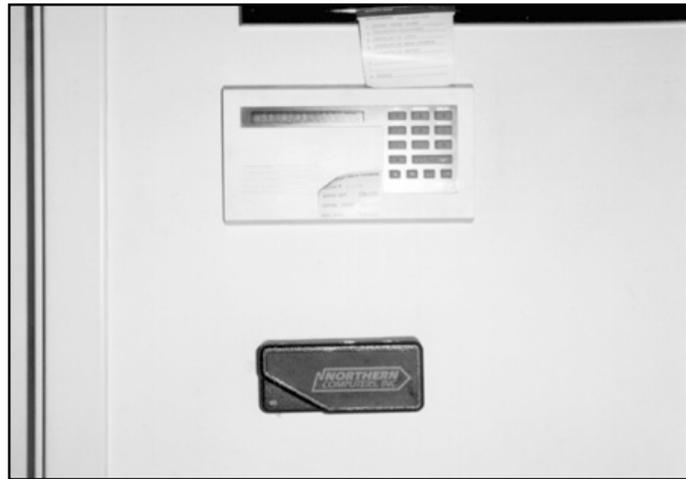
Figure 32. Key card security system at OGDEN repository

Building 5550 is protected by motion detectors, key locks on exterior doors, controlled access, and a private security company (San Diego Alarm Company). The doors in the storage area remained unlocked during the visit. It is open to anyone who has access to the building during working hours. After 5:30 p.m., access is only possible through a key card (Figure 32). Employees of Analytical Technologies, Inc. work 24 hour shifts and have access to the room at all times.

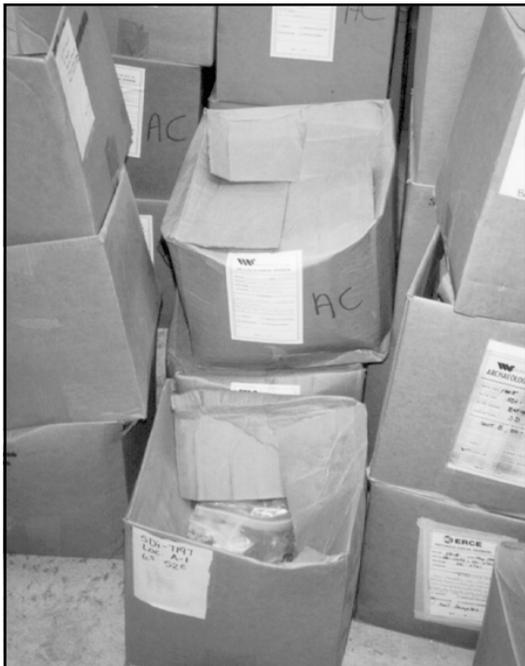
Figure 33. Storage containers for collections at OGDEN

Two types of storage units are used to store the archaeological materials. The majority (59%) of the storage units are boxes that are stacked four or five high on the concrete floor in the smaller of the two storage rooms (Figure 33). The remainder (41%) are stored on homemade wooden shelves in the larger storage area (Figure 34). The shelves are constructed of unsealed 2 by 4 foot wood uprights

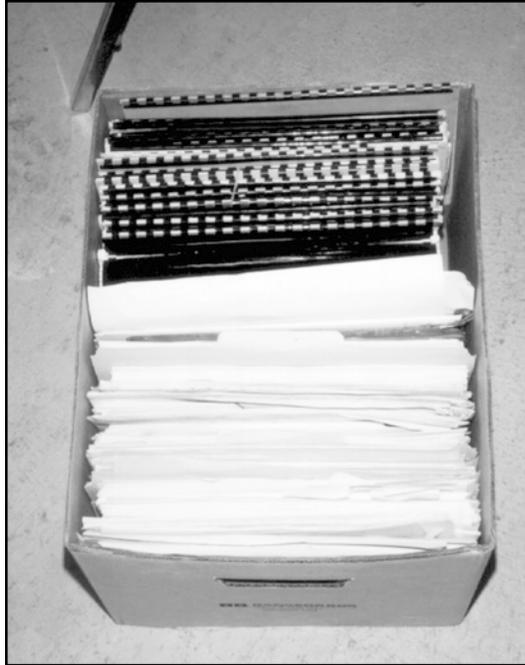
Figure 35. Type of primary containers used for associates records stored at OGDEN

The paper records stored in the storage area are not archivally processed. The records are stored in various sized acidic cardboard boxes with telescoping lids (Figure 35). When arranged, the records are sorted by project name and number. The majority of the boxes are directly labeled in marker with a mixture of box number, site number, site name, and contents. The remaining box labels are pre-

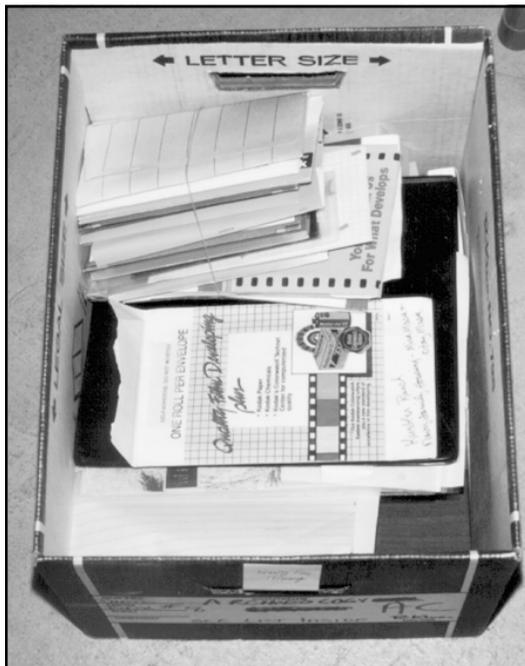
Figure 36. Storage of photographic documents at OGDEN

Photographic records are stored in acidic cardboard boxes in the archaeological materials storage room. All primary containers are directly labeled with marker and contain box number, project name, and content information. Photographic records are stored in acidic manila folders, photograph envelopes, loose in boxes, wrapped in paper and secured with a rubber band, and stored in non-archival plastic sleeves within plastic three-ring binders (Figure 36). Photographic documentation is arranged either by project or by site number and year of project. Included in the photographic records are color and black and white prints, negatives, slides, and contact print sheets. Most photographs are directly labeled in marker with site number, provenience, date, and roll number. The contact print sheets and individual slides are not labeled. Many of the color photographs are beginning to fade. Photographs loose in boxes are curled and some are torn.
