Department of Defense Legacy Resource Management Program

PROJECT 15-707 s

20th-CENTURY BUILDING MATERIALS AND SUITABLE SUBSTITUTES: EXTERIOR MATERIALS

January 2017s

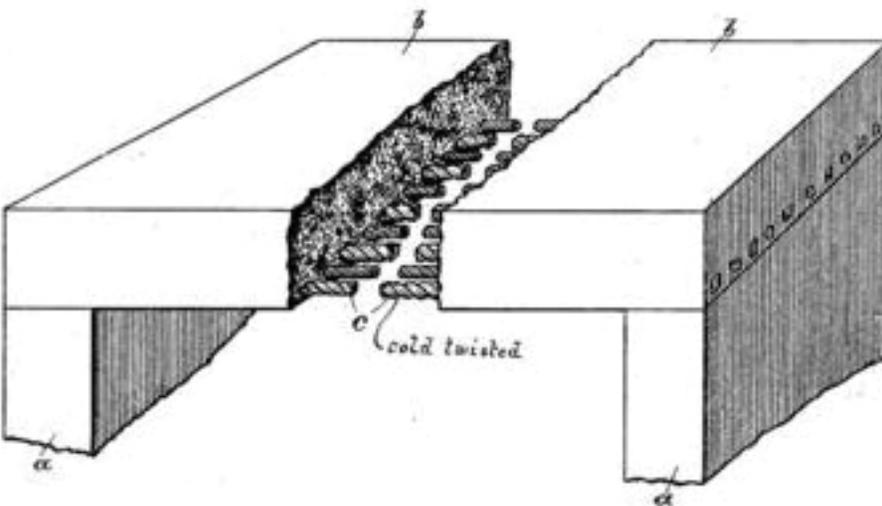
Illustration 3: Ernest L. Ransome's patented design for cold-twisted iron reinforcement in concrete (U.S. Patents 1894:516113 A).

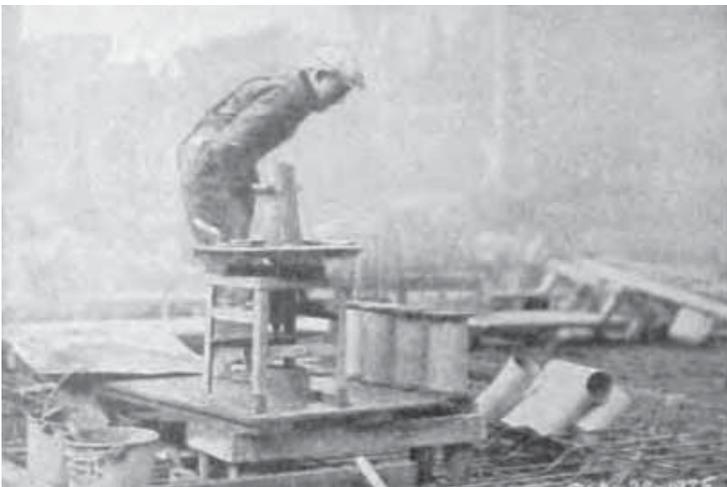
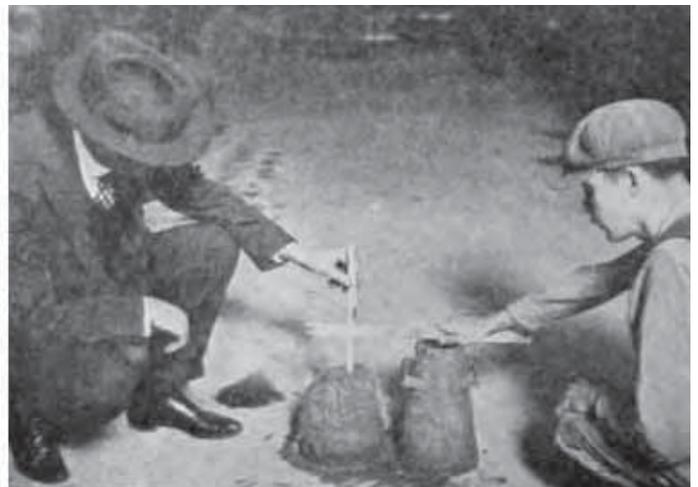
Illustrations 4 and 5: The images show the “Slump Test” inspection method for cast-in-place concrete, which is conducted on-site (Atlas Portland Cement Company 1927:12).

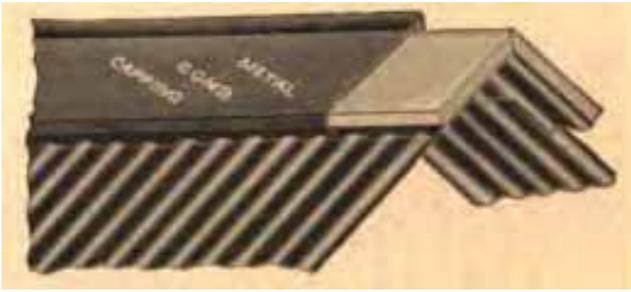
Illustration 12: Corrugated metal roofs required a cap along the ridge (Globe Iron and Corrugating Company 1890:25-26).

For roofing, corrugated metal was to be started at the eave, with 4 to 6 inches of projection. Side-by-side panels were lapped by one corrugation. The sheets were nailed in the lap, 8 inches apart. Flat roofs required thick metallic paint between the laps, while pitched roofs required the use of a metal ridge cap. The construction method for the use of corrugated metal as siding was to start at the bottom of the wall. The side-by-side sheets would also lap by one corrugation. Heavier gauges were necessary for buildings that needed exterior durability (Globe Iron and Corrugating Company 1890:32). The lapped method was historically the more common application. In 1884, L. Lewis Sagendorph invented a “V-crimp” connection, creating a corrugated metal roof with distinct seams (Illustrations 10 and 11; U.S. Patents 1884:302286). The simple construction methods using corrugated metal quickly led to its popularity (Illustrations 12 to 15).

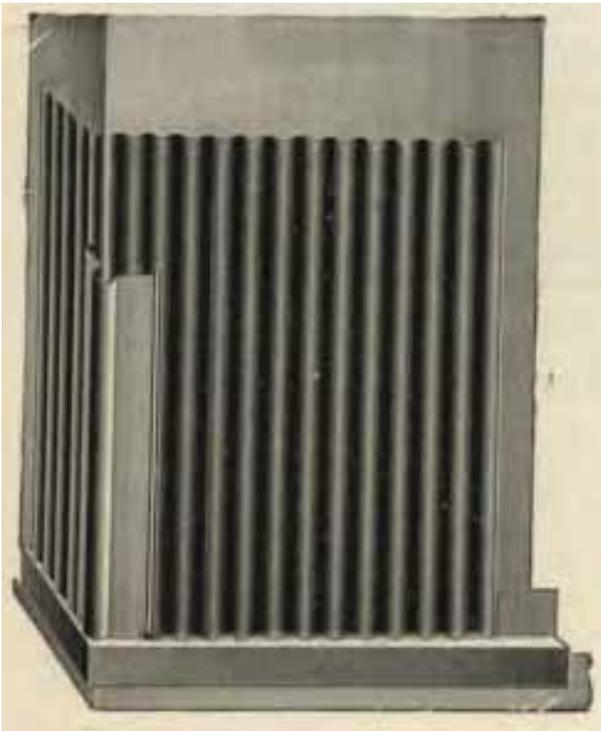
Illustration 14: An example of corrugated siding, with application beginning at the bottom of the wall (Milwaukee Corrugating Co. 1920:146).

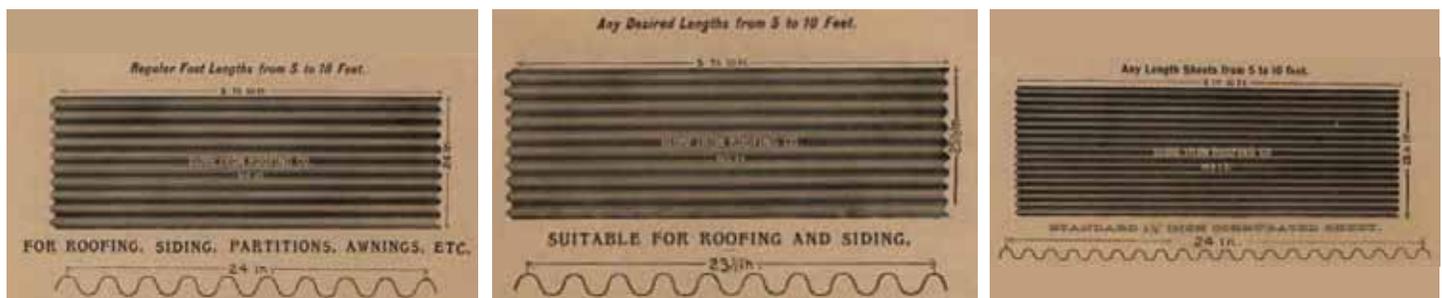
Illustrations 20-22: A sample of corrugated iron sheets for roofs, siding, partitions, awnings, or other (unspecified) applications (Globe Iron and Corrugating Company 1890:25-26).

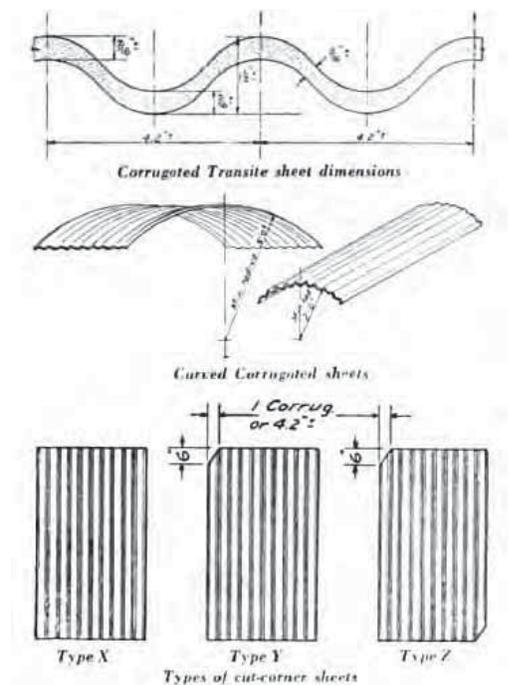
Illustration 23: Details of corrugated asbestos-cement panels (Johns-Manville 1944:9).

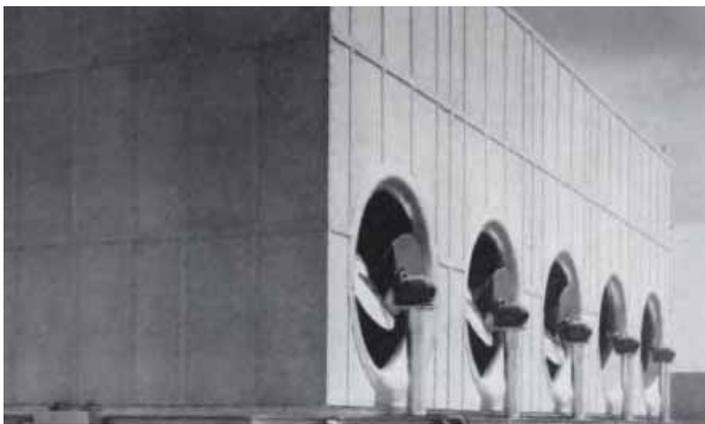
Illustration 24: An example of flat asbestos-cement panels on a cooling tower (Johns-Manville 1944:13).

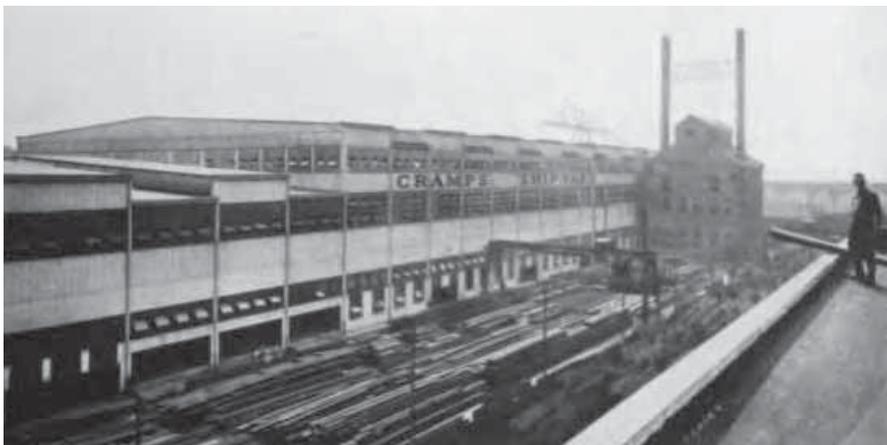
Illustration 27: Asbestos-cement corrugated siding was ideal for large buildings, especially those in harsh environments like this shipyard building in Philadelphia, Pennsylvania (Keasbey & Mattison Company 1918:11).

Corrugated asbestos-cement was designed for industrial roofing and siding for structural efficiency and the ability to withstand many forms of destruction common in chemical or metallurgical processes (Illustrations 25 and 26). Asbestos-cement was touted for its durability, fire-resistant qualities, ease of application, and minimal upkeep. Asbestos-cement materials were used extensively by railroads, public utilities, maritime, and industrial plants because of a high resistance to fumes, alkaline vapors, atmospheric conditions, and sudden temperature changes (Illustration 27; Johns-Manville 1948:1-2).

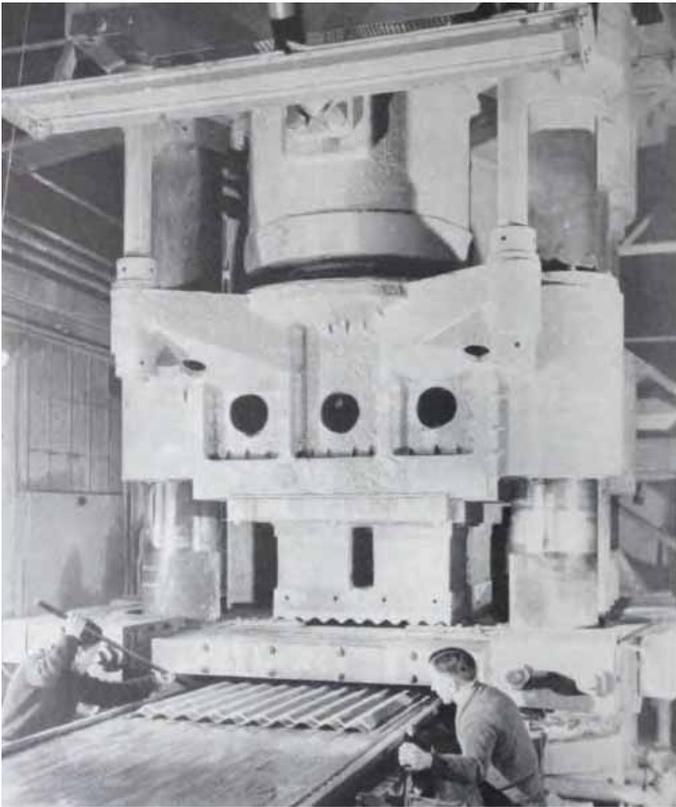
Illustration 28: A photograph of the standard press machinery used in 1944 (Johns-Manville 1944:2).

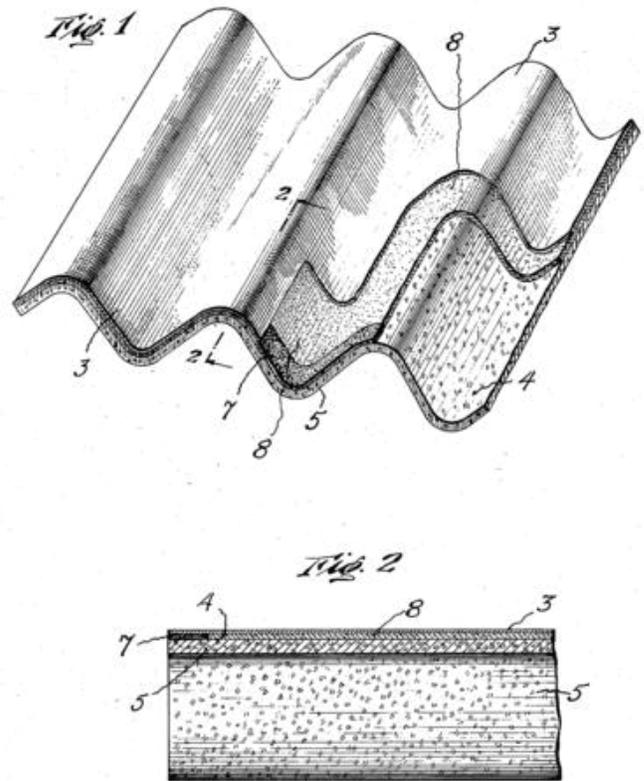
Illustration 29: An example of a reinforced asbestos-cement panel, with a layer of textile between two asbestos-cement boards (U.S. Patents 1943:2335208 A).

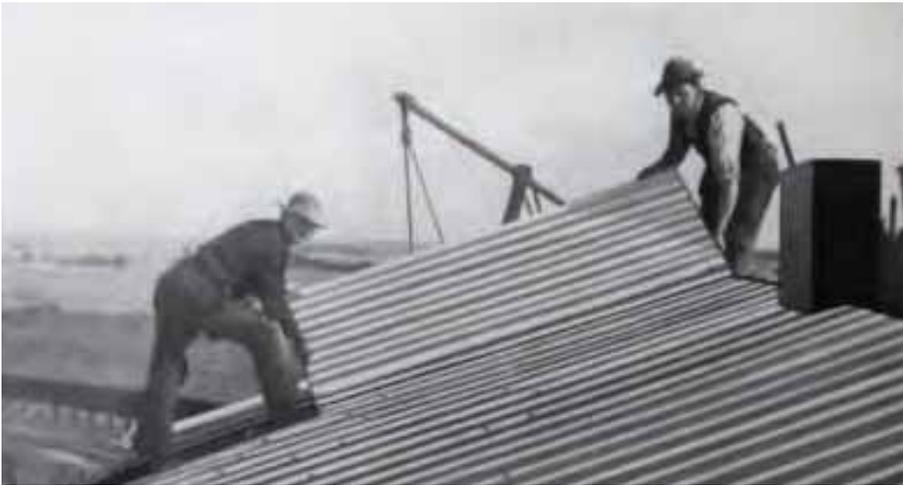
Illustration 30: The application of asbestos-cement corrugated roofing on a steel structure (Kearsby & Mattison Company 1918:28).

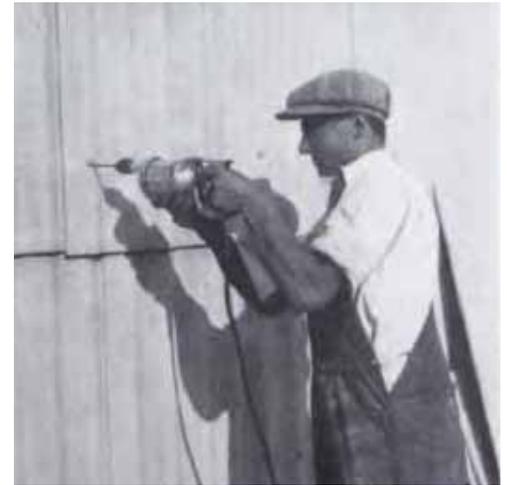
Illustration 31: The application of asbestos-cement panels was easy and quick (Johns-Manville 1944:7).

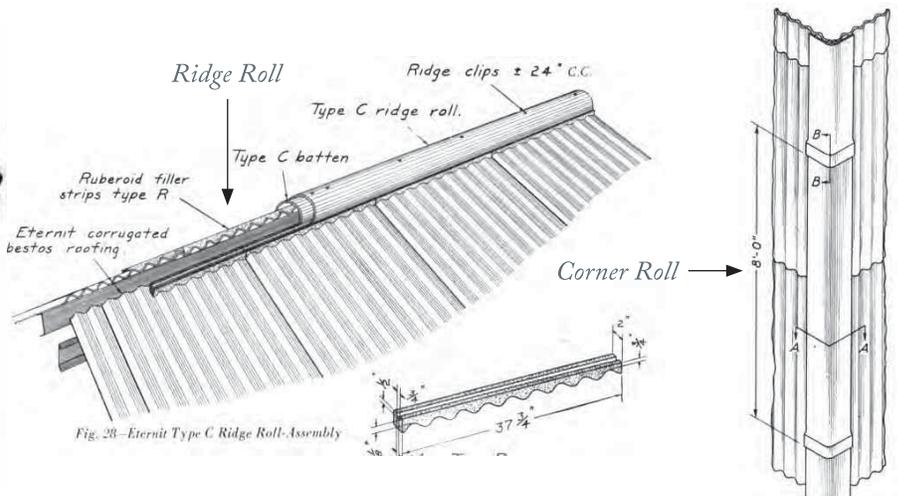
Illustrations 33 and 34: Asbestos-cement panel roofing required a ridge roll, and corrugated asbestos-cement panel siding required a corner roll; each was made of asbestos-cement ((Ruberoïd Co. 1930:14-15).

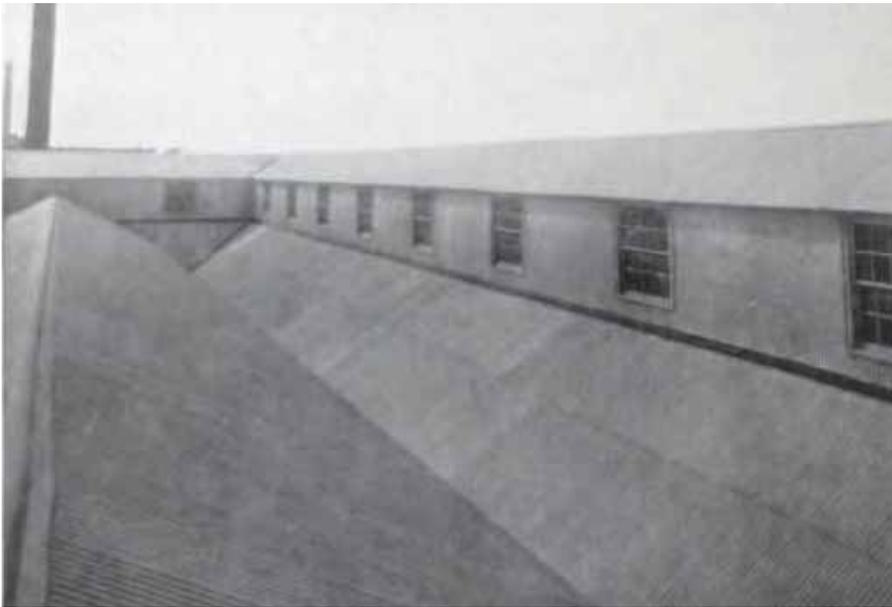
Illustration 35: An example of corrugated asbestos-cement panels on the roof of an industrial plant (Asbestos Manufacturing Company 1909:16).

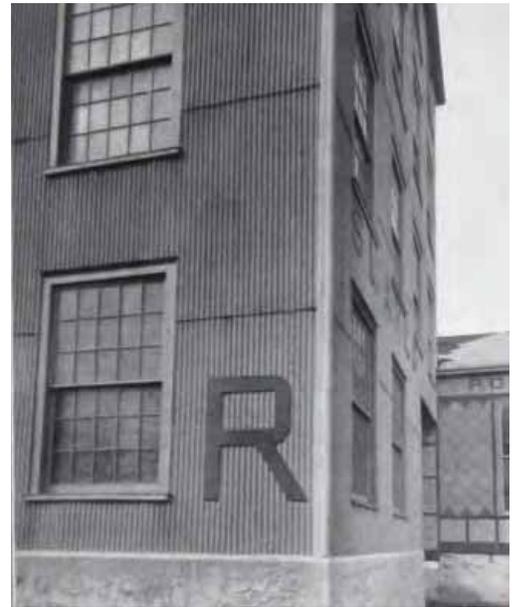
Illustration 36: An example of corrugated asbestos-cement panels as siding on an industrial plant (Asbestos Manufacturing Company 1909:17).

Asbestos-cement panels were also called “asbestos building lumber,” because the large sheets could be installed just like ordinary lumber for floors or partitions (GluedIdeas.com, accessed April 2016). The product was advertised as a substitute for corrugated iron or steel roofing and cladding (Illustrations 35 and 36). Asbestos-cement panels were almost exclusively used for industrial applications (NPS website, accessed January 2016). Flat panels were suggested for ceilings, roofing, and siding in industrial buildings, furnace casings, ductwork, and residential construction. Corrugated asbestos-cement panels were recommended for roofing, siding, and awnings specifically

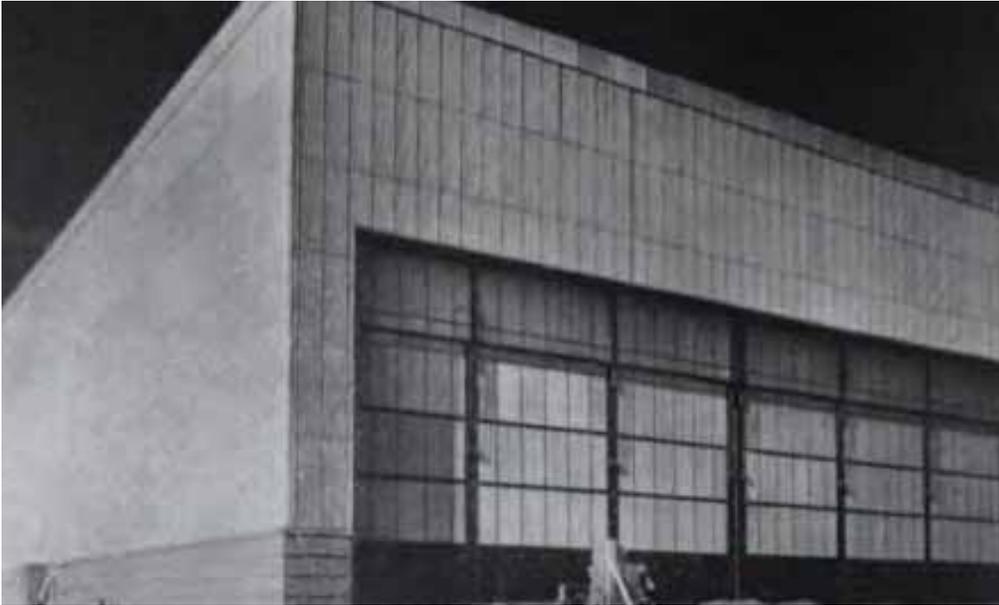
Illustration 38: An example of a curtain wall constructed with flat asbestos-cement panels (Johns-Manville 1944:32).

metal, two materials already embraced by Modernist principles. Asbestos-cement was a technologically advanced building material, and was advertised as such. The panels of asbestos-cement could be easily incorporated into a curtain wall system, which was a key feature of Modernist architecture (Illustrations 38 and 39; Johns-Manville 1944:31).

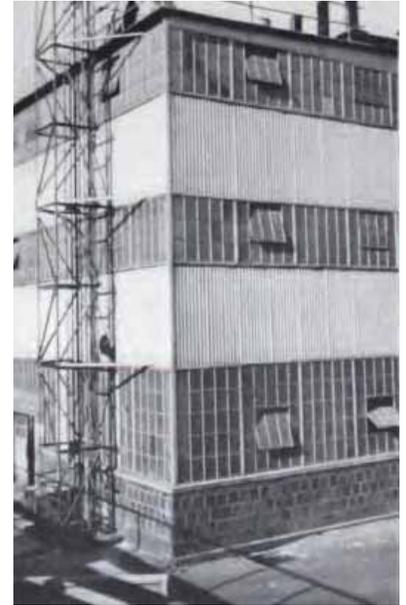
Illustration 39: An example of a curtain wall constructed with corrugated asbestos-cement panels (Johns-Manville 1944:33).

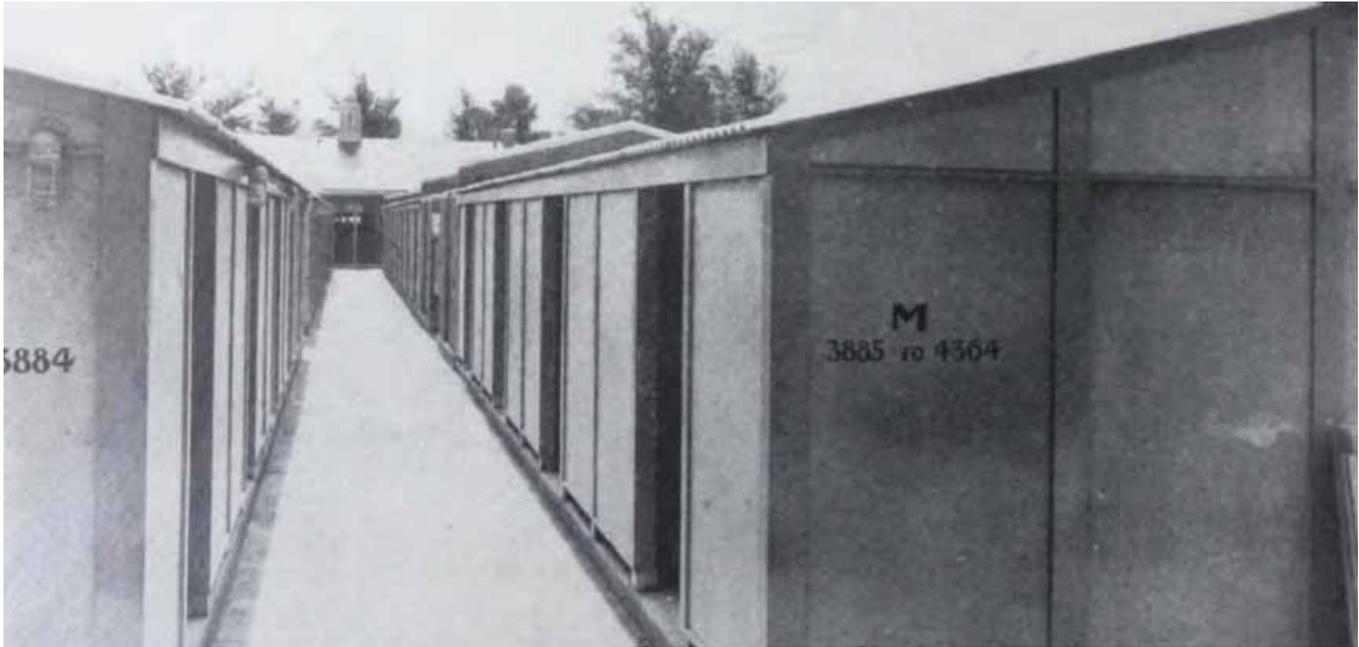
Illustration 40: Buildings often integrated both flat and corrugated asbestos-cement panels, as seen here (Johns-Manville 1944:28).

construction (Illustration 40). It was also considered to be an “architectural and engineering advancement with wide possibilities for use in post-war building” (Johns-Manville 1944:31).

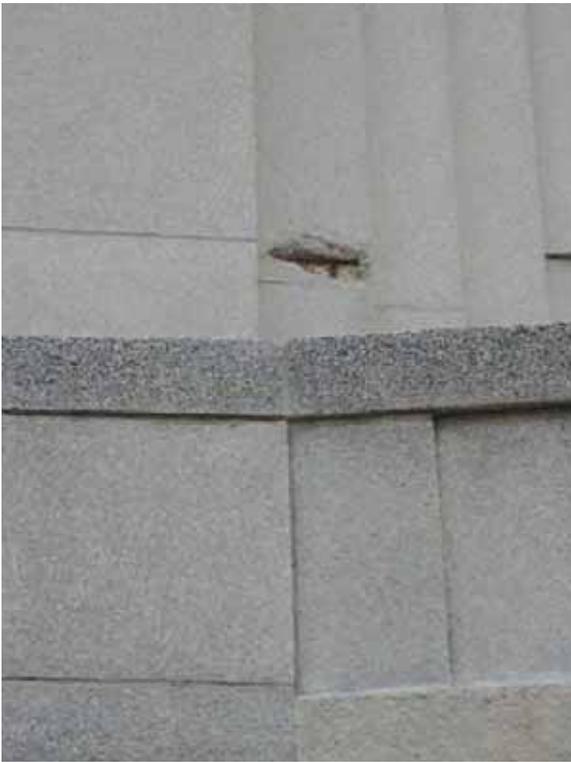
Illustration 49: A section of rusted steel reinforcement on NSFC Building 1 has resulted in the spalling of the concrete (Graves 2012).

Illustration 49: A section of rusted steel reinforcement on NSFC Building 1 has resulted in the spalling of the concrete (Graves 2012). | 55

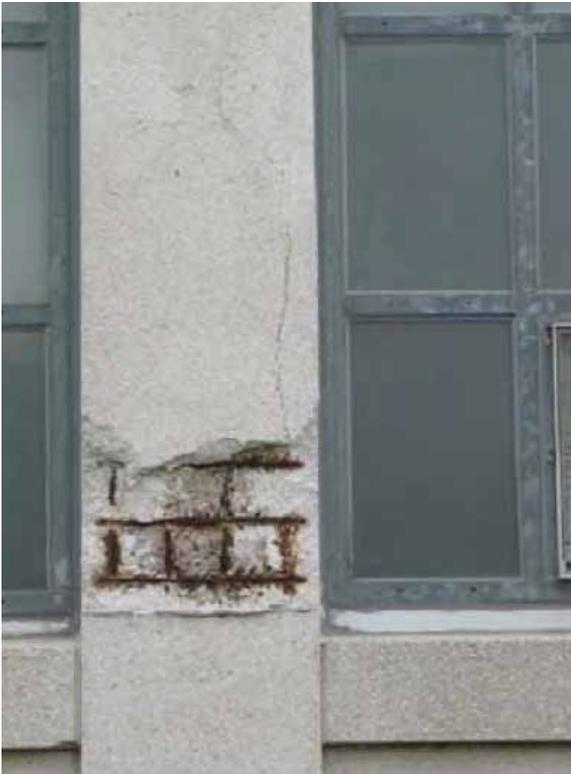
Illustration 50: The grid of the steel reinforcement is visible on NSFC Building 1, as the rusted steel has caused the delamination and spalling of the surface concrete (Graves 2012).

Illustration 50: The grid of the steel reinforcement is visible on NSFC Building 1, as the rusted steel has caused the delamination and spalling of the surface concrete (Graves 2012). | 55

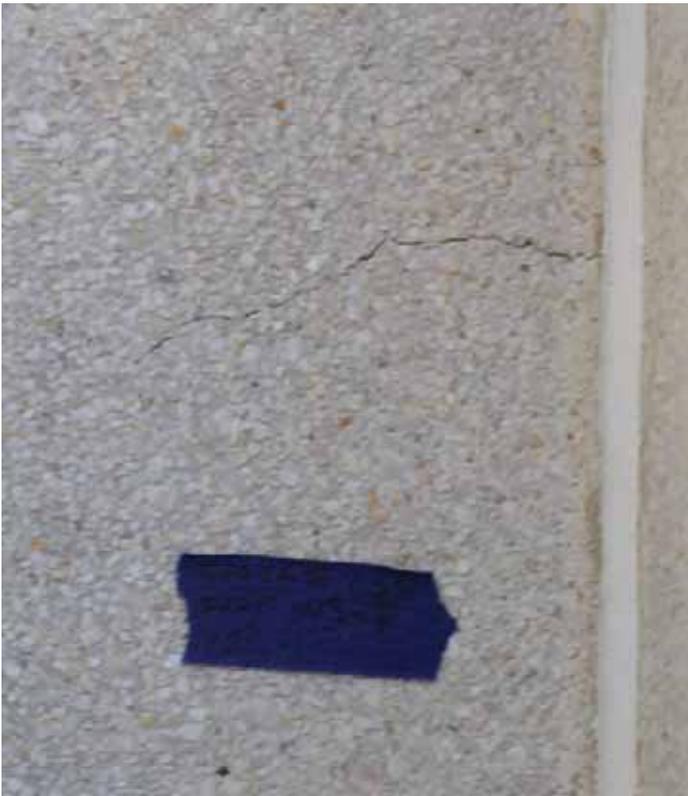
Illustration 51: An example of a hairline crack on Building 3 at NSA Bethesda. The concrete is undergoing repairs, and the blue tape is used to mark the location of a crack that will be filled with an epoxy injection (Photographer: Samantha Driscoll 2015).

Illustration 51: An example of a hairline crack on Building 3 at NSA Bethesda. The concrete is undergoing repairs, and the blue tape is used to mark the location of a crack that will be filled with an epoxy injection (Photographer: Samantha Driscoll 2015). | 57

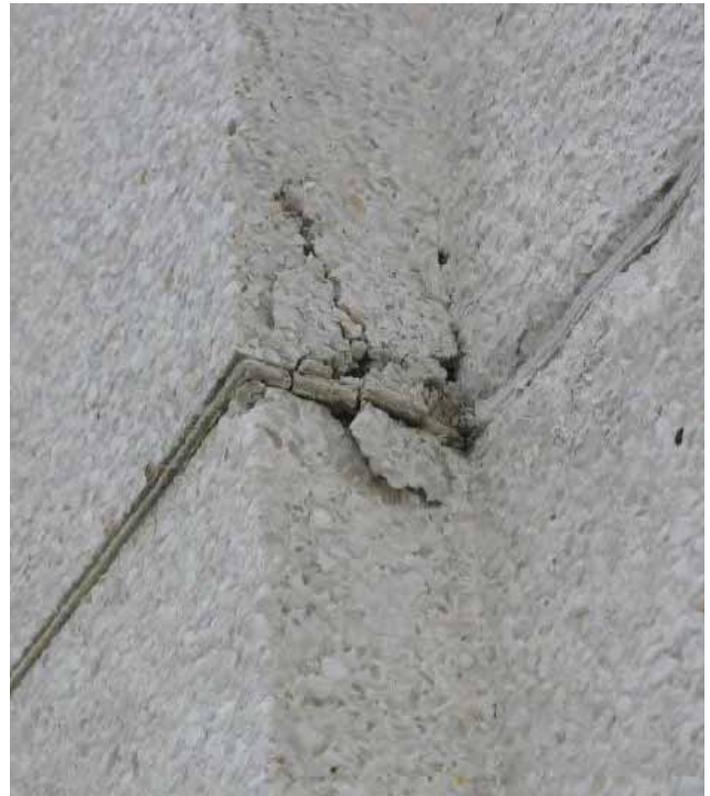
Illustration 52: An example of a pop-out around a joint on Building 1 at NSFC (Graves 2012).

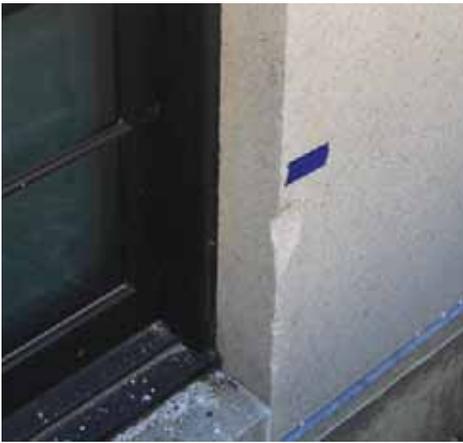
Illustration 53: An example of spalling on Building 3 at NSA Bethesda. The concrete is undergoing repairs, and the blue tape is used to mark the location of a needed repair (Photographer: Samantha Driscoll 2015).

Spalling, scaling, and delaminating are the loss of surface material. These conditions are most often associated with freezing and thawing or the corrosion of reinforcing steel. For the freeze and thaw cycle, moisture is absorbed and expands when frozen, causing cracking and displacement. Similarly, if the reinforcing steel becomes corroded, the steel expands and puts pressure on the surrounding concrete until it cracks and is displaced. Spalling, scaling, and delaminating may also be caused by improper finishes, which detach in thin layers (Illustrations 53, 54, and 55). If the spalling is severe enough, it can affect the load-carrying capacity of the concrete (Gaudette and Slaton 2007:7).

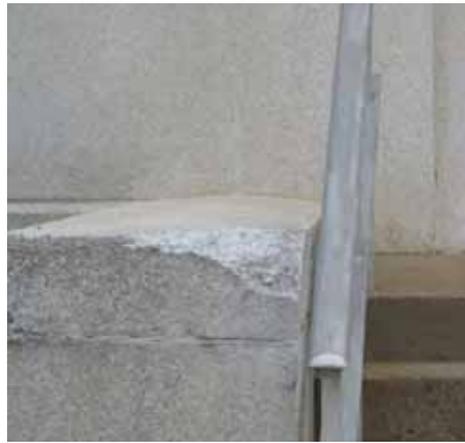
Illustration 54: An example of spalling on Building 3 at NSFC (Graves 2012).

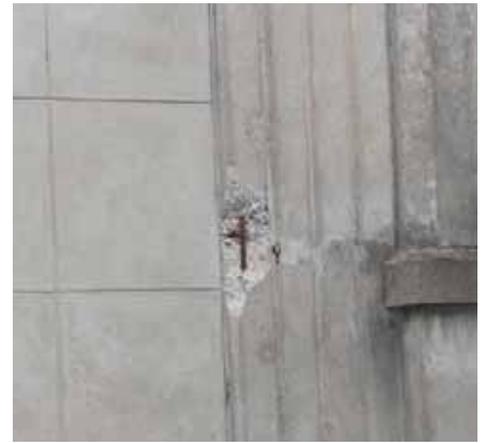
Illustration 55: Corrosion of steel reinforcement, as shown in this example from Building 173 at Picatinny Arsenal, is a common cause of spalling (Photographer: Samantha Driscoll 2015).

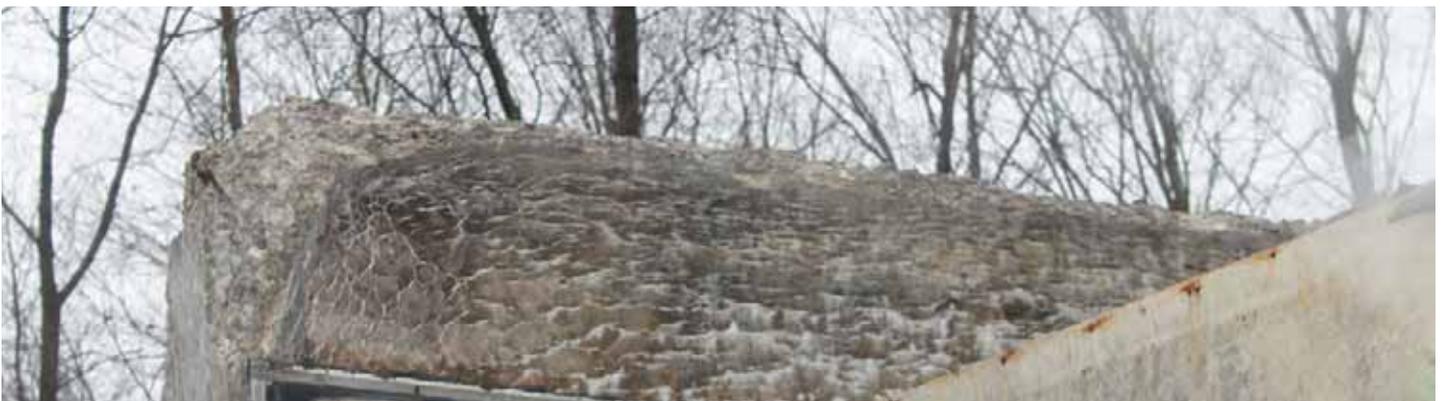
Illustration 56: Building 1507 at Picatinny Arsenal has a rather extreme example of efflorescence, cracking, and spalling due to moisture infiltration (Photographer: Samantha Driscoll 2015).

Illustration 56: Building 1507 at Picatinny Arsenal has a rather extreme example of efflorescence, cracking, and spalling due to moisture infiltration (Photographer: Samantha Driscoll 2015). | 58

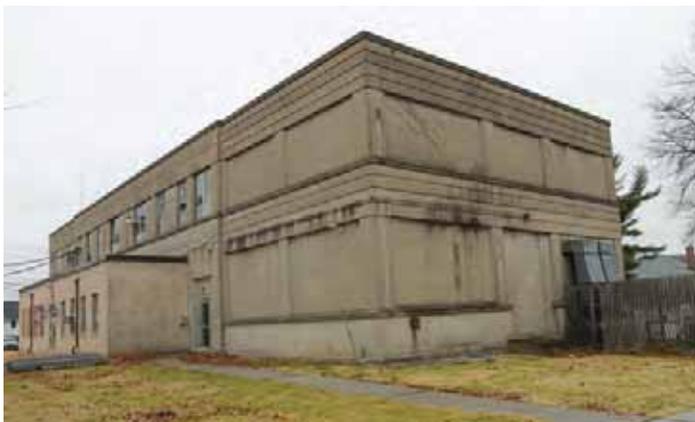
Illustration 57: Building 173 at Picatinny Arsenal showing staining along concrete. The staining will be removed with a low pressure powerwash with mild detergent, a technique approved by the NJHPO (Photographer: Samantha Driscoll 2015).

Building 173 at Picatinny Arsenal is an example of stained concrete that will be cleaned (Illustrations 57 and 58). Building 173 is a contributing resource to the Administration and Research Historic District. Built in 1942, the historic use of the building was as a guard house, telephone building/transformer station, and firehouse (Picatinny Arsenal ICRMP 2014:n.p.). The staining is only an aesthetic issue, with no known structural implications for the historic concrete. The last cleaning was likely 20 to 30 years ago. For Building 173, Picatinny Arsenal will clean the concrete by powerwashing with a mild detergent at a low pressure, a technique approved by the New Jersey Historic Preservation Office (NJHPO) (Huggan 2015). In accordance with Picatinny Arsenal's Programmatic Agreement with the NJHPO, this action does not require a separate Section 106 consultation.

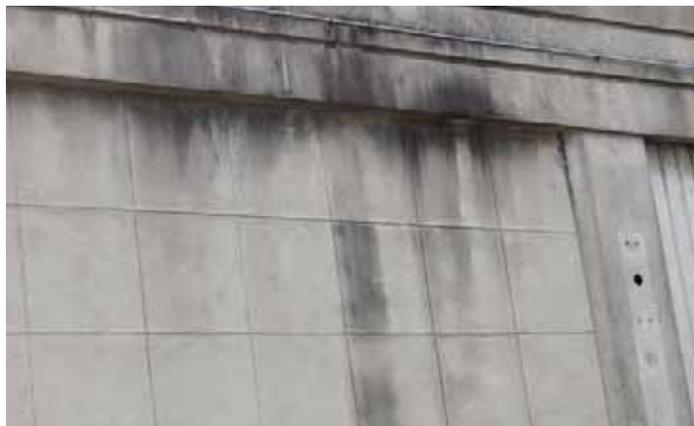
Illustration 58: Detail of staining on Building 173 at Picatinny Arsenal. The last cleaning of the concrete is estimated to have occurred between 20 and 30 years ago (Photographer: Samantha Driscoll 2015).

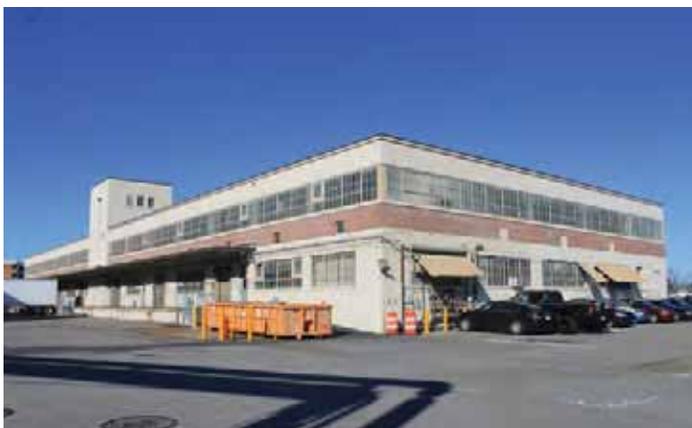
Illustration 59: Building 280 at NSA NNSY is an example of maintained, sealed, and painted concrete (Photographer: Samantha Driscoll 2016).

At NSA NNSY, there are two examples of sealed and painted concrete maintenance. Building 280 and Building 276 are two of the seven contributing resources to the Support and Supply Area Precinct of the Naval Shipyard Historic District. Building 280 was built in 1942 for the historic use of flammable storage. Building 276 was built in 1942 as a general storehouse (NSA NNSY Regional ICRMP 2013:10.16). Both buildings were built with cast-in-place concrete (Robbins 2016). The buildings have been in continual use, and the concrete has been maintained through sealant and paint, resulting in no noticeable material issues (Illustrations 59 and 60). With proper maintenance, the service life of the concrete is indefinite.

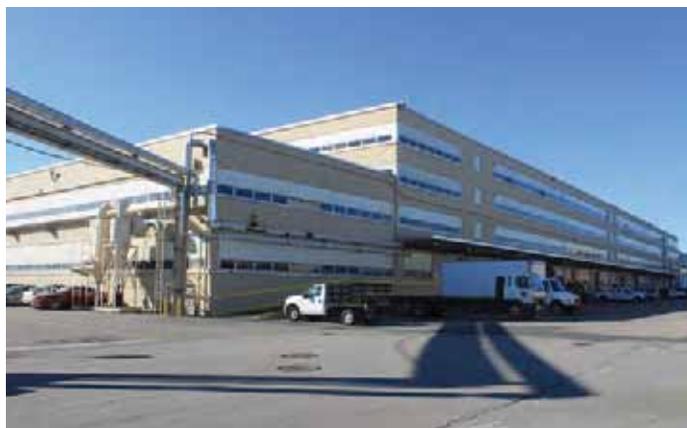
Illustration 60: Building 276 at NSA NNSY is an example of maintained, sealed, and painted concrete (Photographer: Samantha Driscoll 2016).

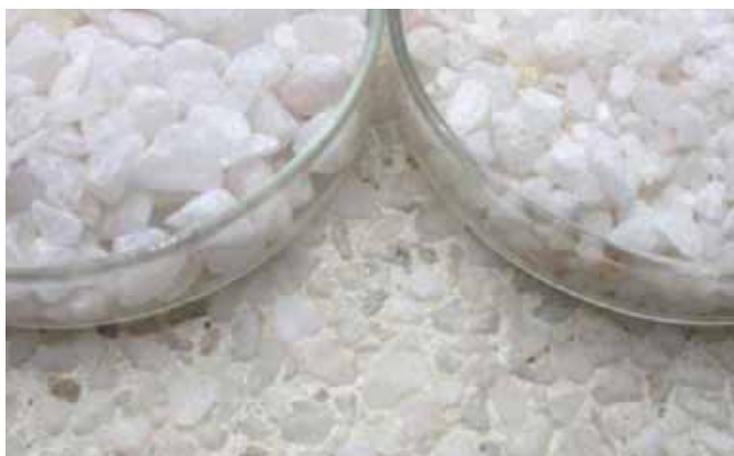
Illustration 61: The historic concrete (bottom) was analyzed for the aggregate type. In this case, it was quartz (John Milner Inc. 2006).

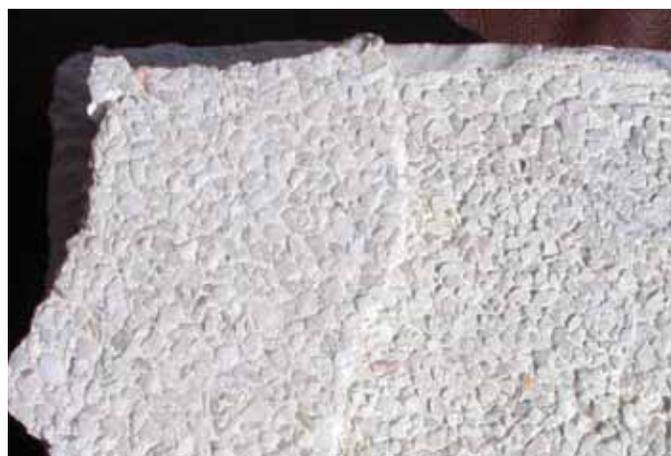
Illustration 62: A mock-up was created (right) and compared to the historic example (left) to determine patch compatibility (John Milner Inc. 2006).

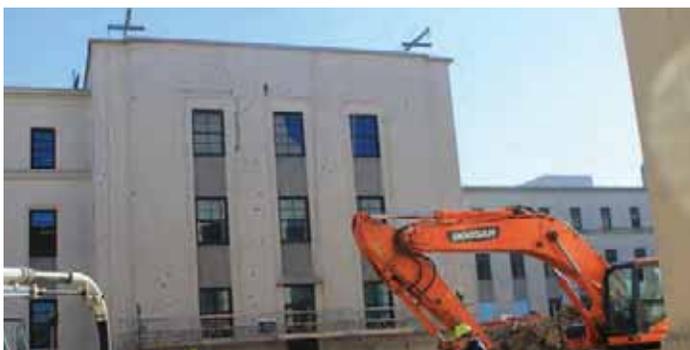
Illustration 63: Building 3 at NSA Bethesda during repair work to correct cracking, spalling, and exposed reinforcement (Photographer: Samantha Driscoll 2015).

As of December 2015, Building 3 repair work was underway and Building 5 had not yet been started (Illustrations 63 and 64). Similar to Building 1, the work on Building 3 was targeted to cracks and patching. The same method

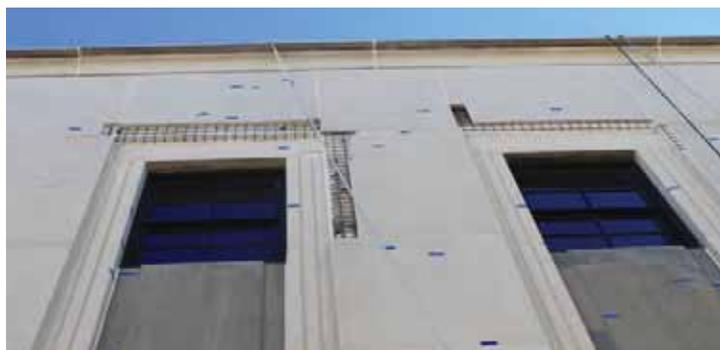
Illustration 64: Detail of the corroded and exposed steel reinforcement on Building 3, which caused the de-lamination and spalling of the surface concrete. Wire mesh and stainless steel bars will be inserted in these areas prior to patching for stability (Photographer: Samantha Driscoll 2015).

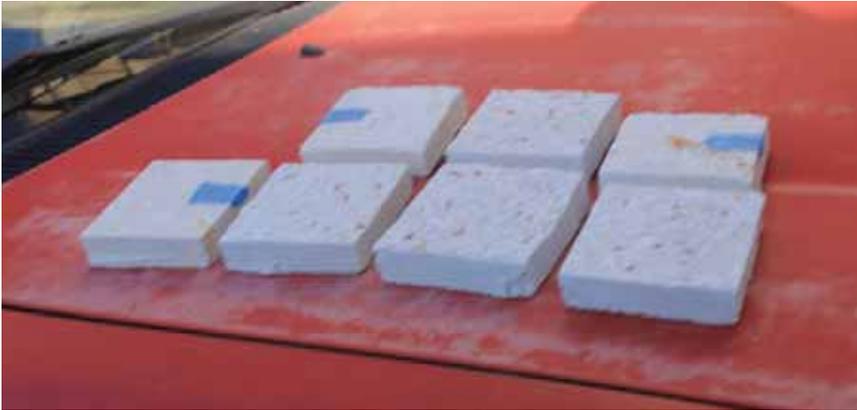
Illustration 65: The concrete mock-ups for the patching to Building 3. Each sample varies slightly in color and/or aggregate type (Photographer: Samantha Driscoll 2015).

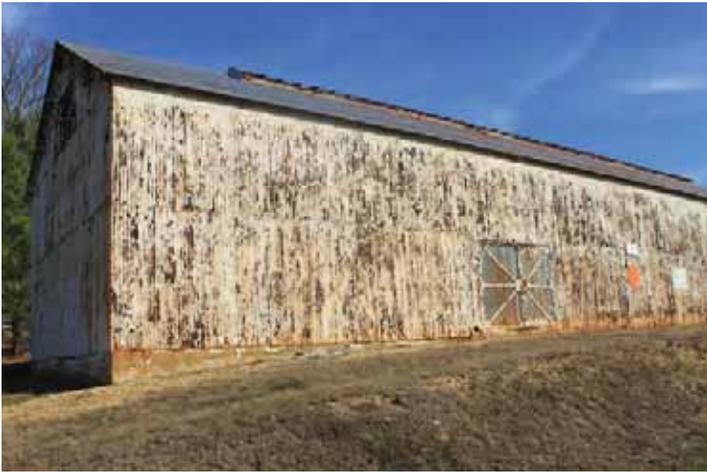
Illustration 66: Building 224 at NSF Indian Head, built in 1915, is an example of steel corrugated metal. Note the amount of corrosion below the peeling paint (Photographer: Samantha Driscoll 2015).

Illustration 66: Building 224 at NSF Indian Head, built in 1915, is an example of steel corrugated metal. Note the amount of corrosion below the peeling paint (Photographer: Samantha Driscoll 2015). | **67**

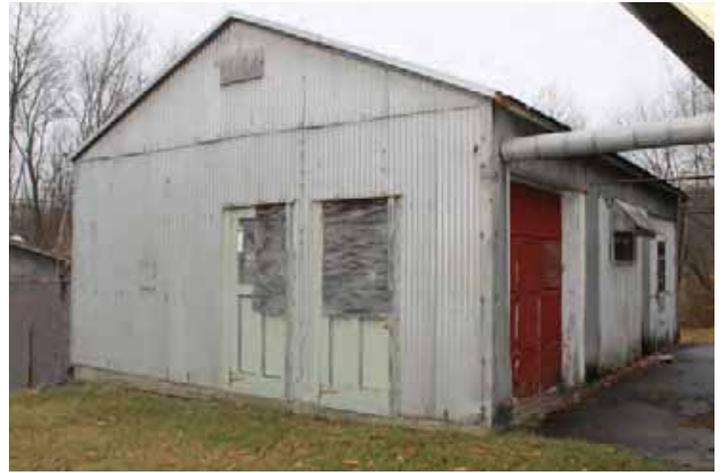
Illustration 67: Building 1504 at Picatinny Arsenal, built in 1956, is an example of aluminum corrugated metal. Note there is no evidence of corrosion (Photographer: Samantha Driscoll 2015).

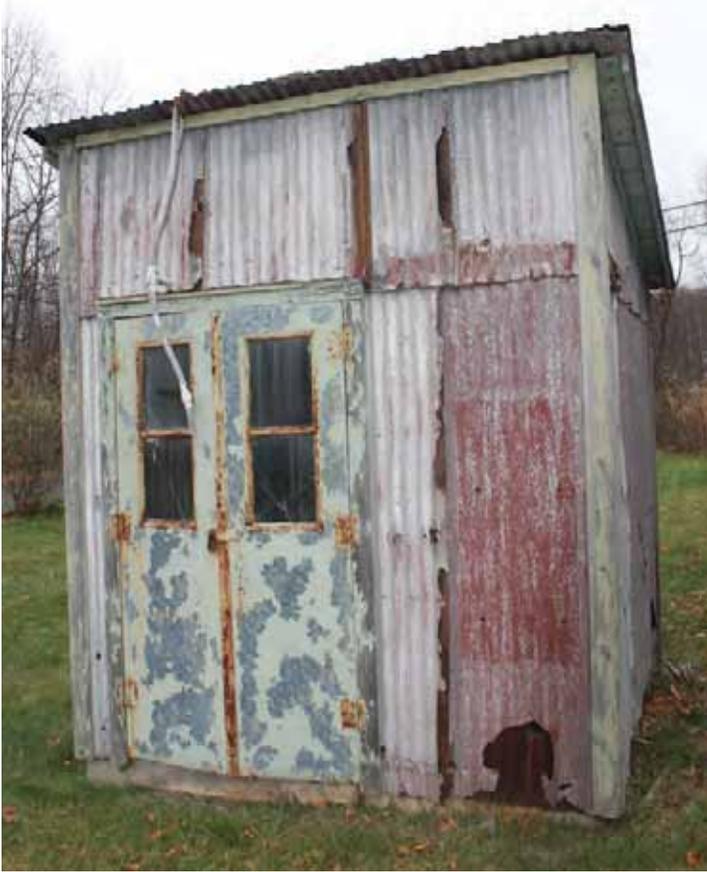
Illustration 68: Building 1504A at Picatinny Arsenal has suffered a lack of maintenance, resulting in corrosion (Photographer: Samantha Driscoll 2015).

Illustration 68: Building 1504A at Picatinny Arsenal has suffered a lack of maintenance, resulting in corrosion (Photographer: Samantha Driscoll 2015). | **68**

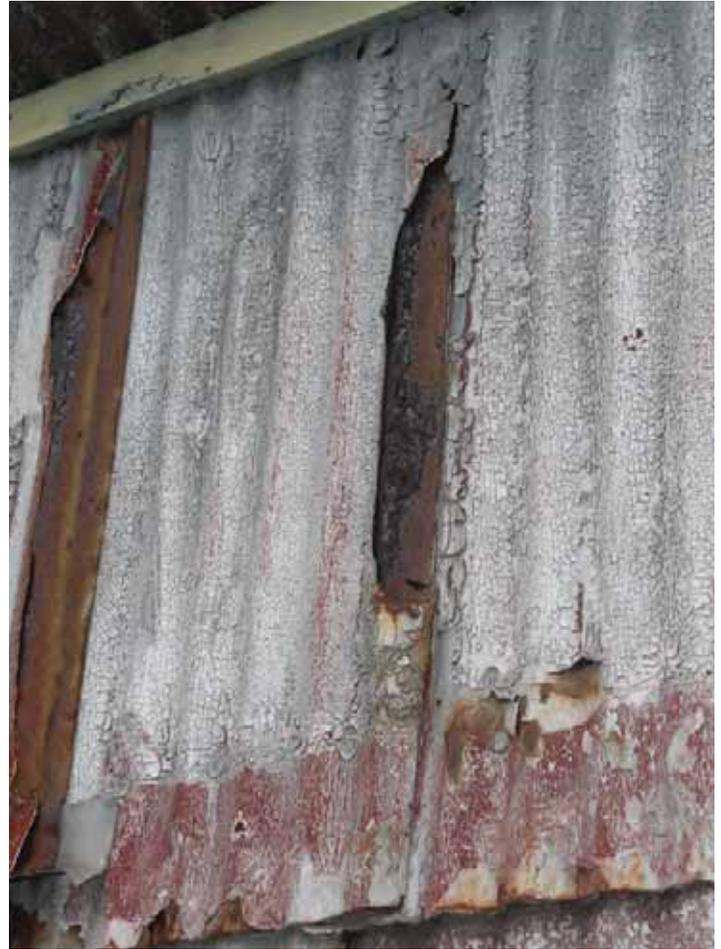
Illustration 69: Detail of corrosion on Building 1504A. Painting is the primary maintenance of corrugated steel, as it protects the steel from moisture (Photographer: Samantha Driscoll 2015).

Illustration 69: Detail of corrosion on Building 1504A. Painting is the primary maintenance of corrugated steel, as it protects the steel from moisture (Photographer: Samantha Driscoll 2015). | **68**

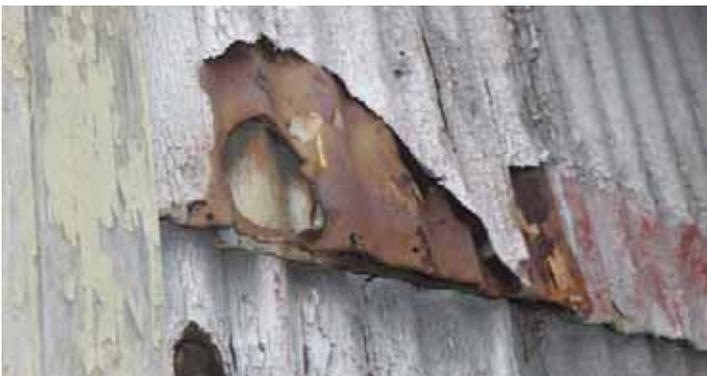
Building 1504A is a contributing resource to the Rocket Test Area Historic District. Built in 1948, the historic use of the building was as test stand #3; storage bottle stand and manifold; general purpose warehouse ordinance facility; and conditioning building (Picatinny Arsenal 2014:n.p.). The uses of the building warranted utilitarian, sturdy, fireproof construction, which corrugated steel cladding and roofing supplied. However, as a support building, Building 1504A has not received proper maintenance. The corrugated metal cladding was painted, but over time the paint has peeled and left the steel susceptible to moisture, resulting in corrosion (Illustrations 68, 69, and 70).

Illustration 70: Corrosion is not just an aesthetic issue, it can make the material unstable. As seen here, the corrosion has caused a hole in the corrugated steel (Photographer: Samantha Driscoll 2015).

Paint is the most important line of defense against corrosion, especially if the metal has not been galvanized. Severe weather or debris can scratch paint off, allowing moisture infiltration to cause corrosion. If paint becomes scratched or peeled, the area must be sealed and repainted as soon as possible (Kline 2014:n.p.). The paint used should be specific to metal and should be applied with a roller or brush, as spray can be uneven. Two coats are recommended, and regular touch-ups should occur (Build Direct website, accessed March 2016). If the corrugated metal has any sign of rust, a rust inhibitor should be used prior to any coating or painting to reduce the spread of rust (About Home website, accessed March 2016). Sealants are required at the perimeter of the metal sheet, as well as at all penetrations (Facilitiesnet website, accessed March 2016). The sealants will require regular touch-ups. There are also waterproof coatings that can be applied to the corrugated metal to protect the metal from corrosion.

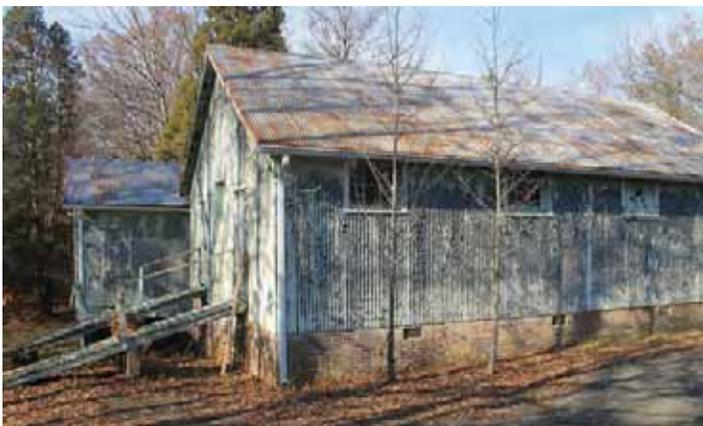
Building 179 is a contributing resource to the Naval Powder Factory Historic District. Built in 1904, the historic use of the building was as storage as Dryhouse #7 (NSF Indian Head ICRMP 2012:3-24). Building 179 has galvanized corrugated steel cladding and non-galvanized steel roofing (Illustration 71). The cladding was once painted but has not been properly maintained, and the paint is peeling off. However, the exposed corrugated steel is not corroding, indicating that it was galvanized. In contrast, the roof appears to have been treated or painted, but the protective layer has failed. The result is obvious corrosion. Though the cladding is not corroded, it appears to have suffered distortion (Illustration 72). The corrugated metal lapped installation may have been

Illustration 71: Building 179 at NSF Indian Head shows the galvanized corrugated steel cladding, though not maintained, is not experiencing corrosion. The corrugated steel roof appears to have had a treatment, though it failed and corrosion has occurred (Photographer: Samantha Driscoll 2015).

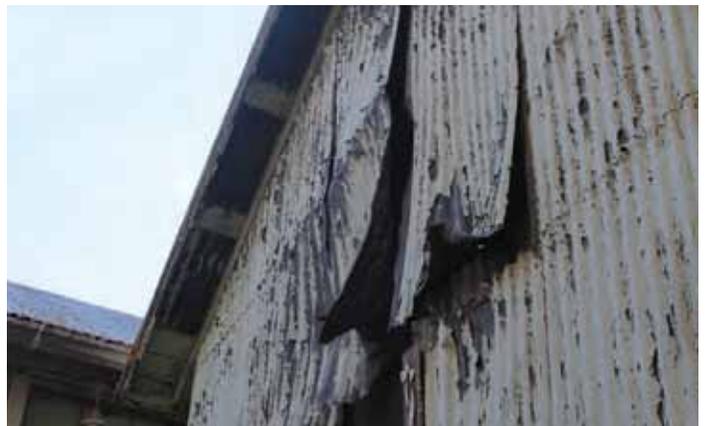
Illustration 72: Building 179 also has distortion of its corrugated steel cladding, which may have occurred from weather or physical damage (Photographer: Samantha Driscoll 2015).

compromised due to wind, or this may be a result of physical damage. Regardless, the distortion shows the flexibility of corrugated metal, which may be an issue in harsh weather patterns when the material can bend and fail.

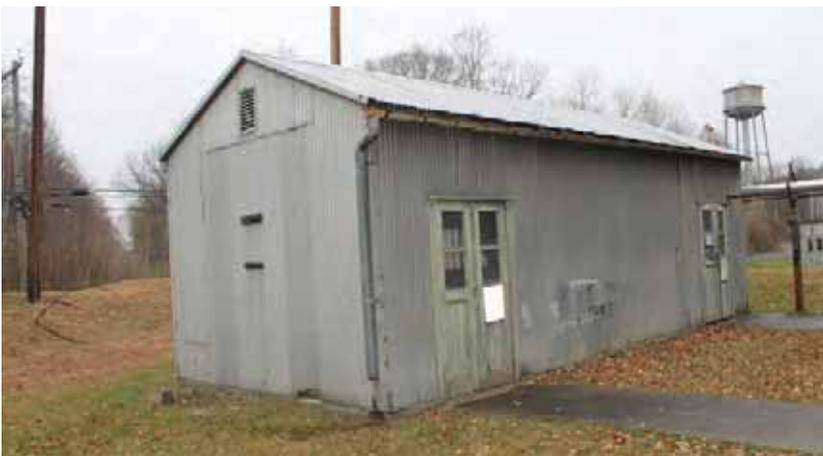
Illustration 73: Building 1506 at Picatunny Arsenal is clad in corrugated aluminum. In the center of the front elevation is a patch of in-kind material fitted with incompatible fasteners (Photographer: Samantha Driscoll 2015).

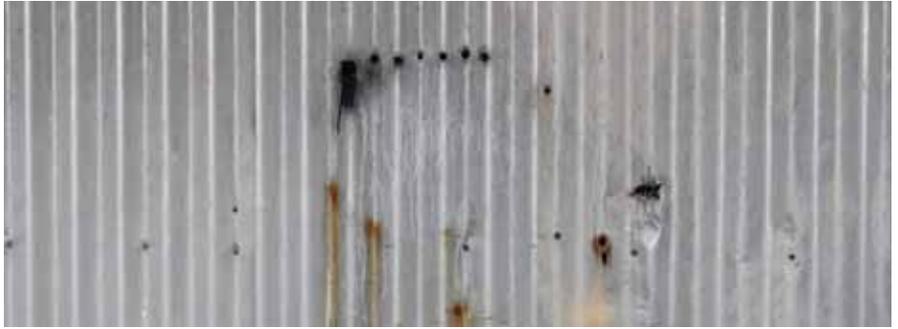
in-kind material. The patch fit securely to the material by aligning the corrugations. The visibility of the patch is an example of using incompatible metal fasteners. The steel nails used to apply the patch have corroded, causing staining on the historic corrugated aluminum (Illustration 74).

Illustration 74: Detail of the in-kind material patch on Building 1506. Note the alignments of the corrugations make the patch almost undetectable, but the corroded steel fasteners have caused staining (Photographer: Samantha Driscoll 2015).

Repairs to metal roofing and cladding can prove difficult. If the patch has even slightly different composition, thermal expansion and contraction can cause the patch to fail. Metal sheeting can be patched with metal, but the repair metal must be a compatible type, and ideally the same type. If incompatible metals come in contact, the result is corrosion, which causes cracking, splitting, and failure of the patch (Kline 2014:n.p.). To create a patch, the area must first be cleaned. Then the sheet metal, of the same type of metal as the surrounding historic material, should be cut to a size at least 2 inches larger than the damaged area on all sides. The patch corners should then be rounded, as to not catch debris later. A sealant should be applied to the damaged area before the patch is placed. Screws should then be placed every 3 to 4 inches around the perimeter to provide uniform pressure. The patch can be painted to match the corrugated metal (About Home website, accessed March 2016).
