Department of Defense Legacy Resource Management Program

PROJECT 15-707 s

20th-CENTURY BUILDING MATERIALS AND SUITABLE SUBSTITUTES: EXTERIOR MATERIALS

January 2017s

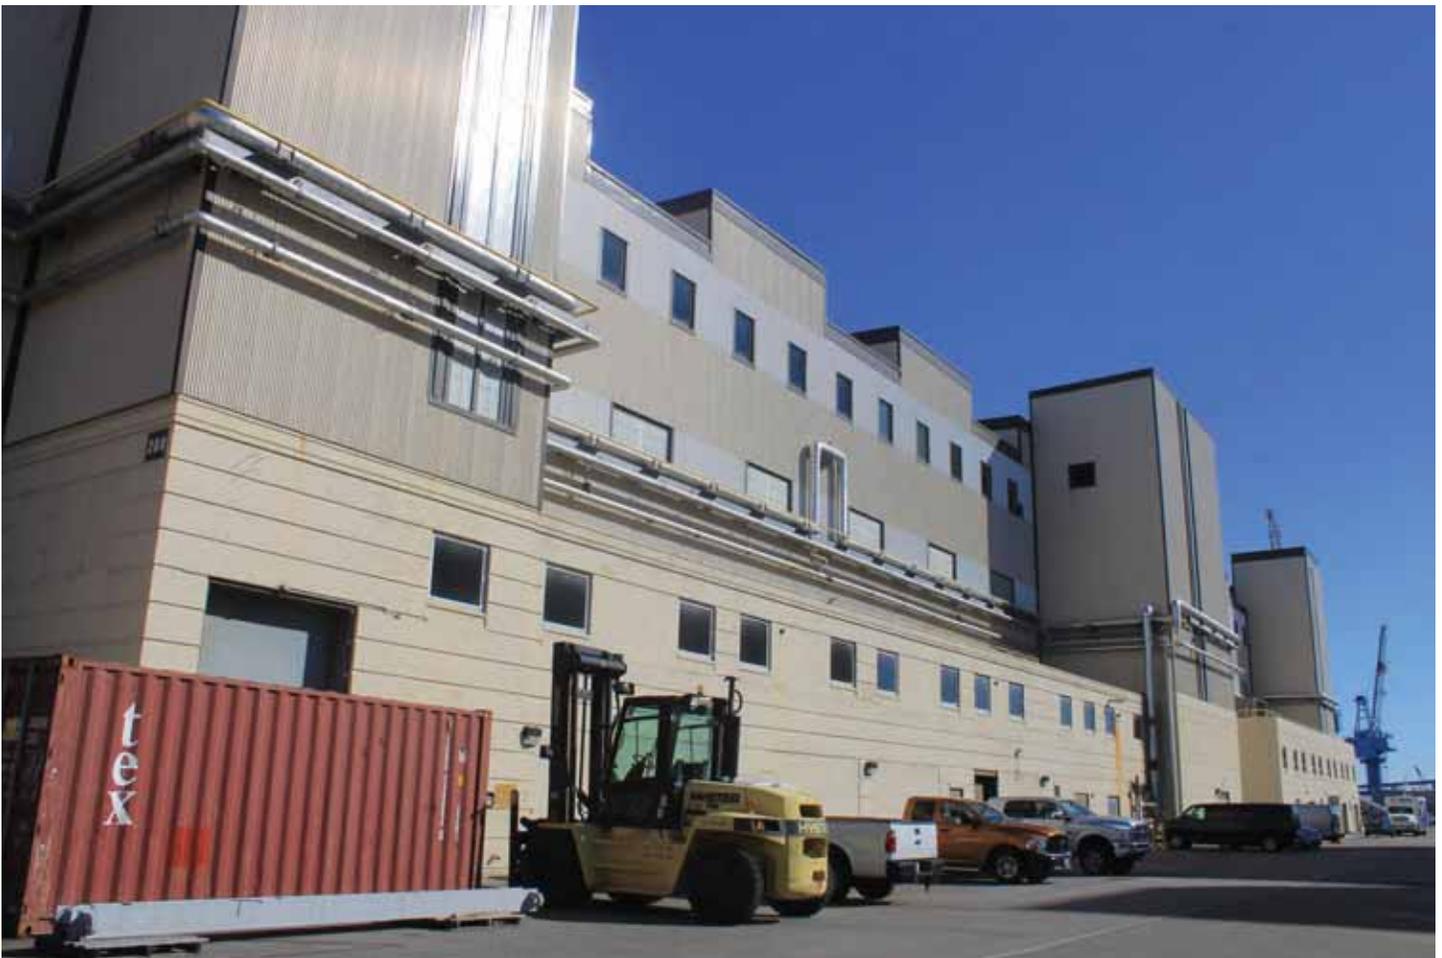
Illustration 75: Building 268 at NNSY has replacement corrugated metal cladding, which has been painted. As long as the rhythm of corrugation can be retained, in-kind replacement should be considered for any type of corrugated metal (Photographer: Samantha Driscoll 2016).

Illustration 75: Building 268 at Norfolk Naval Shipyard has replacement corrugated metal cladding, which has been painted. As long as the rhythm of corrugation can be retained, in-kind replacement should be considered for any type of corrugated metal (Photographer: Samantha Driscoll 2016). | 73

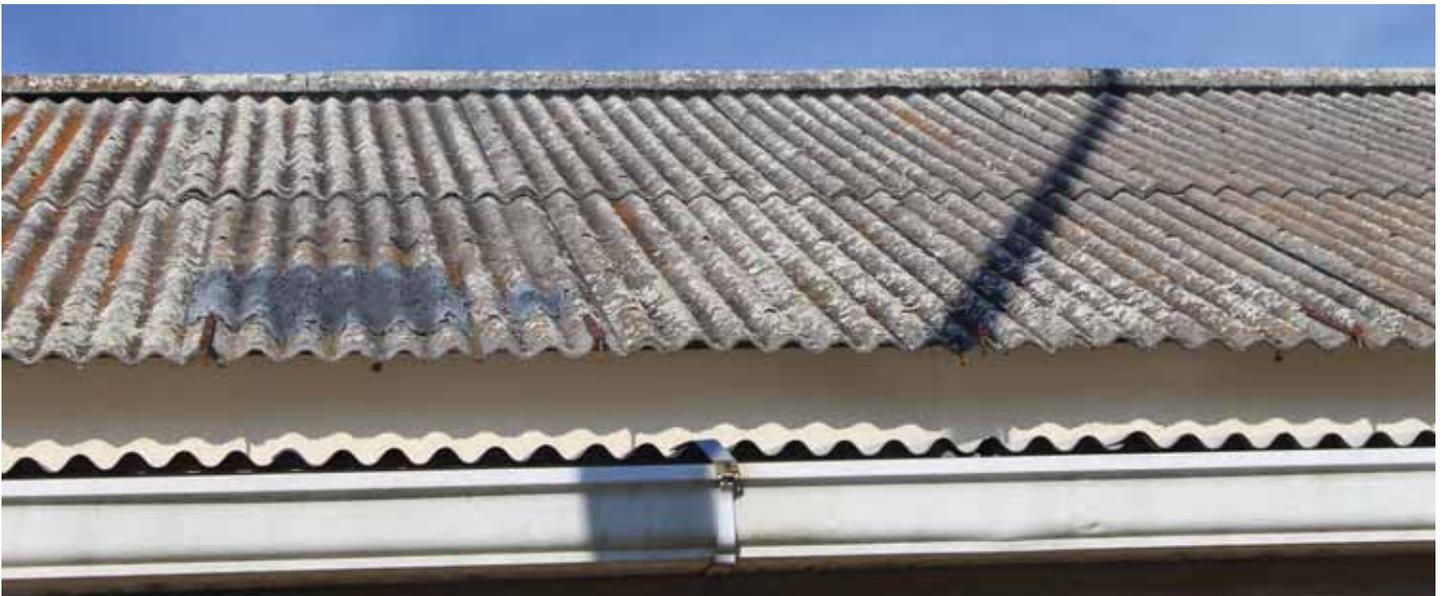
Illustration 76: Building 466 at NSF Indian Head has a corrugated asbestos-cement roof with degradation. The material has begun to break down and looks rough, which may release asbestos fibers (Photographer: Samantha Driscoll 2015).

Illustration 76: Building 466 at NSF Indian Head has a corrugated asbestos-cement roof with degradation. The material has begun to break down and looks rough, which may release asbestos fibers (Photographer: Samantha Driscoll 2015). | 75

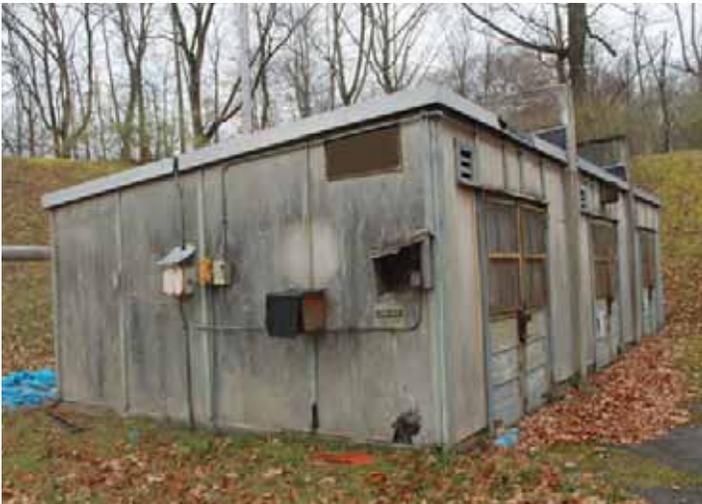
Illustration 77: Building 1507 at Picatunny Arsenal is clad in flat panel asbestos-cement that is heavily stained, indicating degradation (Photographer: Samantha Driscoll 2015).

Illustration 77: Building 1507 at Picatinny Arsenal is clad in flat panel asbestos-cement that is heavily stained, indicating degradation (Photographer: Samantha Driscoll 2015). | 76

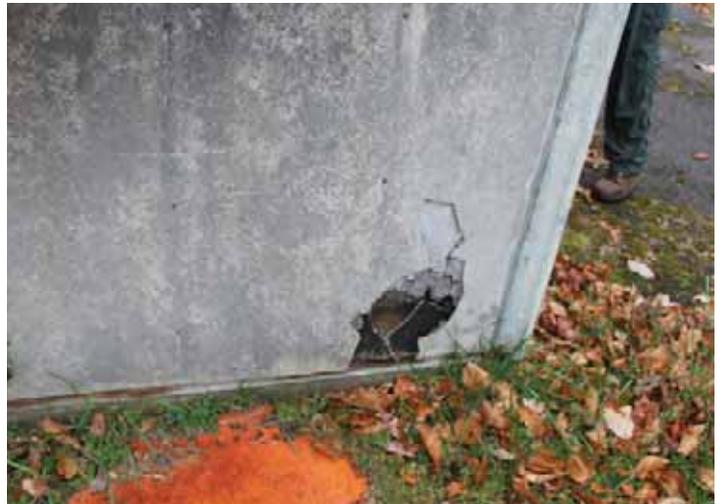
Illustration 78: Detail of a crumbled section of asbestos-cement on Building 1507 at Picatunny Arsenal (Photographer: Samantha Driscoll 2015).

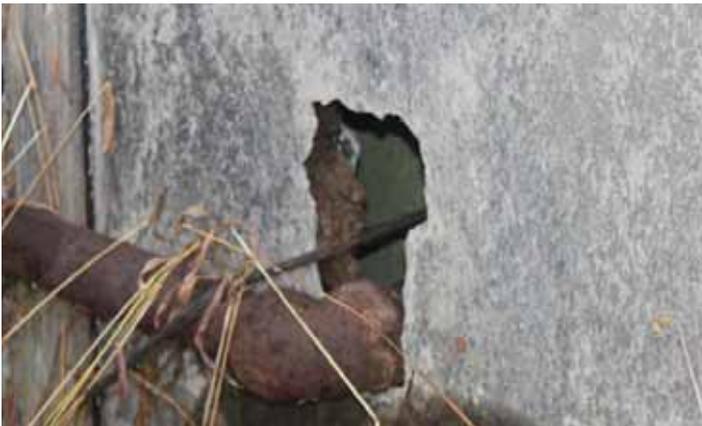
Building 1507 is a contributing resource to the Rocket Test Area Historic District. Built in 1946, the historic use of the building was as a general purpose magazine (Picatunny Arsenal ICRMP 2014:n.p.). Due to its requirement for fireproof characteristics, the former magazine was clad in flat panel asbestos-cement. The asbestos-cement has not been maintained and is heavily stained (Illustration 77). The staining may be caused by moisture, environmental factors, erosion, or biological growth. According to NESHAP, asbestos-cement can become friable due to processes such as weathering (NAVFAC 2012:4-5). There are also cracks and areas where the asbestos-cement has crumbled (Illustrations 78 and 79). One example surrounds a corroded metal pipe, indicating a leak as the culprit. The asbestos-cement material on Building 1507 should not be repaired; it should be replaced with a suitable substitute.

Illustration 79: Detail of a crumbled section of asbestos-cement located around a corroded pipe on Building 1507 at Picatunny Arsenal, indicating moisture as the cause (Photographer: Samantha Driscoll 2015).

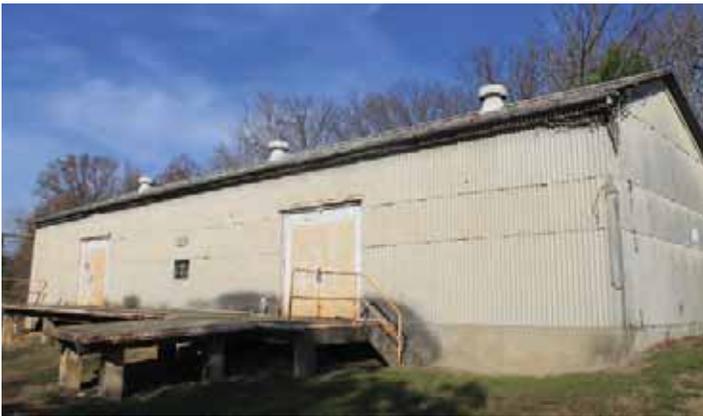
asbestos-cement cladding and roofing (Illustration 80). Asbestos-cement was ideal for the support building, as it was fireproof and required almost no maintenance. However, Building 448 has condition issues. There are several hairline cracks, which indicate material degradation (Illustration 81). The more obvious condition is the dark staining, which is degradation by erosion that caused cracking and crumbling along the foundation line (Illustration 82). According to NESHAP, asbestos-cement can become friable due to processes such as weathering (NAVFAC 2012:4-5). Degradation, cracks, and crumbling are all indications the material is or may become friable. Utilitarian buildings like Building 448 are unlikely to receive the maintenance they need, so the asbestos-cement needs replacement.

Illustration 80: Building 448 at NSF Indian Head is clad in corrugated asbestos-cement. Note the dark degradation areas along the foundation line (Photographer: Samantha Driscoll 2015).

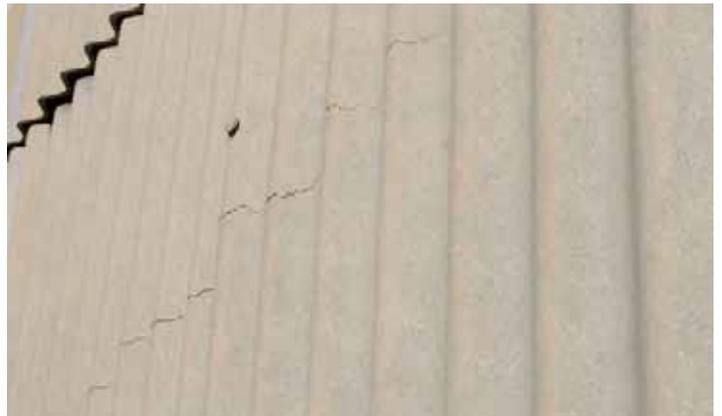
Illustration 81: Detail of the hairline cracks visible in the corrugated asbestos-cement on Building 448 (Photographer: Samantha Driscoll 2015).

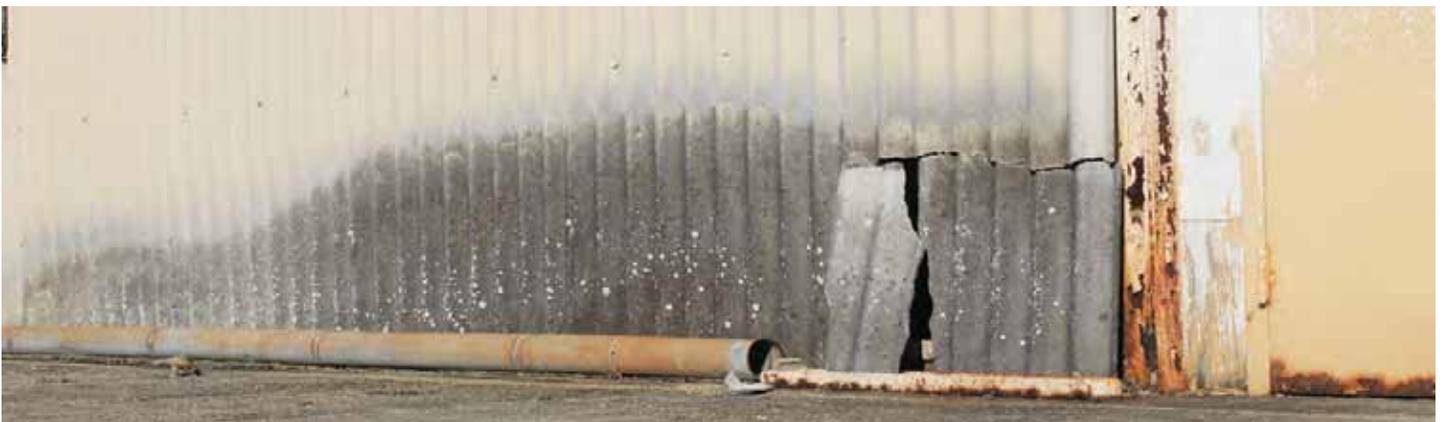
Illustration 82: Detail of the staining, erosion, discoloration, and lichen growths on Building 448, indicative of degradation (Photographer: Samantha Driscoll 2015).

Illustration 82: Detail of the staining, erosion, discoloration, and lichen growths on Building 448, indicative of degradation (Photographer: Samantha Driscoll 2015). | 77

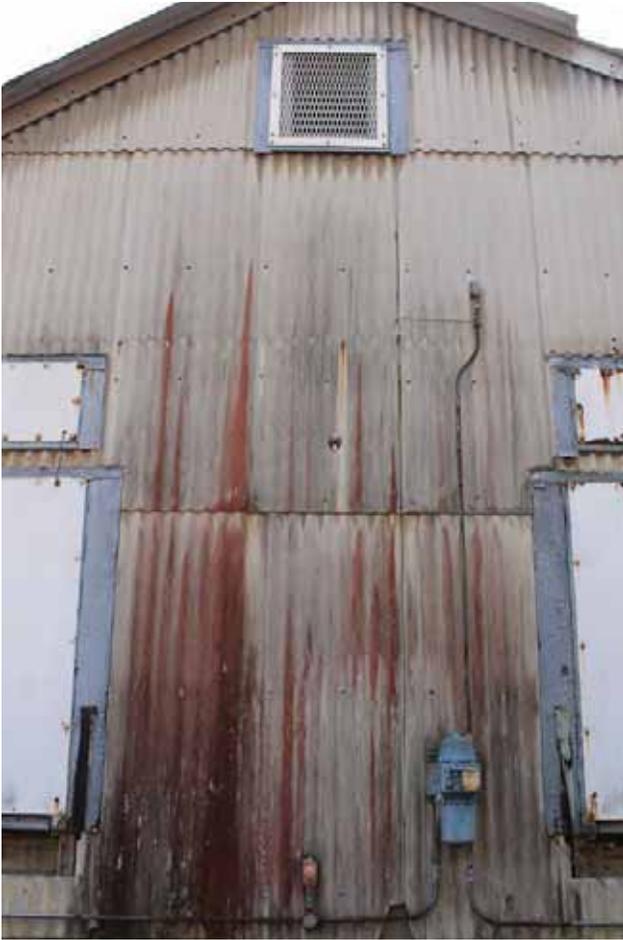
Illustration 83: The corrugated asbestos-cement cladding has severe stains, indicating lichen growth (Photographer: Samantha Driscoll 2015).

Illustration 83: The corrugated asbestos-cement cladding has severe stains, indicating lichen growth (Photographer: Samantha Driscoll 2015). | 78

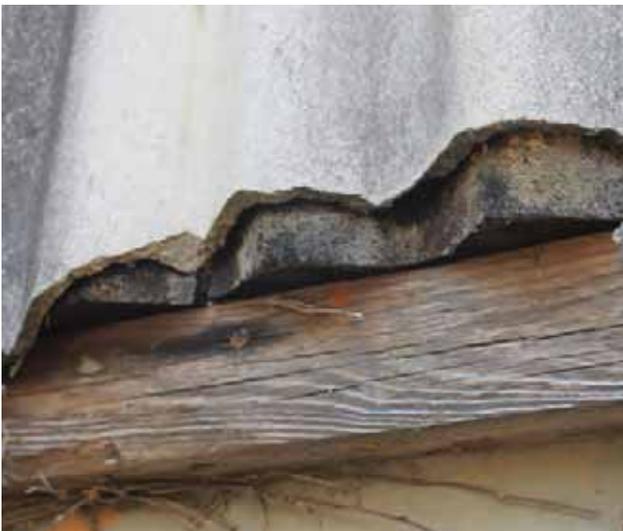
Illustration 84: Detail of the corrugated asbestos-cement wall where the material has crumbled off. Note the thinness of the asbestos-cement panels, as well as the exposed insulation layer (Photographer: Samantha Driscoll 2015).

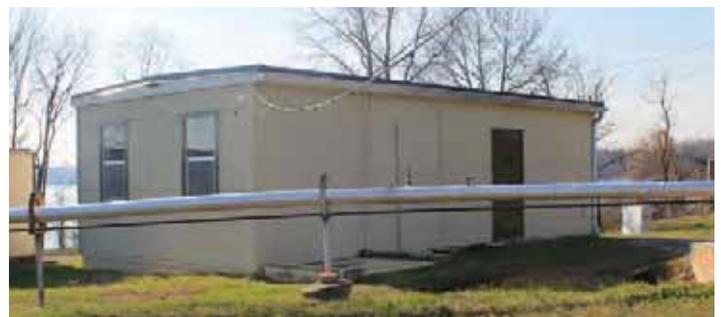
Building 544D is a contributing resource to the Extrusion Plant Historic District. Built in 1944, the historic use of the building was as an electronic physical laboratory (NSF Indian Head ICRMP 2012:C-22). This provides an example of flat panel asbestos-cement that has been maintained (Illustration 85). The panels had begun to form hairline cracks, and the installation

Illustration 85: Building 544D has flat panel asbestos-cement, which was set to be replaced, but instead was maintained through sealing and painting (Photographer: Samantha Driscoll 2015).

initiated a replacement plan. The installation initially planned to use Hardie Board, a fiber cement siding material, and submitted a letter to the MHT, which concurred with the replacement as a suitable substitute. However, the installation opted to remove the lead paint on the panels and seal and repaint them instead. The result solved the cracking, and the panels were able to be left in place. The approved suitable substitute was not used (Wright 2015).

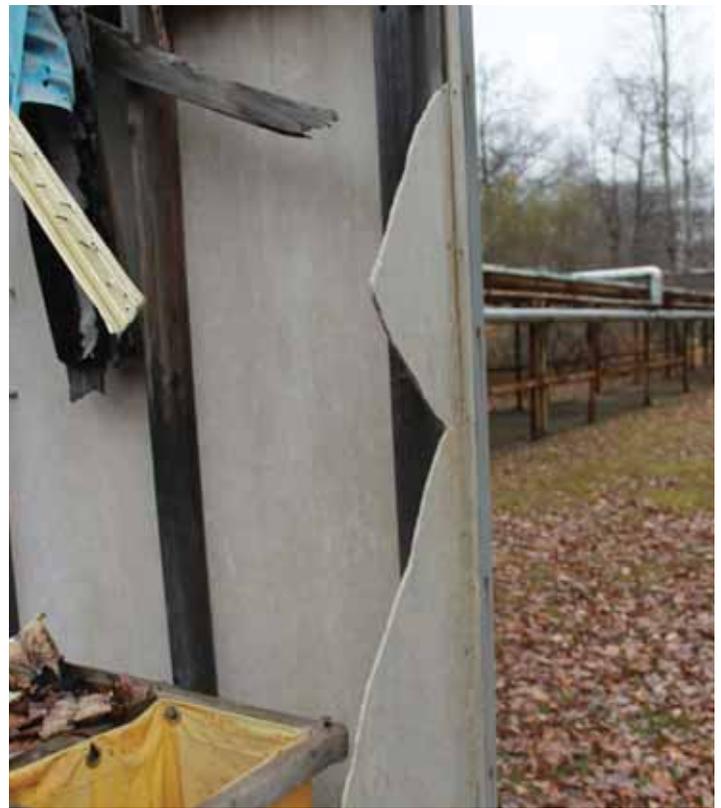
Illustration 86: Detail of Building 1508 at Picatinny Arsenal where large sections of flat panel asbestos-cement have been broken. Note the thin, brittle nature of asbestos-cement (Photographer: Samantha Driscoll 2015).

Illustration 86: Detail of Building 1508 at Picatinny Arsenal where large sections of flat panel asbestos-cement have been broken. Note the thin, brittle nature of asbestos-cement (Photographer: Samantha Driscoll 2015). | **80**

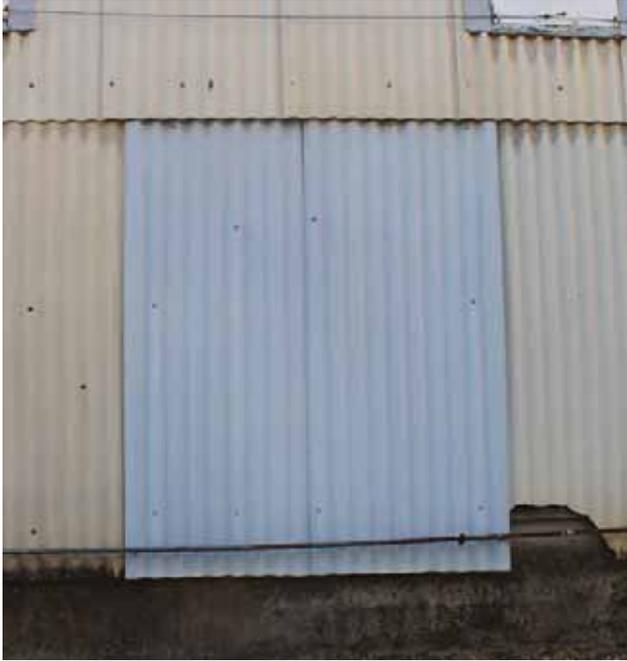
Illustration 87: Building 508 at NSF Indian Head replaced two formed corrugated asbestos-cement panels with corrugated metal panels. Attention was paid to the width of the corrugations, and the rhythm was maintained. The material should be painted to match the historic material surrounding it and camouflage the replacement material (Photographer: Samantha Driscoll 2015).

Illustration 87: Building 508 at NSF Indian Head replaced two formed corrugated asbestos-cement panels with corrugated metal panels. Attention was paid to the width of the corrugations, and the rhythm was maintained (Photographer: Samantha Driscoll 2015). | **82**

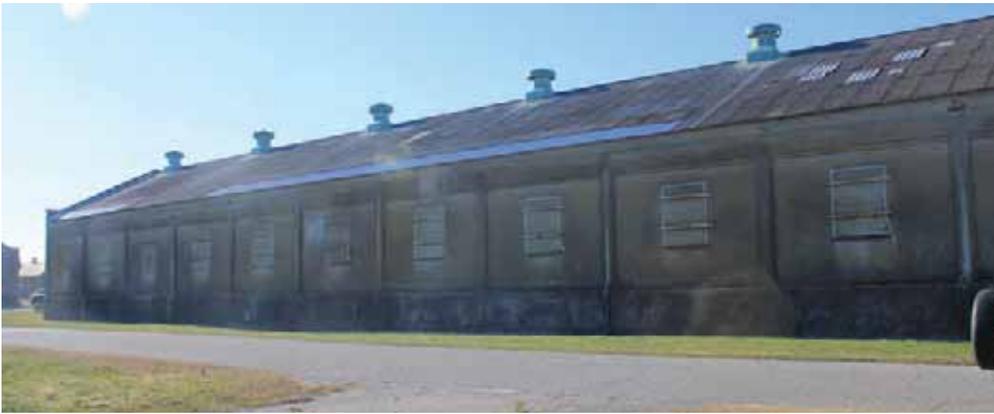
Illustration 88: Building 74 at NNSY, St. Juliens Creek Annex has several corrugated metal patches on the corrugated asbestos-cement roof. While the replacement patches have similar corrugation widths, the difference in materials is obvious. If the corrugated metal was painted, the patches would blend more with the historic fabric (Photographer: Samantha Driscoll 2016).

Illustration 88: Building 74 at NNSY, St. Juliens Creek Annex has several corrugated metal patches on the corrugated asbestos-cement roof. While the replacement patches have similar corrugation widths, the difference in materials is obvious. If the corrugated metal was painted, the patches would blend more with the historic fabric (Photographer: Samantha Driscoll 2016). | **83**

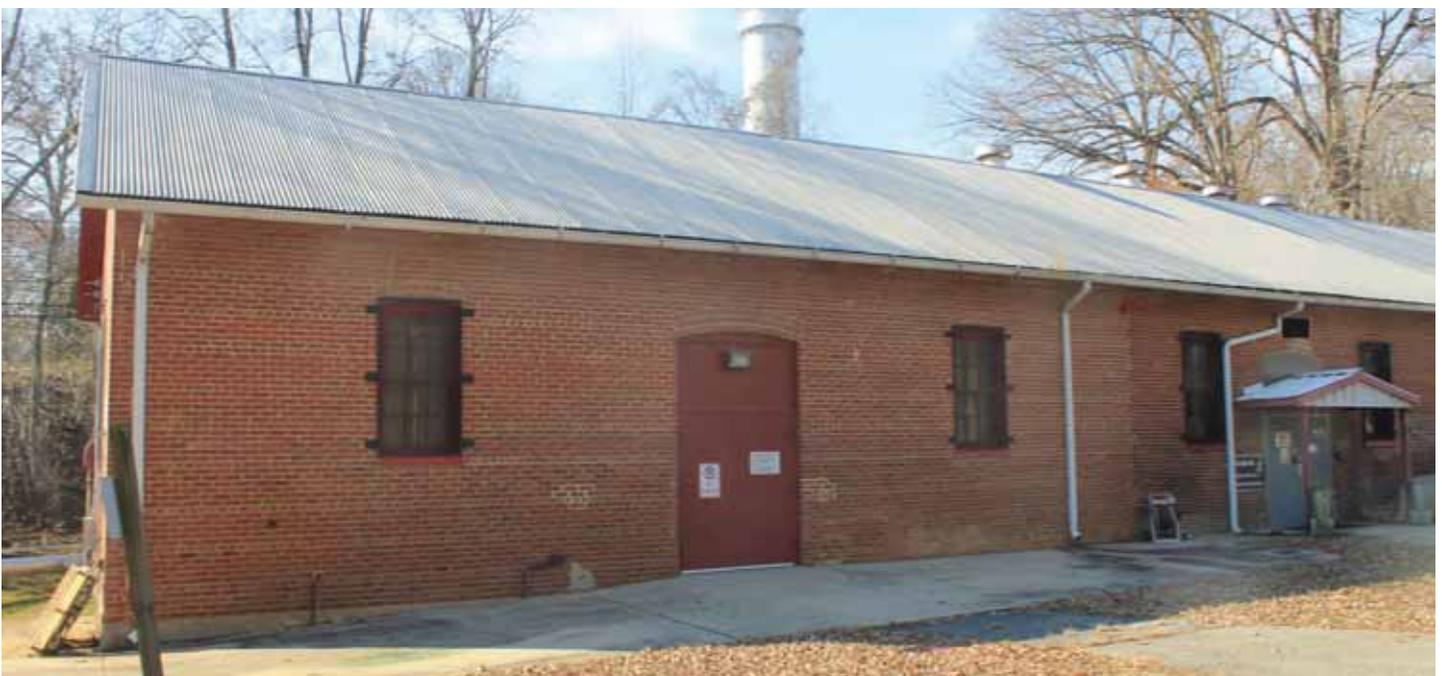
Illustration 89: Building 160 at NSF Indian Head is an example of a suitable substitute replacement roof. The corrugated asbestos-cement roof was replaced with a corrugated metal roof in 2010 (Photographer: Samantha Driscoll 2015).

Illustration 89: Building 160 at NSF Indian Head is an example of a suitable substitute replacement roof. The corrugated asbestos-cement roof was replaced with a corrugated metal roof in 2010 (Photographer: Samantha Driscoll 2015). | **83**

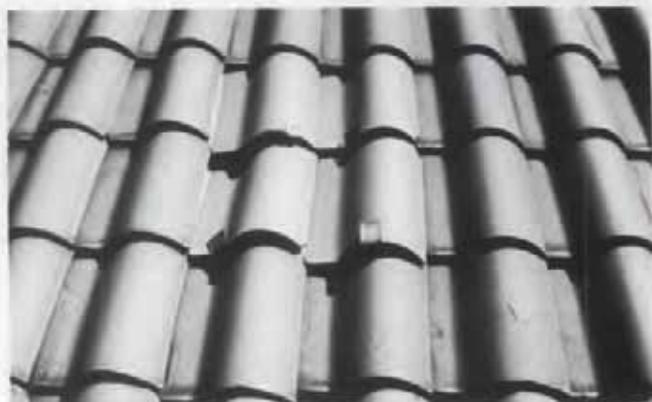
Repairs on this pantile roof were made with new tiles held in place with metal hangers. (Main Building, Ellis Island, New York)

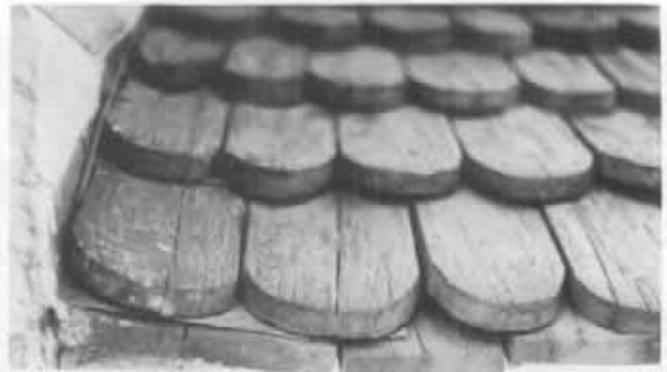
Replacement of particular historic details is important to the individual historic character of a roof, such as the treatment at the eaves of this rounded butt wood shingle roof. Also note that the surface of the roof was carefully sloped to drain water away from the side of the dormer. In the restoration, this function was augmented with the addition of carefully concealed modern metal flashing. (Mount Vernon, Virginia)

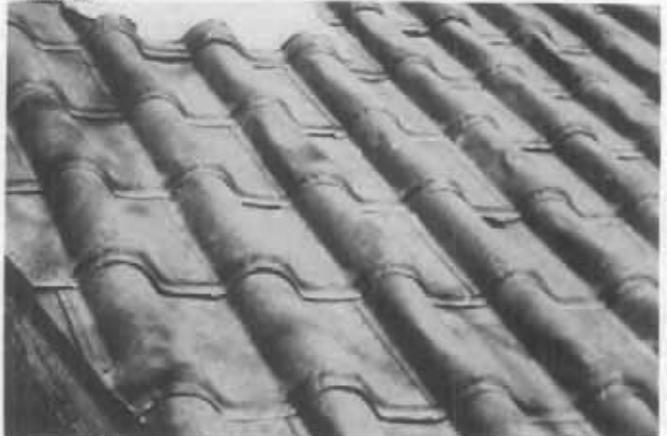
Galvanized sheet-metal shingles imitating the appearance of pantiles remained popular from the second half of the 19th century into the 20th century. (Episcopal Church, now the Jerome Historical Society Building, Jerome, Arizona, 1927)

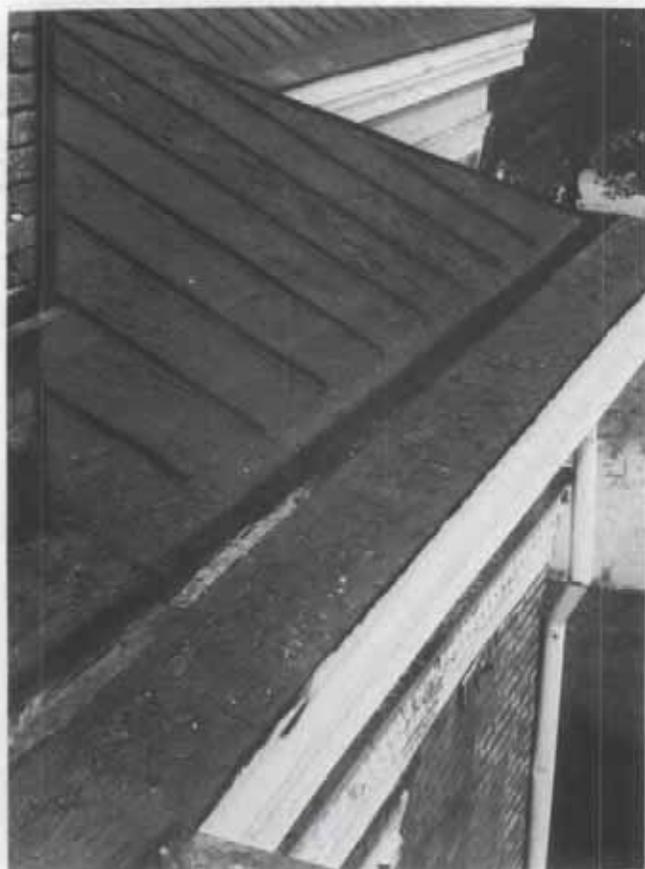
Repeated repair with asphalt, which cracks as it hardens, has created a blistered surface on this sheet-metal roof and built-in gutter, which will retain water. Repairs could be made by carefully heating and scraping the surface clean, repairing the holes in the metal with a flexible mastic compound or a metal patch, and coating the surface with a fibre paint. (Roane County Courthouse, Kingston, Tennessee, photo courtesy of Building Conservation Technology, Inc.)

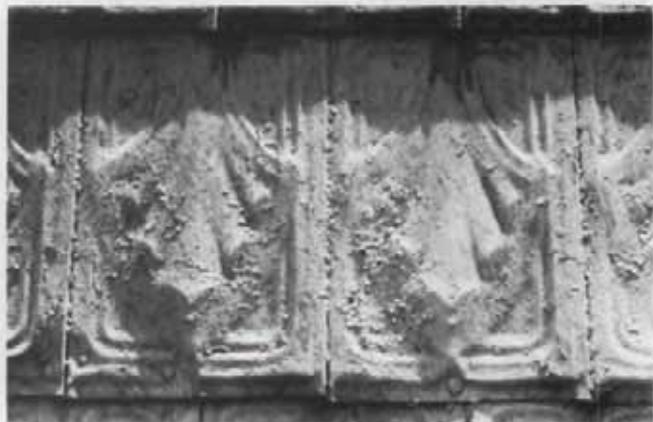
Tin shingles, commonly embossed to imitate wood or tile, or with a decorative design, were popular as an inexpensive, textured roofing material. These shingles $8\frac{3}{8}$ inch by $12\frac{1}{2}$ inch on the exposed surface) were designed with interlocking edges, but they have been repaired by surface nailing, which may cause future leakage. (Ballard House, Yorktown, Virginia, photo by Gordie Whittington, National Park Service)

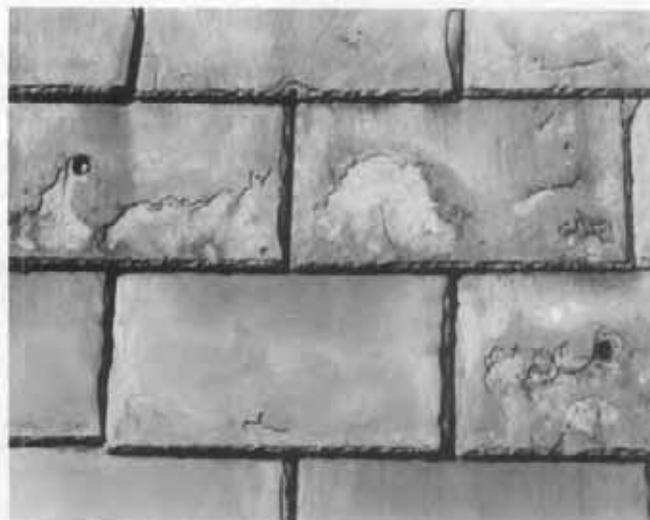
This detail shows slate delamination caused by a combination of weathering and pollution. In addition, the slates have eroded around the repair nails, incorrectly placed in the exposed surface of the slates. (Lower Pontalba Building, New Orleans, photo courtesy of Building Conservation Technology, Inc.)

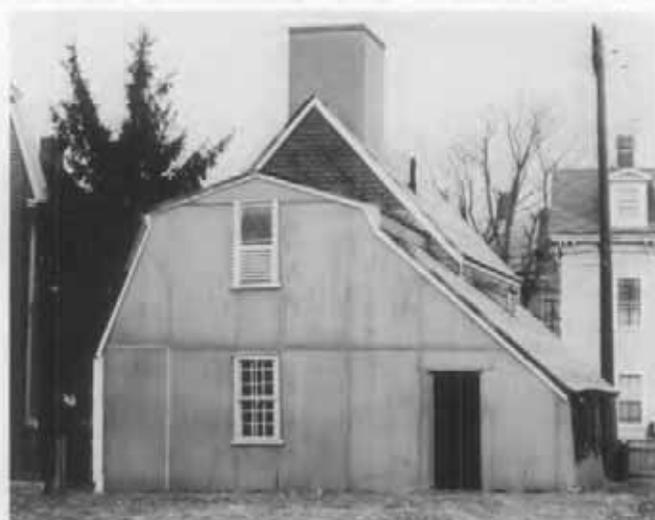
Temporary stabilization or "mothballing" with materials such as plywood and building paper can protect the roof of a project until it can be properly repaired or replaced. (Narbonne House, Salem, Massachusetts)

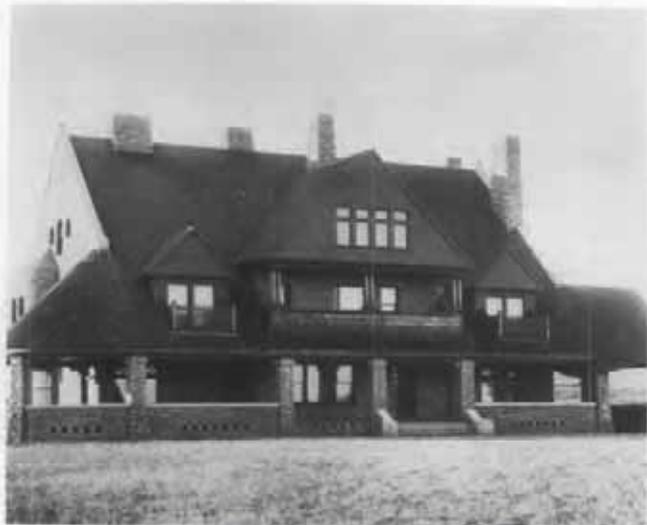
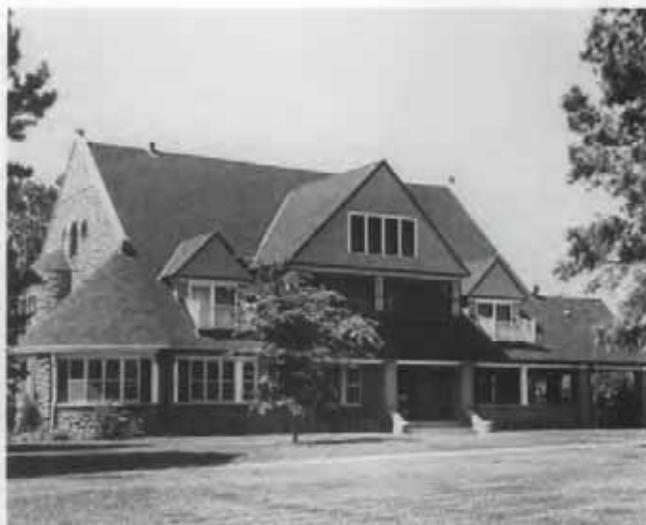
These two views of the same house demonstrate how the use of a substitute material can drastically affect the overall character of a structure. The textural interest of the original tile roof was lost with the use of asphalt shingles. Recent preservation efforts are replacing the tile roof. (Frank House, Kearney, Nebraska, photo courtesy of the Nebraska State Historical Society, Lincoln, Nebraska)

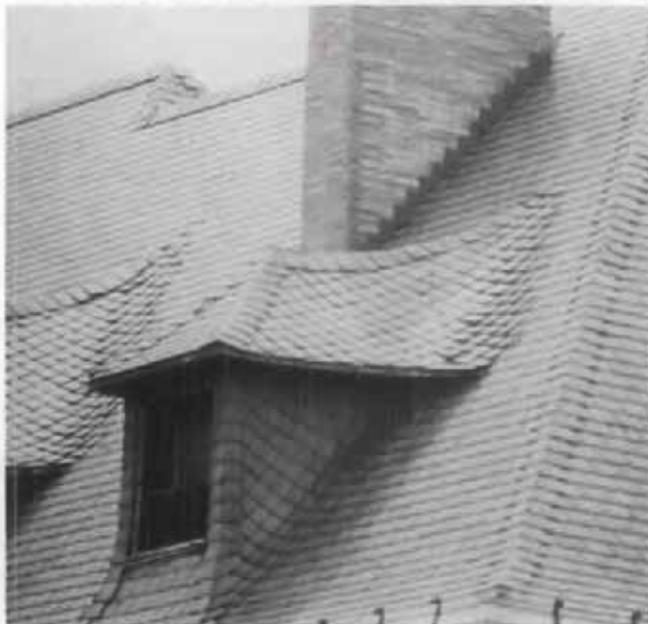
Because of the roof's visibility, the slate detailing around the dormers is important to the character of this structure. Note how the slates swirl from a horizontal pattern on the main roof to a diamond pattern on the dormer roofs and side walls. (18th and Que Streets, NW, Washington, D.C.)

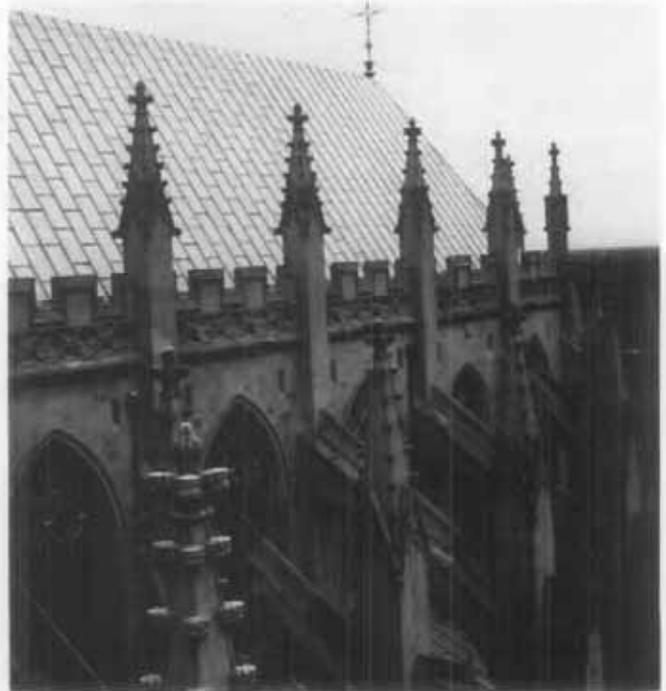
Good design and quality materials for the roof surface, fastenings, and flashing minimize roofing failures. This is essential on roofs such as on the National Cathedral where a thorough maintenance inspection and minor repairs cannot be done easily without special scaffolding. However, the success of the roof on any structure depends on frequent cleaning and repair of the gutter system. (Washington, D.C., photo courtesy of John Burns, A.I.A.)

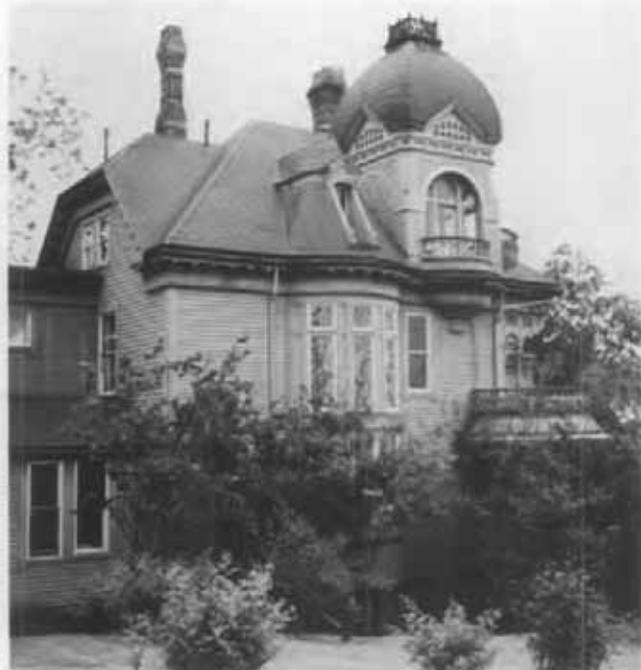
Special problems inherent in the design of an elaborate historic roof can be controlled through the use of good materials and regular maintenance. The shape and detailing are essential elements of the building's historic character, and should not be modified, despite the use of alternative surface materials. (Gamwell House, Bellingham, Washington)

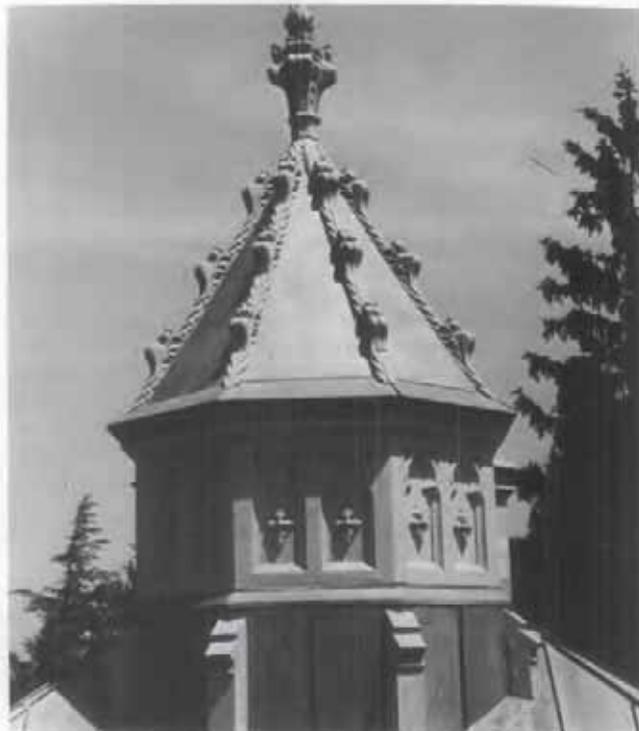
Decorative features such as cupolas require extra maintenance. The flashing is carefully detailed to promote run-off, and the wooden ribbing must be kept well-painted. This roof surface, which was originally tin plate, has been replaced with lead-coated copper for maintenance purposes. (Lyndhurst, Tarrytown, New York, photo courtesy of the National Trust for Historic Preservation)

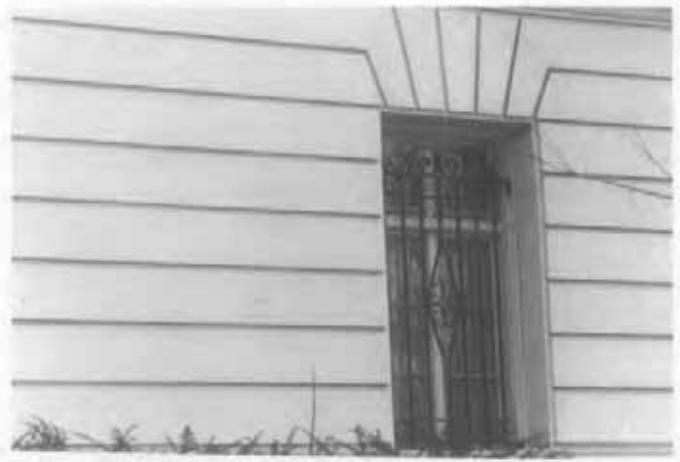
Illus. 2. Stucco has for many centuries represented a number of building materials. Seen here is the ground floor of a Beaux Arts mansion, circa 1900, which represents a finely laid stone foundation wall executed in scored stucco. Photo: Sharon C. Park, AIA.

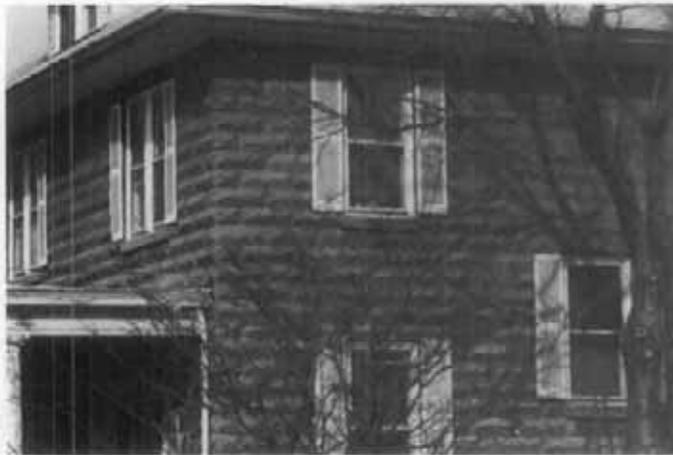
Illus. 3. Casting concrete to represent quarried stone was a popular late 19th-century technique seen in this circa 1910 mail-order house. While most components were delivered by rail, the foundations and exterior masonry were completed by local craftsmen. Photo: Sharon C. Park, AIA.

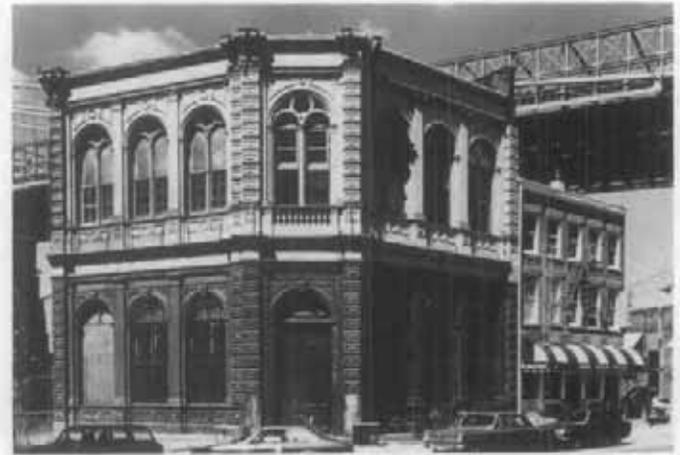
Illus. 4. The 19th-century also produced a variety of metal products used in imitation of other materials. In this case, the entire exterior of the Long Island Safety Deposit Company is cast-iron representing stone. Photo: Becket Logan, Friends of Cast Iron Architecture.

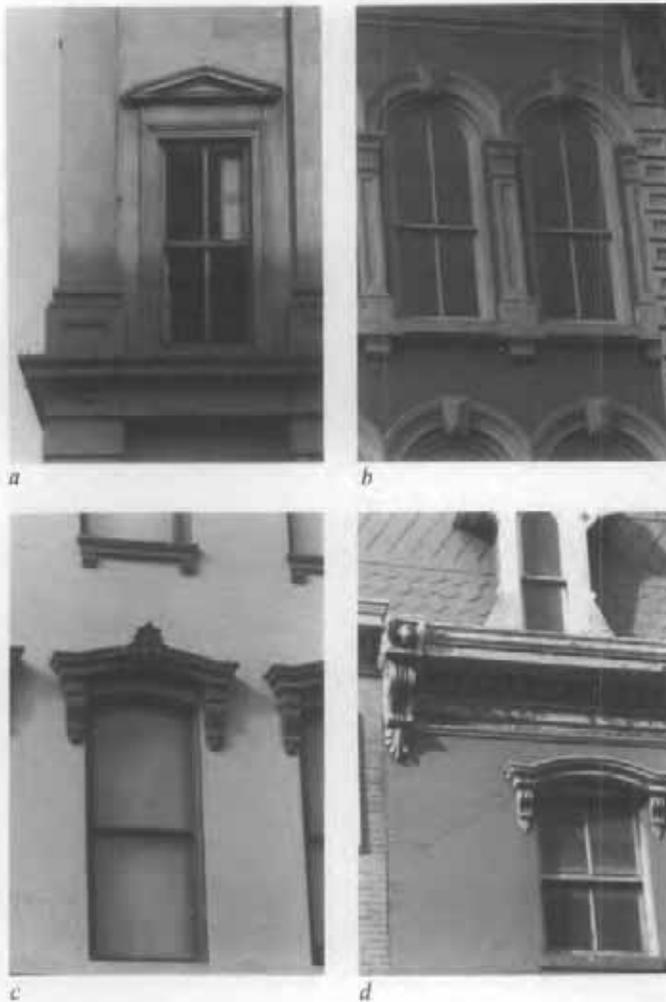
Illus. 5. The four historic examples of various window hoods shown are: (a) stone; (b) cast stone; (c) cast-iron; and (d) sheet metal. The criteria for selecting substitute materials today (availability, quality, delivery dates, cost) are not much different from the past. Photo: Sharon C. Park, AIA.

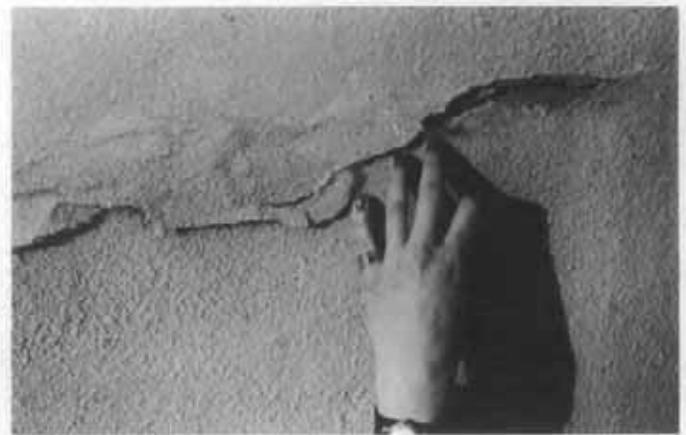
Illus. 6. Substitute materials should never be considered as a cosmetic cover-up for they can cause great physical damage and can alter the appearance of historic buildings. For example, a fiberglass coating was used at Ranchos de Taos, NM, in place of the historic adobe coating which had deteriorated. The waterproof coating sealed moisture in the walls and caused the spalling shown. It was subsequently removed and the walls were properly repaired with adobe. Photo: Lee H. Nelson, FAIA.

Because the overzealous use of substitute materials can greatly impair the historic character of a historic structure, all preservation options should be explored thoroughly before substitute materials are used. It is important to remember that the purpose of repairing damaged features and of replacing lost and irreparably damaged ones is both to match visually what was there and to cause no further deterioration. For these reasons it is not appropriate to cover up historic materials with synthetic materials that will alter the appearance, proportions and details of a historic building and that will conceal future deterioration (see illus. 6).

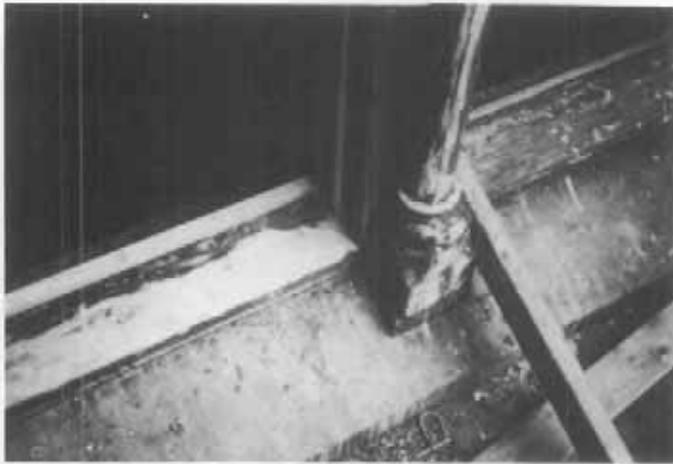
Illus. 7. Whenever possible, historic materials should be repaired rather than replaced. Epoxy, a synthetic resin, has been used to repair the wood window frame and sill at the Auditors Building (1878) Washington, DC. The cured resin is white in this photo and will be primed and painted. Photo: Lee H. Nelson, FAIA.

Some materials have been used successfully for the repair of damaged features such as epoxies for wood infilling, cementitious patching for sandstone repairs, or plastic stone for masonry repairs. Repairs are preferable to replacement whether or not the repairs are in kind or with a synthetic substitute material (see illus. 7).

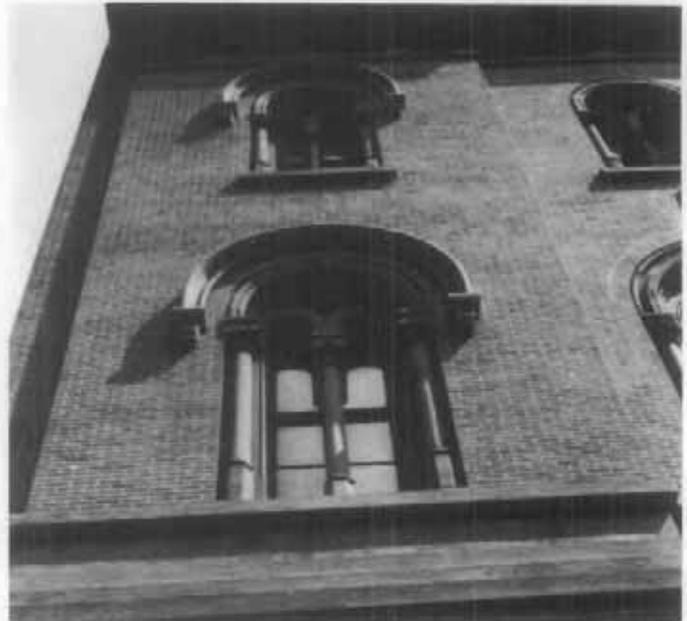
Illus. 8. Even when materials are not locally available, it may be possible and cost effective to find sources elsewhere. For example, the local sandstone was no longer available for the restoration of the New York Shakespeare Festival Public Theater. The deteriorated sandstone window hoods, were replaced with stone from Germany that closely matched the color and texture of the historic sandstone. Photo: John G. Waite.

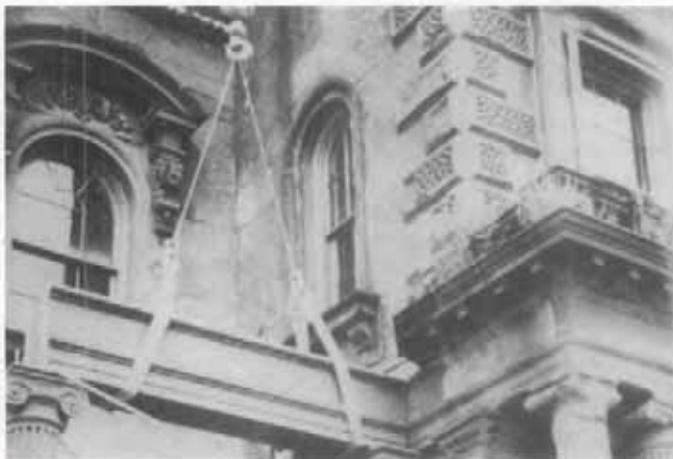
Illus. 9. Simple solutions should not be overlooked when materials are no longer available. In the case of the Morse-Libby Mansion (1859), Portland, ME, the deteriorated brownstone porch beam was replaced with a carved wooden beam painted with sand impregnated paint. Photo: Stephen Sewall.

as a replacement section, achieved using readily available traditional materials, conventional tools and work skills. (see illus. 9). Simple solutions should not be overlooked.

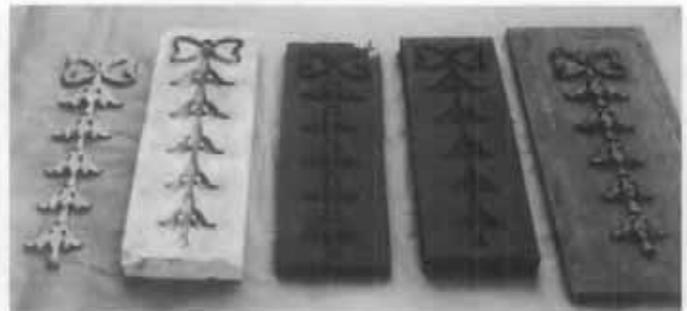
Illus. 10. The use of substitute materials is not necessarily cheaper or easier than using the original materials. The complex process of fabricating the polyester bronze reproduction pieces of the gilded wood molding for the clockcase at Independence Hall required talented artisans and substantial mold-making time. From left to right is the final molded polyester bronze detail; the plaster casting mold; the positive and negative interim neoprene rubber molds; and the expertly carved wooden master. Photo: Courtesy of Independence National Historical Park.

aluminum, cast stone, fiberglass, polymer concretes, glass fiber reinforced concretes and terra cotta. Mold making and casting takes skill and craftsmen who can undertake this work are available. (see illus. 10, 11). Efforts should always be made, prior to replacement, to seek out artisans who might be able to repair ornamental elements and thereby save the historic features in place.

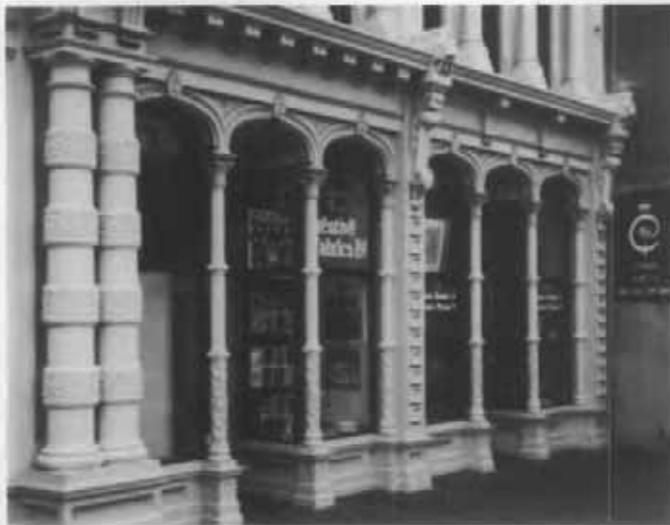
Illus. 11. The unavailability of historic craft techniques is another reason to consider substitute materials. The original first floor cast iron front of the Grand Opera House, Wilmington, DE, was missing; the expeditious reproduction in cast aluminum was possible because artisans working in this medium were available. Photo: John G. Waite.

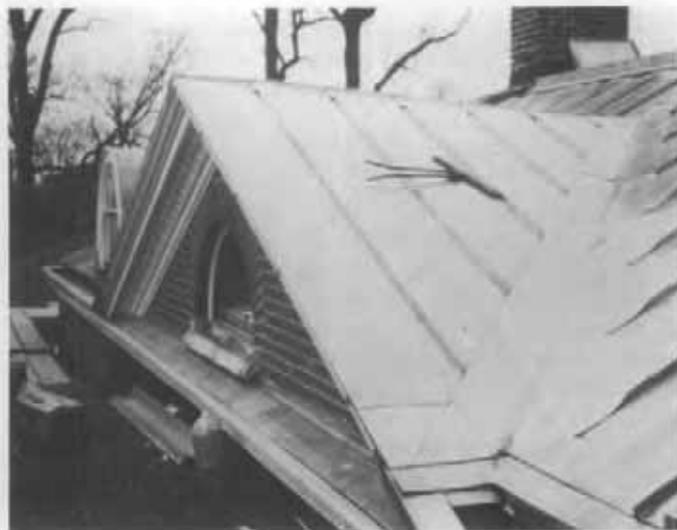
Illus. 12. Substitute materials may be considered when the original materials have not performed well. For example, early sheet metals used for roofing, such as tinplate, were reasonably durable, but the modern equivalent, terne-coated steel, is subject to corrosion once the thin tin plating is damaged. Terne-coated stainless steel or lead-coated copper (shown here) are now used as substitutes. Photo: John G. Waite.

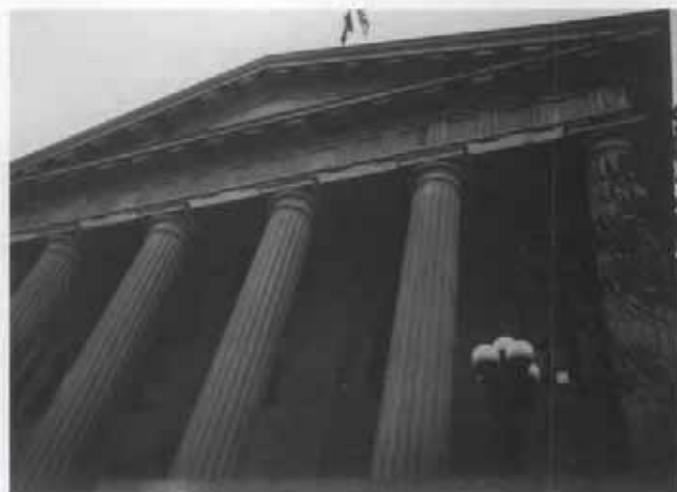
Illus. 13. Code-related changes are of concern in historic preservation projects because the integrity of the historic resource may be irretrievably affected. In the case of the Old San Francisco Mint, the fiberglass cornice was used to bring the building into seismic conformance. The original cornice was deteriorated, and the replacement (1982) was limited to the projecting pediment. The historic stone fascia was retained as were the stone columns. The limited replacement of deteriorated material did not jeopardize the integrity of the building. Photo: Walter M. Sontheimer.

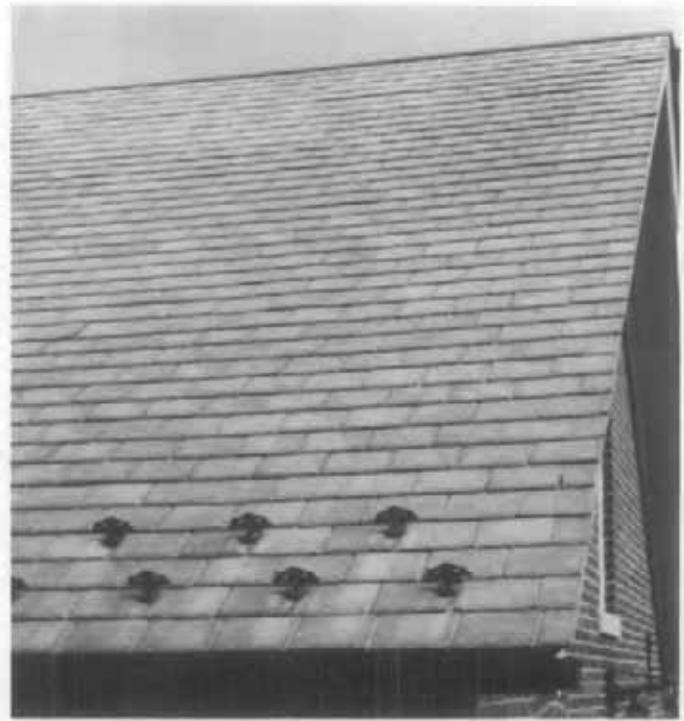
Illus. 14. The visual qualities of the historic feature must be matched when using substitute materials. In this illustration, the lighter weight mineral fiber cement shingles used to replace the deteriorated historic slate roof were detailed to match the color, size, shape and pattern of the original roofing and the historic snow birds were reattached. Photo: Sharon C. Park, AIA.
