Department of Defense Legacy Resource Management Program

PROJECT 15-707 s

20th-CENTURY BUILDING MATERIALS AND SUITABLE SUBSTITUTES: EXTERIOR MATERIALS

January 2017s

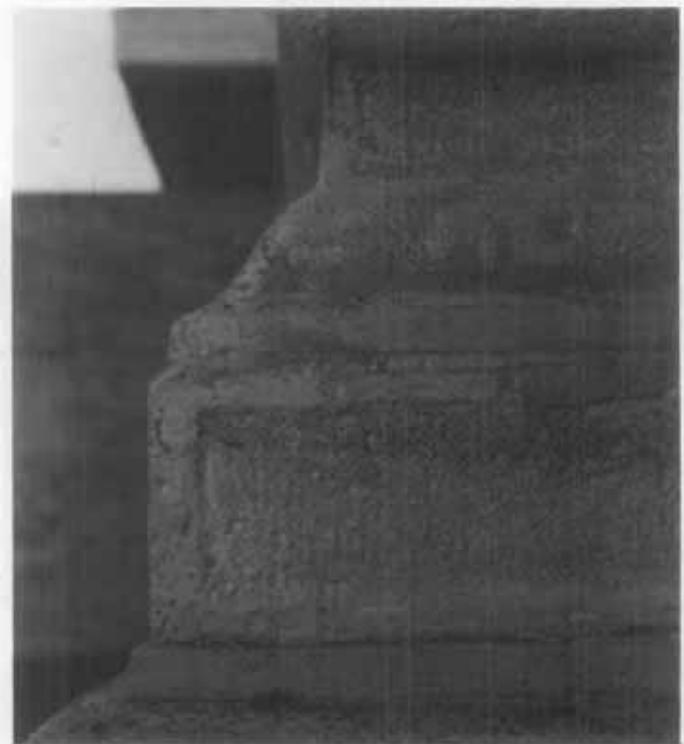
Illus. 15. Poor quality workmanship can be avoided. In this example, the crudely cast concrete entrance pier (shown) did not match the visual qualities of the remaining historic sandstone (not shown). The aggregate is too large and exposed; the casting is not crisp; the banded tooling edges are not articulated; and the color is too pale. Photo: Sharon C. Park, AIA.

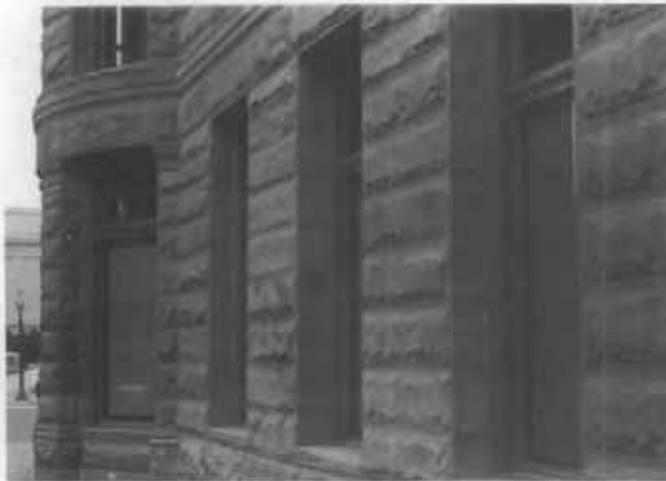
Illus. 16. The good quality substitute materials shown here do match the historic sandstone in color, texture, tooling and surface details. Dry-tamp cast stone was used to match the red sandstone that was no longer available. The reconstructed first floor incorporated both historic and substitute materials. Sufficient molds were made to avoid the problem of detecting the substitutes by their uniformity. Photo: Sharon C. Park, AIA.

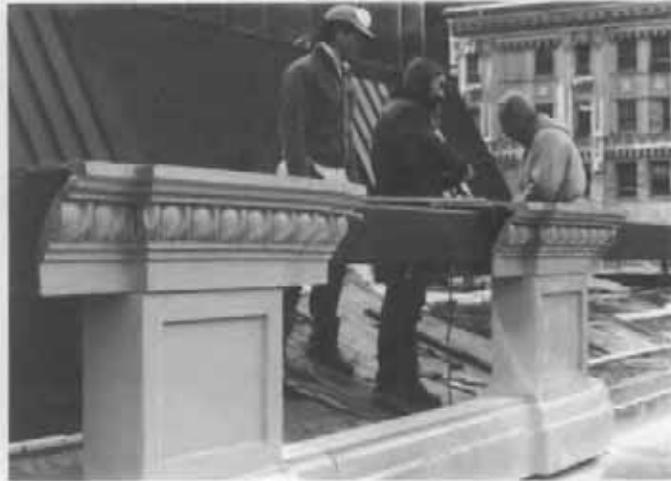
Illus. 18. Substitute materials must be properly installed to allow for expansion, contraction, and structural security. The new balustrade (a polymer concrete modified with glass fibers) at Carnegie Hall, New York City, was installed with steel structural supports to allow window-washing equipment to be suspended securely. In addition, the formulation of this predominantly epoxy material allowed for the natural expansion and contraction within the predesigned joints. Photo: Courtesy of MJM Studios.

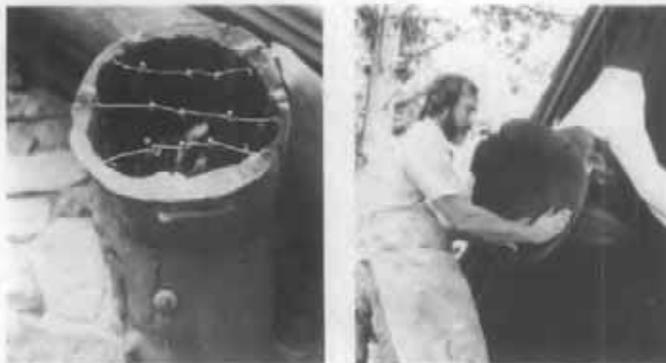
Illus. 17. Care must be taken to ensure that the replacement materials will work within a predesigned system. At the Norris Museum, Yellowstone National Park, the 12-inch diameter log rafters, part of an intricate truss system, had rotted at the inner core from the exposed ends back to a depth of 48 inches. The exterior wooden shells remained intact. Fiberglass rods (left photo) and specially formulated structural epoxy were used to fill the cleaned out cores and a cast epoxy wafer end with all the detail of the original wood graining was laminated onto the log end (right photo). This treatment preserved the original feature with a combination of repair and replacement using substitute materials as part of a well thought out system. Photos: Courtesy of Harrison Goodall.

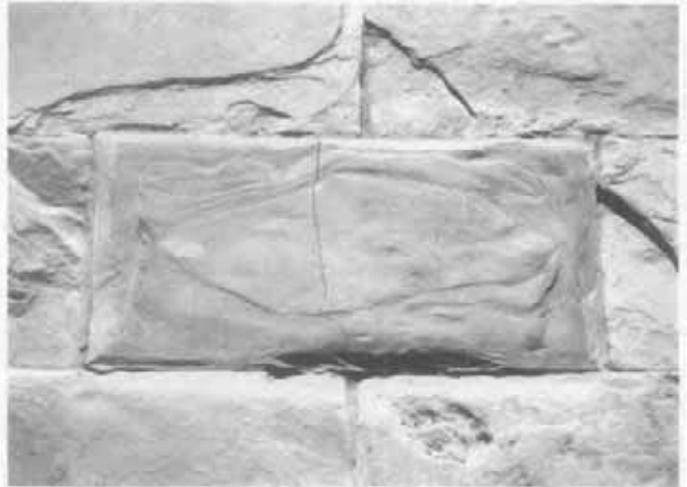
Illus. 19. When the physical properties are not matched, particularly thermal expansion and contraction properties, great damage can occur. In this case, an extremely rigid epoxy replacement unit was installed in a historic masonry wall. Because the epoxy was not modified with fillers, it did not expand or contract systematically with the natural stones in the wall surrounding it. Pressure built up resulting in a vertical crack at the center of the unit, and spalled edges to every historic stone that was adjacent to the rigid unit. Photo: Walter M. Sontheimer.

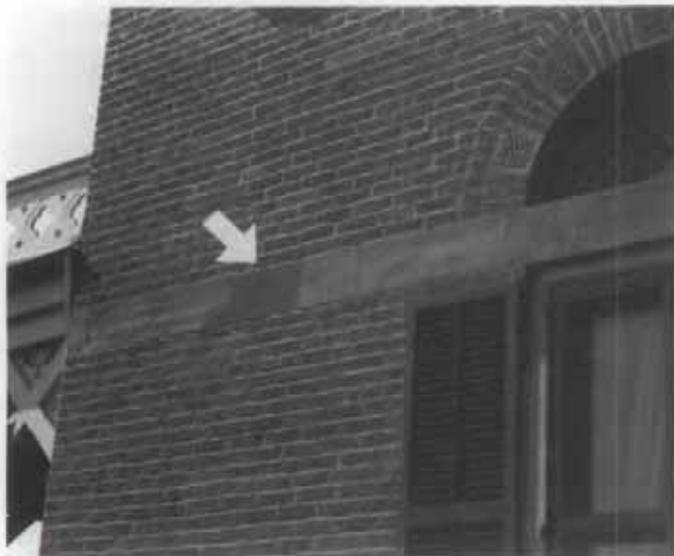
Illus. 21. Change of color over time is one of the greatest problems of synthetic substitute materials used outdoors. Ultra-violet light can cause materials to change color over time; some will lighten and others will darken. In this photograph, the synthetic patching material to the sandstone banding to the left of the window has aged to a darker color. Photos: Sharon C. Park, AIA.

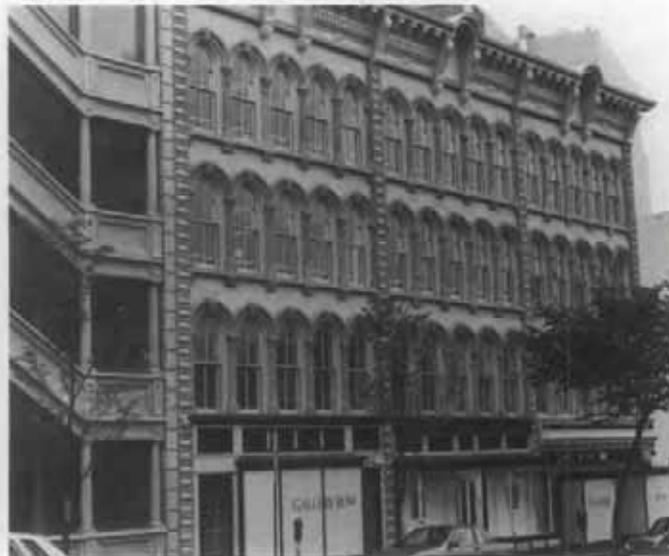
Illus. 22. A fiber reinforced polymer (fiberglass) cornice and precast concrete elements replaced deteriorated features on the 19th-century exterior. Photo: Sharon C. Park, AIA.

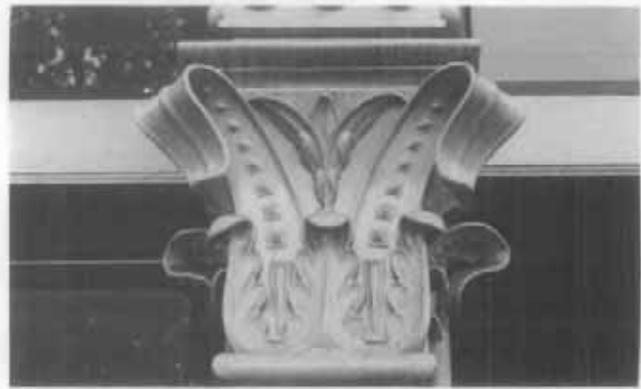
Close-up detail showing the crisp casting in aluminum of this 19th-century replica column and capital for a storefront. Photo: Sharon C. Park, AIA.

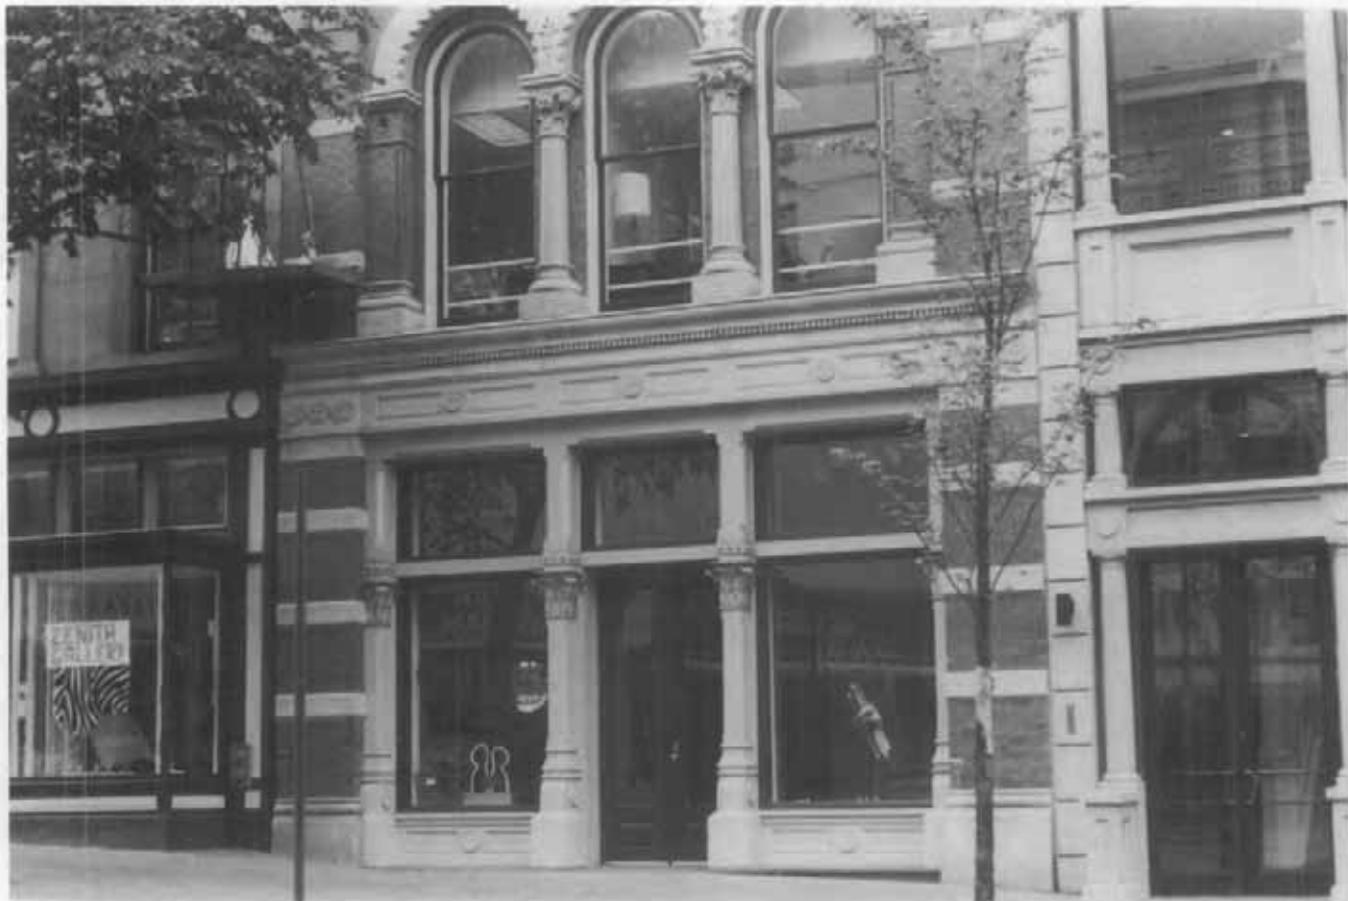
The new cast aluminum storefront replaced the lost 19th-century cast-iron original. Photo: Sharon C. Park, AIA.

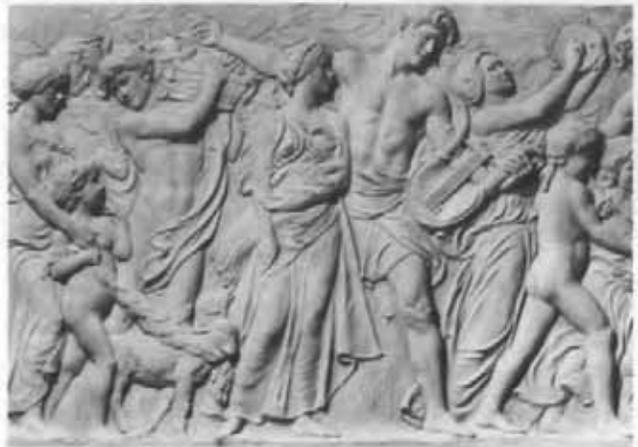
This glass fiber reinforced concrete sculptural wall panel will replace the seriously damaged resin and plaster original. A finely textured surface was achieved by spraying the GFRC mix into molds that were created from the historic panel and resculpted based on historic photographs. Photo: Courtesy of MJM Studios.

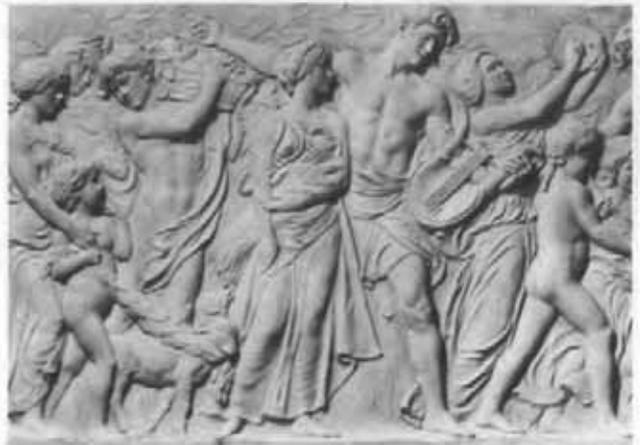
This glass fiber reinforced concrete sculptural wall panel will replace the seriously damaged resin and plaster original. A finely textured surface was achieved by spraying the GFRC mix into molds that were created from the historic panel and resculpted based on historic photographs. Photo: Courtesy of MJM Studios.

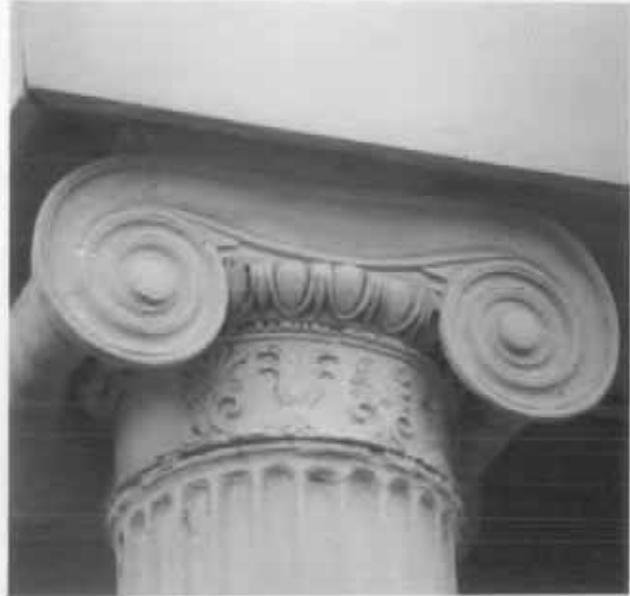
This replica column capital was made using epoxy resins poured into a mold taken from the building. The historic wooden column shaft was repaired during the restoration. Photo: Courtesy Dell Corporation.

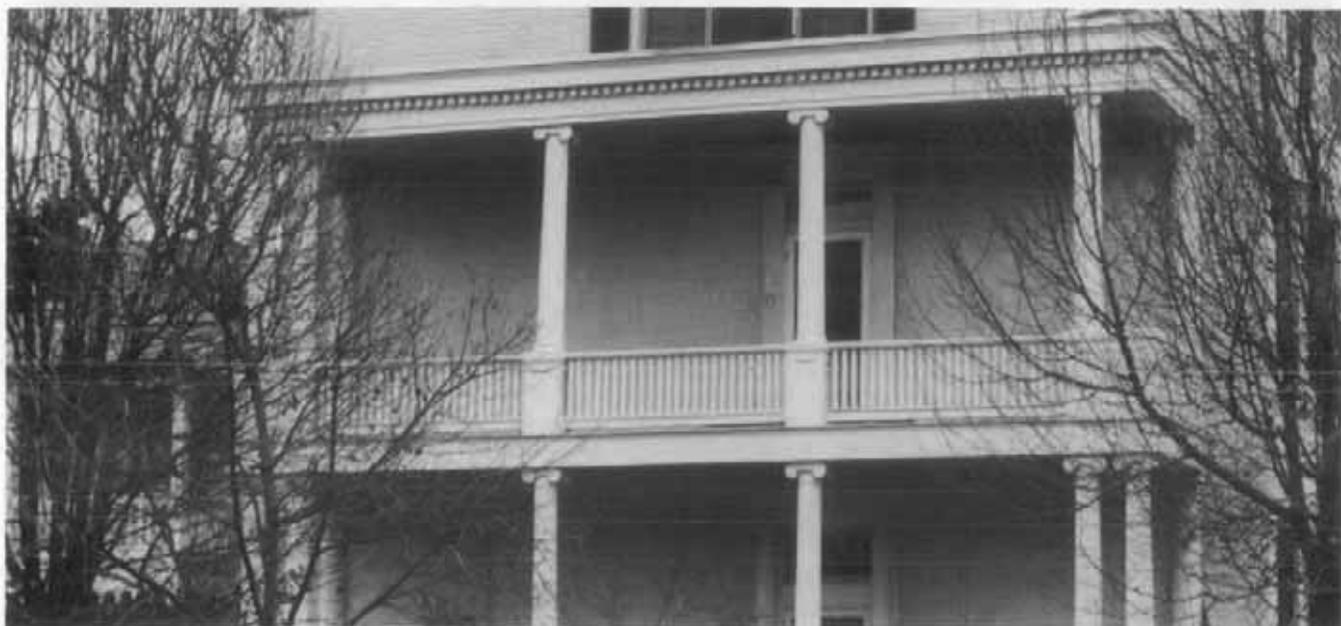
Columns were repaired and a capital was replaced in epoxy on this 19th-century 2-story porch. Photo: Dell Corporation

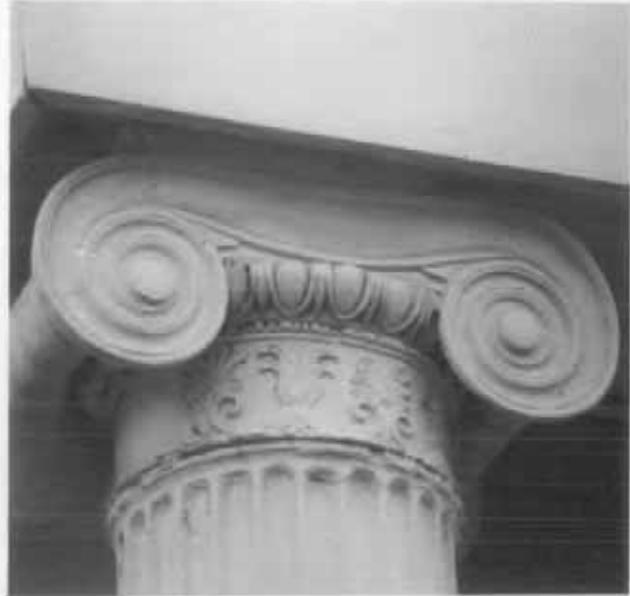
This replica column capital was made using epoxy resins poured into a mold taken from the building. The historic wooden column shaft was repaired during the restoration. Photo: Courtesy Dell Corporation.

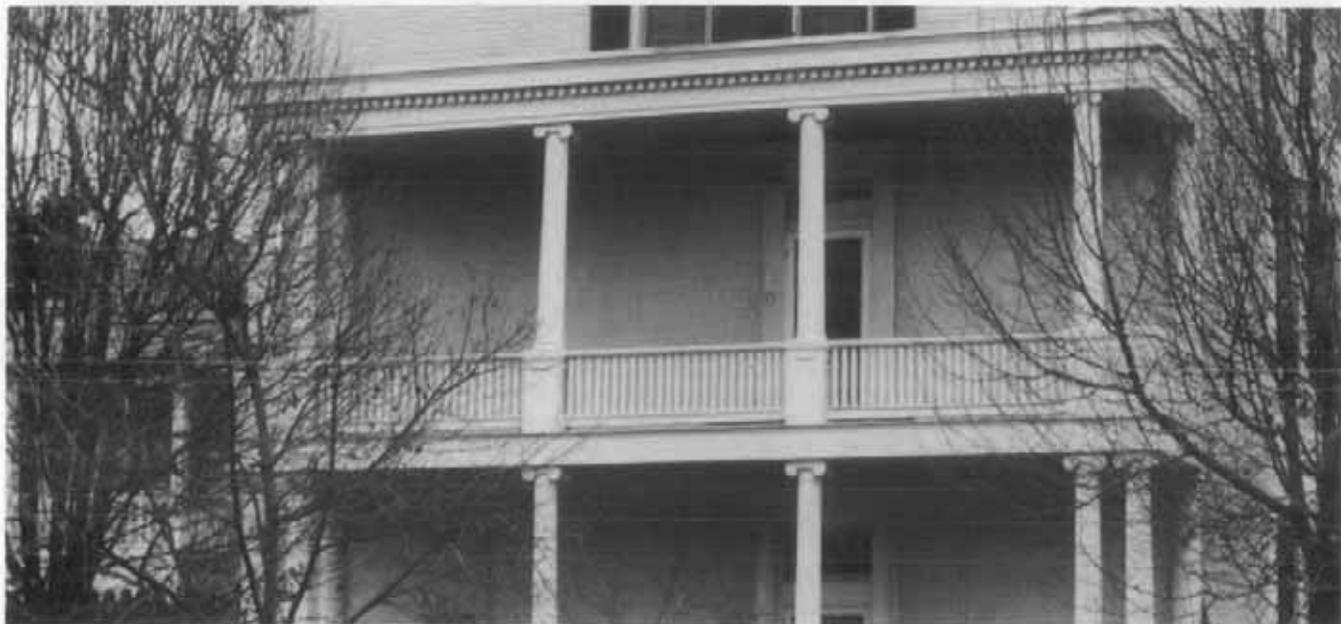
Columns were repaired and a capital was replaced in epoxy on this 19th-century 2-story porch. Photo: Dell Corporation

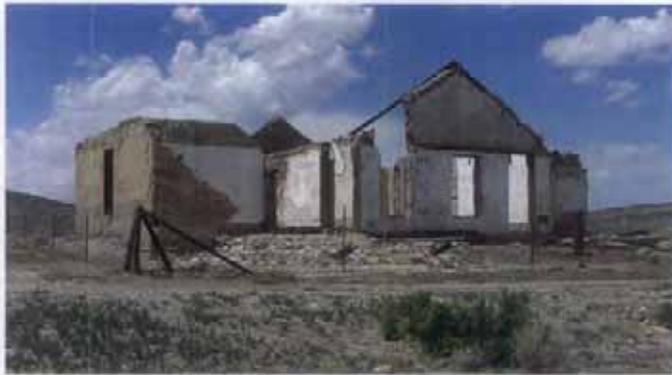
Figure 2. Chatterton House was the home of the post trader at Fort Fred Steel in Wyoming, one of several forts established in the 1860s to protect the Union Pacific Railroad. The walls of the post trader's house were built using stone aggregate and lime, without cement. The use of this material presents special preservation challenges.

Impressed by the economic advantages of poured gravel wall or "lime-grout" construction, the Quartermaster General's Office of the War Department embarked on a campaign to improve the quality of building for frontier military posts. As a result, lime-grout structures were constructed at several western posts soon after the Civil War, including Fort Fred Steele and Fort Laramie, both in Wyoming (Fig. 2). By the 1880s, sufficient experience had been gained with unreinforced concrete to permit construction of much larger buildings. A notable example from this period is the Ponce de Leon Hotel in St. Augustine, Florida.

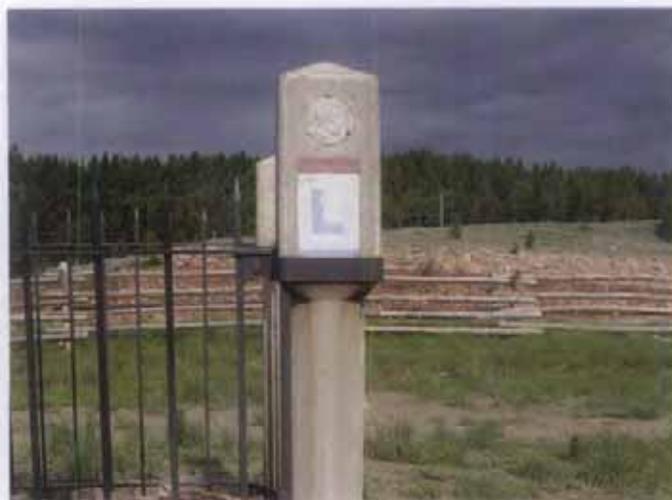
Figure 3. The Lincoln Highway Association promoted construction of a high quality continuous hard surface roadway across the country. The Boys Scouts of America installed concrete road markers along the Lincoln Highway in 1928.

Highway as an example. Concrete “seedling miles” were constructed in remote areas to emphasize the superiority of concrete over unimproved dirt. The Association believed that as people learned about concrete, they would press the government to construct good roads throughout their states. Americans’ enthusiasm for good roads led to the involvement of the federal government in road-building and the creation of numbered U.S. routes in the 1920s (Fig. 3).

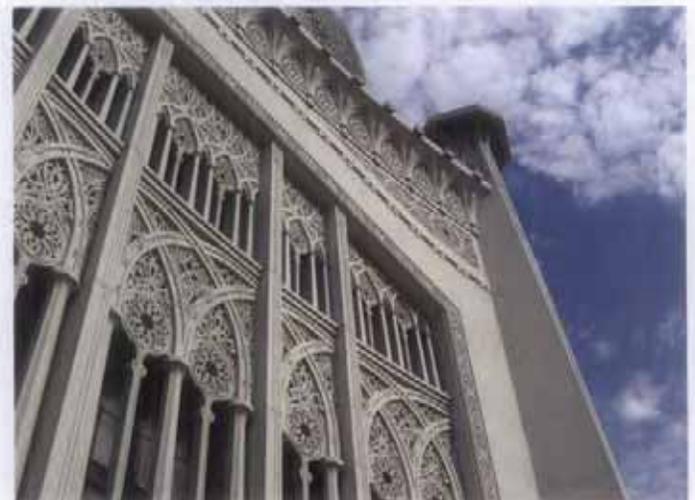
Figure 4. The highly ornamental concrete panels on the exterior facade of the Baha'i House of Worship in Wilmette, Illinois, illustrate the work of fabricator John J. Earley, known as "the man who made concrete beautiful."

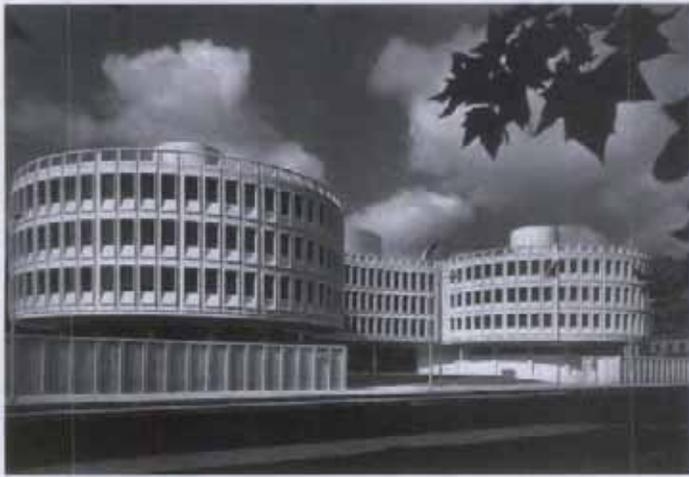
Figure 5. Following World War II, architects and engineers took advantage of improvements in concrete production, quality control, and advances in precast concrete to design structures such as the Police Headquarters building in Philadelphia, Pennsylvania, constructed in 1961. Photo: Courtesy of the Philadelphia Police Department.

During the early twentieth century, Ernest Ransome in Beverly, Massachusetts, Albert Kahn in Detroit, and Richard E. Schmidt in Chicago, promoted concrete for use in “Factory Style” utilitarian buildings with an exposed concrete frame infilled with expanses of glass. Thomas Edison’s cast-in-place reinforced concrete homes in Union Township, New Jersey (1908), proclaimed a similarly functional emphasis in residential construction. From the 1920s onward, concrete began to be used with spectacular design results: examples include John J. Earley’s Meridian Hill Park in Washington, D.C.; Louis Bourgeois’ exuberant, graceful Baha’i Temple in Wilmette, Illinois (1920–1953), for which Earley fabricated the concrete (Fig. 4); and Frank Lloyd Wright’s Fallingwater near Bear Run, Pennsylvania (1934). Continuing improvements in quality control and development of innovative fabrication processes, such as the Shockbeton method for precast concrete, provided increasing opportunities for architects and engineers. Wright’s Guggenheim Museum in New York City (1959); Geddes Brecher Qualls & Cunningham’s Police Headquarters building in Philadelphia, Pennsylvania (1961); and Eero Saarinen’s soaring terminal building at Dulles International Airport outside Washington, D.C., and the TWA terminal at Kennedy Airport in New York (1962), exemplify the masterful use of concrete achieved in the modern era (Fig. 5).

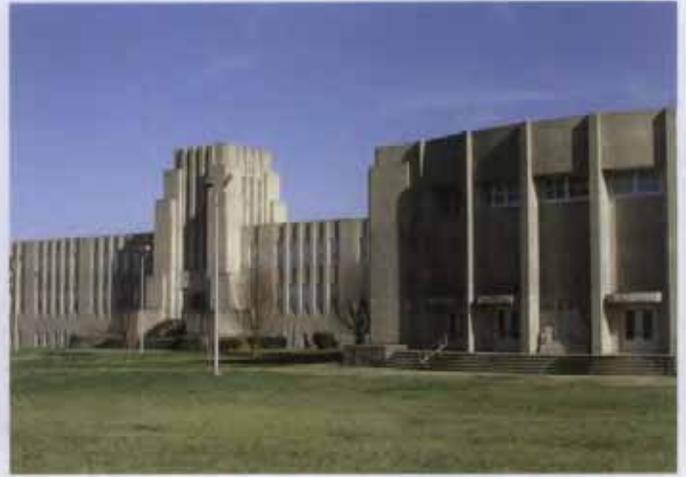
Figure 6. The Bailey Magnet School in Jackson, Mississippi, was designed as the Jackson Junior High School by the firm of N.W. Overstreet & Town in 1936. The streamlined building exemplifies the applicability of concrete to creating a modern architectural aesthetic. Photo: Bill Burris, Burris/Wagon Architects, P.A.

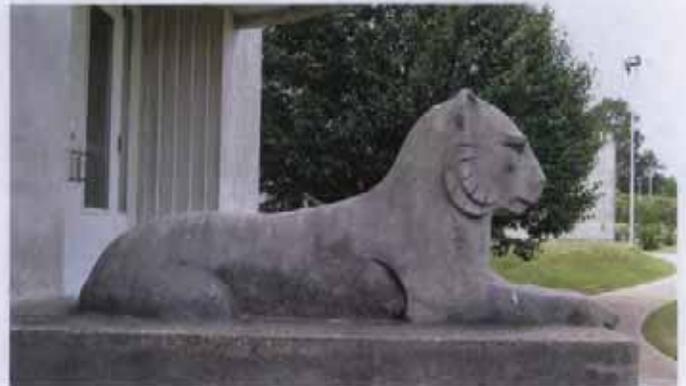
Figure 7. Detailed bas reliefs as well as sculptures, such as this lion at the Bailey Magnet School, could be used as ornamentation on concrete buildings. Sculptural concrete elements were typically cast in molds.

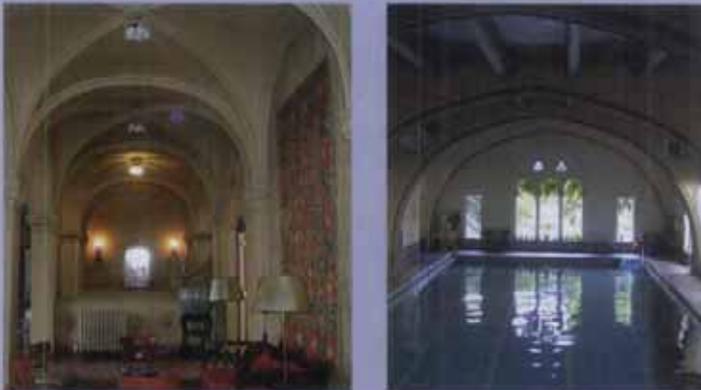
Figure 10. The Berkeley City Club has significant interior spaces and features of concrete construction, including the lobby and pool. Photos: Una Gilmartin (left) and Brian Kehoe (right), Wiss, Janney, Elstner Associates, Inc.

The expanded use of concrete provided new opportunities to create dramatic spaces and ornate architectural detail on the interiors of buildings, at a significant cost savings over traditional construction practices. The architectural design of the Berkeley City Club in Berkeley, California, expressed Moorish and Gothic elements in concrete on the interior of the building (Fig. 10). Used as a woman's social club, the building was designed by noted California architect Julia Morgan and constructed in 1929. The vaulted ceilings, columns, and ornamental capitals of the lobby and the ornamental arches and beamed ceiling of the "plunge" are all constructed of concrete.

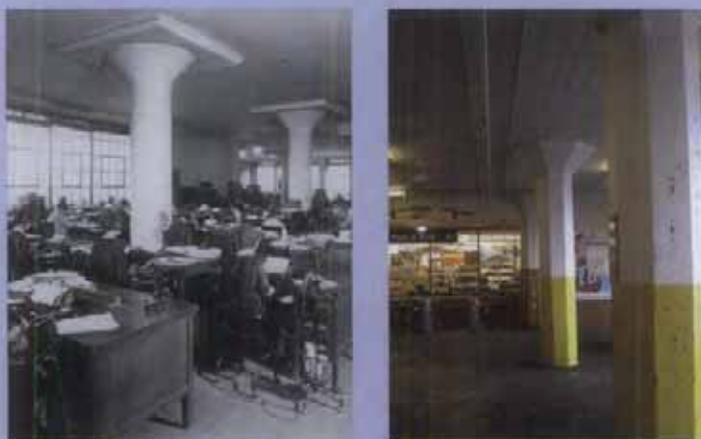
Figure 11. Whether in a circa 1925 office (left) or in a parking garage and retail facility (right), exposed concrete structures help characterize these building interiors. Photo: Minnesota Historical Society (left).

The historic character of a building's interior can also be conveyed in a more utilitarian manner in terms of concrete features and finishes (Fig. 11). The exposed concrete structure—columns, capitals, and drop panels—is an integral part of the character of this old commercial building in Minneapolis. In concrete warehouse and factory buildings of the early twentieth century, exposed concrete columns and formboard finish concrete slab ceilings are common features as seen in this warehouse, now converted for use as a parking garage and shops.

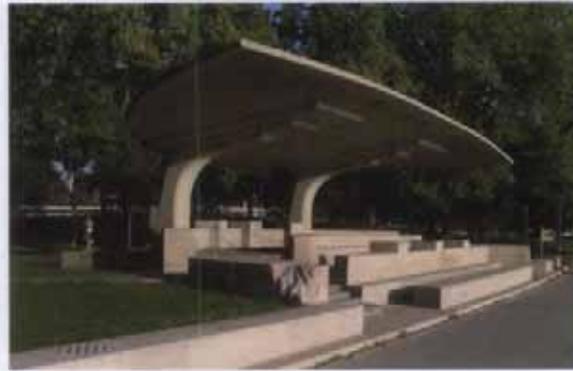
Figure 8. The Chess Pavilion in Chicago's Lincoln Park was designed by architect Morris Webster and constructed in 1956. The pavilion is a distinctive landscape feature, with its reinforced concrete cantilevered slab that provides cover for chess players.

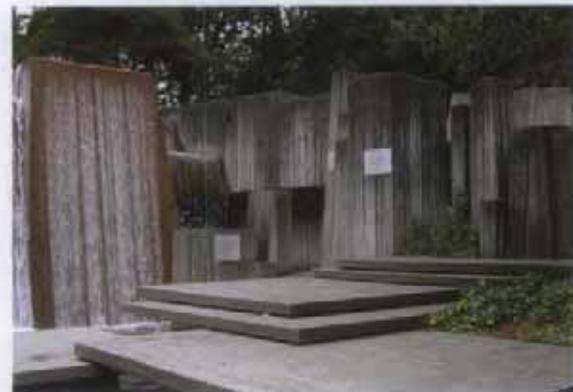
Figure 9. The Ira C. Keller Fountain in Portland, Oregon, was designed by Lawrence Halprin and constructed in 1969. The fountain is constructed primarily of concrete pillars with formboard textures and surrounding elements, patterned with geometric lines, which facilitate the path of water. Photo: Anita Washko, Wiss, Janney, Elstner Associates, Inc.

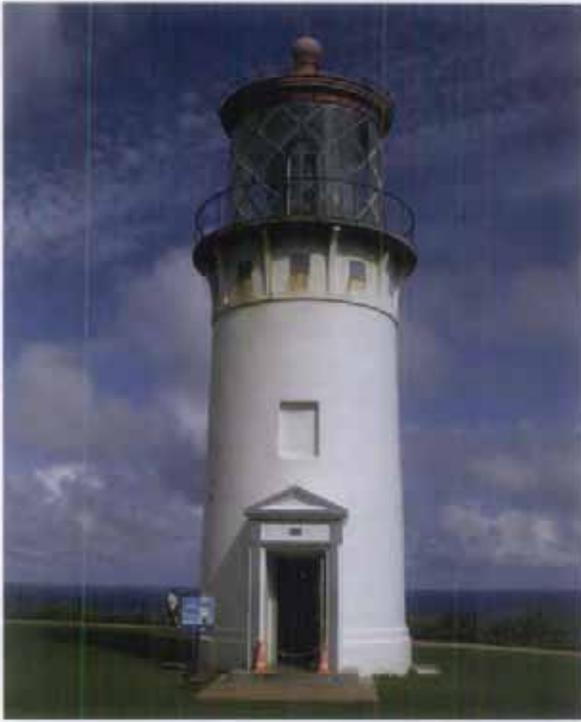
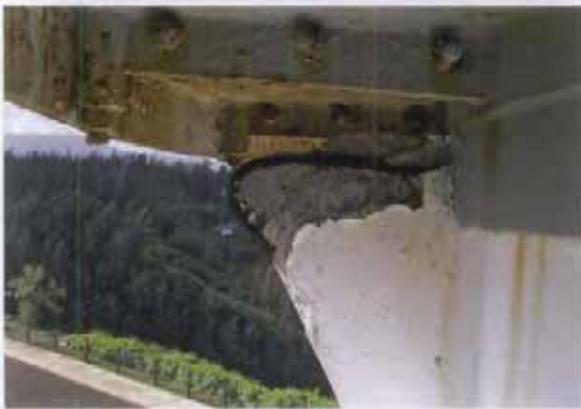
Figure 12. The concrete lighthouse at the Kilauea Point Light Station, Kilauea, Kauai, Hawaii, was constructed circa 1913. The concrete, which was a good quality, high strength mix for its day, is in good condition after almost one hundred years in service. Deterioration in the form of spalling related to corrosion of embedded reinforcing steel has occurred primarily in areas of higher ornamentation such as projecting bands and brackets (see close-up photo).

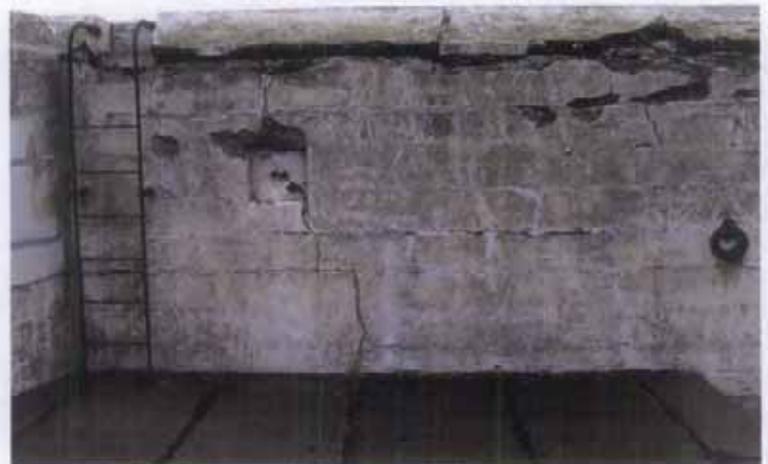
Figure 13. Fort Casey on Admiralty Head, Fort Casey, Washington, was constructed in 1898. The lift lines from placement of concrete are clearly visible on the exterior walls and characterize the finished appearance.

In concrete structures built prior to the First World War, concrete was often placed into forms in relatively short vertical lifts due to limitations in lifting and pouring techniques available at the time. Joints between different concrete placements (often termed cold joints or lift lines) may sometimes be considered an important part of the character of a concrete element (Fig. 13). However, wide joints may permit water to infiltrate the concrete, resulting in more rapid paste erosion or freeze-thaw deterioration of adjacent concrete in cold climates.

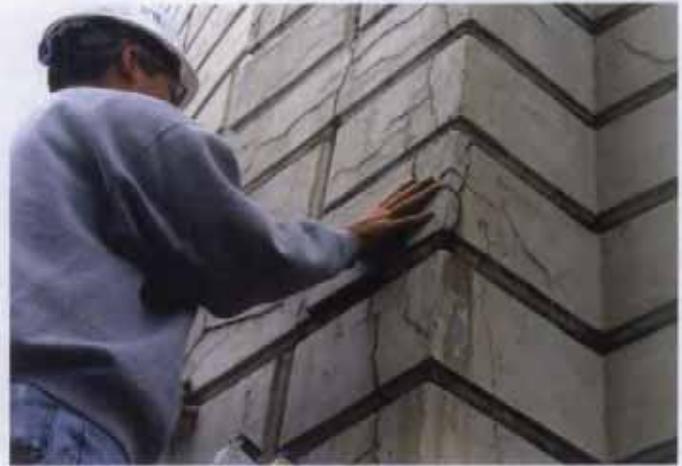
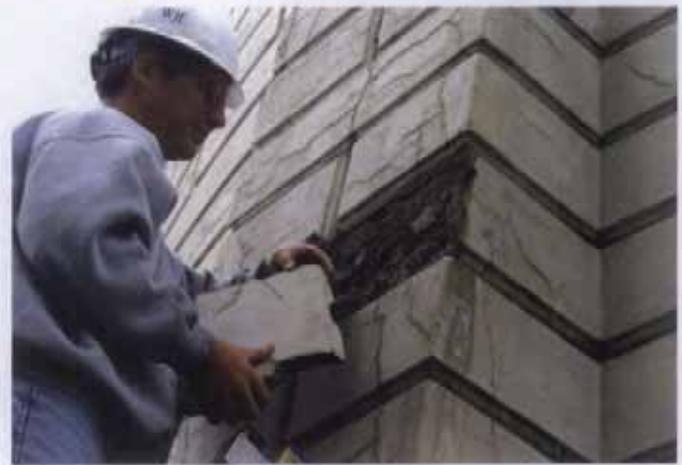
Figures 14. Layers of architectural concrete that have debonded (spalled) from the surface were removed from a historic water tank during the investigation performed to assess existing conditions. Photos: Anita Washko, Wiss, Janney, Elstner Associates, Inc.

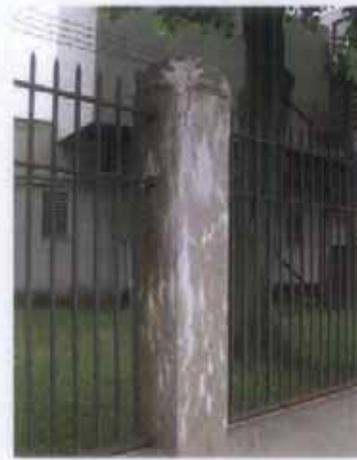
Figure 15. Evidence of moisture movement through concrete is apparent in the form of mineral deposits on the concrete surface. Cyclic freezing and thawing of entrapped moisture, and corrosion of embedded reinforcement, have also contributed to deterioration of the concrete column on this fence at Crocker Field in Fitchburg, Massachusetts, designed by the Olmsted Brothers.

Staining of the concrete surface can be related to soiling from atmospheric pollutants or other contaminants, dirt accumulation, and the presence of organic growth. However, stains can also indicate more serious underlying problems, such as corrosion of embedded reinforcing steel, improper previous surface treatments, alkali-aggregate reaction, or efflorescence, the deposition of soluble salts on the surface of the concrete as a result of water migration (Fig. 15).

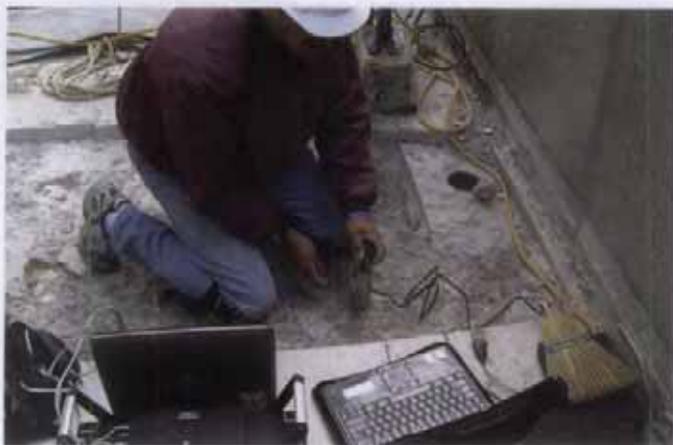
Figure 16. Impact echo testing is performed on a concrete structural slab to help determine depth of deterioration. In this method, a short pulse of energy is introduced into the structure and a transducer mounted on the impacted surface of the structure receives the reflected input waves or echoes. These waves are analyzed to help identify flaws and deterioration within the concrete.

A number of nondestructive testing methods can be used in the field to evaluate concealed conditions. Basic techniques include sounding with a hand-held hammer (or for horizontal surfaces, a chain) to help identify areas of delamination. More sophisticated techniques include impact-echo testing (Fig. 16), ground penetrating radar, pulse velocity, and other methods that characterize concrete thickness and locate voids or delaminations. Magnetic detection instruments are used to locate embedded reinforcing steel and can be calibrated to identify the size and depth of reinforcement. Corrosion measurements can be taken using copper-copper sulfate half-cell tests or linear polarization techniques to determine the probability or rate of active corrosion of the reinforcing steel.

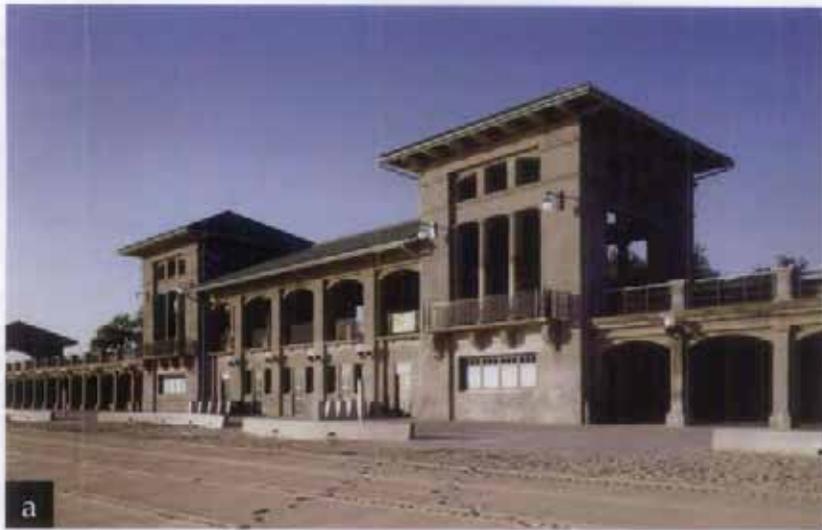
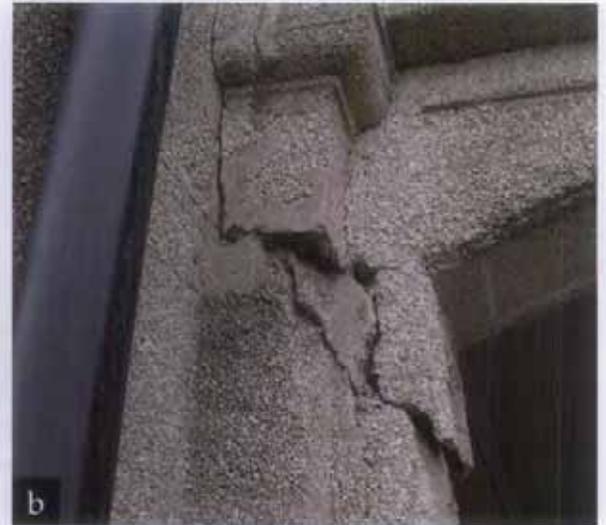
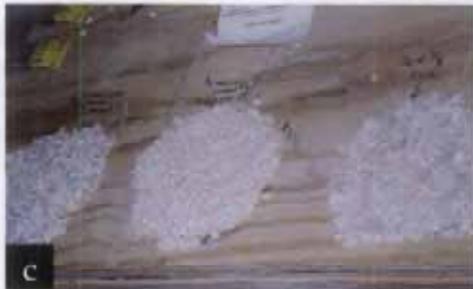
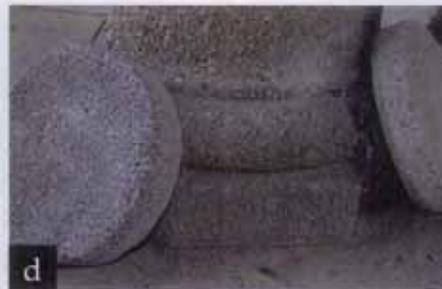
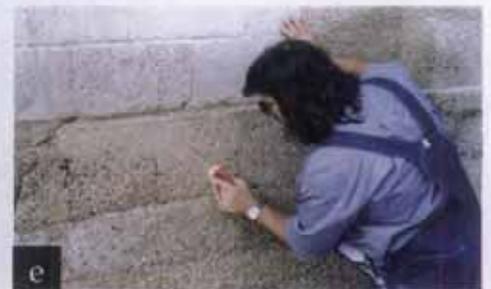
Figure 17. (a) The 63rd Street Beach House was constructed on the shoreline of Chicago in 1919. The highly exposed aggregate concrete of the exterior walls of the beach house was used for many buildings in the Chicago parks as an alternative to more expensive stone construction. Photo: Leslie Schwartz Photography. (b) Concrete deterioration included cracking, spalling, and delamination caused by corrosion of embedded reinforcing steel and concrete damage due to cyclic freezing and thawing. (c) Various sizes and types of aggregates were reviewed for matching to the original concrete materials. (d) Mock-ups of the concrete repair mix were prepared for comparison to the original concrete. Considerations included aggregate type and size, cement color, proportions, aggregate exposure, and surface finish. (e) The craftsman finished the surface to replicate the original appearance in a mock-up on the structure. Here, he used a nylon bristle brush to remove loose paste and expose the aggregate, creating a variable surface to match the adjacent original concrete.

For any concrete repair project, the process of investigation, laboratory analysis, trial samples, mock-ups, and full-scale repairs allows ongoing refinement of the repair work as well as implementation of quality-control measures. The trial repair process provides an opportunity for the owner, architect, engineer, and contractor to evaluate the concrete mix design and the installation and finishing techniques for the repairs from both technical and aesthetic standpoints. The final repair materials and procedures should match the original concrete in appearance while meeting the established criteria for durability. Information gathered through trial repairs and mock-ups is invaluable in refining the construction documents prior to the start of the overall repair project (Fig. 17).

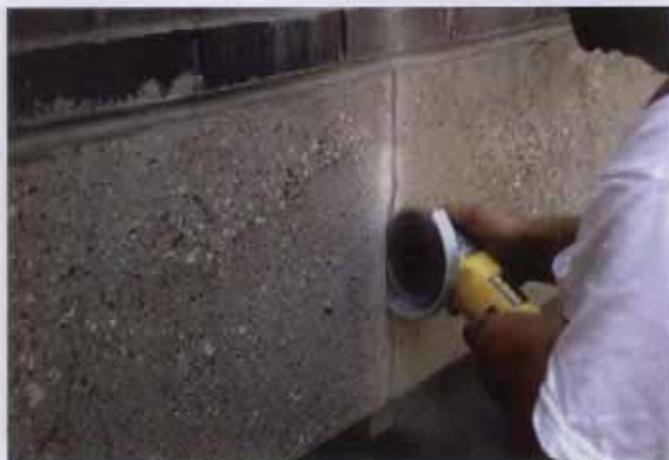
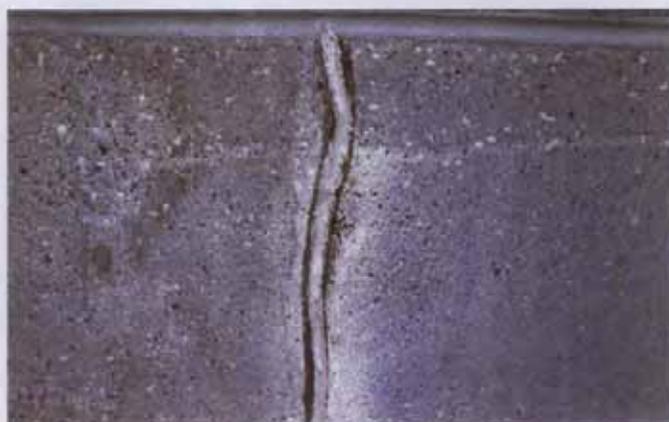
Figure 19. A high-speed grinder is used to widen a crack in preparation for installation of a sealant. This process is called "routing." After the crack is prepared, the sealant is installed to prevent moisture infiltration through the crack. Although sealant repairs can provide a durable, watertight repair for moving cracks, they tend to be very visible.

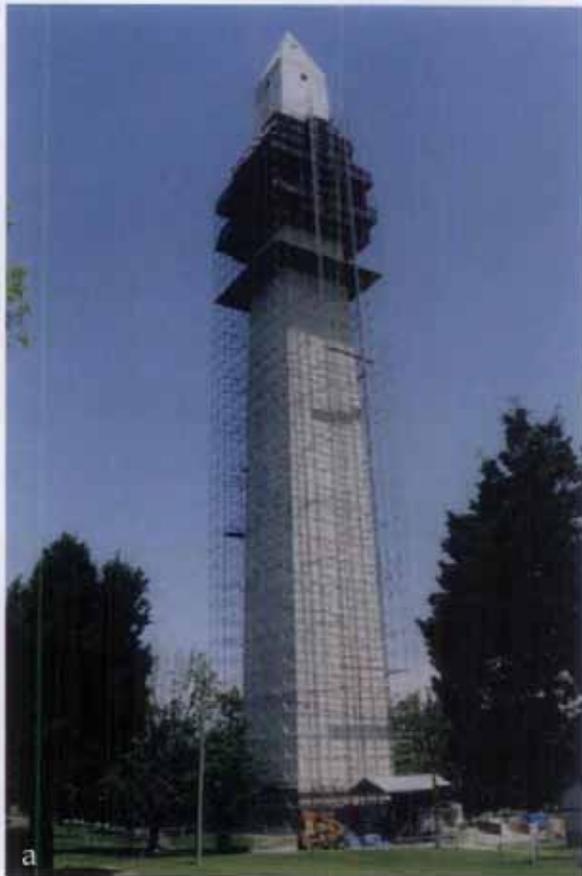
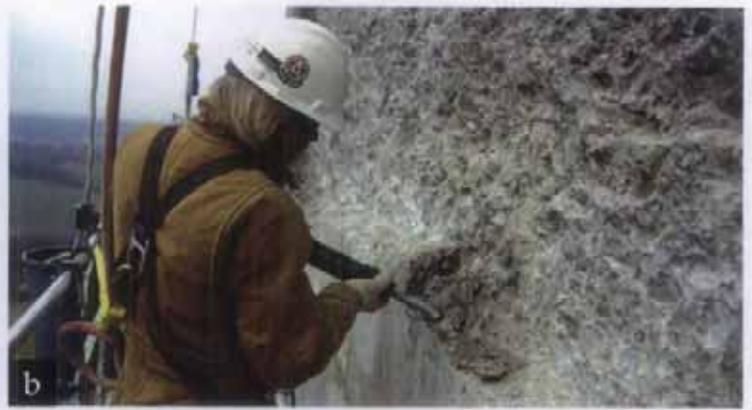
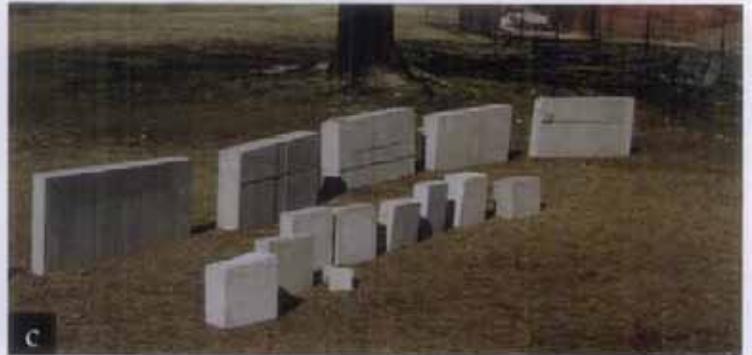
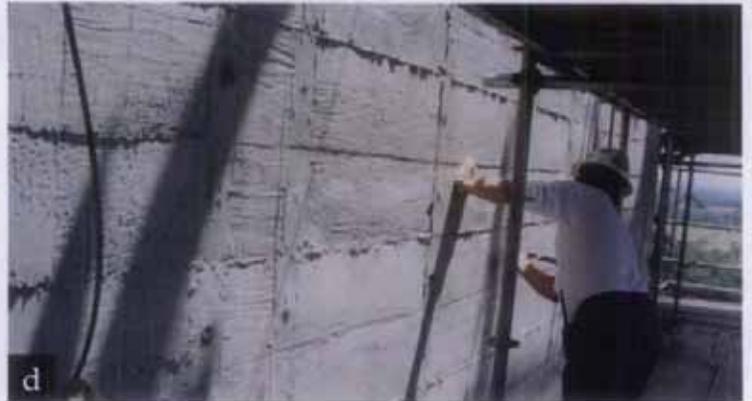
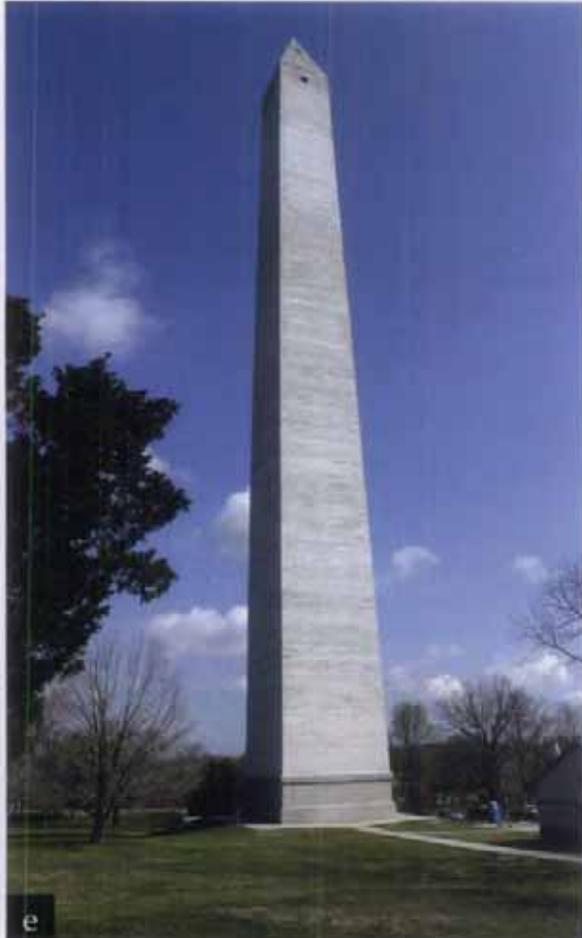
Figure 20. (a) The Jefferson Davis Memorial in Fairview, Kentucky, constructed from 1917–1924, is 351 feet tall and constructed of unreinforced concrete. The walls of the memorial are 8 feet thick at the base and 2 feet thick at the top of the wall. Access to the monument for investigation was provided by rappelling techniques, while ground supported and suspended scaffolding was used to access the exterior during repairs. (b) The concrete was severely deteriorated at isolated locations, with spalling and damage from cyclic freezing and thawing of entrapped water. In addition, previous repairs were at the end of their service life and removal of deteriorated concrete and failed previous repairs was required. Light duty chipping hammers were used to avoid damage to adjacent material when removing deteriorated concrete to the level of sound concrete. (c) Field samples were performed to match the color, finish, and texture of the original concrete. A challenge in matching of historic concrete is achieving variability of appearance. (d) The completed surface after repairs exhibits intentional variability of the concrete surface to match the appearance of the original concrete. Some formwork imperfections that would normally be removed by finishing were intentionally left in place, to replicate the highly variable finish of the original concrete. (e) The Jefferson Davis Memorial after completion of repairs in 2004. Photo e: Joseph Lenzi, Senler, Campbell & Associates, Inc.

due to original construction techniques, architectural design, or differential exposure to weather. Trial repairs and mock-ups are used to evaluate the proposed replacement concrete work and to refine construction techniques (Fig 20).
