Nationwide Context and Evaluation Methodology for Farmstead and Ranch Historic Sites and Historic Archaeological Sites on DoD Property

Carey L. Baxter, Susan I. Enscoe, Ellen R. Hartman, Benjamin C. Mertens, Dawn A. Morrison / U.S. Army Engineer Research and Development Center (ERDC)
Construction Engineering Research Laboratory (CERL)

December 2020

Final Technical Report (TR)

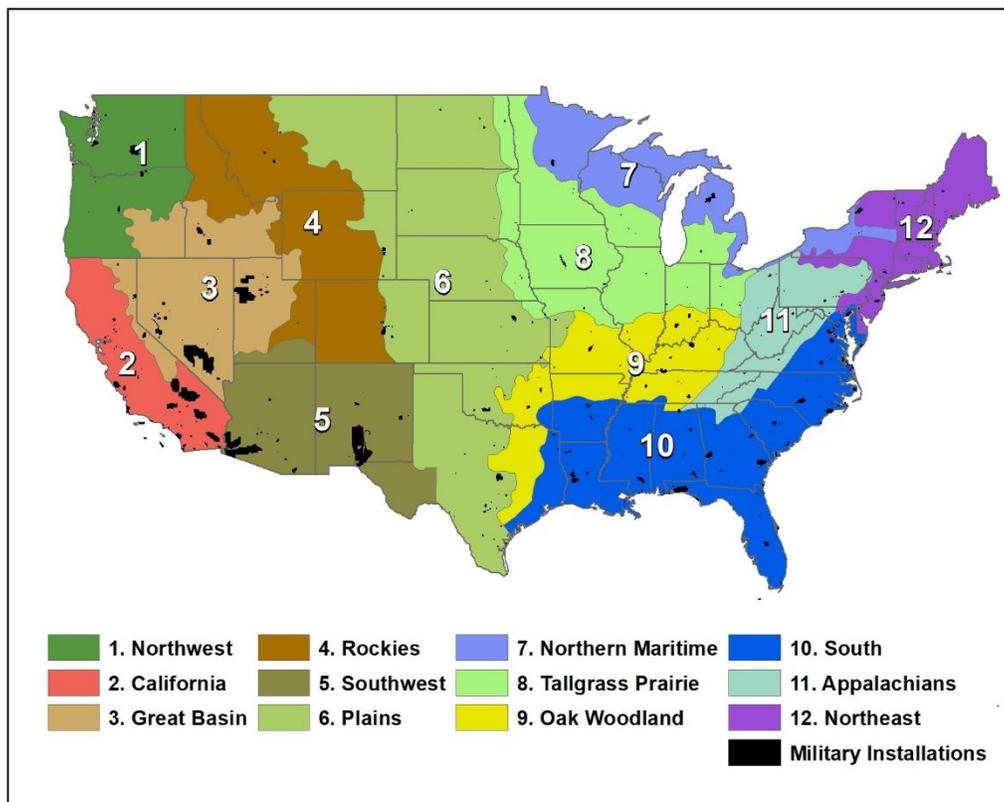
Figure 1. Regional Divisions for Beta Tests.

used to construct farms and ranches in those areas. The map below (Figure 1) is overlaid with the locations of current DoD property to broadly indicate what types of farms or ranches could be found at a particular installation.

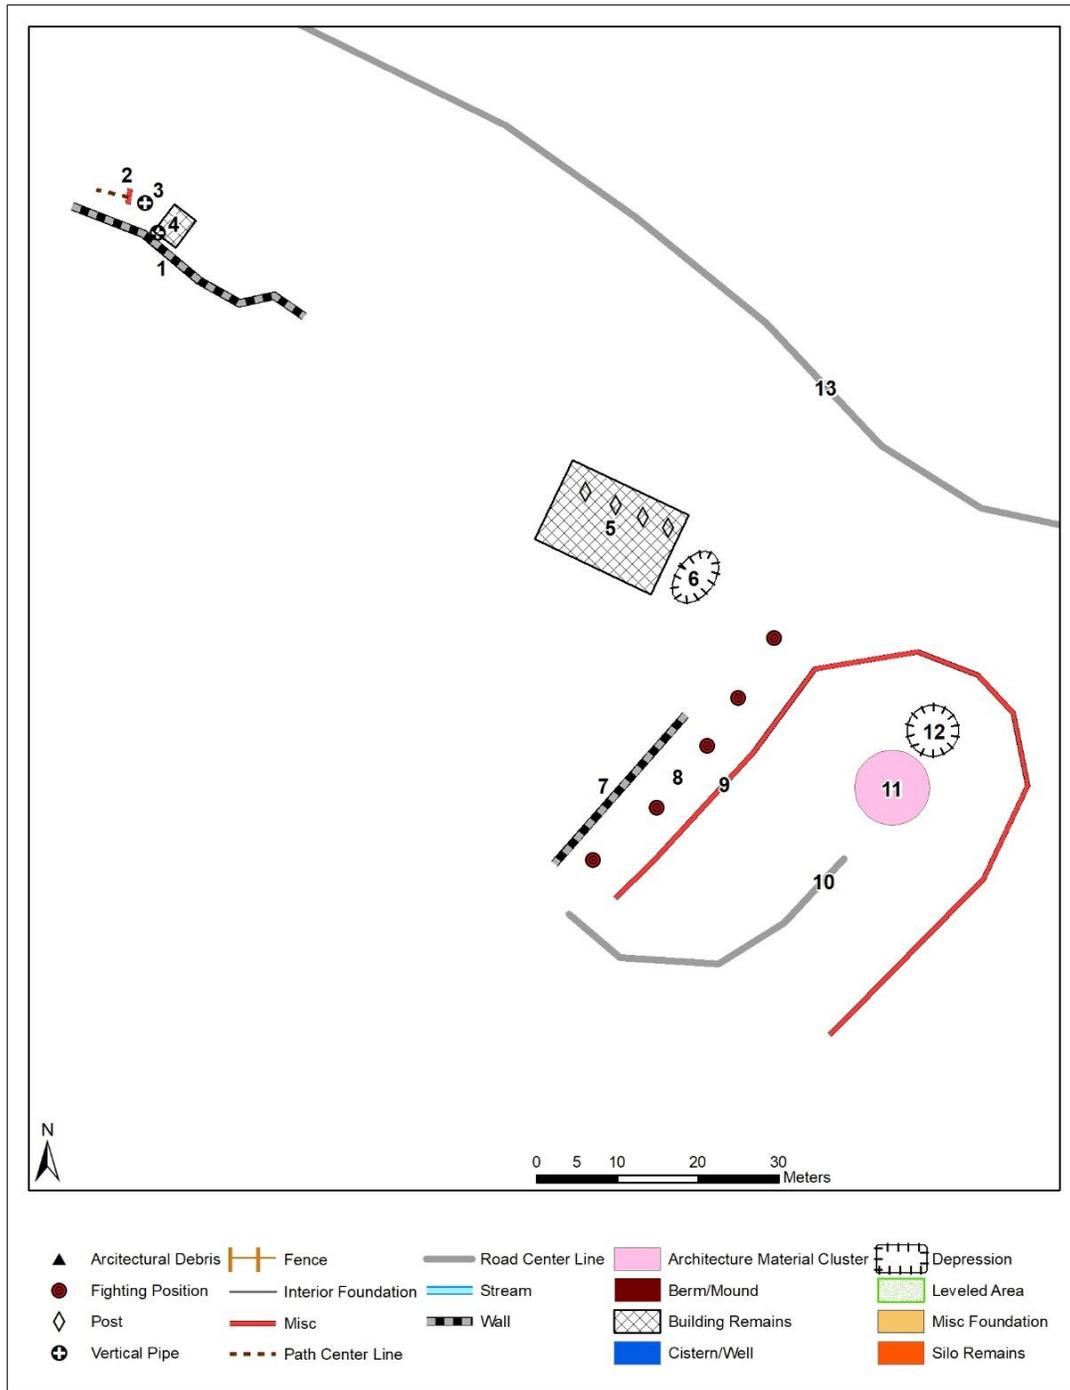
Figure 11. Site 11RY2117 site map.

The site feature descriptions are:

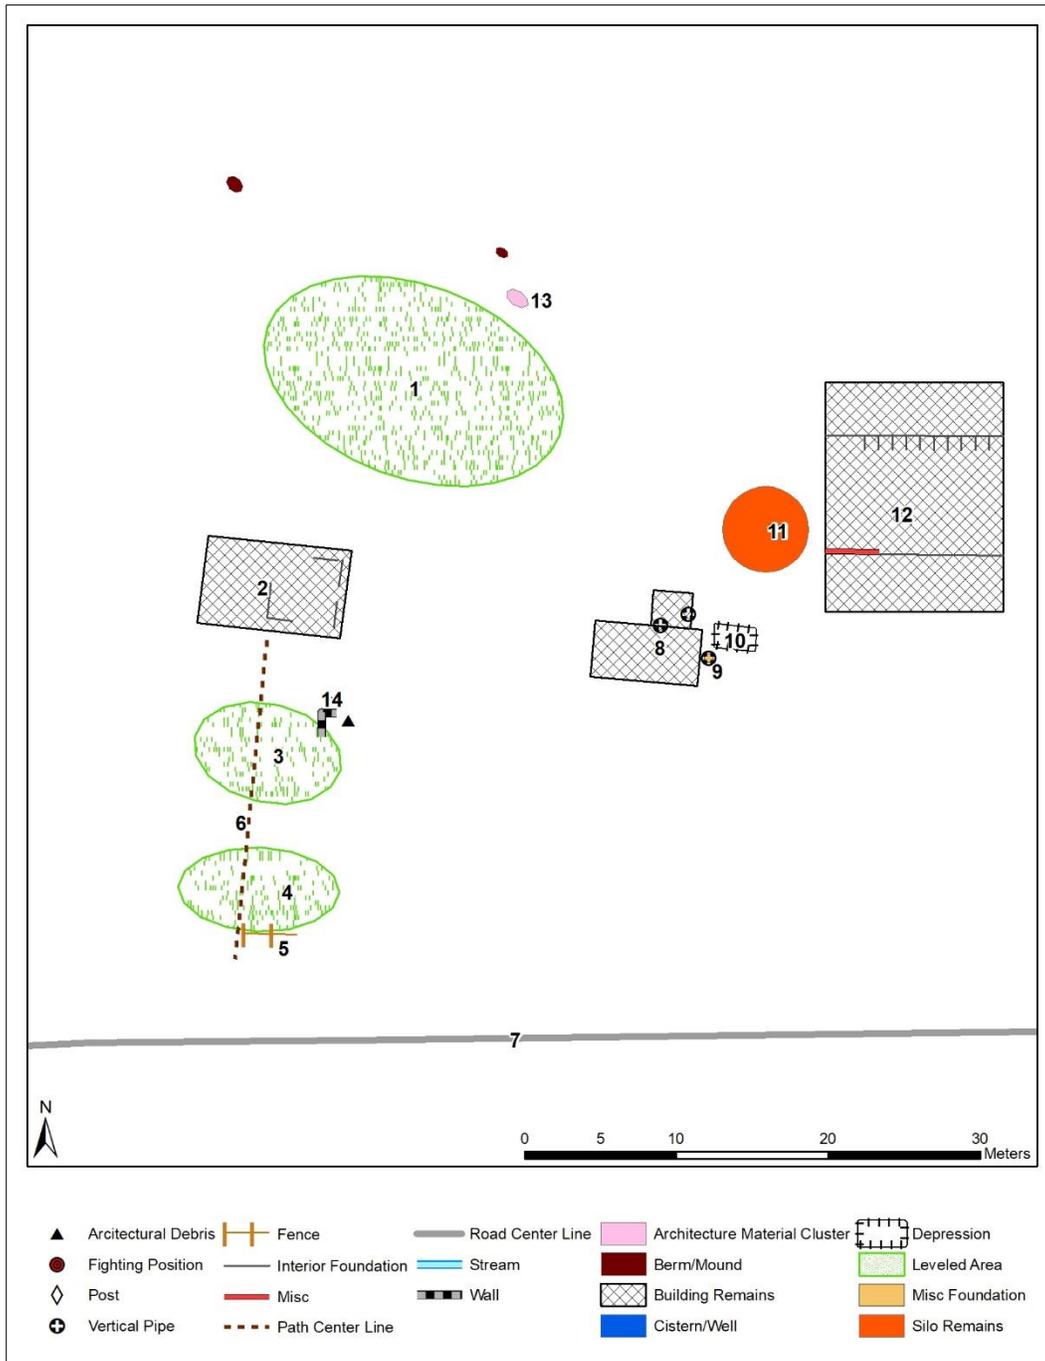
Figure 17. Site 14RY2136 site map.

Feature descriptions are as follows:

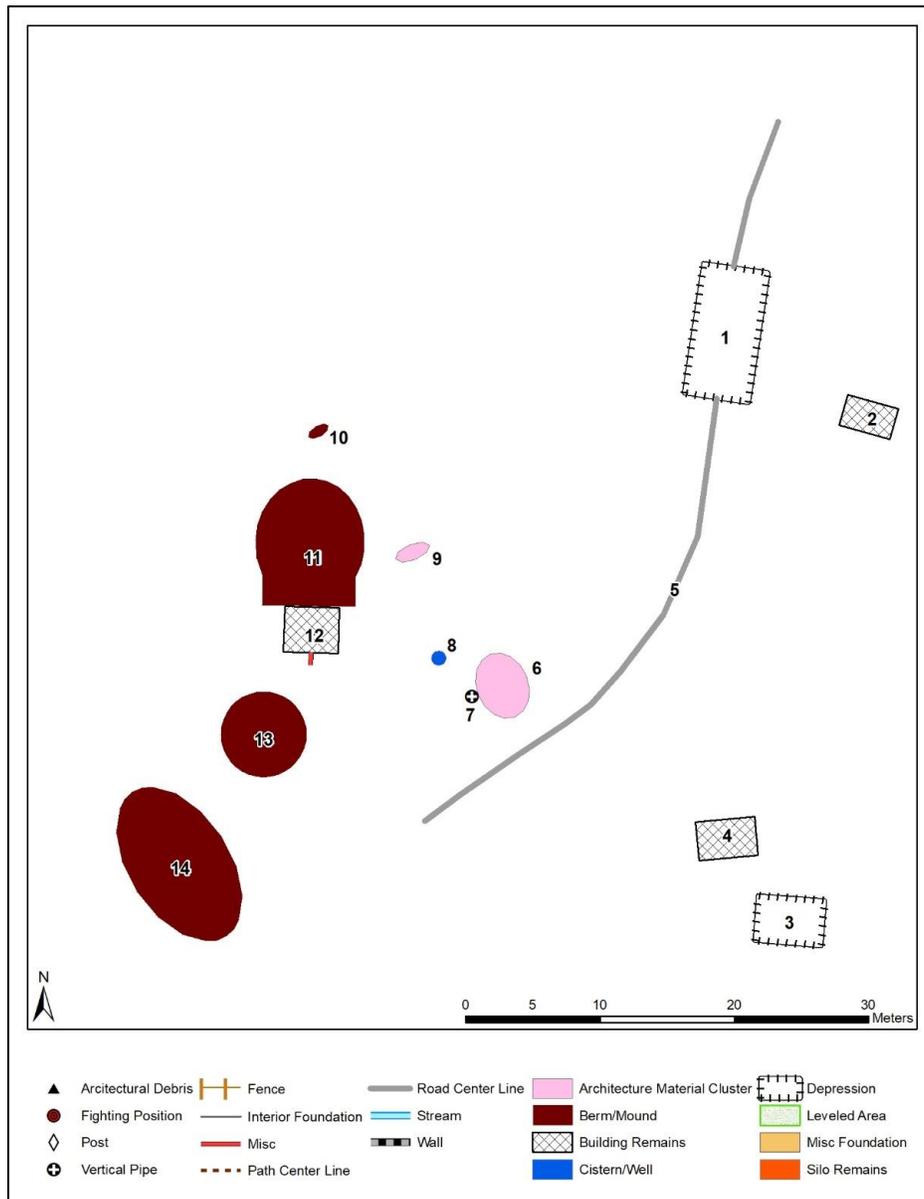
Figure 25. Site 14RY2138 site map.

Feature descriptions are as follows:

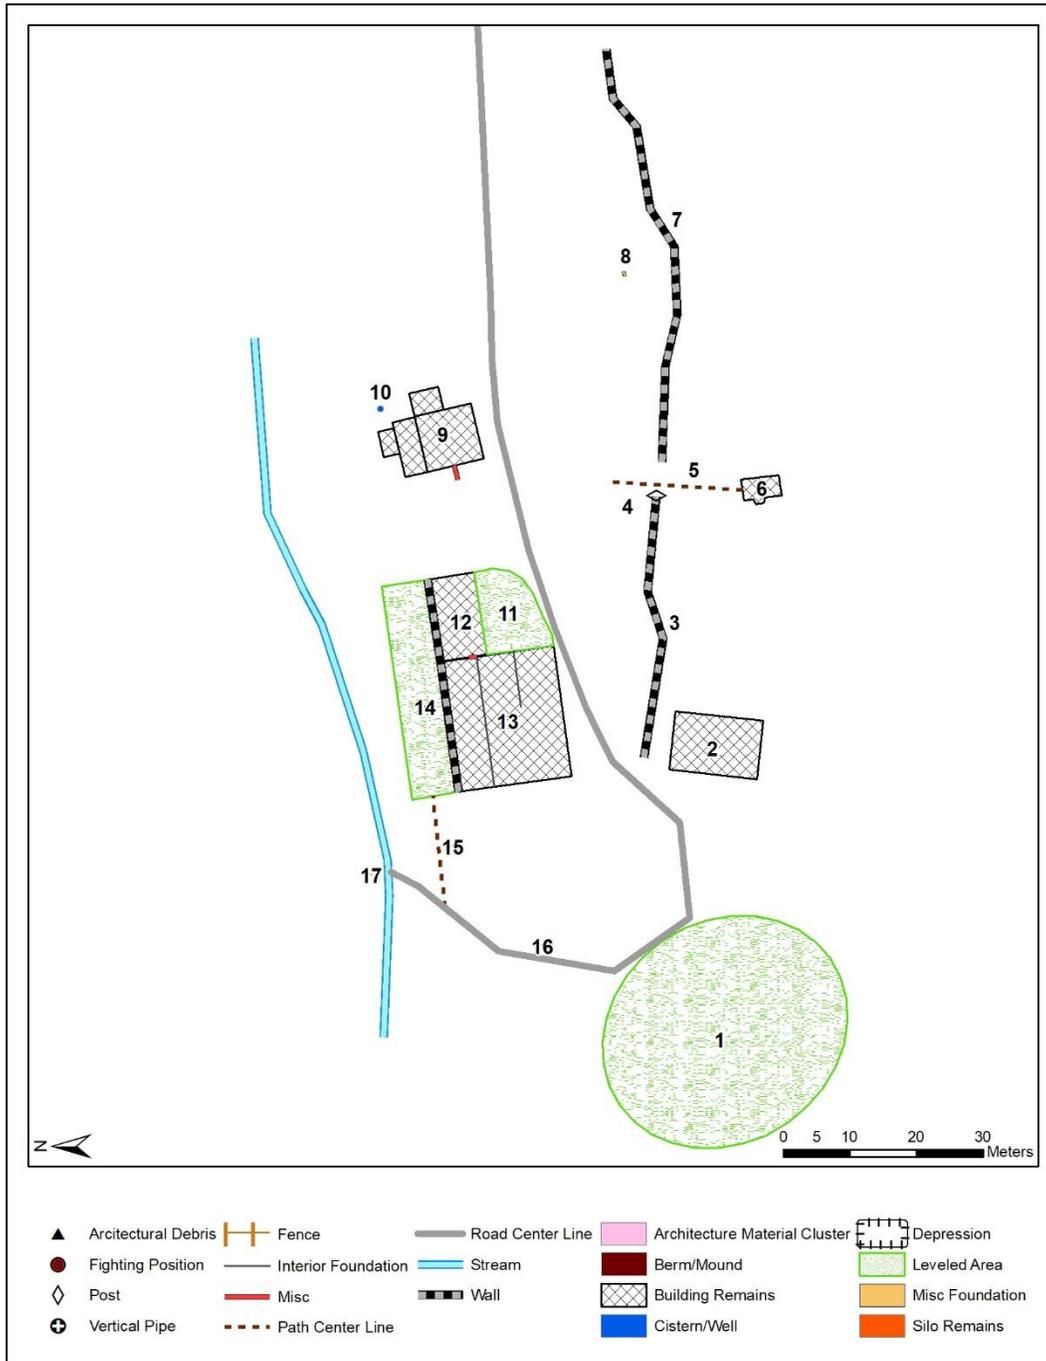
Figure 30. 11RY2140 Site Map. (Please note map has been rotated 90 degrees to fit page).

Feature descriptions are as follows:

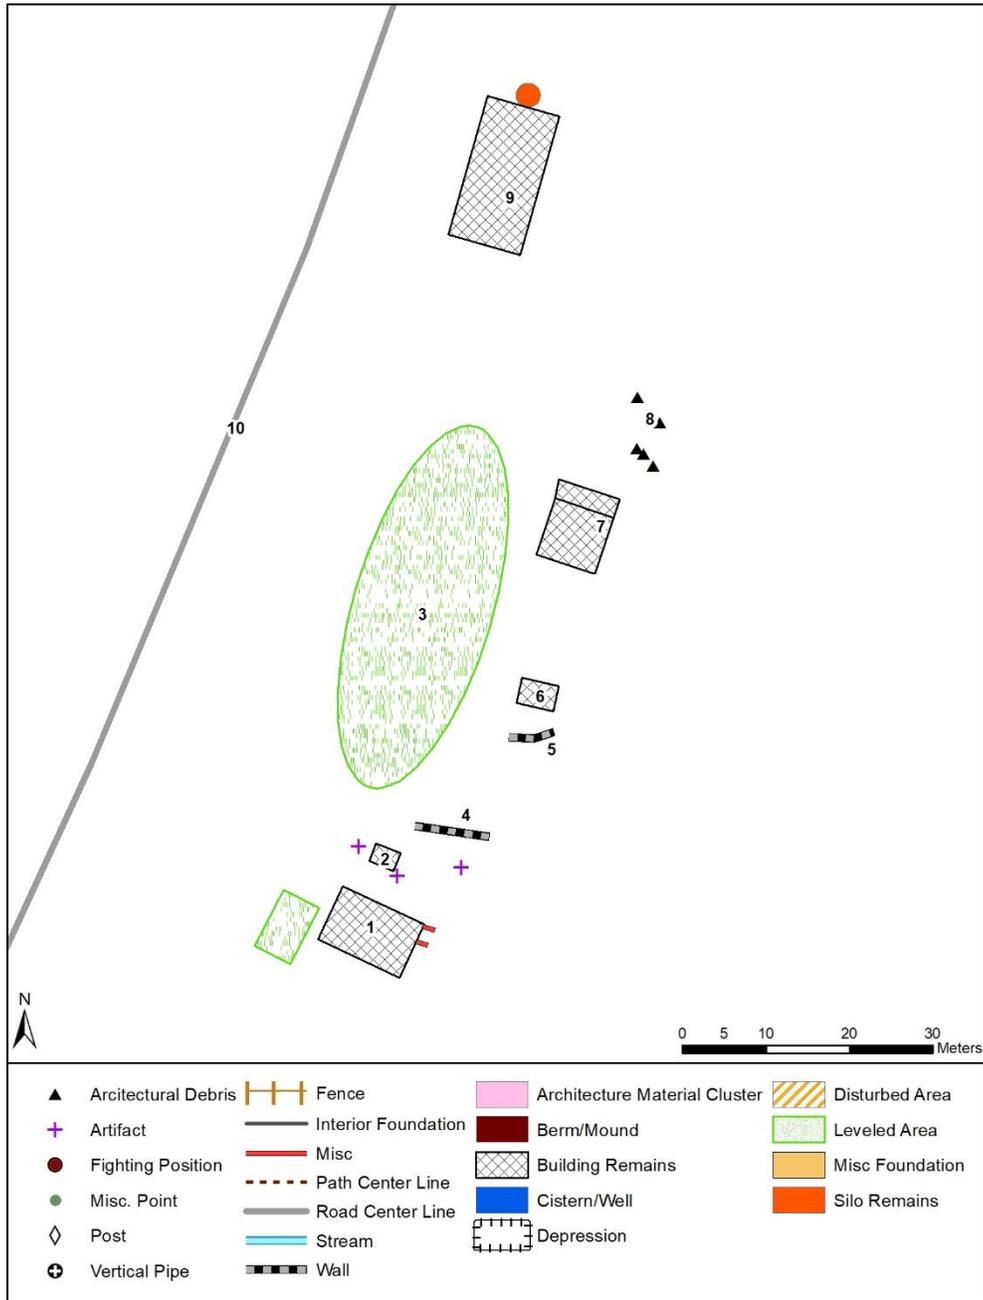
Figure 36. Site 47M0286 site map.

The site feature descriptions are:

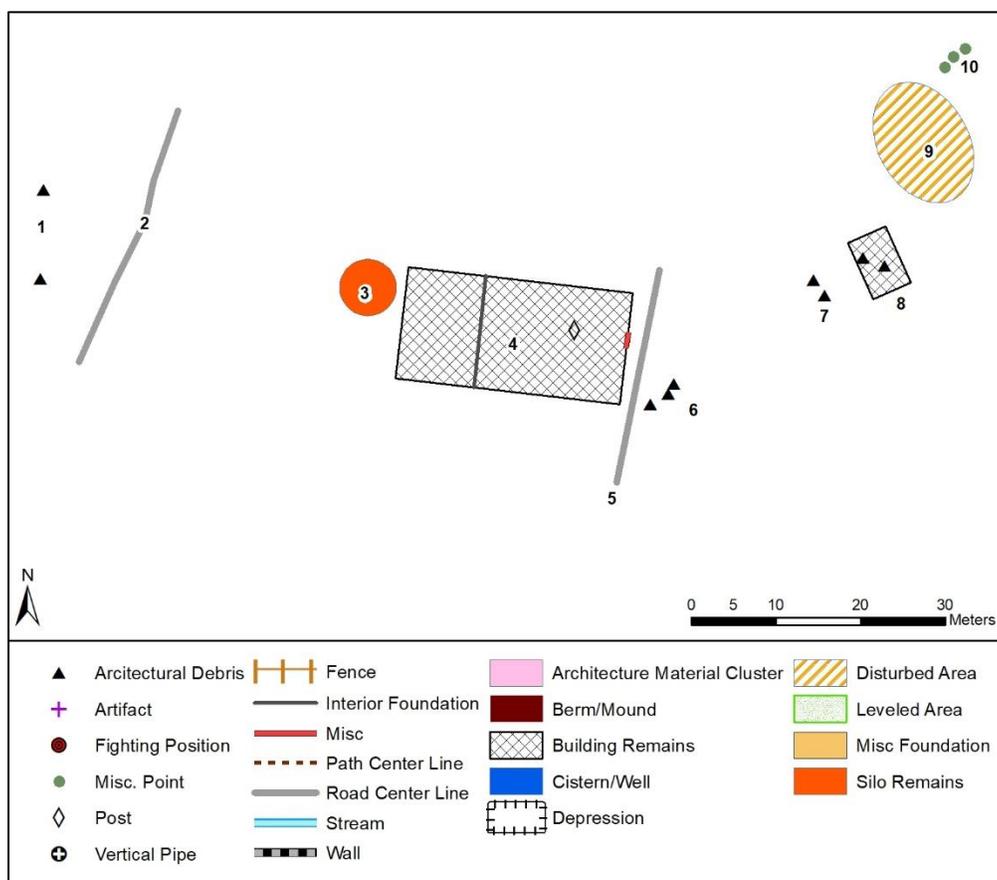
Figure 38. Site 47M0465 site map.

The site feature descriptions are:

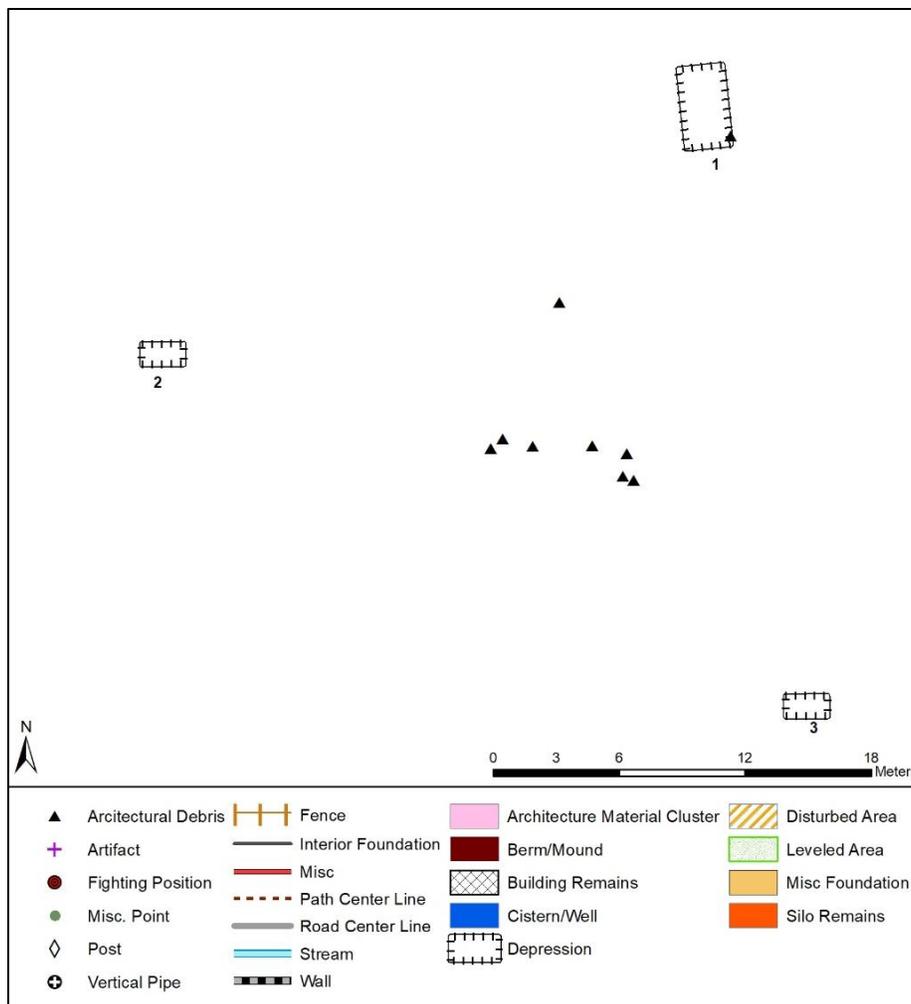
Figure 44. Site 47M0848 site map.

The site feature descriptions are:

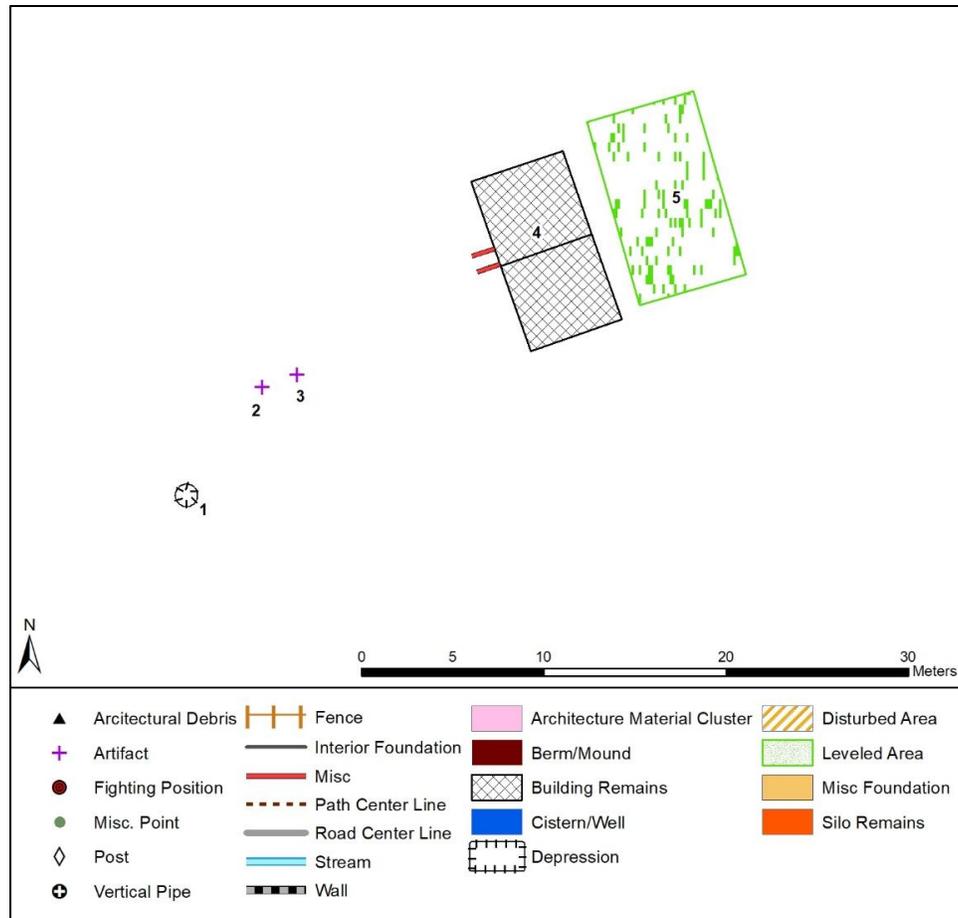
Figure 46. Site 47M0897 site map.

The site feature descriptions are:

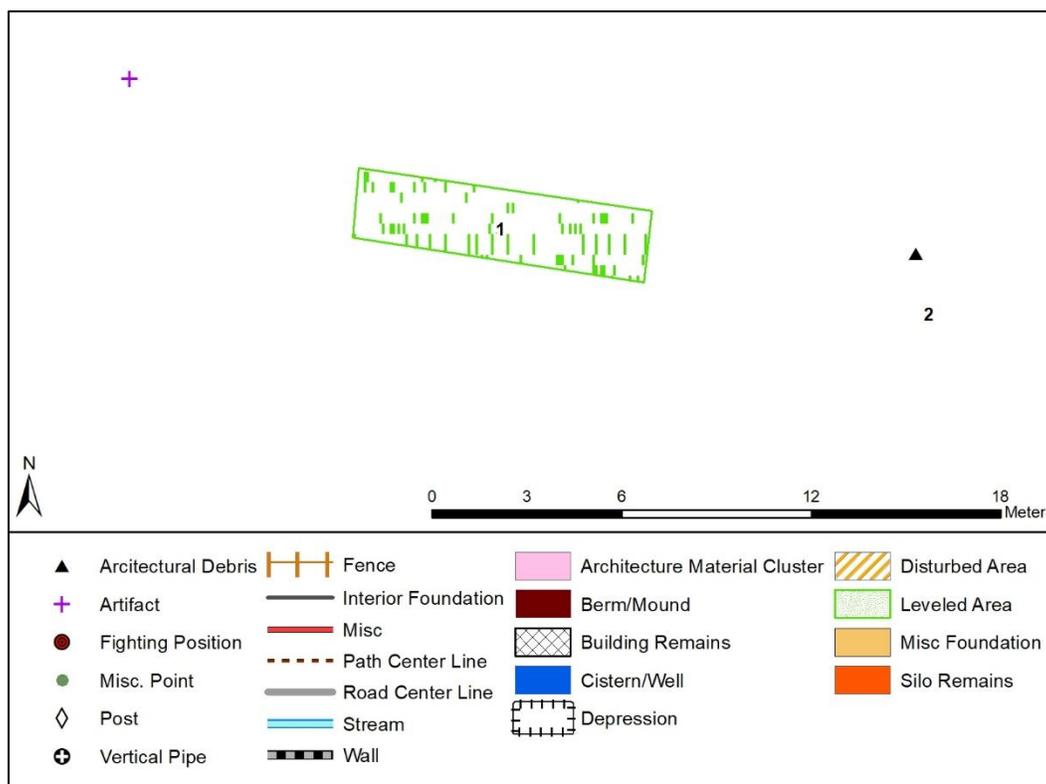
Figure 50. Site 47M0903.

The site feature descriptions are:

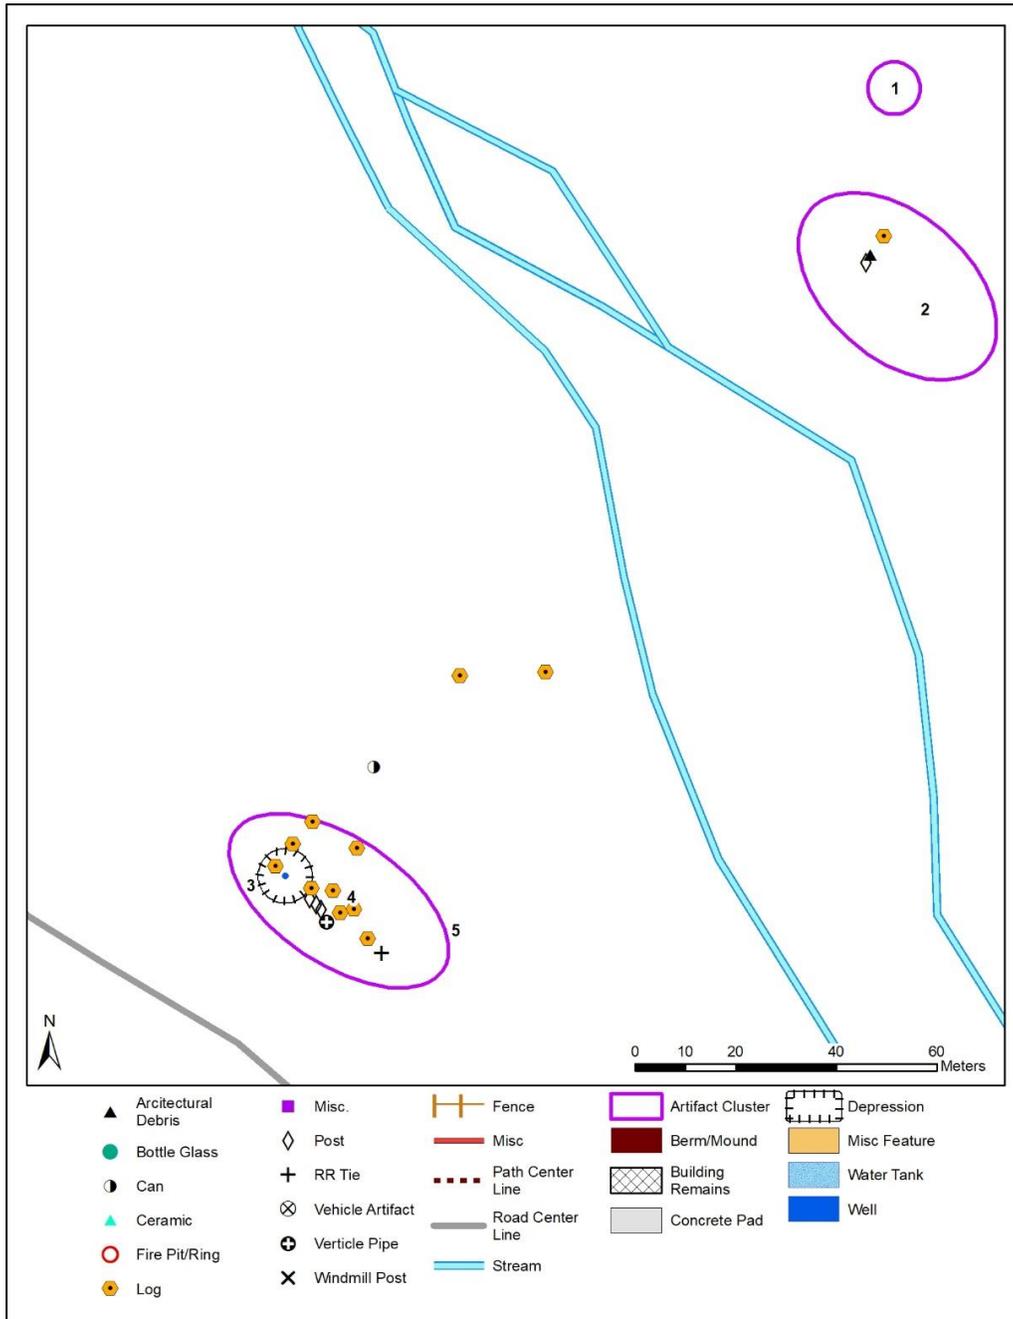
Figure 52. Site map of AZ Y:6:24

The site feature descriptions are:

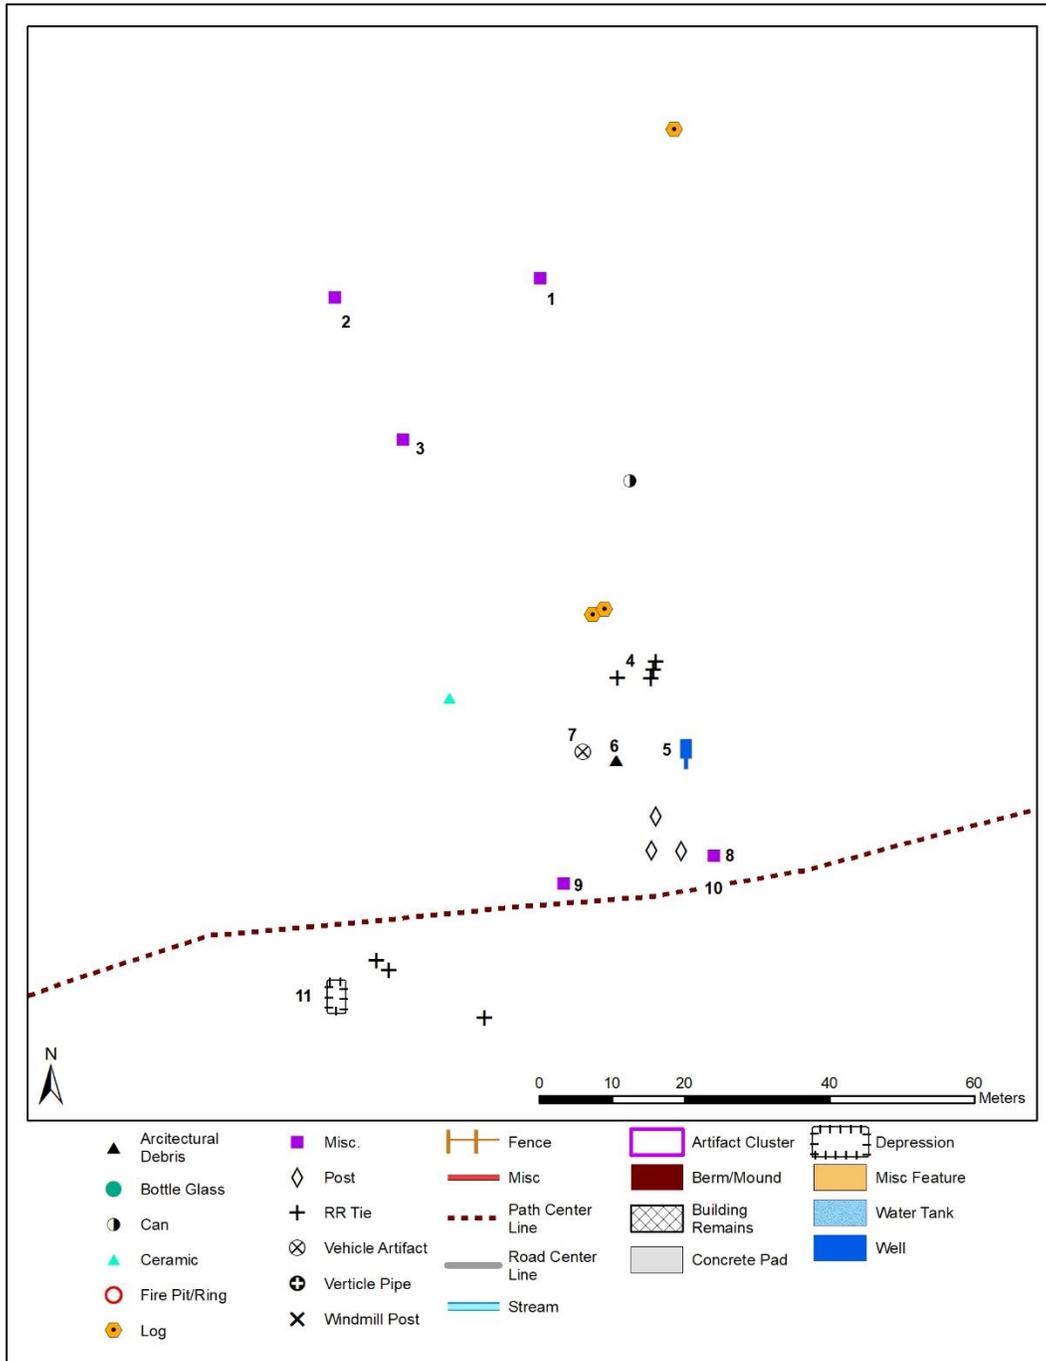
Figure 58. Site AZ Y:8:196 site map.

The site feature descriptions are:

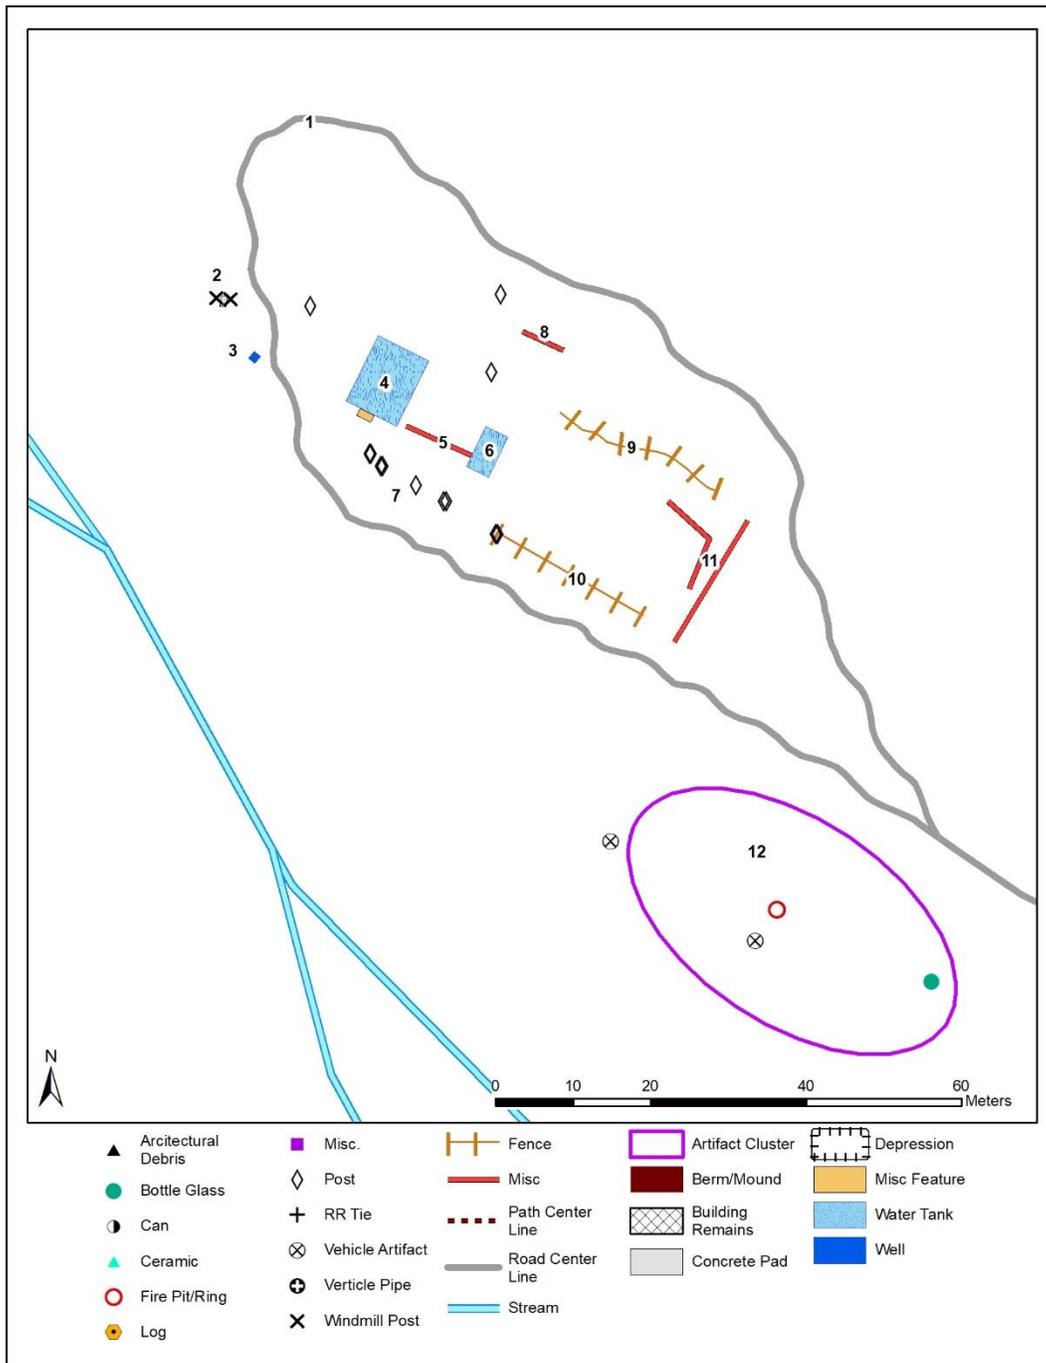
Figure 63. Site AZ Z:5:10 site map.

The site feature descriptions are:

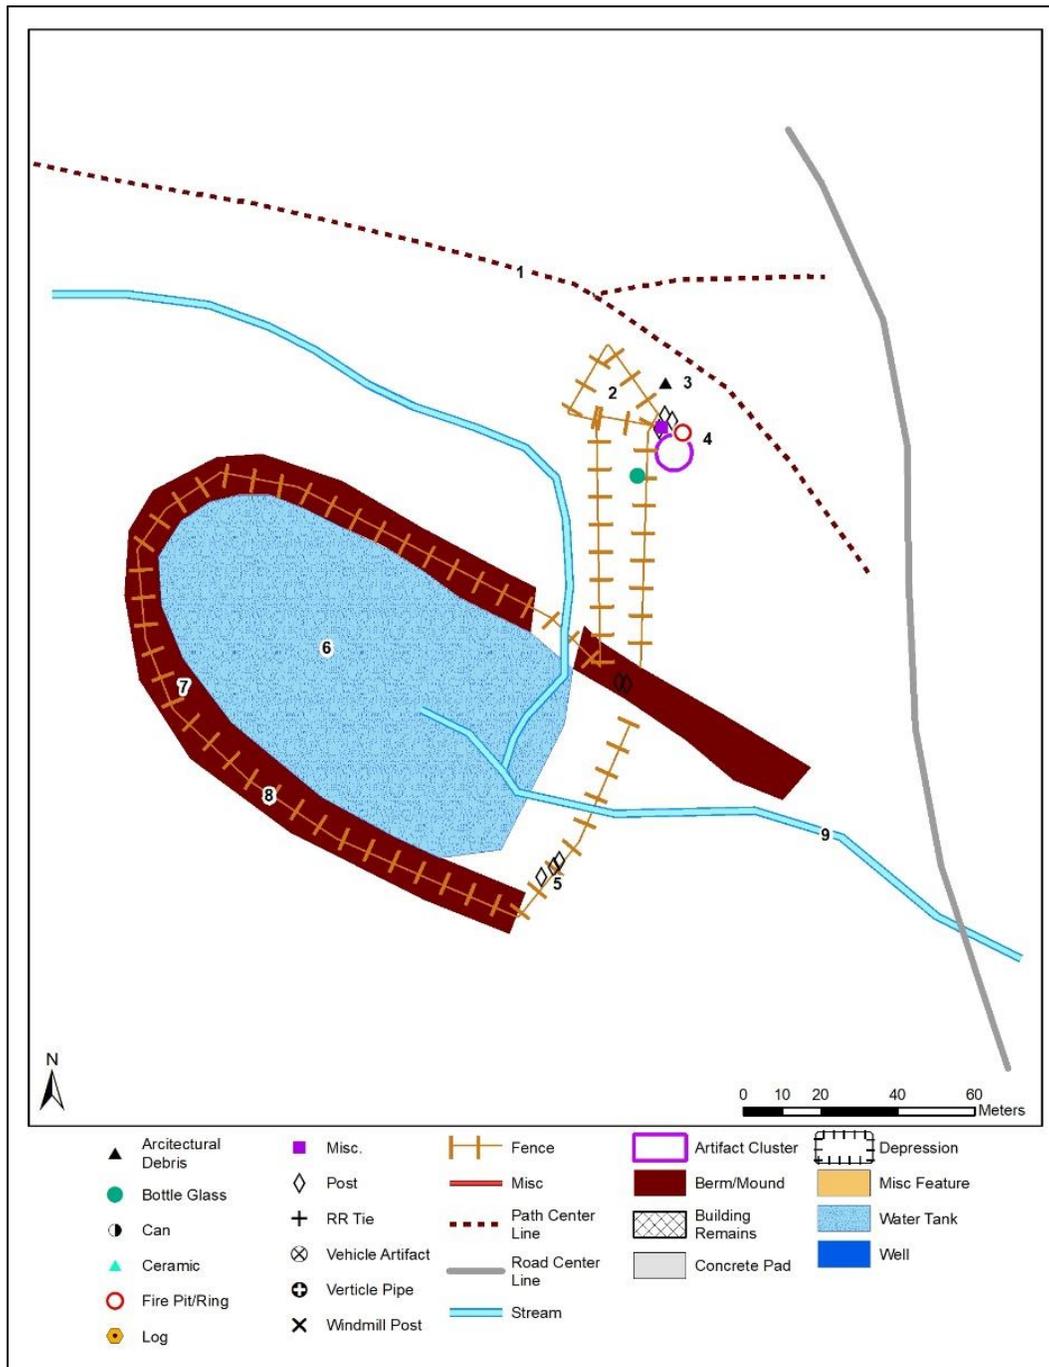
Figure 70. Site AZ Z:6:81 site map.

The site feature descriptions are:

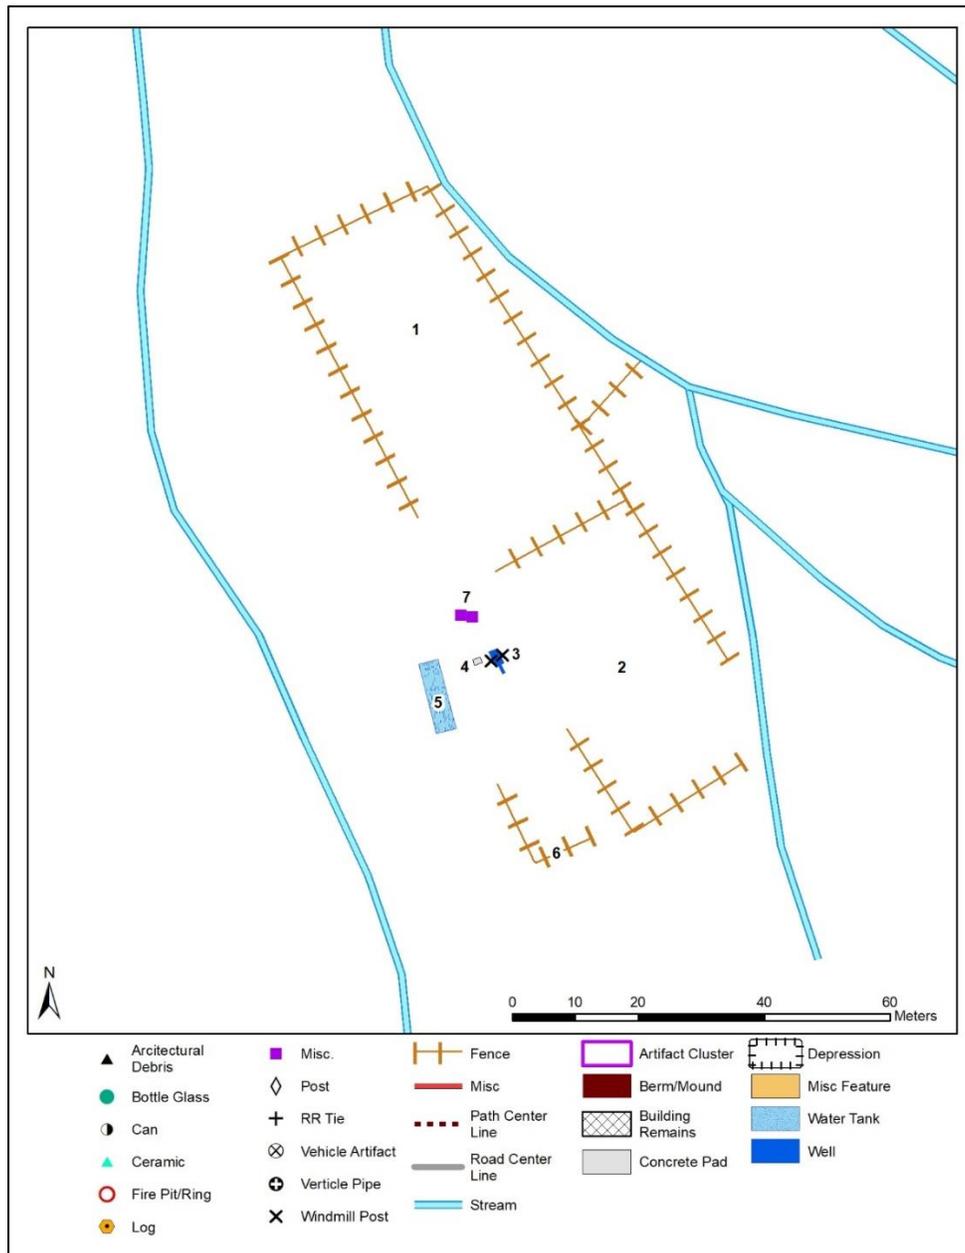
Figure 74. Site AZ Z:6:197 site map.

The site feature descriptions are:

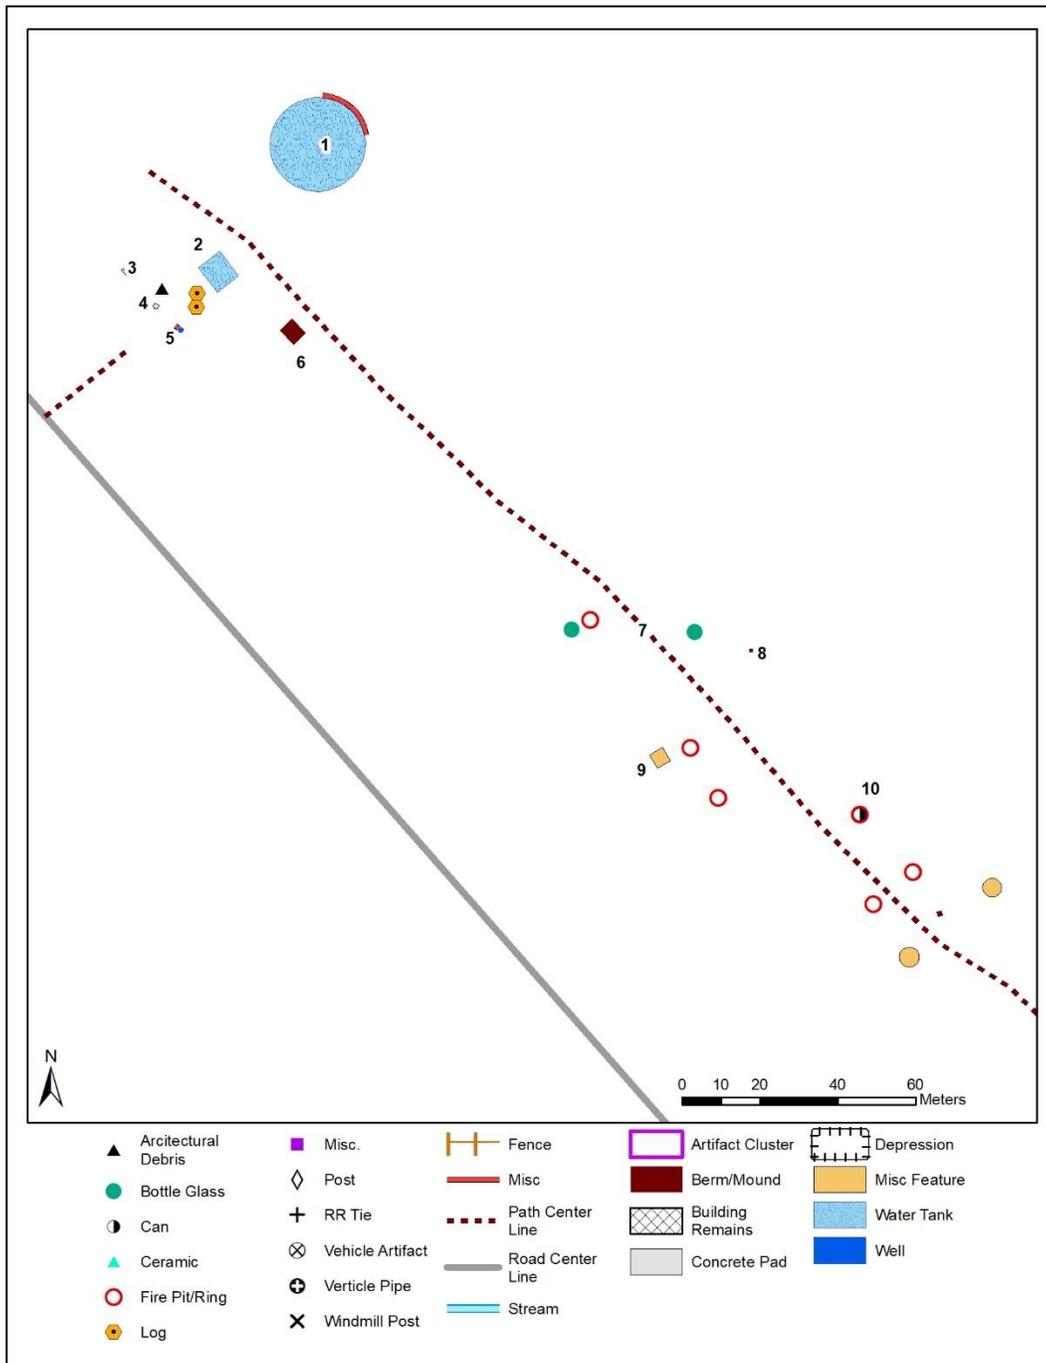
Figure 79. Site BMGR-00-B-09 site plan.

The site feature descriptions are:

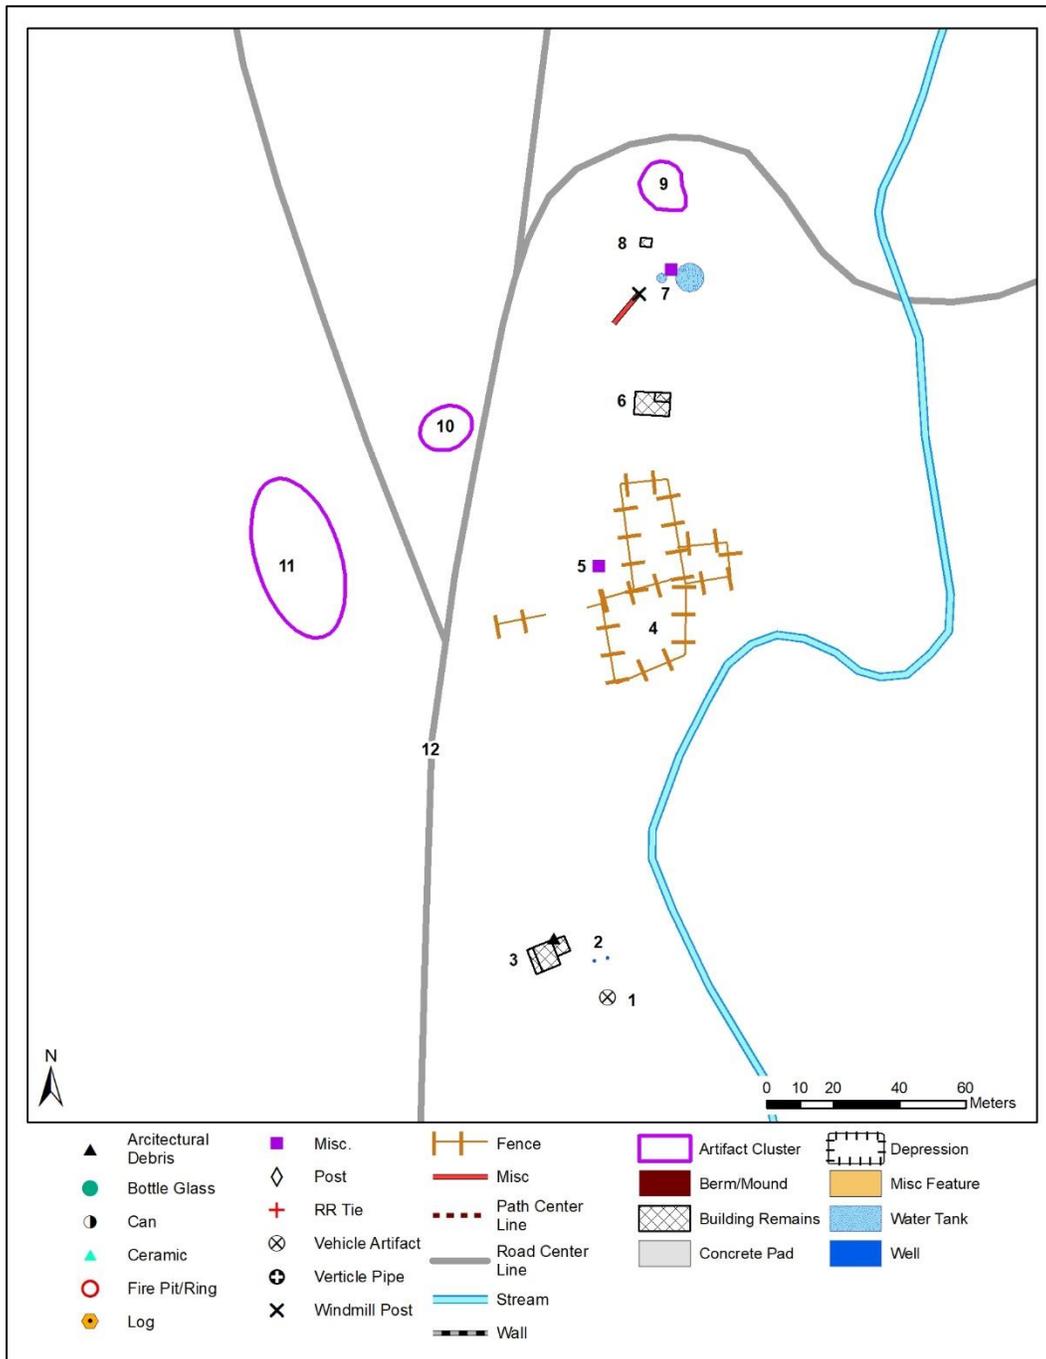
Figure 85. Site 5LA2320 site Map.

The site feature descriptions are:

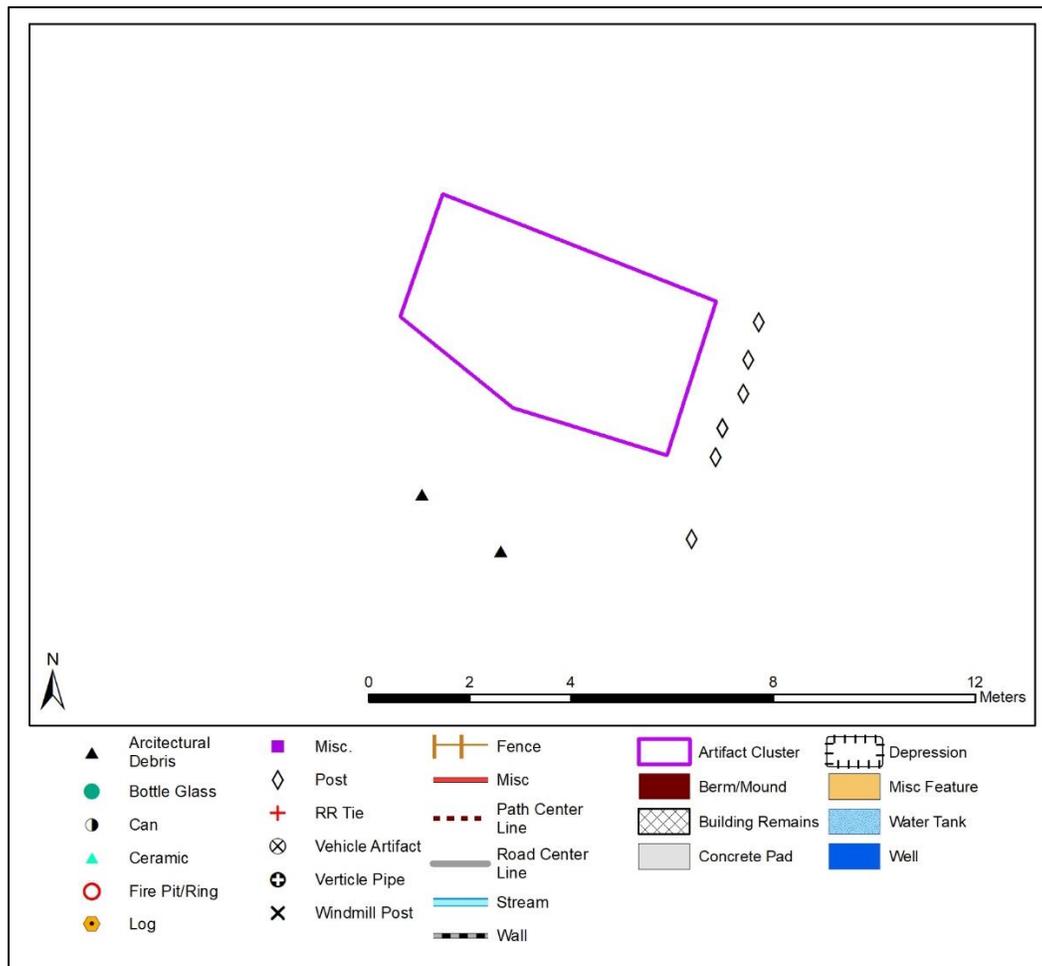
Figure 90. Site 5LA3250 site map.

The remains of the house consist of a row of vertical railroad ties located on the upslope side of the feature (Figure 91). Down slope from the posts is a scatter of logs and lumber planks (Figure 9 and shown in Figure 90 as an artifact cluster). This represents the collapsed roof. The logs and lumber are oriented perpendicular to the slope. Mixed in with the lumber was a small amount of wire nails and miscellaneous metal fragments including a
