Nationwide Context and Evaluation Methodology for Farmstead and Ranch Historic Sites and Historic Archaeological Sites on DoD Property

Carey L. Baxter, Susan I. Enscoe, Ellen R. Hartman, Benjamin C. Mertens, Dawn A. Morrison / U.S. Army Engineer Research and Development Center (ERDC)
Construction Engineering Research Laboratory (CERL)

December 2020

Final Technical Report (TR)

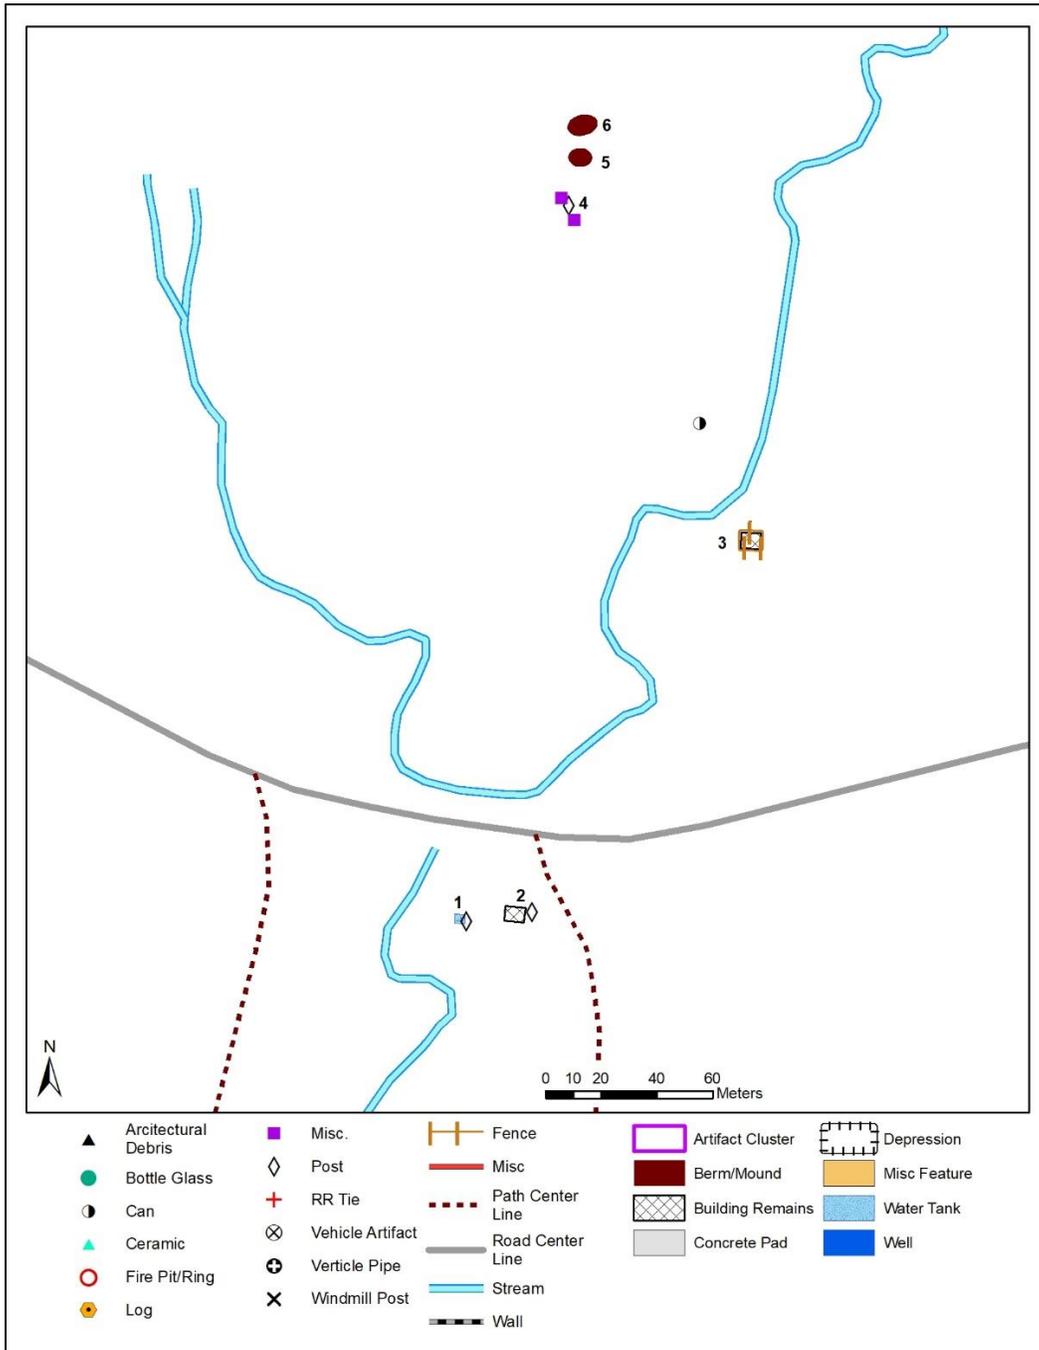
Figure 94. Site 5LA4406 site map.

The site feature descriptions are:

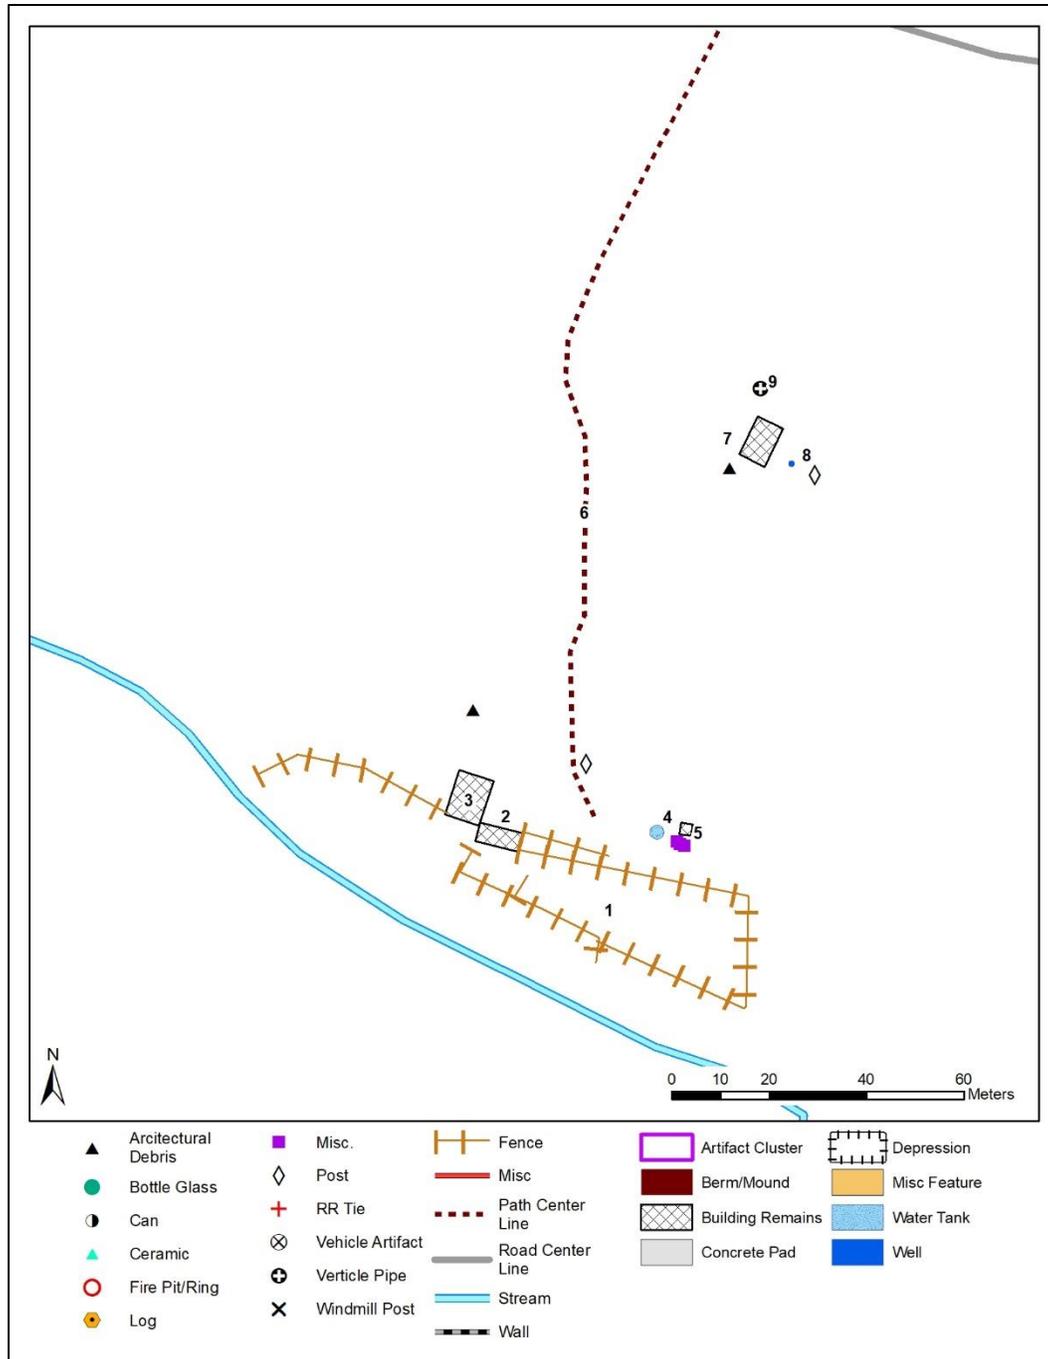
Figure 99. Site 5LA5820 site map.

The site feature descriptions are:

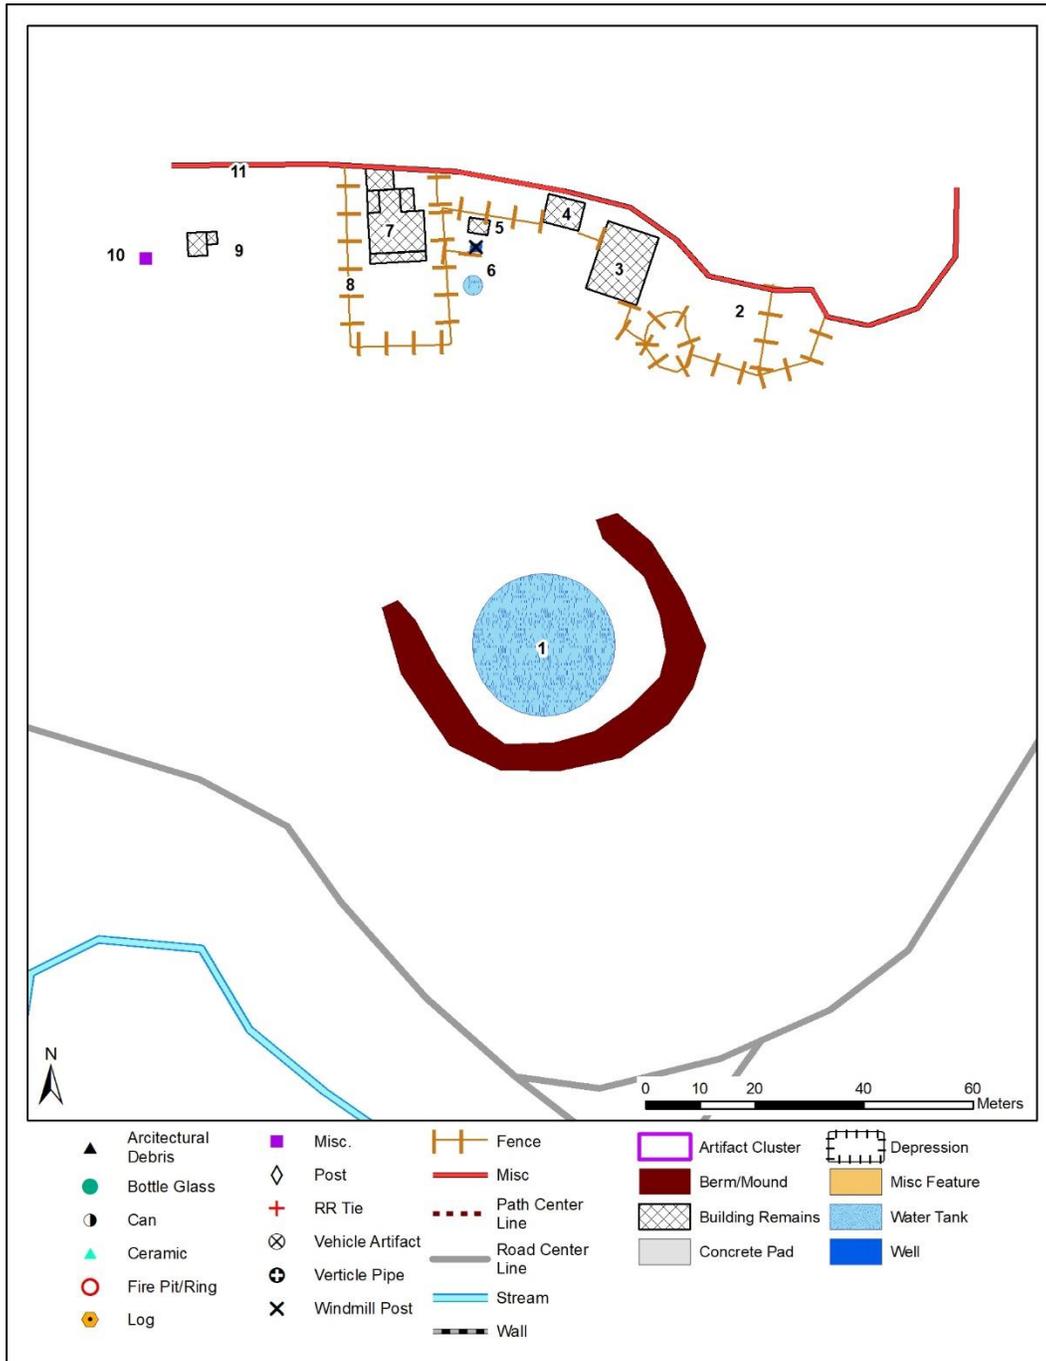
Figure 104. Site 5LA 5830 site map.

The site feature descriptions are:

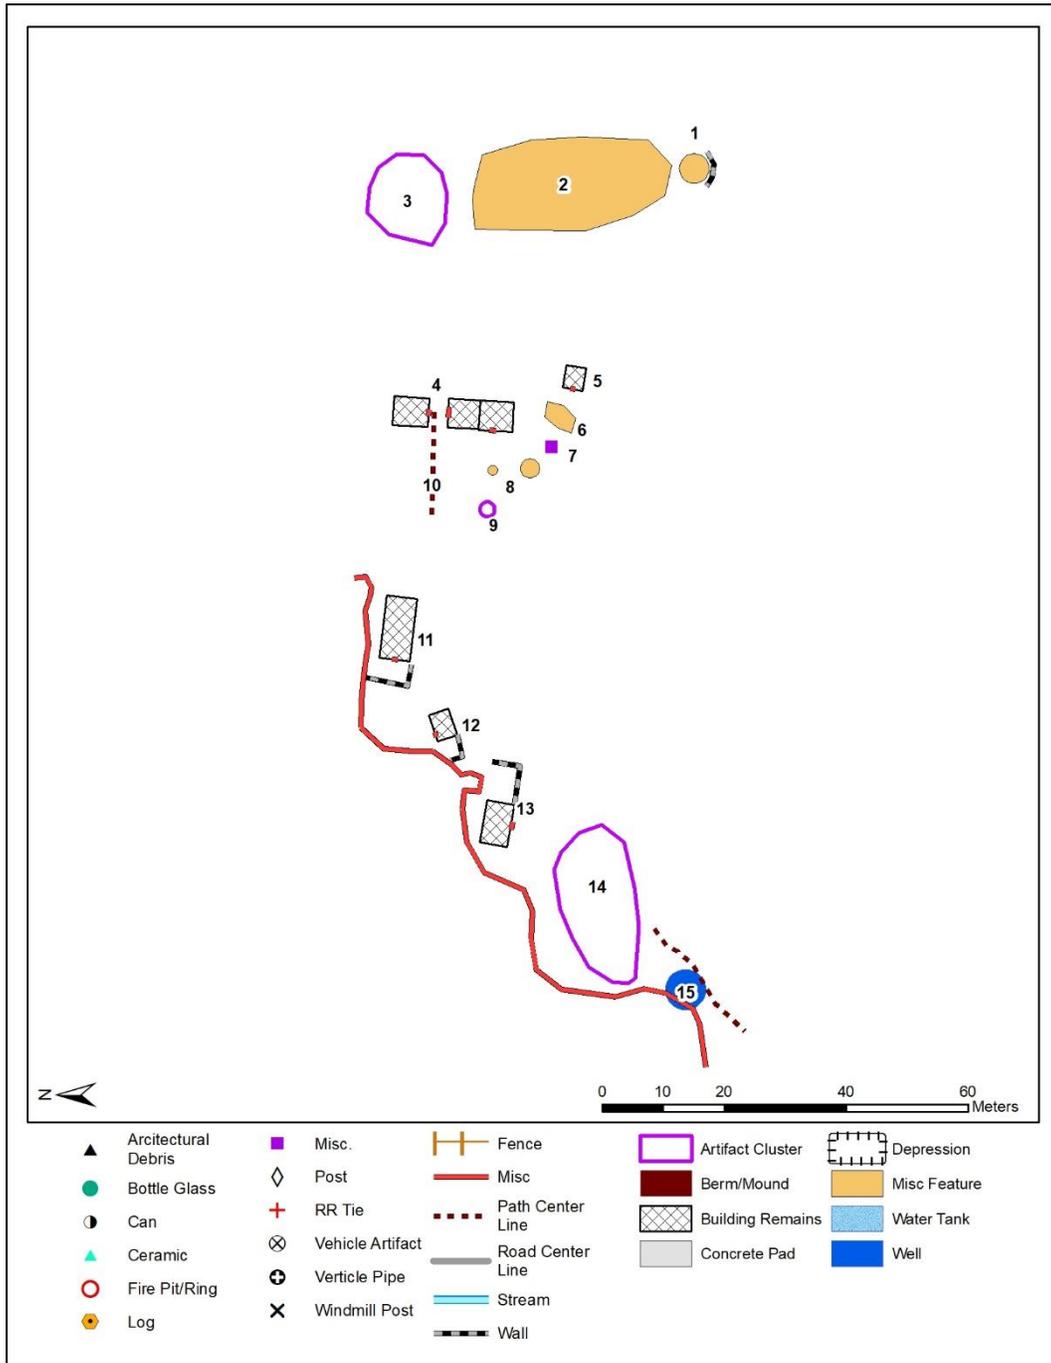
Figure 110. Site 5LA6104 site map. Please note orientation is rotated 90 degrees.

The site feature descriptions are:

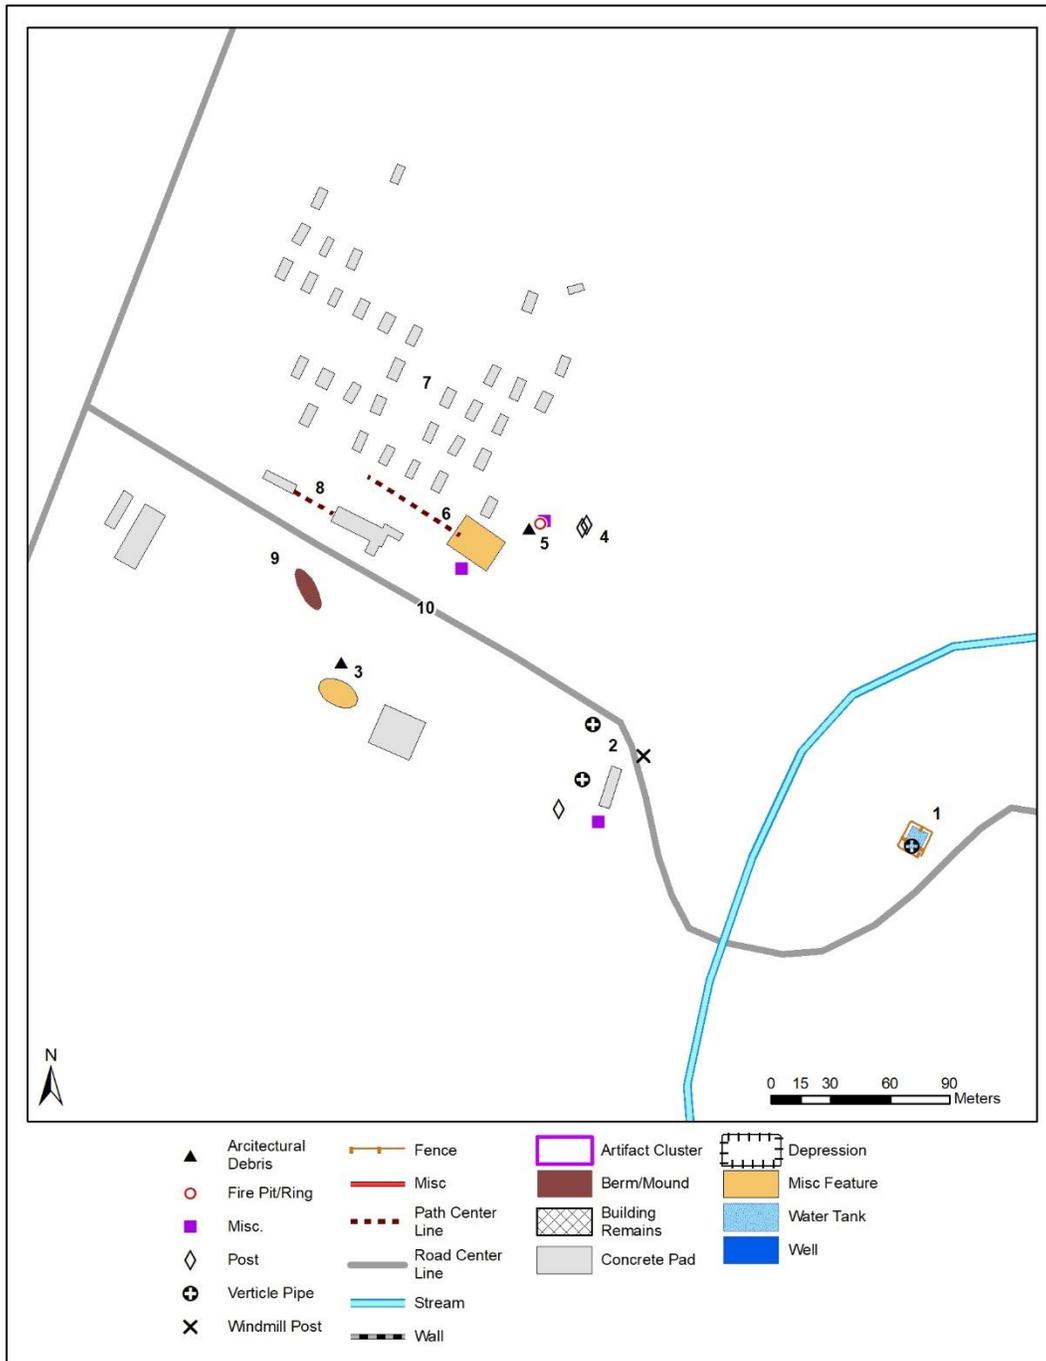
Figure 117. Site CA-MNT-258 site map.

The site feature descriptions are:

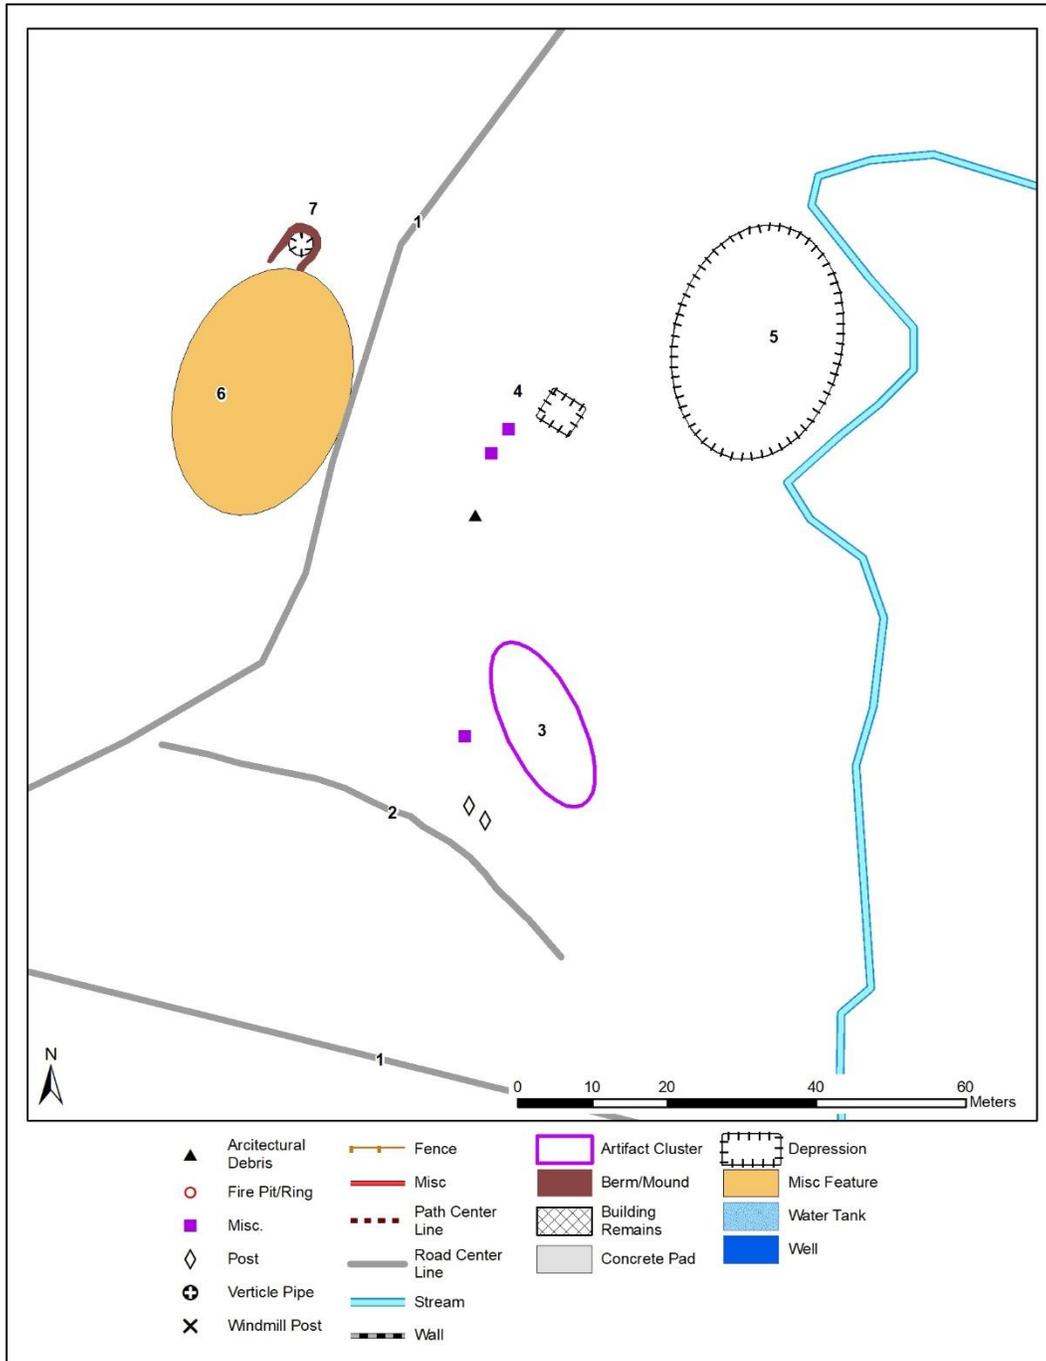
Figure 121. Site CA-MNT-1531 site map.

The site feature descriptions are:

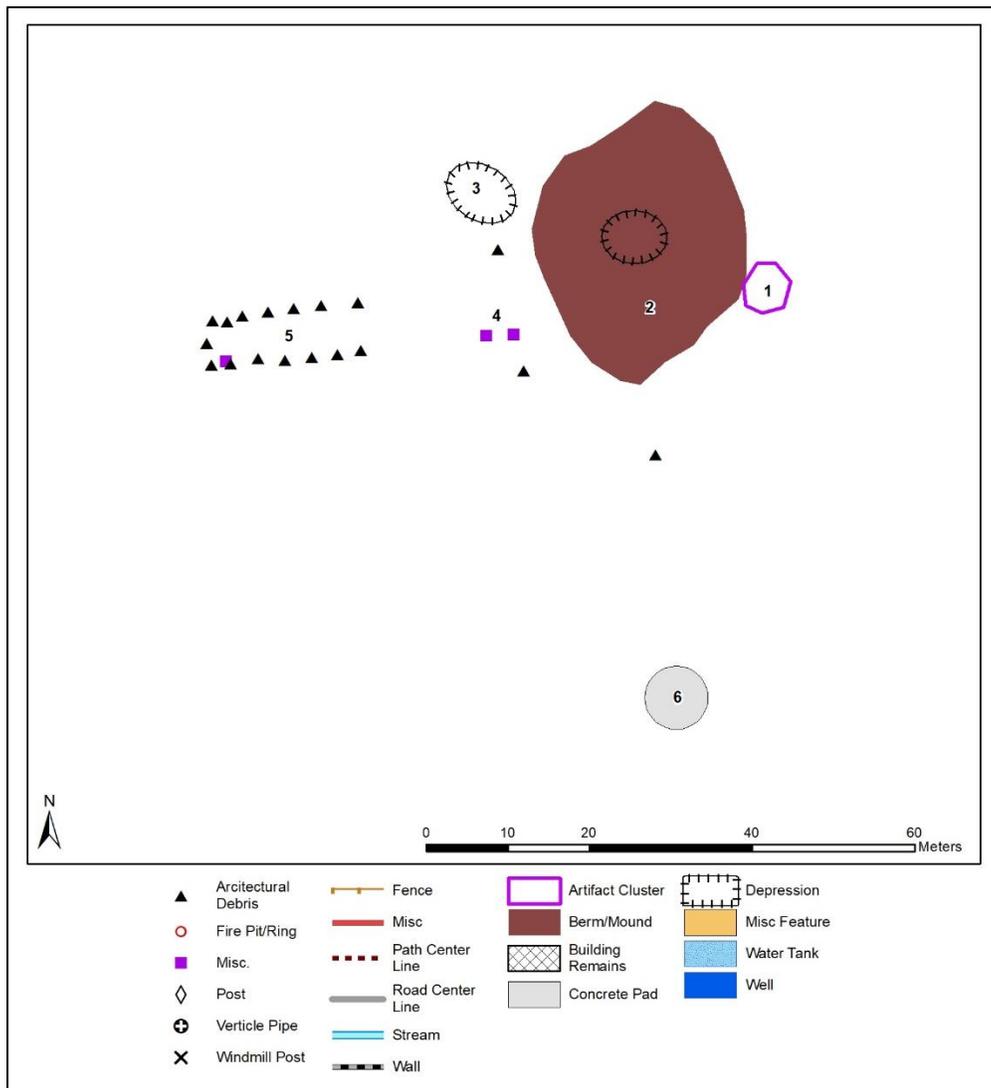
Figure 125. Site CA-MNT-1542 site map.

The site feature descriptions are:

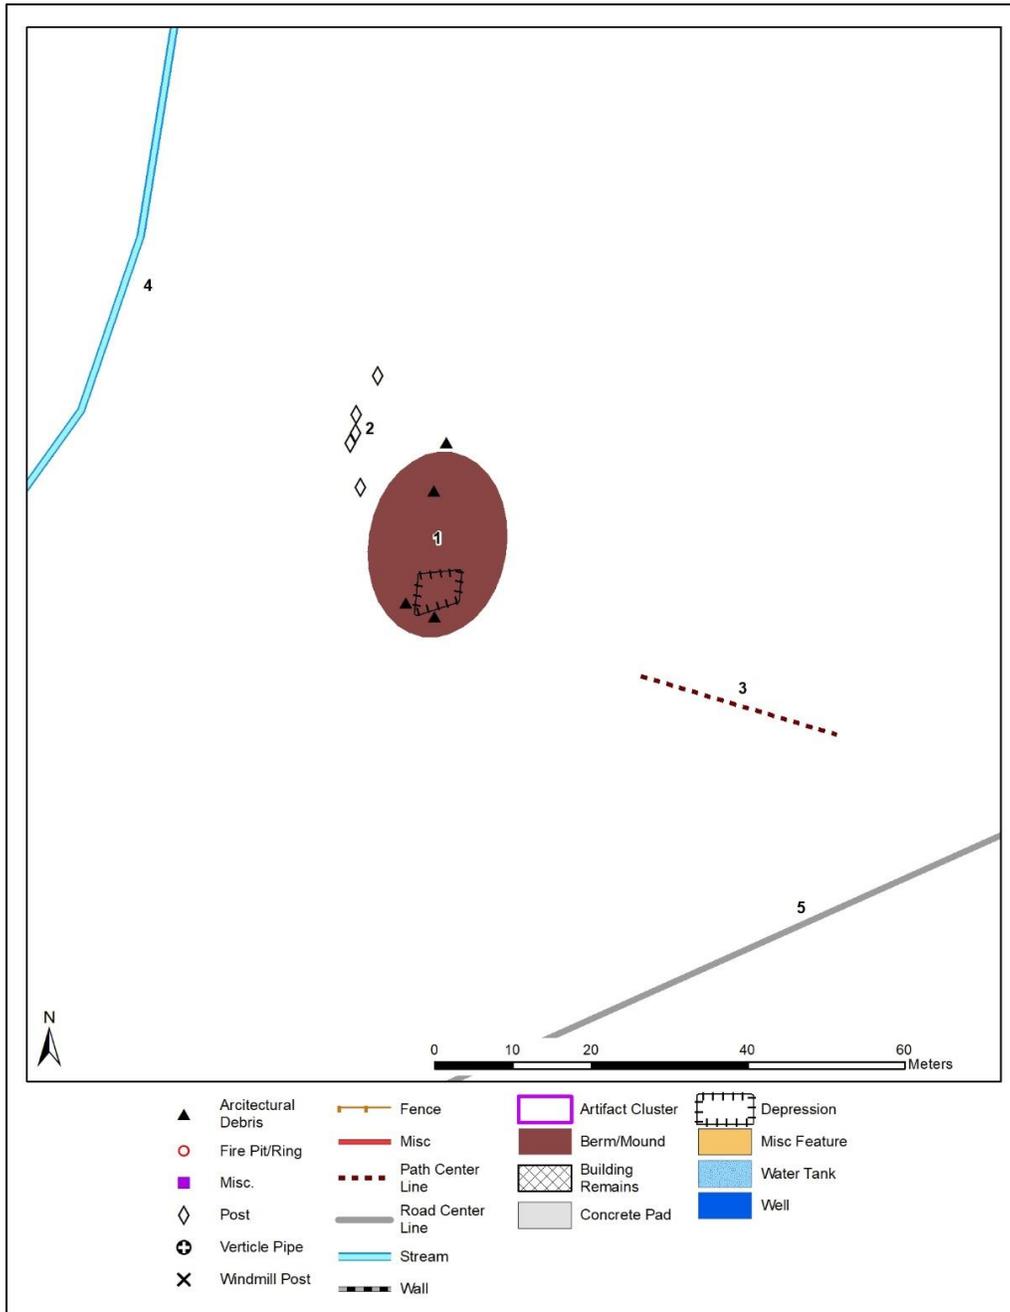
Figure 130. Site CA-MNT-1569 Site map.

Site CA-MNT-1569 is a melted adobe structure with a rectangular depression on the southern side. The site was heavily overgrown and the only artifacts observed were seen in the exposed erosion areas around the depression (Figure 131). This depression may represent an interior room to the structure. The small pile of river cobbles on the north side of the site may represent a firepit or chimney remains but no evidence of burning could be seen. The wooden post and barbed wire fence are located on the west side

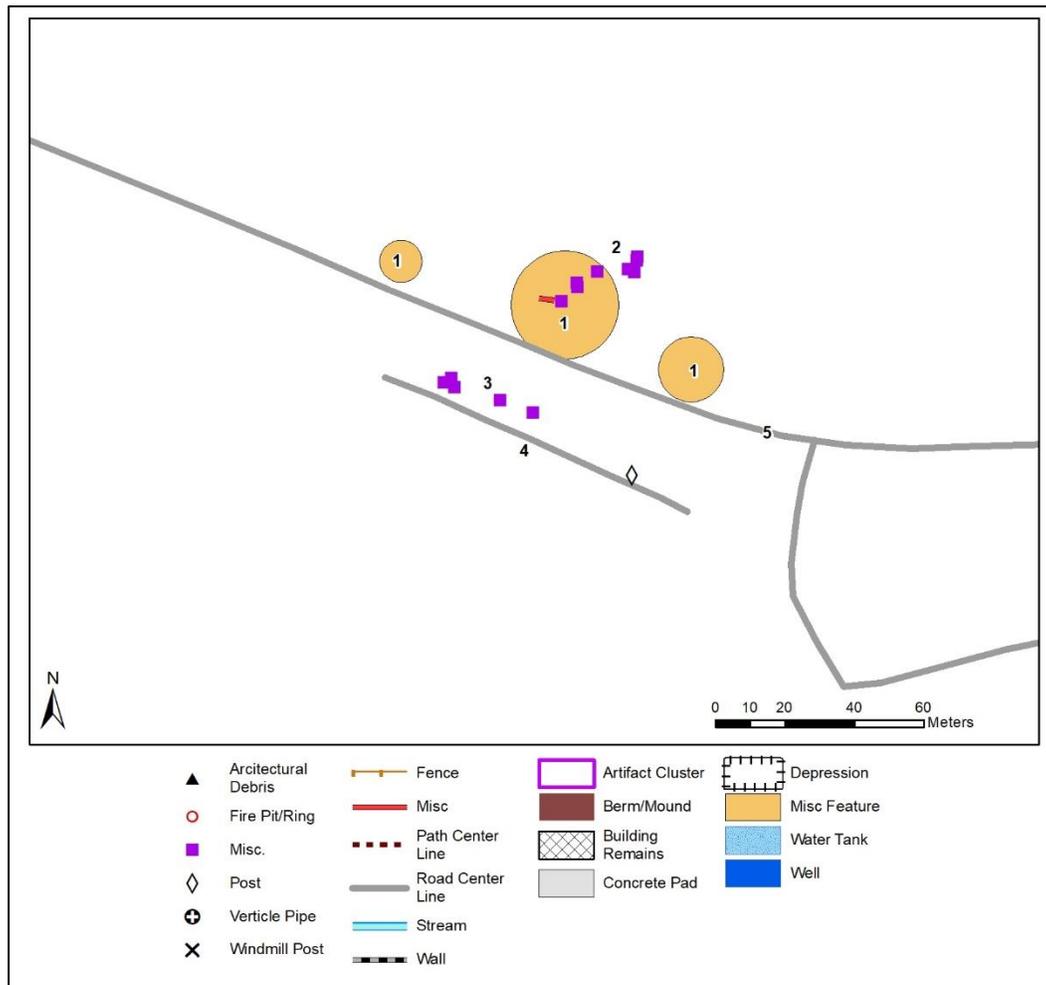
Figure 134. CA-MNT-1638 Site map.

The site feature descriptions are:
