# Beirut Port Explosion: Comparison of Field Damage to Explosive Safety Standards

## Abstract

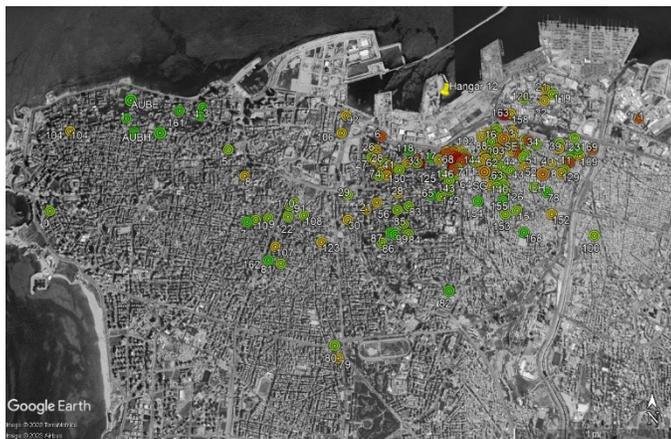
Figure 1. AUB Surveyed Building Locations and Damage Classification

In the aftermath of the explosion, researchers and engineers at American University Beirut (AUB) set up a hotline for residents or building owners to schedule a structural damage assessment. The initial observations from these assessments show that damage can be classified, and the buildings tagged, using three main categories: destructive (red), partially destructive (yellow), non-destructive (green) damage. The damage classification of over 150 buildings is shown in Figure 1 using appropriately colored circles.

The level of damage is mainly dependent on the type, age, and the location of these buildings. The damage assessment for these buildings was performed to inform the public about the extent of damage that occurred and to assist in the engineering decision between repairing or demolition of the affected buildings.

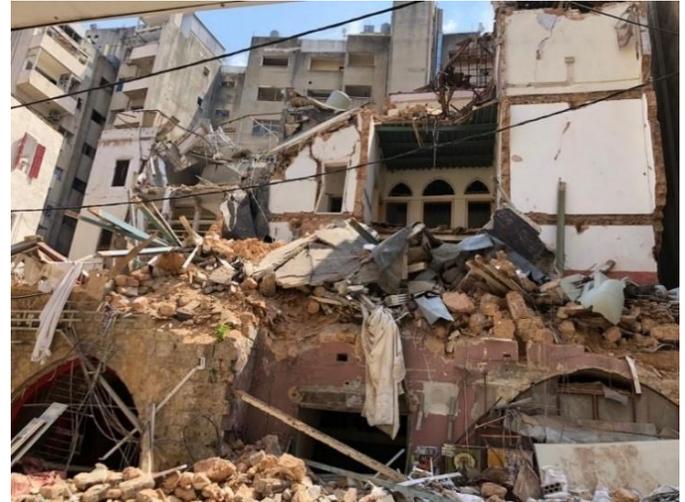
Figure 2. Historical Building Total Collapse

Approximately a third of the buildings surveyed experienced destructive damage. Those buildings, located within a setback of 1.5 km (0.932 miles) from Hangar 12, were mainly made of masonry

blocks dating older than 50 years. The buildings exhibiting destructive damage collapsed, as did the unreinforced masonry bearing wall of the building as shown in Figure 2. This building is located about 1 km (0.621 miles) away from the explosion, and it is classified as a historical masonry building that consists of unreinforced masonry blocks from natural stones with wooden roof trusses. This type of building is designed to resist gravity and wind loads only; it cannot resist lateral loads (i.e., earthquake or blast loading). This is due to the absence of seismic structural systems and horizontal diaphragms that can help in resisting shock waves due to an explosion.

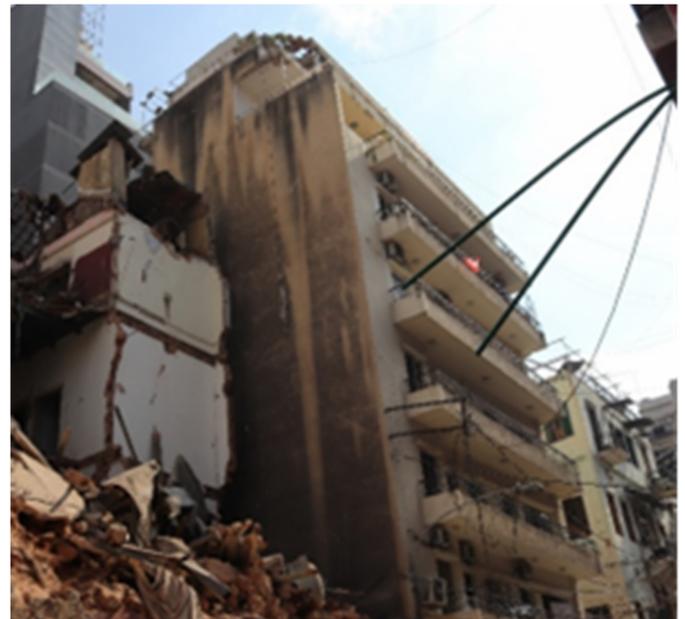
Figure 3. Reinforced Concrete Building without Severe Damage

A reinforced-concrete building located near the collapsed historical building, as shown in Figure 3, withstood the blast load without any severe damage recorded. It is assumed that the gravity reinforced-concrete building frame provided adequate stiffness capable of resisting the blast shock waves.

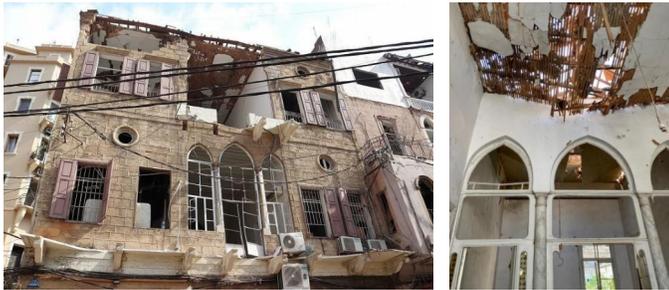
Figure 4. Natural Stone Masonry Historical Building with Partial Collapse

The buildings identified as having partially destructive damage are not totally collapsed but were still severely affected by the explosion. Figure 4 shows a building identified as having partially destructive severe damage. The building is classified as a historical building that consists of natural stone masonry bearing walls with wooden roof

trusses. This building is located around 1.2 km (0.746 miles) away from the explosion. The traditional balconies with thin cantilever slabs collapsed and the top timber roof truss failed. This is because the timber roof trusses, as constructed, cannot act as diaphragms to resist any lateral load. The third floor of the exterior wall of this building also experienced severe damage.

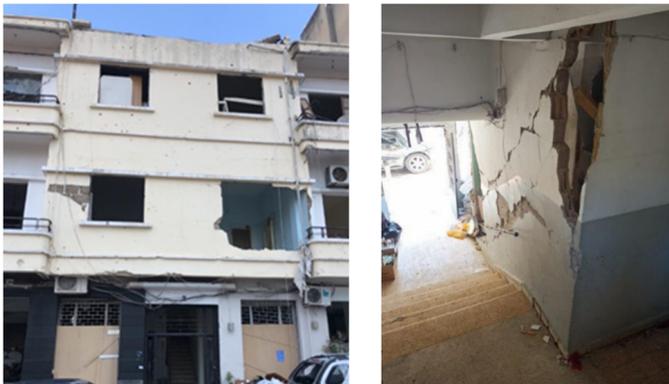
Figure 5. 1950's Reinforced Concrete Building Non-Structural Damage

Reinforced concrete buildings primarily from the 1950s (Figure 5) did not encounter any structural damage even though they were close to the explosion location (within 1 km (0.621 miles) from the explosion); this is mainly due to their location being surrounded by tall new buildings reducing the explosion intensity. Only non-structural damage was observed such as partition walls (CMU), doors, and windows.

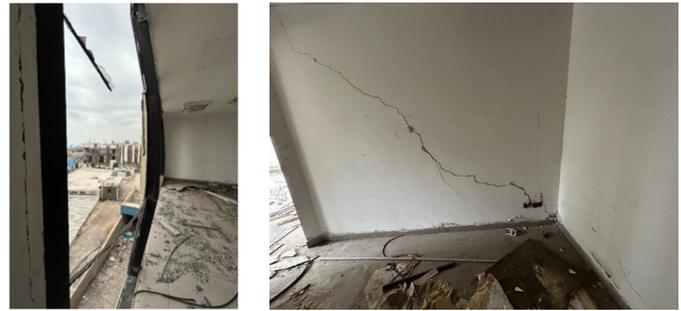
Figure 6. Post-2010 Reinforced Concrete Building Non-Structural Damage

Near the Beirut port (facing the port to the south) is an 11-story reinforced concrete building constructed post-2010. The building's high stiffness in both directions due to the reinforced concrete shear wall system was able to resist the blast-induced lateral loads. Despite the substantial impact, no severe structural damage occurred. The entire aluminum double-glazed façade facing the explosion site exhibited a convex curvature as shown in Figure 6 (aligned with the blast shock wave impact), exerting compressive forces on the supporting partition walls (CMU). This led to the development of cracks along the CMU wall joint. The building façade, composed of double-glazed glass, experienced complete damage, with all its elements affected. At higher floors, the partition walls (CMU) increasingly exhibit both horizontal and diagonal cracks; this is mainly due to some foundation movement resulting from a 3.3 magnitude earthquake from the blast [13] with the blast shock waves.

This building was designed following seismic codes to resist earthquakes using reinforced-concrete shear wall systems that provide the building with very high stiffness in both directions, which was able to resist the blast-induced lateral loads. While this damage may seem minor with respect to the structural damage experienced by other types of buildings, it can severely impact a community's ability to recover and occupy buildings damaged in this manner.

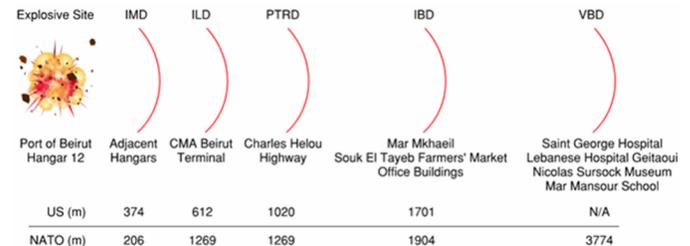
Figure 7. QD Summary from Hangar 12

Another way to assess the field survey data is to utilize explosive safety standards, which have been developed by organizations such as the United States Department of Defense Explosive Safety Board [14], the United Kingdom Ministry of Defence [15], and North Atlantic Treaty Organization [16] over the past several decades. As shown in Figure 7, the siting requirements include minimum distances between the stored explosives (Hangar 12) and inhabited buildings, public traffic routes, electrical systems, and other explosive storage locations.

The goal of explosive safety siting is two-fold: public life-safety and to mitigate the propagation of explosives between storage locations. Quantity-Distance (QD) arcs – for vulnerable buildings (VBD), inhabited buildings (IBD), public traffic routes (PTRD), munitions-related occupied buildings (defined as intraline distance, ILD), and related unoccupied munitions storage magazines (defined as intermagazine distance, IMD), which are listed in order of decreasing radius to the explosive source – are developed to establish minimum setback distances based on the net explosive weight (NEW) stored in Hangar 12. The expected damages, injuries, and fatalities at each QD are provided in Table 1.

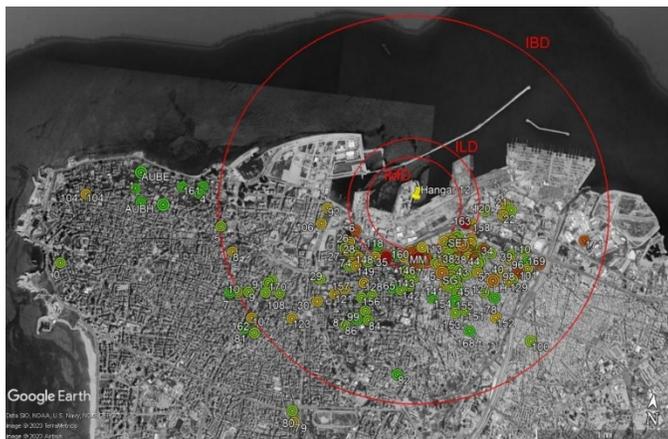
Figure 8. AUB Surveyed Building Locations and Revised QD Arcs

The observations from the field survey assessments show that damage can be classified, and the buildings tagged, using three main categories: destructive (red), partially destructive (yellow), non-destructive (green) damage. The damage classification of over 150 buildings is shown in Figure 8 using appropriately colored circles and with the US (red) and NATO (yellow) IBD arcs overlaid. Figure 9 shows one mid-rise residence building with widespread façade failure such as that expected in a building located within an IBD arc.

Given the lack of use of these siting standards in the storage of the explosives in Hangar 12, many buildings that would be classified as either inhabited or vulnerable buildings were located well within these IBD standoff distances. For example, the apartment building considered in the Façade Detailed Analysis herein was located only 517.18 m (1697 ft) from the blast source, subjecting it to anticipated ILD-level damages, which include major structural and façade damage. In contrast to these predicted damages, the building did not exhibit structural damage, as discussed. The discrepancies between the damages predicted by explosives safety criteria (Figure 7 and Table 1) and those observed in the field survey (Figure 8) can be used to produce an updated estimate of the net explosive weight (NEW) involved in the ammonium nitrate explosion.

As summarized in Table 2, these revised QD arcs result in a TNT equivalent net explosive weight between 1406 and 2288 tons, as compared to the initial assumption of 630 tons. PTRD is not shown as it is calculated as 60% of IBD, and damage to vehicles was not specifically investigated as part of the field assessment to use for comparison. Using the TNT equivalency of ANFO from ASCE/SEI 59-22, the total quantity of stored explosives based on the explosives safety standards is estimated to be between 2000-3000 tons. Based on the field assessment and damage witnessed throughout the city, the actual quantity of ammonium nitrate contributing to the explosion in Hangar 12 would have to had been closer to the total stored amount, meaning that almost all material contributed to the explosion. This highlights the conservative nature of explosive safety standards and assumptions on how the blast load develops.
