## 2024 ATF Perforating Gun Test Series to Support Quantitative Risk Assessment

Prepared by:  
A-P-T Research, Inc.  
4950 Research Dr.  
Huntsville, AL 35805  
Phone: 256.327.4015  
Fax: 256.837.7786  
[www.ap-t-research.com](http://www.ap-t-research.com)  
January 20, 2026  
T-26-00101

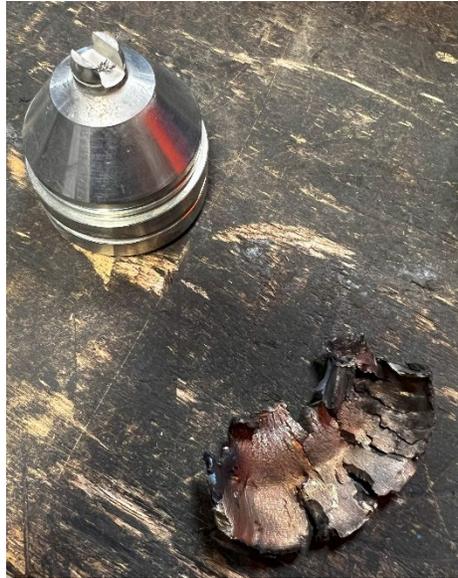
**Figure 4: Phase 1 Calibration Shot Perforator**

As stated in Section 3.1, only one calibration shot was performed in Phase 1. This calibration shot took place on July 15, 2024, and was performed by Company A. This shot utilized a Company A gun with a 3 1/8 in outer diameter, 23 in length, containing 6 shots per ft. Each charge had a NEW of 21.5 g. The gun was placed horizontally on a stand in a trench with sand barrels at each end to catch the bulkhead and other fragments. Upon completion of this calibration shot, it was found that the bulkhead of the gun was launched several feet into the sand

barrel. The results from this calibration shot corroborated the recommendation of extending the north side of the grid to 1,300 ft for Test 1. Unfortunately, the mass of recovered fragments from this test was not recorded and therefore an exact percentage of how much mass was recovered cannot be provided. Furthermore, there are no images showcasing the recovered fragments of the carrier tube and perforators. Figure 4 shows one of the recovered fragments of the perforators next to an intact one to provide an idea of the size of the fragments that were produced in this calibration shot.

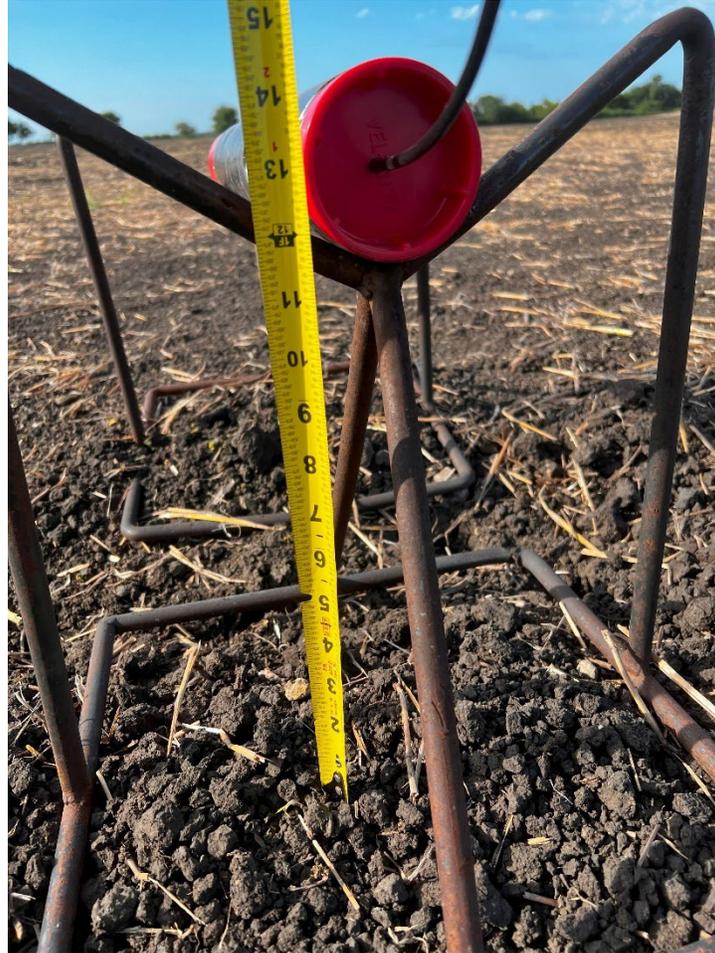
**Figure 5: Test 1 Setup (1 ft Elevation)**

Test 1 took place on July 16, 2024, at 9:28 AM CDT. This test used the same Company A gun as described in Section 3.1.1, and had the gun positioned horizontally at a height of 1 ft above the ground, held in place by a test stand. The gun was oriented North-South with the sub facing south and the bulkhead facing north. The initiators used for this test were RP-81 and were controlled with a Teledyne RISI Inc (RISI) FS-43 Exploding Bridgewire (EBW) firing system. Company A handled the setup of the JPG and initiation of the test. Figure 5 is an example of the test setup for Test 1 and the other tests that had the JPG at 1 ft above ground.

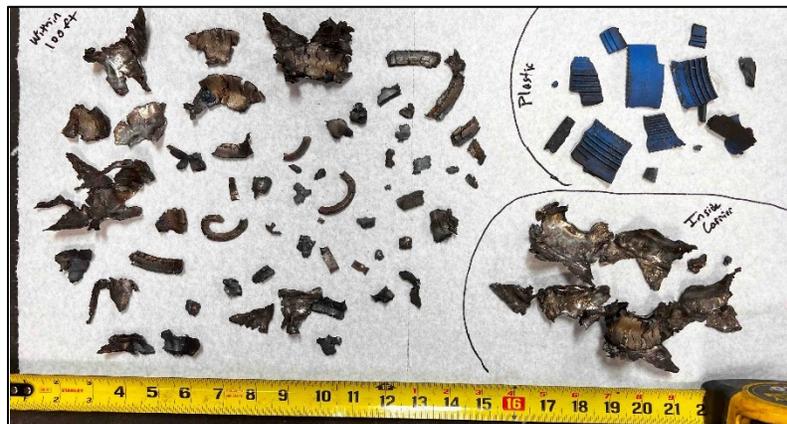
**Figure 7: Test 1 Recovered Fragments**

The mass of the gun was not recorded prior to the initiation of Test 1, therefore four Company A JPGs that were as close as possible to the gun used in the test were weighed, and the average was taken. This average was used as the initial mass for the gun and was calculated to be 10,116.97 g. It should be noted that the initial and recovered mass for this test and all following tests only considered the metal mass; the mass of the plastic end caps was not included in either value. Following the completion of fragment collection, which was done in accordance with Rev 2 of DDESB TP-21 [5], all the recovered pieces were weighed to determine what percentage of the initial mass was found. The collected mass was determined to be 8,864.56 g, which means that 87.62% of the initial mass was recovered. The bulkhead accounted for roughly 7% of the total mass and was never recovered. Upon reviewing the video footage, it was determined that the

bulkhead was launched on or near the  $0^\circ$  line at roughly 526 ft/s. The bulkhead was not observed impacting the ground in the video and no significant impact marks were found along its flight path during fragment collection. Given the high velocity and the lack of noticeable impact marks, it was speculated to have been spinning as it bounced, leading to the bulkhead rebounding out of the test grid beyond the 1,300 ft range without leaving any clear evidence of an impact within the debris recovery area. This speculation could not be confirmed due to the suspected resting place of the bulkhead being an area with dense vegetation that prevented recovery efforts. An image showing the recovered fragments of the carrier tube and perforators is provided in Figure 7. In this figure, fragments recovered within 100 ft are on the left, fragments that were recovered from within the gun body are in the bottom right, and the recovered plastic is in the top right. Unfortunately, the fragments recovered outside of 100 ft were not captured in any images. It should be noted for this test and all following tests that while some plastic fragments were collected, the goal of the fragment collection effort was to recover metal fragments, not plastic. Therefore, the plastic fragments that were recovered were not factored into the number of fragments recovered.

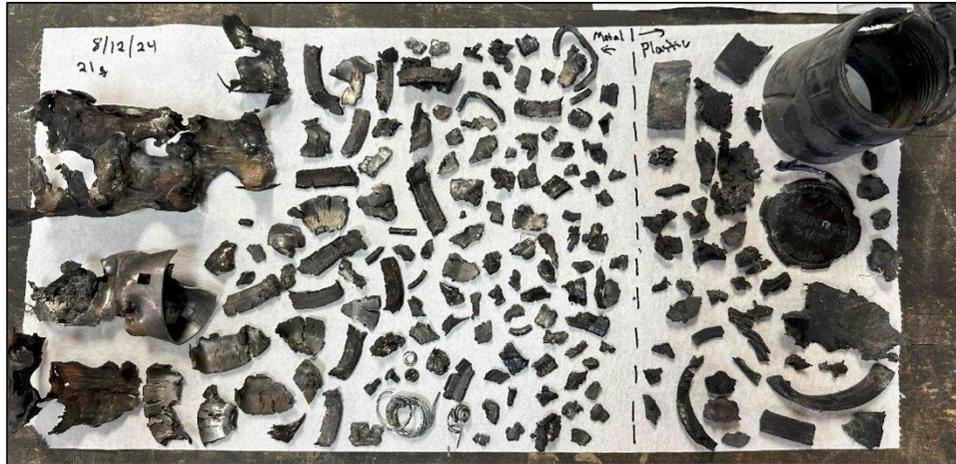
**Figure 10: Phase 2 Calibration Shot 1 Recovered Fragments**

all of the calibration shots in Phase 2 took place on August 12, 2024. The first calibration shot used a Company C JPG with a 3 1/8 in outer diameter, a 24.5 in length, and 6 shots per foot. For this shot, each charge had a NEW of 21.5 g. Prior to the shot, this JPG had a recorded mass of 13,419 g. Of this initial mass, 13,222 g were recovered, meaning 98.5% of the gun's mass was recovered. The fragments of the carrier tube and perforators recovered from this shot are shown in Figure 10. In this figure, all the recovered metal fragments, regardless of mass, are shown on the left, while the recovered plastic is shown on the right.

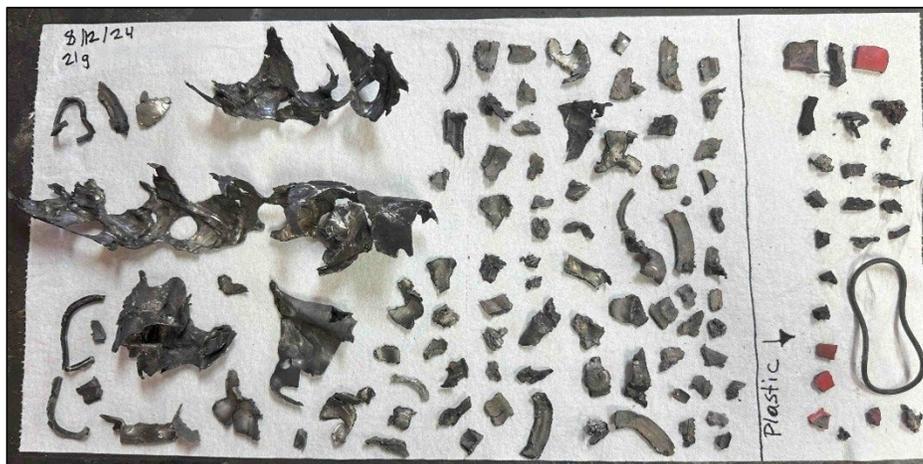
**Figure 11: Phase 2 Calibration Shot 2 Recovered Fragments**

The second calibration shot was done with a Company B gun that had a 3 1/8 in outer diameter, a 21 in length, and 6 shots per foot. Each charge for this gun also had an NEW of 21.5 g. Prior to the shot, this JPG had a recorded mass of 9,428 g. Of this initial mass, 9,053 g were recovered, meaning 96% of the gun's mass was recovered. The fragments of the carrier tube and perforators recovered from this shot are shown in Figure 11. In this figure, all the recovered metal fragments, regardless of mass, are shown on the left, while the recovered plastic is shown on the right.

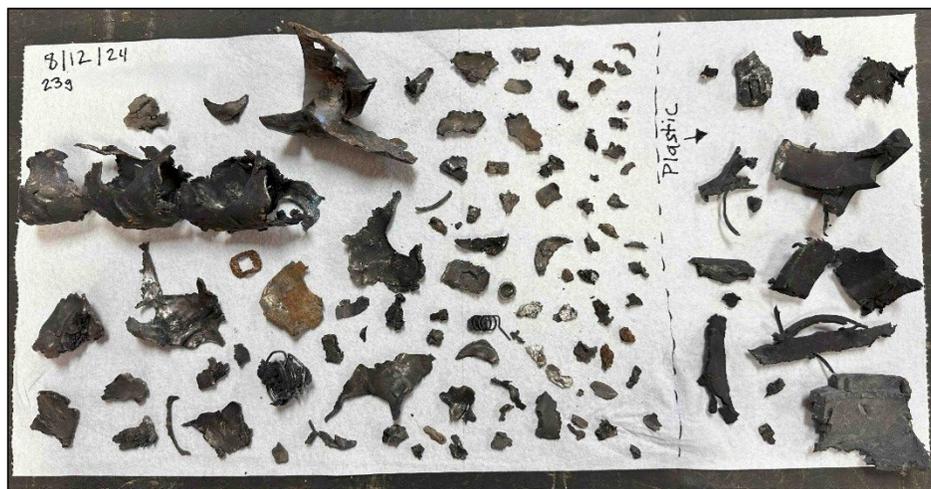
**Figure 12: Phase 2 Calibration Shot 3 Recovered Fragments**

The third calibration shot was done with another Company C JPG with the same specs as in the first calibration shot, however the NEW per charge was increased to 23 g. Prior to the shot, this JPG had a recorded mass of 13,387 g. Of this initial mass, 12,794 g were recovered, meaning 95.6% of the gun's mass was recovered. The fragments of the carrier tube and perforators recovered from this shot are shown in Figure 12. In this figure, all the recovered metal fragments, regardless of mass, are shown on the left, while the recovered plastic is shown on the right.

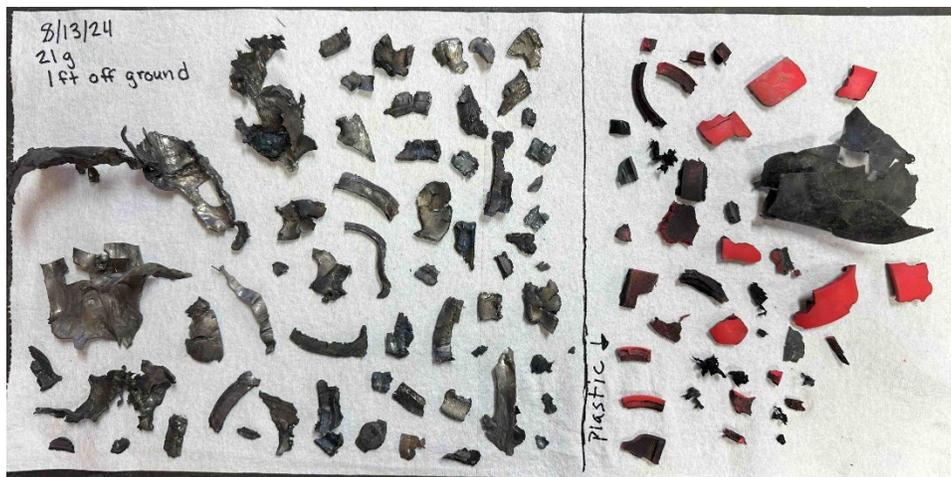
**Figure 14: Test 2 Recovered Fragments**

Prior to the initiation of Test 2, the mass was recorded as 9,448 g. Upon completion of the recovery effort, it was determined that 8,654 g were collected, equating to 91.6% of the starting mass. The fragments of the carrier tube and perforators recovered from this test are shown in Figure 14. In this figure, all the recovered metal fragments, regardless of mass, are shown on the left, while the recovered plastic is shown on the right. Unlike Test 1, in this test and all other tests done in Phase 2, the recovered fragments were not separated by distance in the pictures.

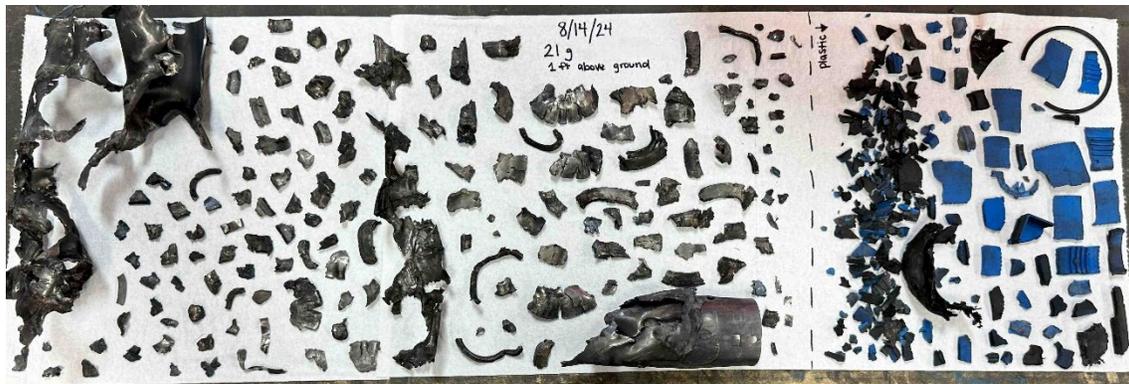
**Figure 16: Test 3 Recovered Fragments**

Prior to the initiation of Test 3, the mass was recorded as 9,639 g. Upon completion of the recovery effort, it was determined that 9,193 g were collected, equating to 95.4% of the starting mass. The carrier tube and perforator fragments recovered from this test are shown in Figure 16. Once again, in this figure all the recovered plastic is on the right-hand side, and all the recovered metal regardless of mass and recovery location is on the left-hand side.

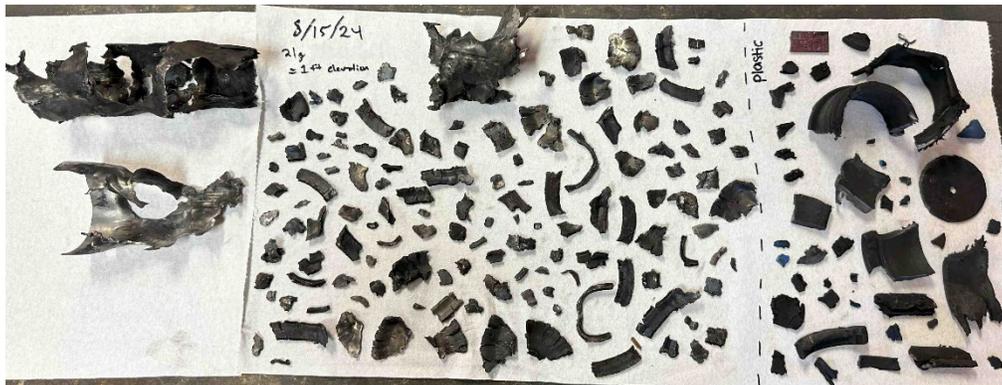
**Figure 18: Test 4 Recovered Fragments**

Prior to the initiation of Test 4, the mass was recorded as 13,416 g. Upon completion of the recovery effort, it was determined that 12,835.4 g were collected, equating to 95.7% of the starting mass. The carrier tube and perforator fragments recovered from this test are shown in Figure 18. It can be seen on the far left of this image that the carrier tube largely remained intact. The pattern of having metal fragments on the left and plastic on the right of the photo continues for this test. Once again, this image contains all the recovered fragments regardless of the distance they were recovered at or their mass.

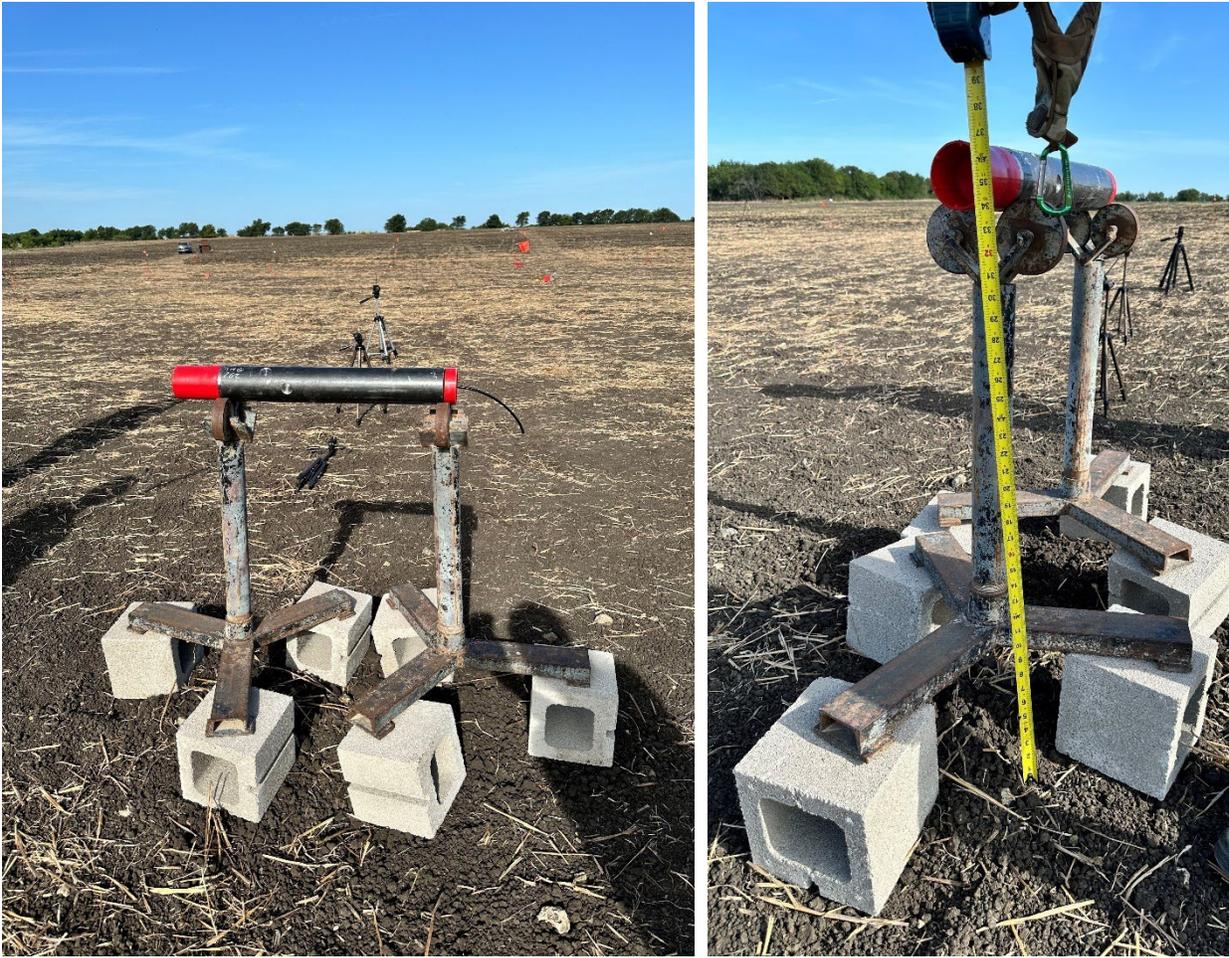
**Figure 20: Test 5 Set Up (3 ft Elevation)**

Test 5 took place on August 16, 2024, at 10:14 AM CDT. This test used a single Company B gun with a 3 1/8 in outer diameter and a 21 in length. This gun contained 6 shots per foot with each charge having an NEW of 21.5 g. This gun was oriented horizontally and positioned 3 ft above ground on a stand. Figure 20 depicts the test setup for Test 5.

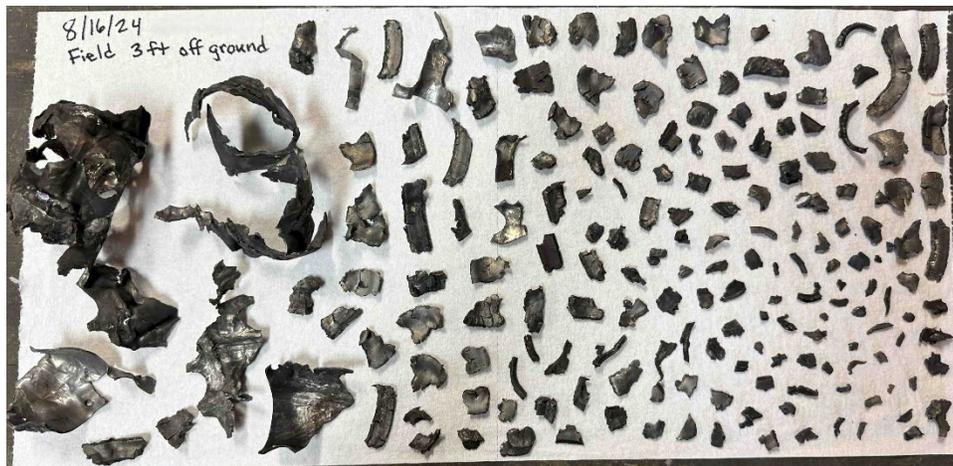
**Figure 21: Test 5 Recovered Fragments**

Prior to the initiation of Test 5, the mass was recorded as 9,502 g. Upon completion of the recovery effort, it was determined that 9,083 g were collected, equating to 95.6% of the starting mass. The carrier tube and perforator fragments recovered from this test are shown in Figure 21. In this test the plastic fragments were left out of the image. Instead, it can be seen that Figure 21 displays all the recovered metal fragments with the largest of them on the top left and the smallest on the bottom right. The fragments displayed in this image were recovered both within and beyond the 100 ft range.

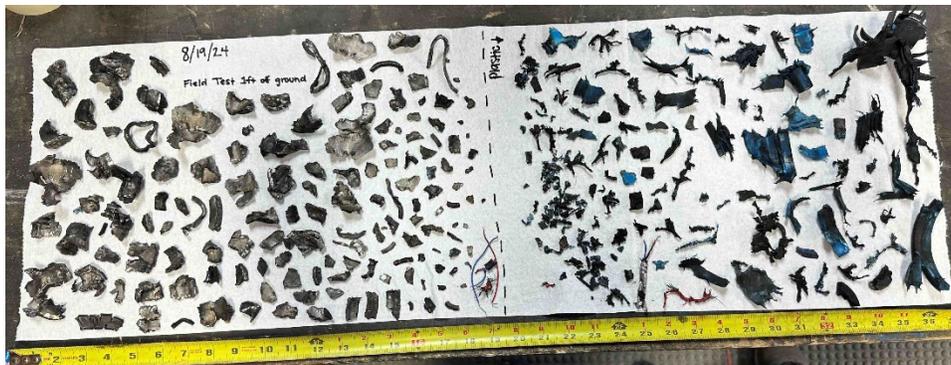
**Figure 23: Test 6 Recovered Fragments**

Prior to the initiation of Test 6, the mass was recorded as 10,467.8 g. Upon completion of the recovery effort, it was determined that 10,134 g were collected, equating to 96.8% of the starting mass. The perforator fragments recovered from this test are shown in Figure 23. As shown on the right side of Figure 23, this test produced many plastic fragments. This is because the internal carrier tube of this gun was made of plastic and not metal like the other guns used in this test series. On the left side of the figure, the metal fragments are once again arranged with the largest in the top left and the smallest in the bottom center of the figure. Furthermore, as with all other tests in this phase, the fragments displayed in this image were recovered at any distance.

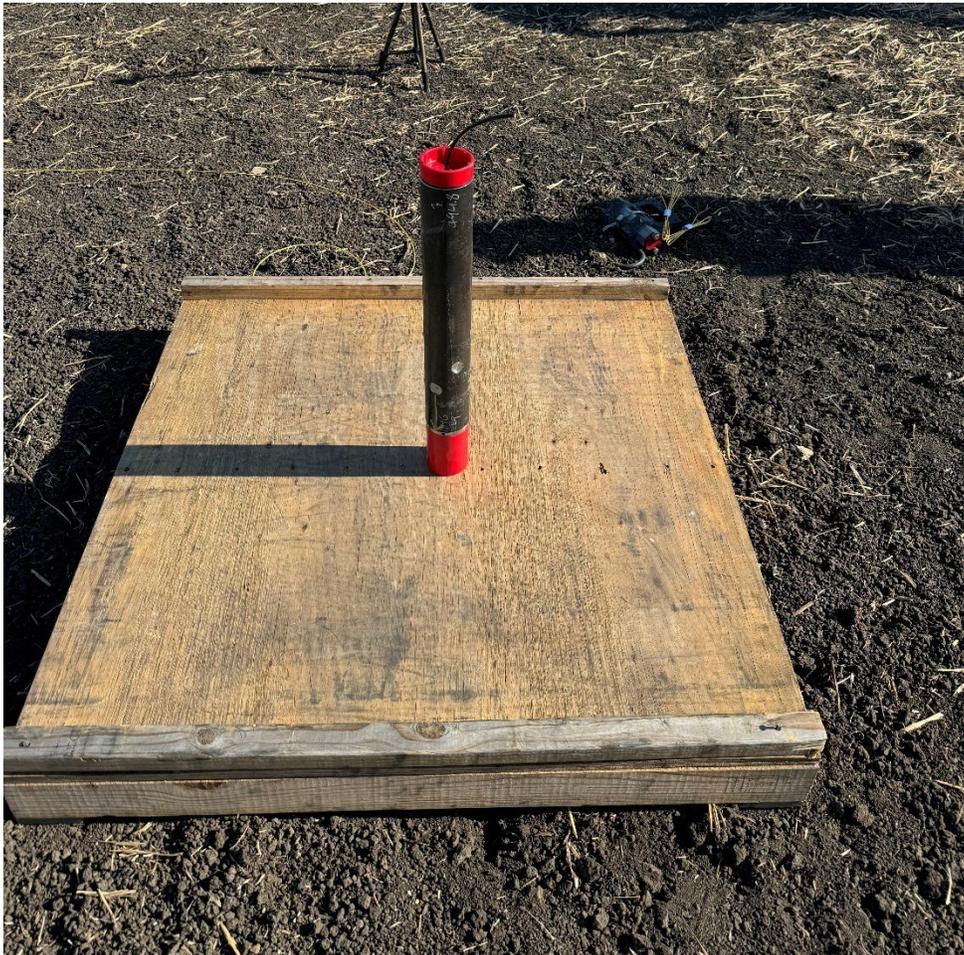
Figure 25: Test 7 Setup (Vertical Orientation)

Test 7 took place on August 20, 2024, at 10:00 AM CDT. This test used a single Company B gun with a 3 1/8 in outer diameter and a 21 in length. This gun contained 6 shots per foot with each charge having an NEW of 21.5 g. This gun was oriented vertically and positioned upright on a pallet. For this test, the sub was facing downwards into the pallet. Furthermore, the gun was oriented such that the charges were not aimed directly at the cameras to help maintain visual clarity. Figure 25 depicts the test setup for Test 7.

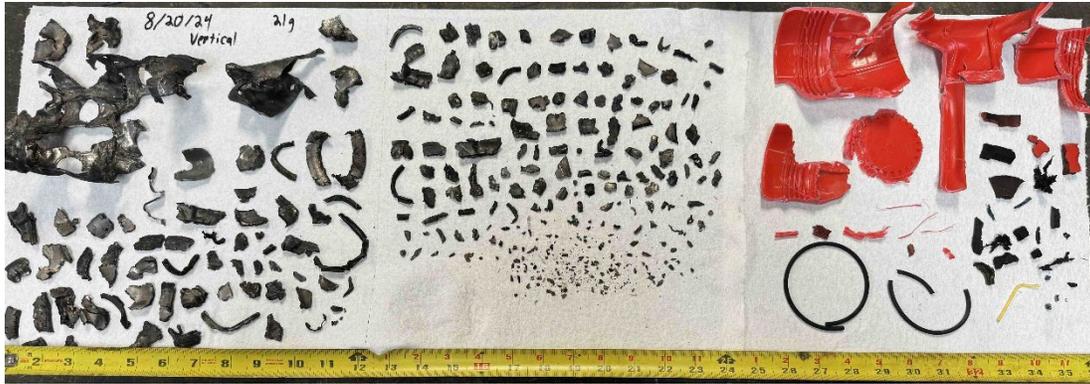
**Figure 26: Test 7 Recovered Fragments**

Prior to the initiation of Test 7, the mass was recorded as 9,494 g. Upon completion of the recovery effort, it was determined that 9,145 g were collected, equating to 96.3% of the starting mass. The carrier tube and perforator fragments recovered from this test are shown in Figure 26. In this figure the metal fragments are once again laid out with the largest in the top left and the smallest in the bottom center of the figure. This figure also includes the various sub 5 g fragments that were recovered from ground zero by magnet in the center of the image. Once again, these fragments were recovered at all distances from ground zero to 400 ft. The recovered pieces of plastic are on the right side of the image.

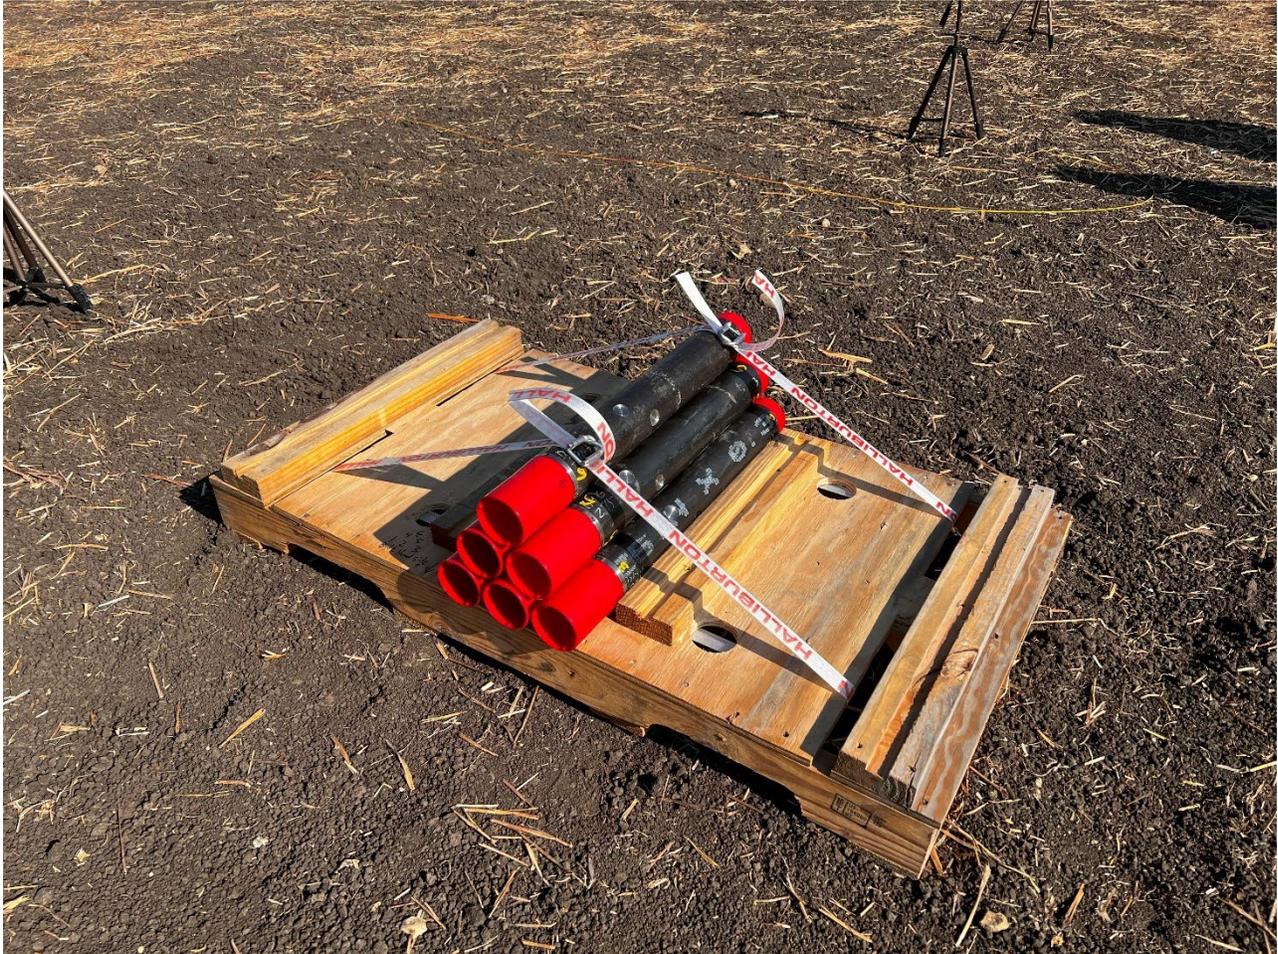
Figure 28: Test 8 Set Up (Multi Gun Test)

was stated in Section 3.2, positioned such that the subs were all facing south; they were not positioned in an alternating “nose-tail” configuration. Furthermore, it is important to note that the guns in this test were all forced to initiate, as this was not a test to see if sympathetic detonation would occur. The JPGs in this test were arranged in a 3-2-1 stack on top of a pallet. Going from west to east, Guns 1 through 3 made up the base of the stack, Guns 4 and 5 were in the middle, and Gun 6 was on the top. Figure 28 depict the test set up for Test 8.

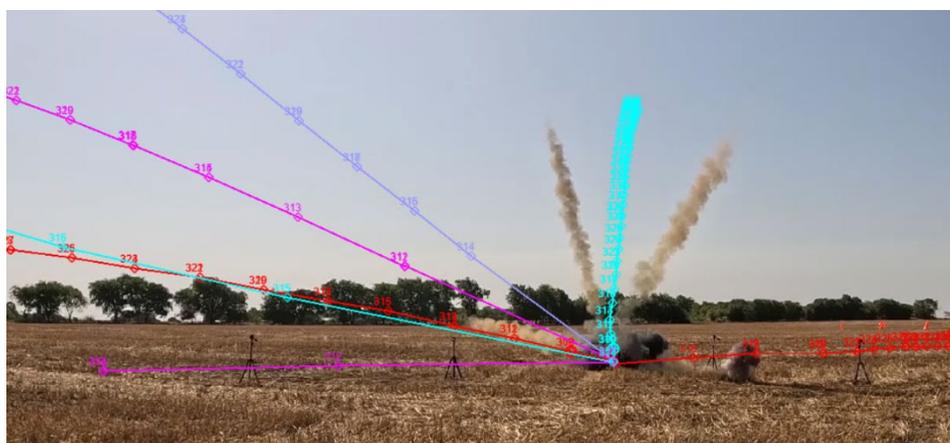
**Figure 32: Test 1 Video Tracking**

Concerning the observed behavior of the fragments that were tracked, most of the fragments appeared to be tumbling, however the gun body showed some interesting behavior. Specifically, the gun body was observed spinning rapidly or “helicoptering” as it traveled upwards, sending smaller fragments in every direction. Figure 32 depicts a sample of the GoPro footage in the tracking software.

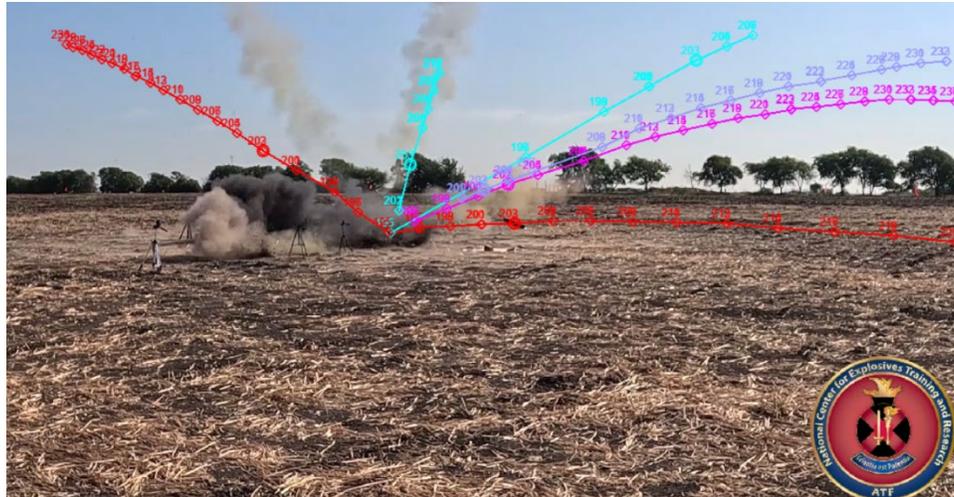
Figure 34: Test 2 Video Tracking

Many of the fragments that were tracked in this test appeared to be tumbling. However, the gun body was observed traveling south with very little tumbling until it impacted the ground around 52 ft away from ground zero and tumbled until it came to a rest around 109 ft away from ground zero. Figure 34 depicts a sample of the GoPro footage in the tracking software.

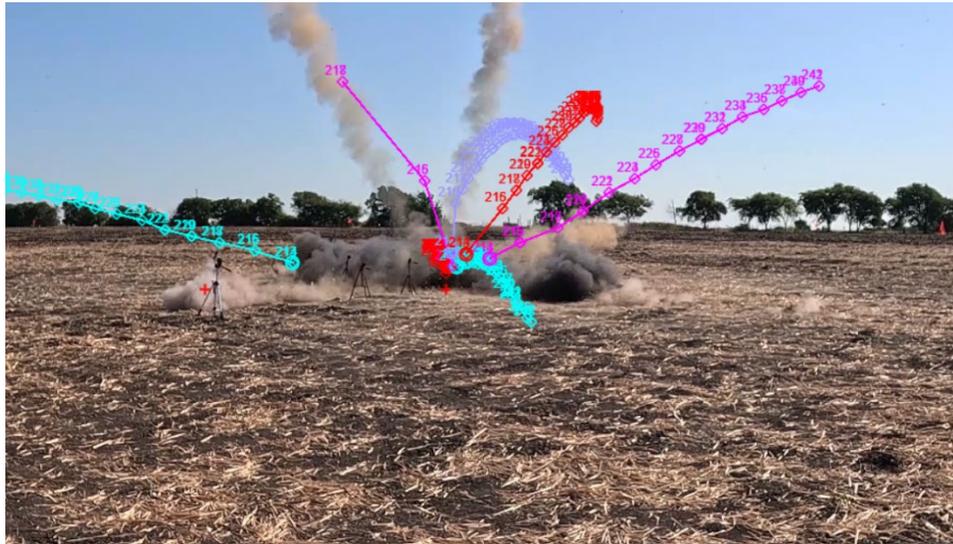
**Figure 36: Test 3 Video Tracking**

Once again, most of the fragments that were observed in this test appeared to be tumbling. The gun body in this test could not be tracked. The gun body stayed very close to ground zero (it was recovered about 2 ft away) and was largely obscured by the gas byproducts and dust from the event. However, the drone footage provides a brief glimpse of how the gun body was behaving. It can be seen spinning in a similar manner to the gun body from Test 1; however, it does not achieve anywhere near the same height. Figure 36 depicts a sample of the GoPro footage in the tracking software.

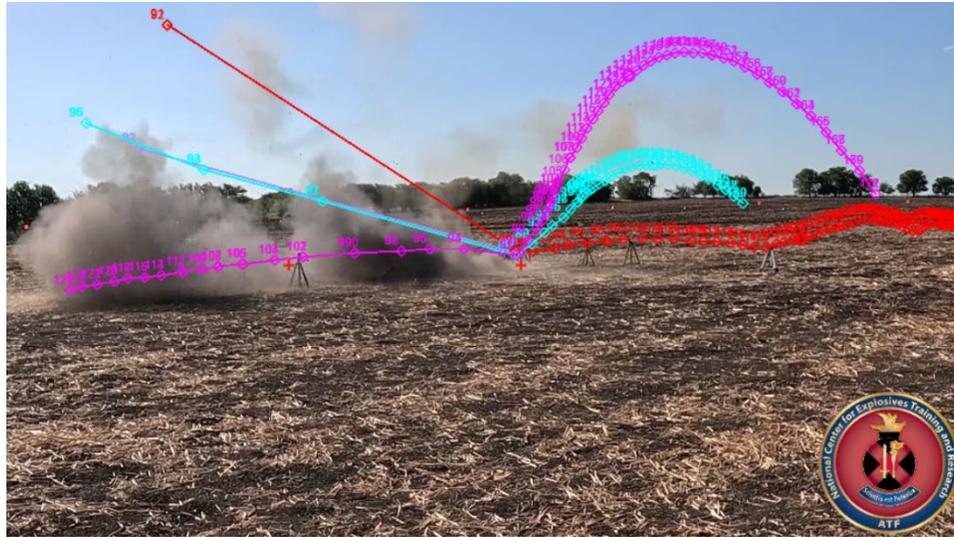
Figure 38: Test 4 Video Tracking

As with the previous tests, most fragments appeared to be tumbling through the air. The gun body was found traveling south slowly spinning vertically in a “tomahawk” fashion. The gun body then impacted the ground and bounced several times, tumbling more erratically each time. Figure 38 depicts a sample of the GoPro footage for this test in the tracking software.

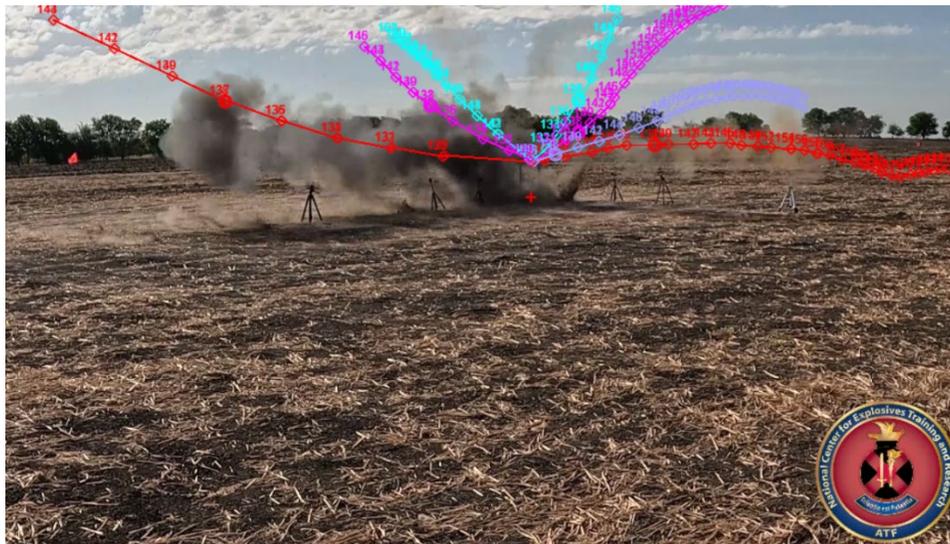
**Figure 40: Test 5 Video Tracking**

Once again, the majority of fragments in this test appeared to be tumbling. The gun body was observed tumbling as it traveled south, even before it first impacted the ground. Figure 40 depicts a sample of the GoPro footage in the tracking software.
