DoD Ergonomics Working Group NEWS

Issue 65, June 2007

Naval Hospital Operating Room: An Ergonomic & Safety Success Story

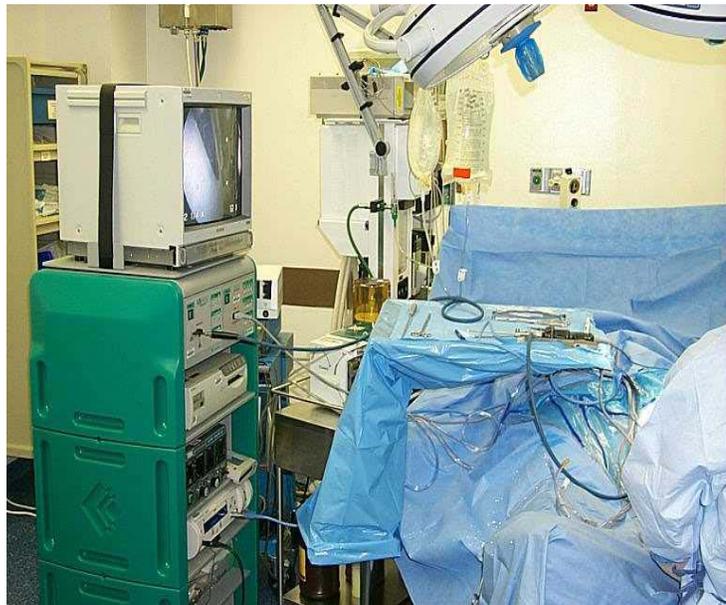
The OR was congested with equipment.

To develop NAVHOSP Rota's recommendations to BUMED, Mr. David Hiipakka, the head of NAVHOSP Rota's Industrial Hygiene & Occupational Health Services, a certified industrial hygienist and Command Ergonomics Team member, conducted a study of the OR, observing numerous surgical procedures. Typical of many ORs, the NAVHOSP Rota OR had become a congested workplace where staff access and mobility were restricted by many pieces of equipment used for diagnostic and surgical procedures. During these procedures, the vast majority of surgical staff and equipment are naturally centered around the operating table and the surgeon. In the NAVHOSP Rota OR, one entire side of the OR table was almost completely blocked by equipment carts, electrical cords, medical gas lines, and other surgical gear.

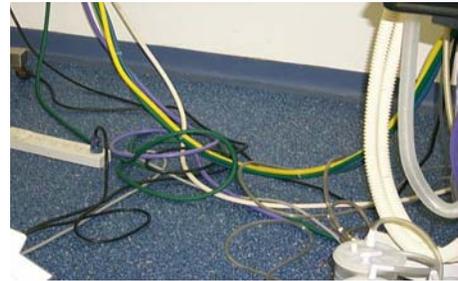
Electrical and gas lines presented a tripping hazard to the OR team.

The crowded working conditions in the OR presented safety issues for the surgical team. For example, electrical cords and gas lines located on the OR floor were a tripping hazard. In addition, surgeons and technicians were in the path of possible exposure to potentially harmful surgical smoke from cauterizing and burning tissue.

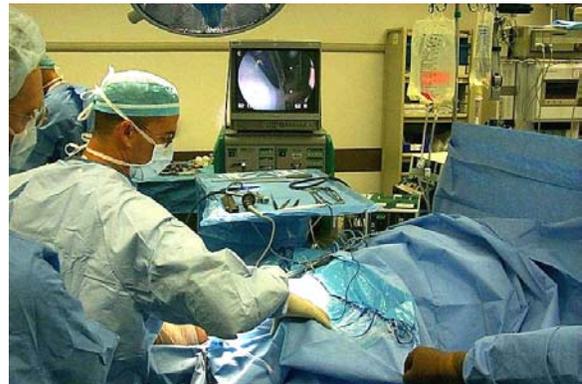
Surgeons and OR staff stand for long hours and adopt non-neutral postures during VES procedures.

- The VES cart blocked one side of the OR table making equipment access and adjustment difficult.
- The distance needed to reach the patient across the operating table created non-neutral working postures.
- While using the VES camera technique, surgeons and OR staff members stood at the operating table for up to 6 hours (more during complicated orthopedic surgery) while maintaining an essentially immobile posture.

Working in the same position, standing for long periods, and/or maintaining non-neutral postures can lead to discomfort of the neck, arms, shoulders, back, knees, and legs. Standing for long periods can also cause pooling of blood in the legs and feet, resulting in aching and fatigue. Frequent, repeated, or lengthy exposures to such risk factors may not allow for adequate rest and recovery of fatigued muscles. When that happens, the worker may develop a work-related musculoskeletal disorder (WMSD)—a musculoskeletal disorder that is caused or made worse by work methods and environment. WMSDs can occur when the physical capabilities of the worker do not match the physical requirements of the job.

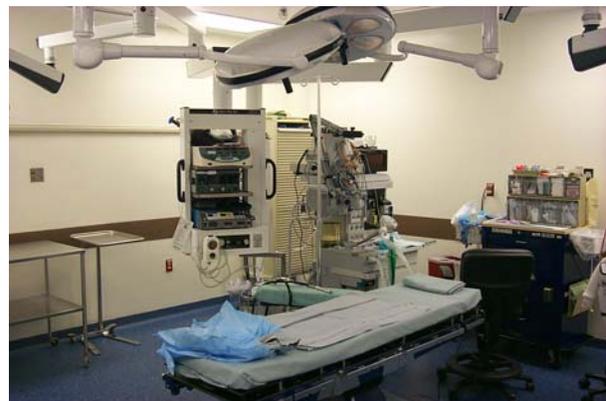
System of ceiling-mounted boom racks and flat-panel video displays located on suspended, swiveling racks reduces clutter in OR and allows surgical team to work in neutral postures.

Based on observations and results of the JR/PD, NAVHOSP Rota’s recommendations for new ergonomically designed OR equipment was validated. This included seating for surgical staff and Skytron equipment carrier racks that would eliminate non-neutral work postures and mitigate the effects of standing for long periods. In the process, potential safety hazards created by cable and gas line clutter and electro-surgical smoke would also be eliminated as these utilities would now be re-routed through ceiling outlets passing through the Skytron system.

The most significant change to the NAVHOSP Rota OR was the installation of the unique *Skytron* system, which allows the myriad of surgical support equipment (e.g., VES cameras, light sources, monitors, surgical smoke evacuators, etc.) to be relocated off the floor onto suspended, swiveling racks. Because equipment and wires are moved off the floor, tripping hazards in the OR have been virtually eliminated.

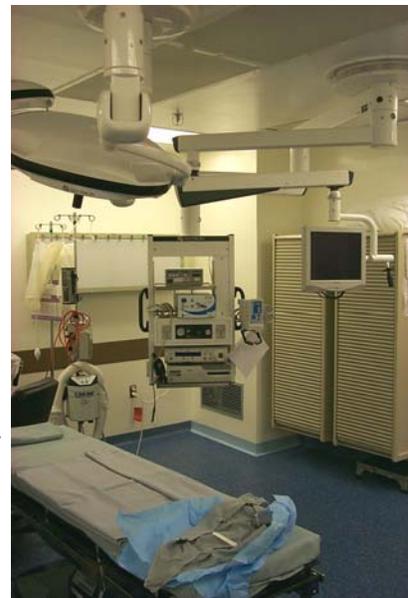
Swiveling racks and height adjustable system eliminate working in non-neutral postures.

The swiveling racks allow lighting and instruments to be moved into positions with a reach of 90 degrees to key target areas via a height adjustable system featuring tethered remote hand controls for convenient up/down placement and operation of equipment per each surgeon’s individual preferences. Thanks to the adjustable equipment shelves allowing 360-degree positioning around the entire periphery of the patient, these features eliminate the need for surgeons and staff to force and contort their bodies around OR gear. *Most importantly, working in non-neutral postures reduces the risk of WMSDs.*

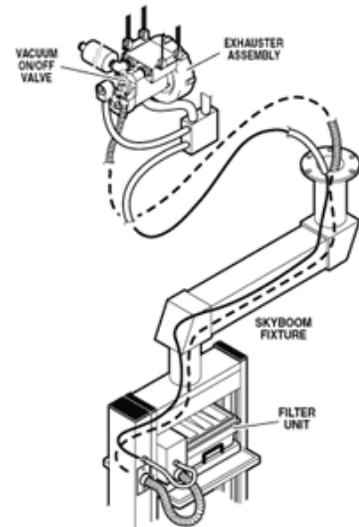
Sky Vacuum captures and removes potentially harmful laser and electro-surgical smoke particles from breathing space of OR team.

The *Sky Vacuum* local exhaust ventilation system was also procured for the NAVHOSP Rota's OR to improve indoor air quality and address the issue of possible pathogenic exposures of the OR staff to potentially harmful electro-surgical smoke. This engineering control is designed to capture and remove potentially harmful laser and electro-surgical smoke particles down to the size of 0.01 microns via its ultra-fine high efficiency filters rated at 99.99994% capture capacity. A side benefit of this filtering system is that it also eliminates odors and contamination typically generated by uncontrolled surgical plumes, while greatly improving vision at the surgical site.
