DoD Ergonomics Working Group NEWS

Issue 108, September 2010

Sierra Army Depot Palletized Loading System Ergonomic Safety Improvement Part 1: The Handle

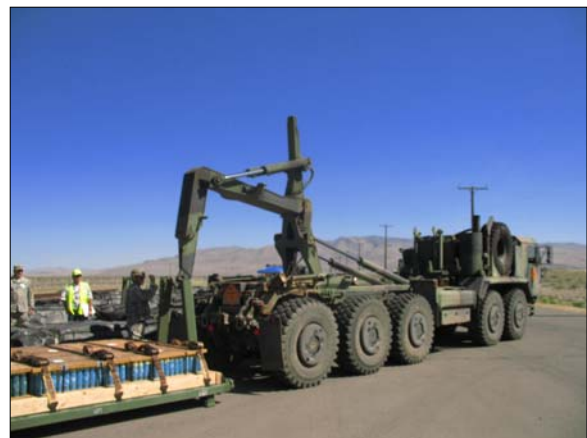
The Sierra Army Depot Safety Office teamed up with members of the 423rd Transportation Company to mitigate hazardous operations on the palletized loading system (PLS). Basic PLS operating functions were dissected and the only real hazard identified was getting up onto the PLS to conduct basic maintenance checks. There were marginal handholds for climbing up to check engine oil, transmission fluid, and coolant level.

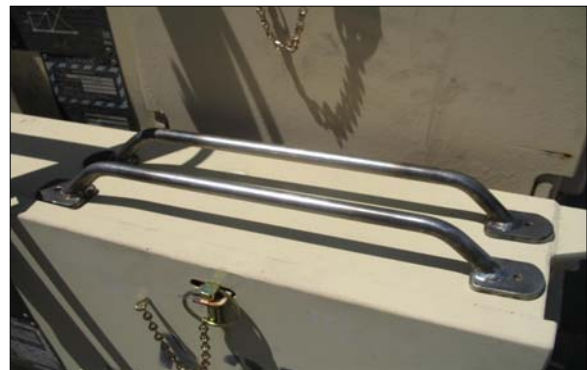
The 423rd Transportation Company Team and the Sierra Safety Team brainstormed the risk and performed a job hazard analysis. The teams concluded that the best ergonomic solution was to install an additional climbing handle on the cooling fan housing. The handle was designed, fabricated, and installed on the PLS at Sierra Army Depot.

Maintenance personnel can now safely use three-point contact when climbing up to conduct service on the PLS.

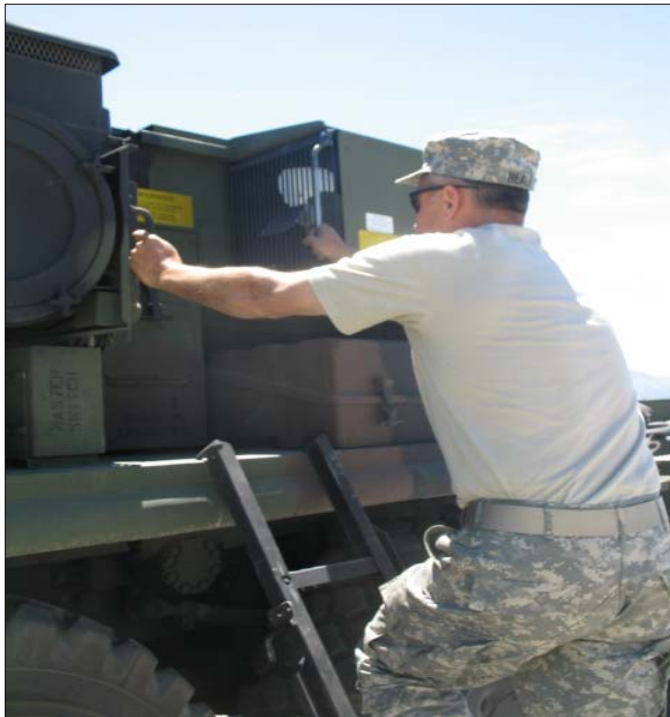
The newly designed safety handle mitigates ergonomic risk factors. It balances body load forces by establishing solid three-point contact when climbing on a PLS to conduct maintenance checks.

The mechanic no longer has to grab the inadequate angled bracket just above the fan blade, which could lead to losing grip and falling.

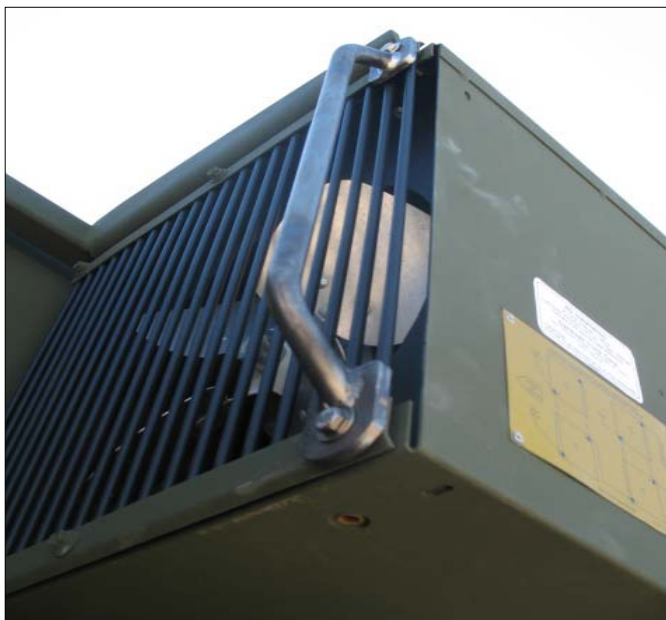
Grabbing the safety handle instead of the angle bracket puts less stress on the wrist tendons when climbing onto the cooling fan housing.

Existing bolt holes were used to avoid extra time prepping and welding on chemical agent resistant coating paint.
