**Department of Defense
Legacy Resource Management Program**

PROJECT NUMBER 16-787

**HISTORIC BUILDINGS AND CONSTRUCTION: A COMPARATIVE
ANALYSIS OF THE DESIGN-BID-BUILD AND DESIGN-BUILD PROCESSES**

SEPTEMBER 2023

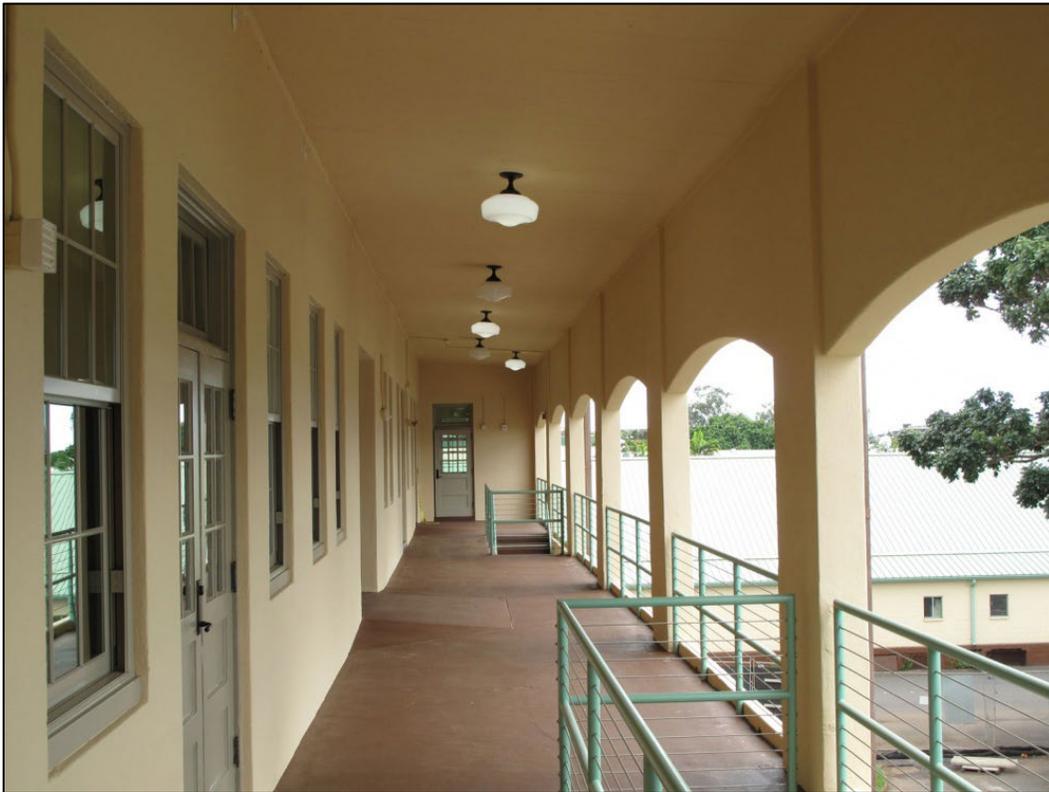
Figure 4. Building 690 showing large windows and balconies for airflow, 2015 (US Army Garrison-Hawaii).

Building 690 at Schofield Barracks is a three-story concrete building constructed in 1929 as a medical staff barracks facility to support the nearby health clinic (Figure 4). It was a DBB rehabilitation project to preserve the 88-year-old historic building while enabling it to continue serving the Army community. Updates to the building included outfitting it with air-conditioning units and interior elevators, while maintaining its architectural features. The Moreton Bay fig tree that had been planted next to the building when it was built in 1929 also remains in place. Its roots had grown into the foundation of the building, but a professional arborist was called in to help cut back the roots and build a root barrier to prevent future damage to the building’s structure. The project won a preservation award in 2017.

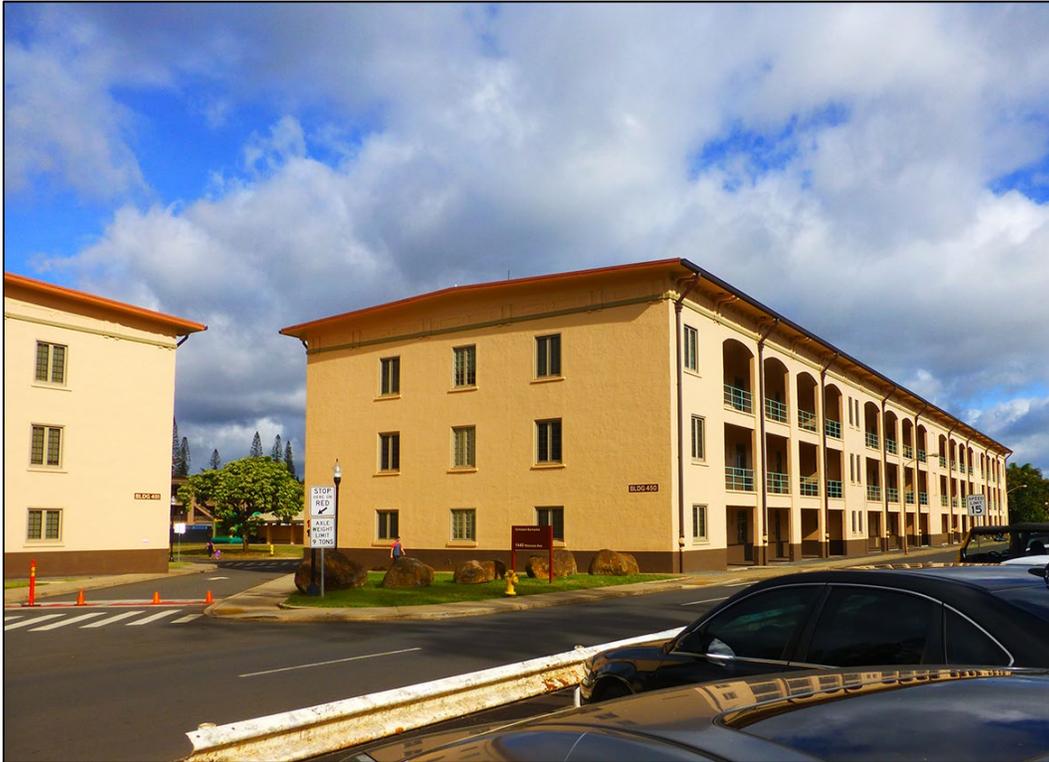
Figure 5. Photograph of Quad D, Building 450, 2016 (ERDC-CERL).

The renovation and upgrades of Quad D, Buildings 450-451 and the surrounding area was a DB project (Figure 5). Project included AC systems, central plant, and upgrades to meet Army barracks criteria including ATRP hardening for close proximity parking. ATRP hardening included replacement of glazing for all exterior windows and exterior glazed doors with laminated glass. The project won a preservation award in 2015.

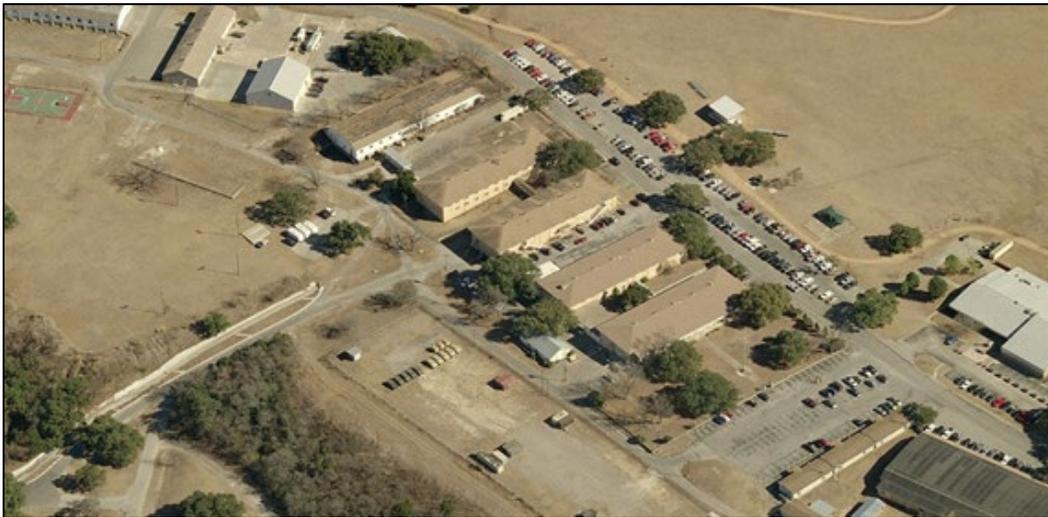
Figure 14. Site location of proposed Building 18 prior to construction [Note WWI-era brick buildings opposite site location. Building 22 is the light gray roof in top left of picture (northeast of site).], 2017 (Texas Military Department).

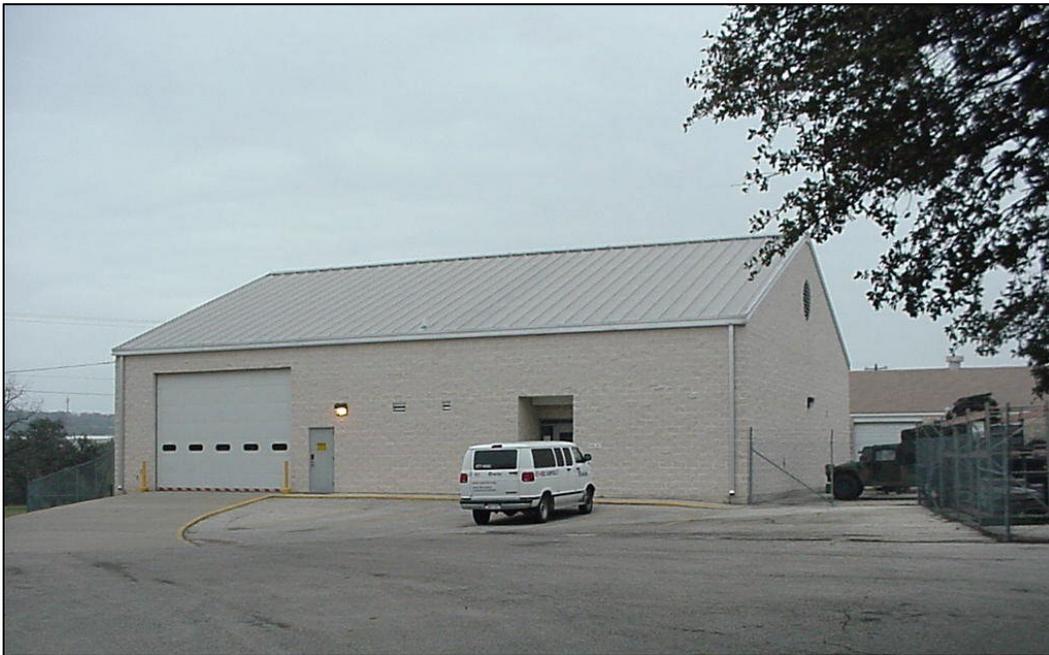
Figure 16. Existing Building 22 (built c. 2001) with split face cast stone walls and metal roof located near APE, 2017 (Texas Military Department).

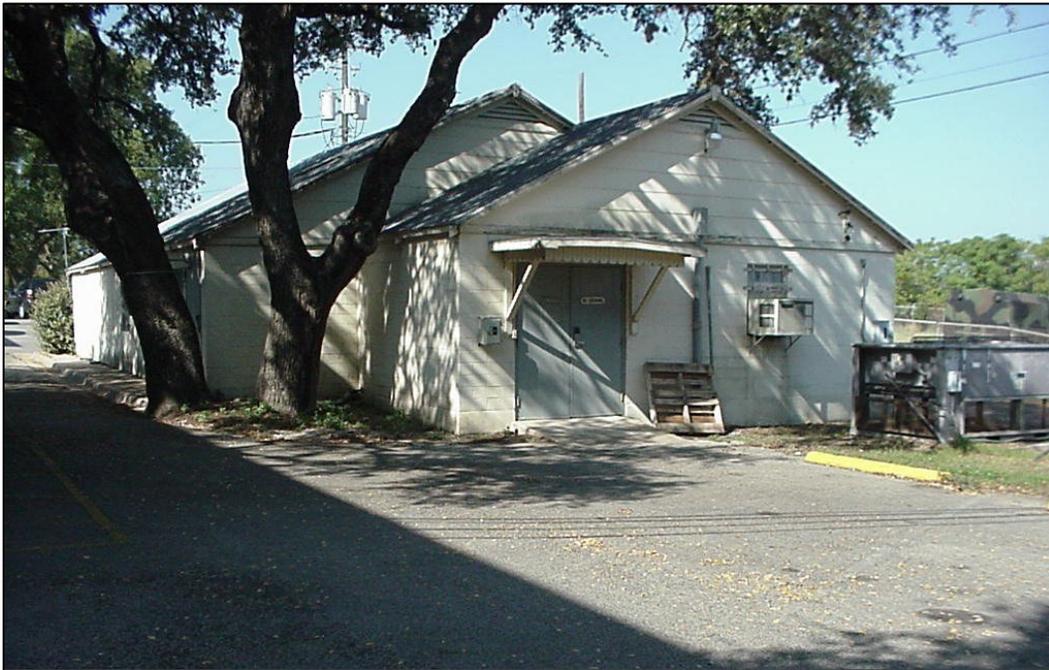
Figure 17. Existing Building 12 (built c. 1942) with CMU walls and metal roof located near APE, 2017 (Texas Military Department).

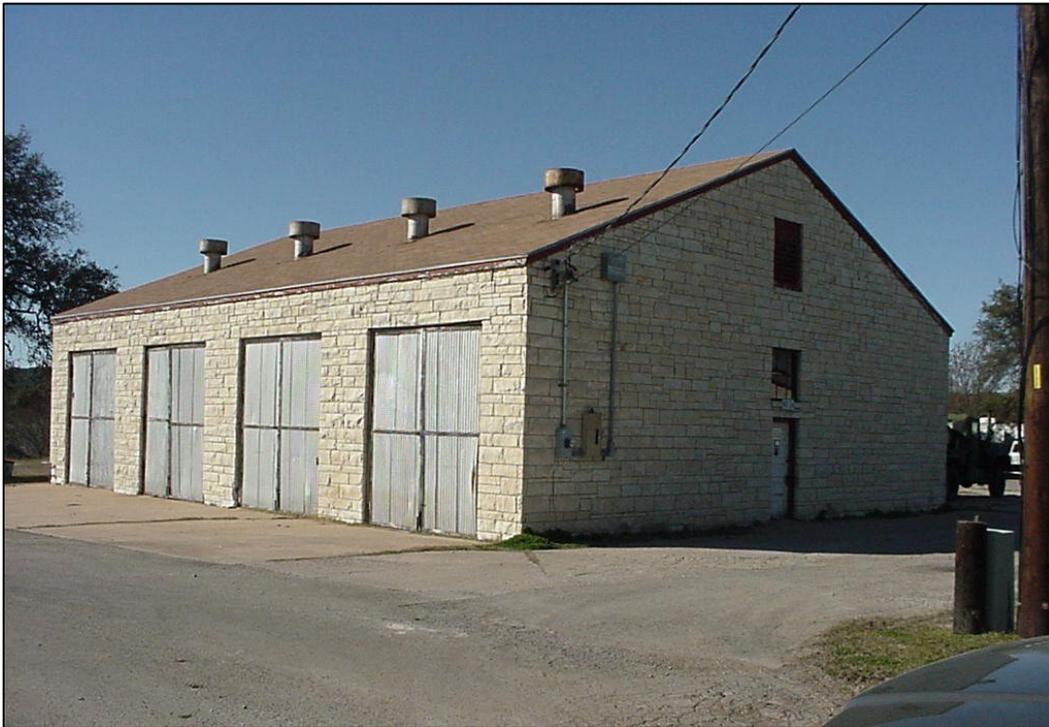
Figure 18. Existing Building 26 (built c. 1942) with limestone walls and shingle roof located near APE, 2017 (Texas Military Department).

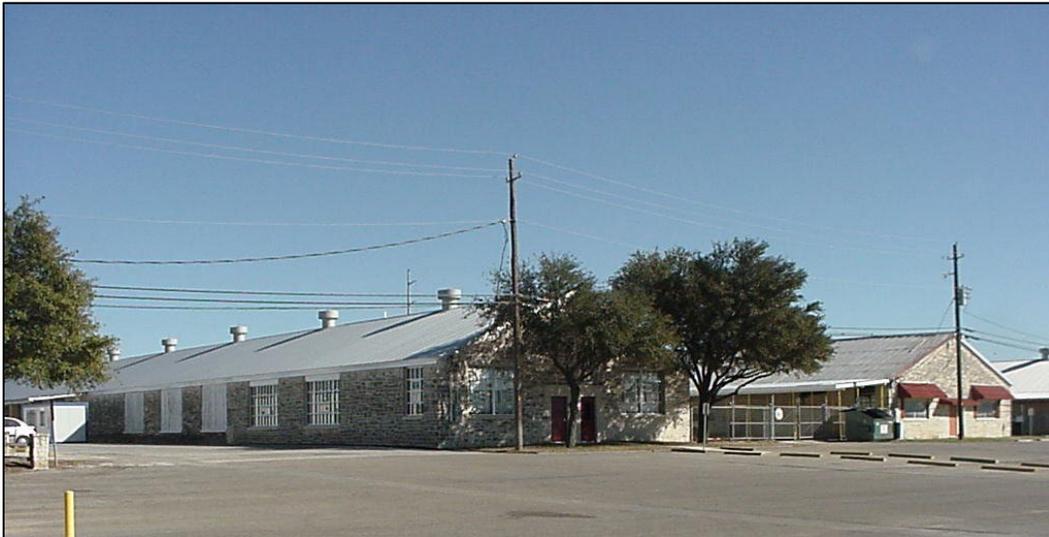
Figure 19. Buildings 35 (1943) and Building 36 (1943) with limestone walls and metal roofs, 2017 (Texas Military Department).

The fenestration on Building 18 takes its cue from the many support buildings in the district. Windows and doors infilled into what is essentially a rhythm of bays. An exact replica of this bay door rhythm as well as the gable roof form is within view of the site, in the form of Building 26 (Figure 18). This motif is predominant throughout Mabry, and many other examples occur around the District and are most evident in the row of 30-series warehouses built in the early 1930s (Figure 19).

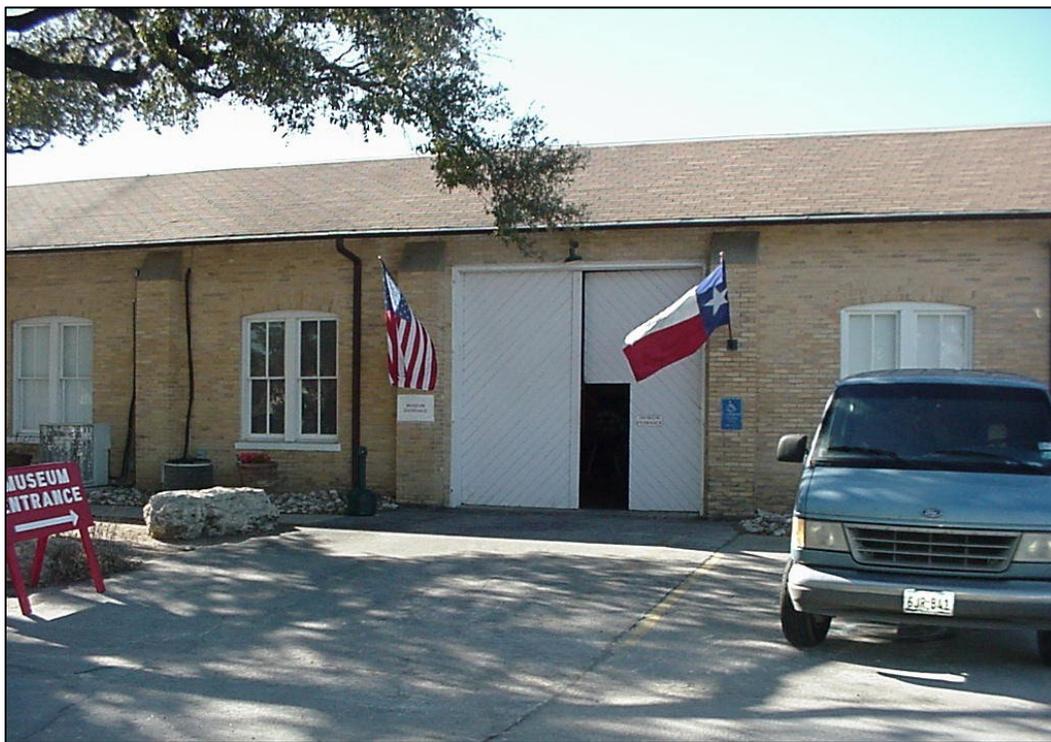
Figure 20. Windows and roof types in adjacent Building 6 (built 1918), 2017 (Texas Military Department).

Where windows occur, they are paired, as is typical on many buildings in the District (Figure 20). The windows incorporated shading devices to comply with current sustainability practices. These would be thin perforated metal shades on galvanized metal brackets reminiscent of many others on the base. The metal brackets would also take their cue from the eave

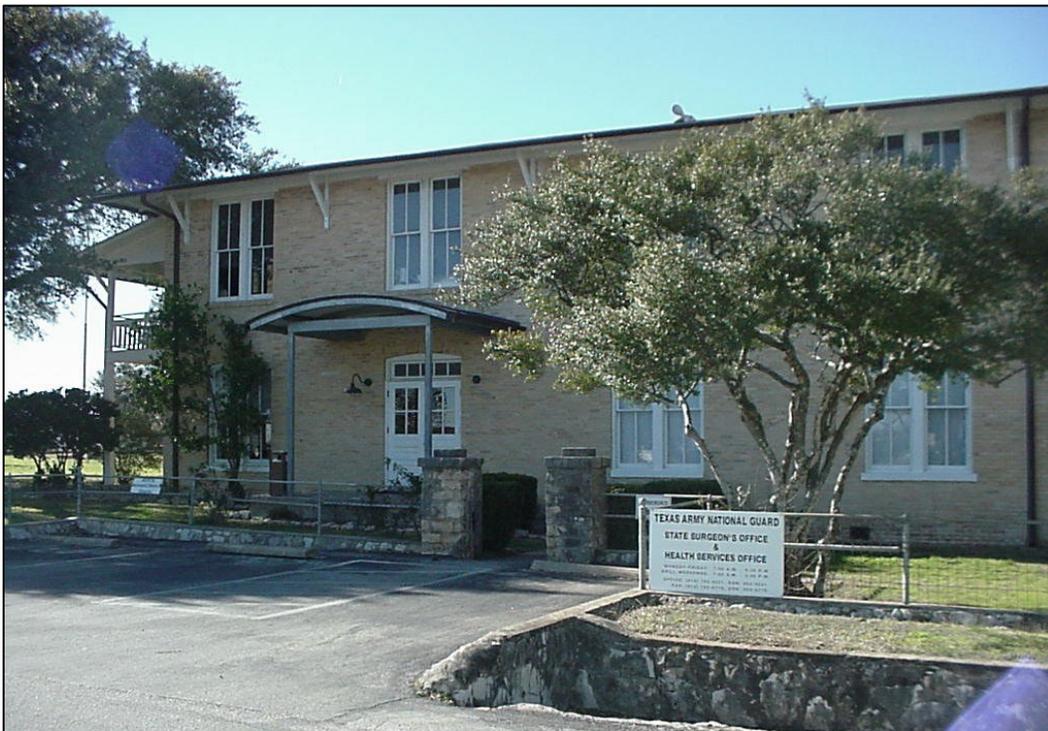
Figure 21. Windows types and entrance in adjacent Building 10 (built 1918), 2017 (Texas Military Department).

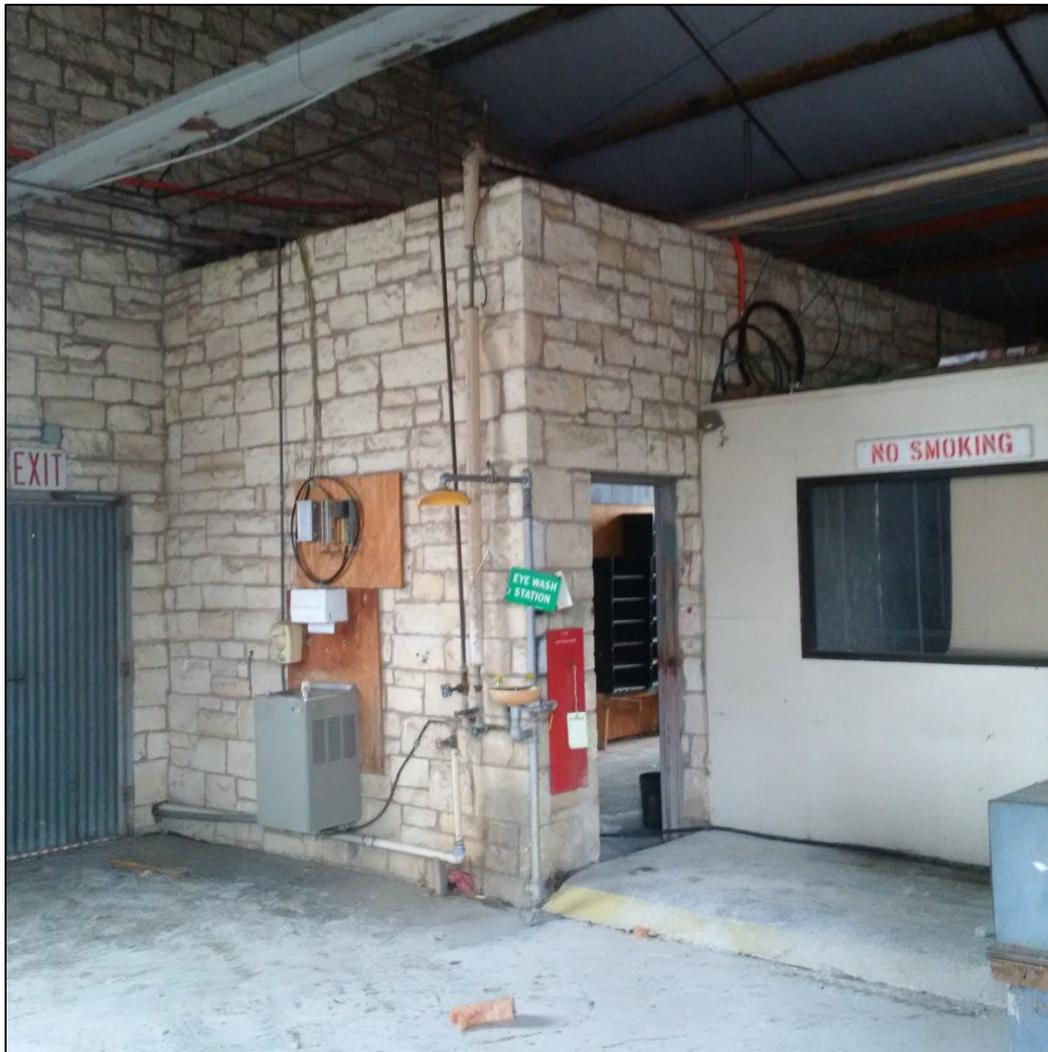
Figure 27. Building 38 prior to rehabilitation showing built in offices abutting historic stonework. These modifications were likely made sometime between 1960s and 1980s, prior to the building's historic designation, 2014 (Texas Military Department).

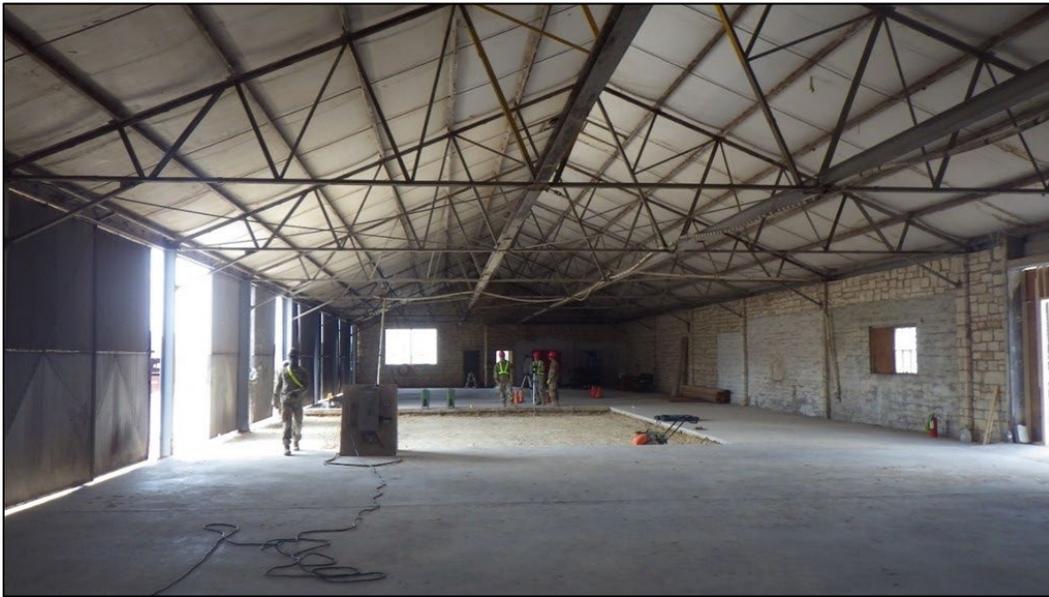
Figure 29. Soldiers from Fort Cavazos (formerly Fort Hood) work to cut foundation after removing all non-historic building interior finishes from warehouse. View to the

west in the approximate vicinity of the former "left" pictured in Figure 24, 2018 (Texas Military Department).

However, as funding constraints and timing for project completion started to present challenges, TXARNG decided to adjust the scope of the troop labor to include additional duties beyond the original demo tasks. The engineer unit from Fort Cavazos (formerly Fort Hood) was soon set to work cutting out foundation slab, removing the historic metal doors and working to frame and drywall the new interior office space (Figure 29). Throughout most of 2018, the unit worked on the building.

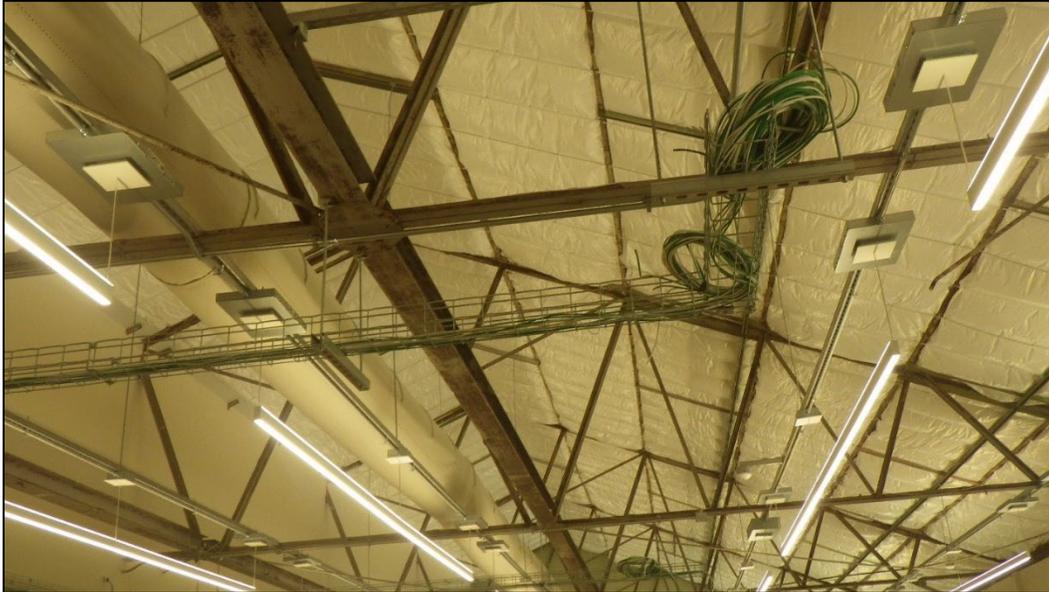
Figure 31. Cable trays for Building 38 were in original design but the connecting posts to bring cables to cubicle drops had to be added when floor outlets were not included in finishing of floors, 2019 (Texas Military Department).

A second problem was encountered as the interior finishes approached completion. An often-overlooked issue in transitioning uses of buildings is the layout and design for communications and networking. In the case of Building 38, the former warehouse was going to become an administrative space for workers. This included enclosed offices along the northern and western elevations, but also a large number of planned cubicles in open areas throughout building. With the fast pace of the DB, there was an omission in design to provide communications and electric drops either in the floor or through ceiling trays to serve the planned cubicle and workspaces. The original 65% design had shown placement of new power poles to allow cable drops down to each cubicle space. However, as the project moved forward, this portion of project was overlooked in midst of other issues.

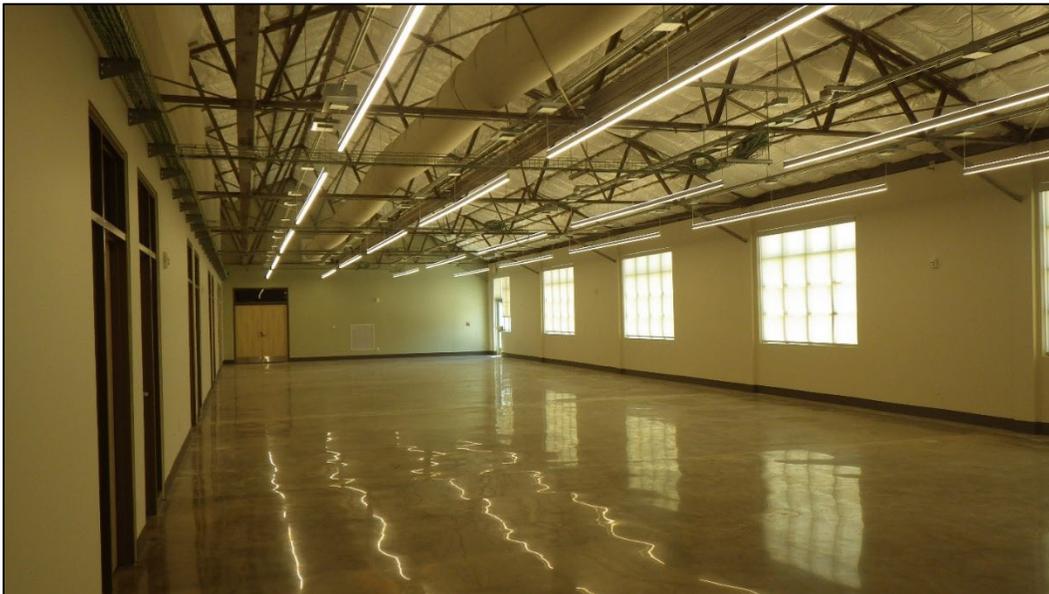
Figure 32. A photo of Building 37, with the finished office space shown and the original historic metal doors mounted back in an “open” position to retain integrity while adaptively reusing the space [Note the absence of floor outlets or posts to provide electrical and communications drop in open space for cubicles.], 2019 (Texas Military Department).

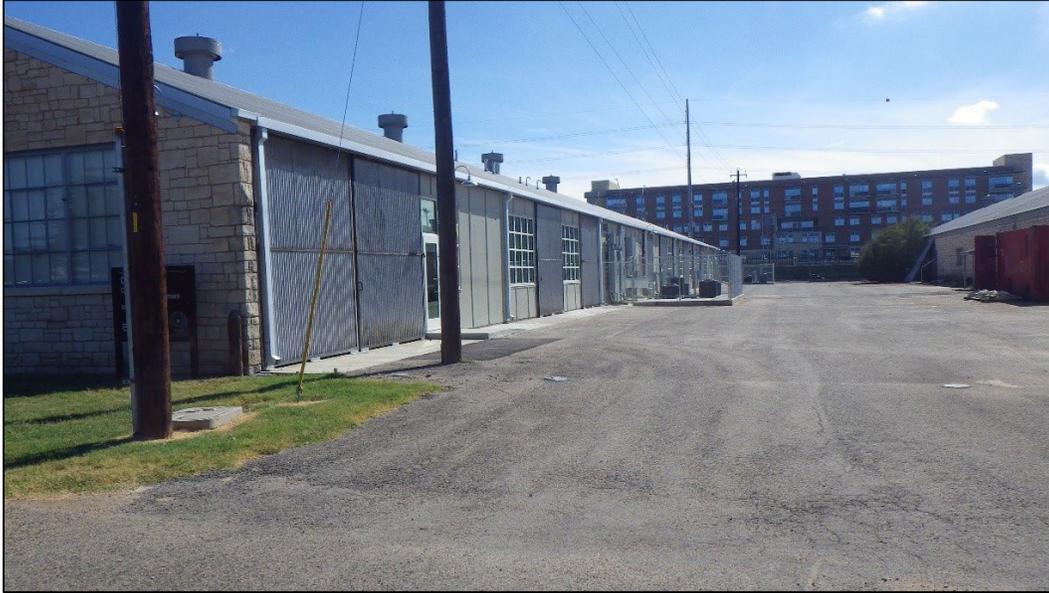
Figure 33. South elevation of Building 38 showing the new wall and windows along with doors in mounted open position to retain historic character. Also note that the far end of building is along a busy highway, so this end of building was designated storage to allow it to safely provide office space to employees in compliance with ATFP standards, 2019 (Texas Military Department).

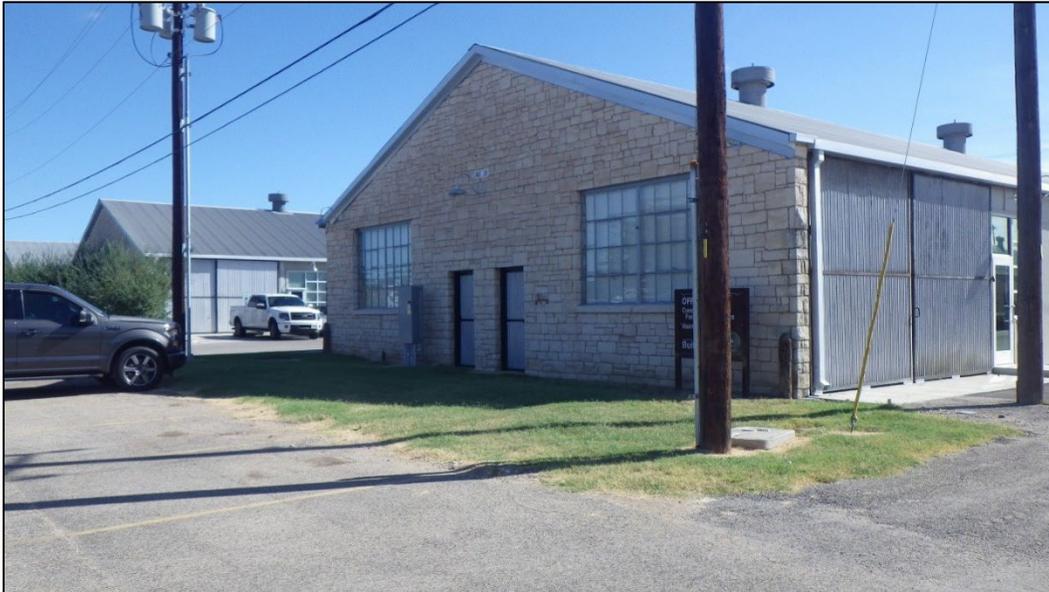
Figure 34. West elevation of building showing the rehabilitated original windows and doors in place. [Note these doors no longer are functional but were left in place to avoid adverse effect to exterior.], 2019 (Texas Military Department).

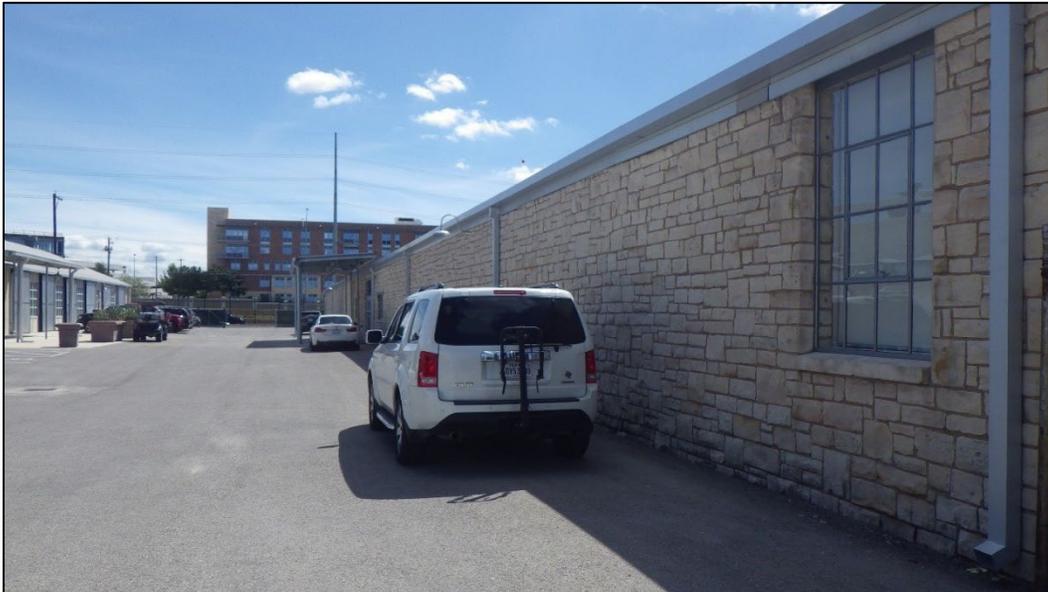
Figure 35. North elevation of Building 38 showing new main entrance for employees in middle of picture. [Note it faces the main entrance of Building 37 for symmetry in visual appearance.], 2019 (Texas Military Department).

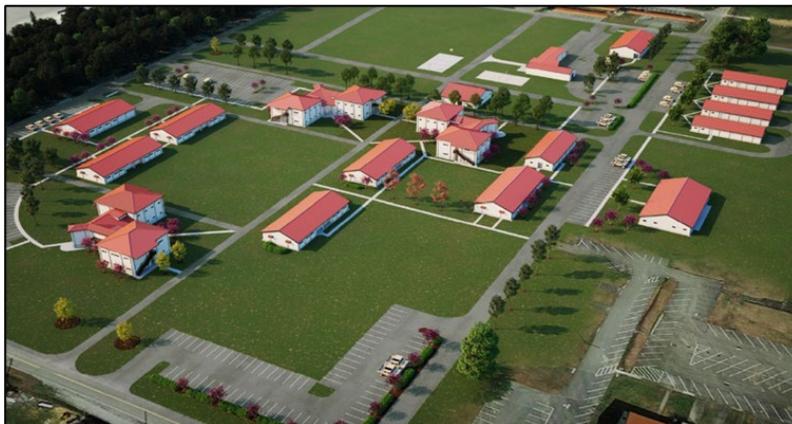
Figure 42. Bird's Eye View, Architect's Rendering of Proposed Enlisted Barracks, Fort McClellan Army National Guard Training Center, Calhoun County, AL (Courtesy of JMR+H Architects).

JMR+H Architect's rendering of a completed barracks building provides a glimpse of the new facilities in the APE (Figure 42). On July 29, 2021, the Fort McClellan Army National Guard Training Center held a groundbreaking ceremony, kicking off a two-and-a-half-year project, replacing 15 WWII-era buildings with three two-story barracks, two single-story barracks, two dining facilities, two company administration buildings, and a battalion headquarters building, totaling 107,812 square feet of new construction with bunk space for more than 350 personnel (Figure 43). In addition to barracks or lodging, this new development will be equipped with laundry facilities, lounges, and Wi-Fi (wireless fidelity) for off-duty hours (Figure 44).

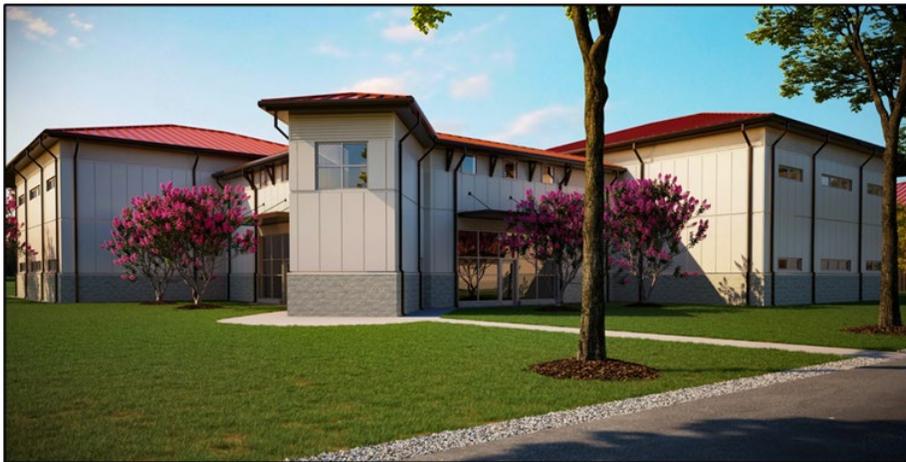
Figure 44. Architect's Rendering of Enlisted Barracks, Fort McClellan Army National Guard Training Center, Calhoun County, AL (Courtesy of JMR+H Architects).

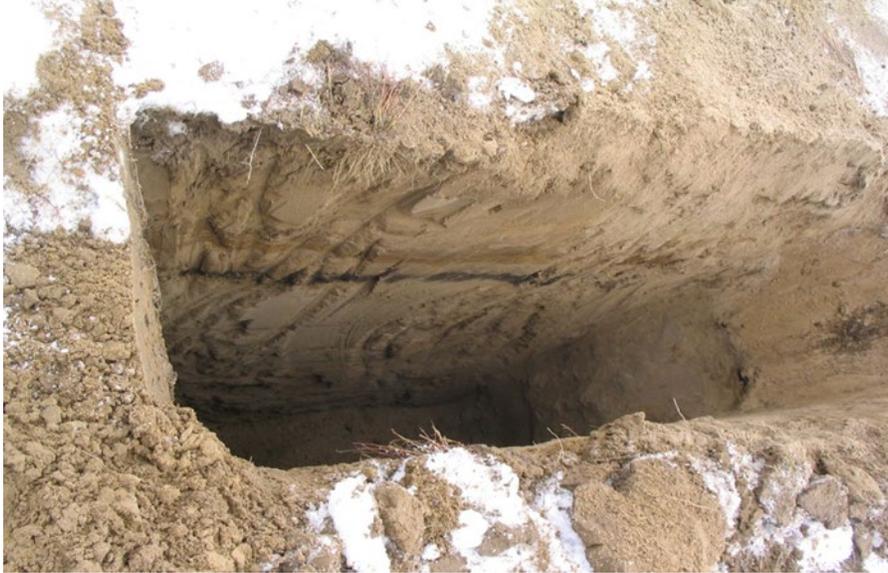
Figure 47, Soil profile for Trench AB 6 showing extensive soil disturbance with no evidence of intact deposition or stratification either above or below the buried A horizon noted (Fort Drum).

Once this footprint was identified, the team decided to test the proposed area using excavation with heavy equipment in order to view soil profiles in order to confirm whether soils had been removed and/or soil depositional integrity had been destroyed. A series of seven test excavations approximately 3-5 m deep and 1-2 m wide were monitored and photographed by the Fort Drum archaeology program coordinator. All the excavations were negative for any type of artifact or feature, and two of the excavations showed extreme soil disturbance (Figure 47).

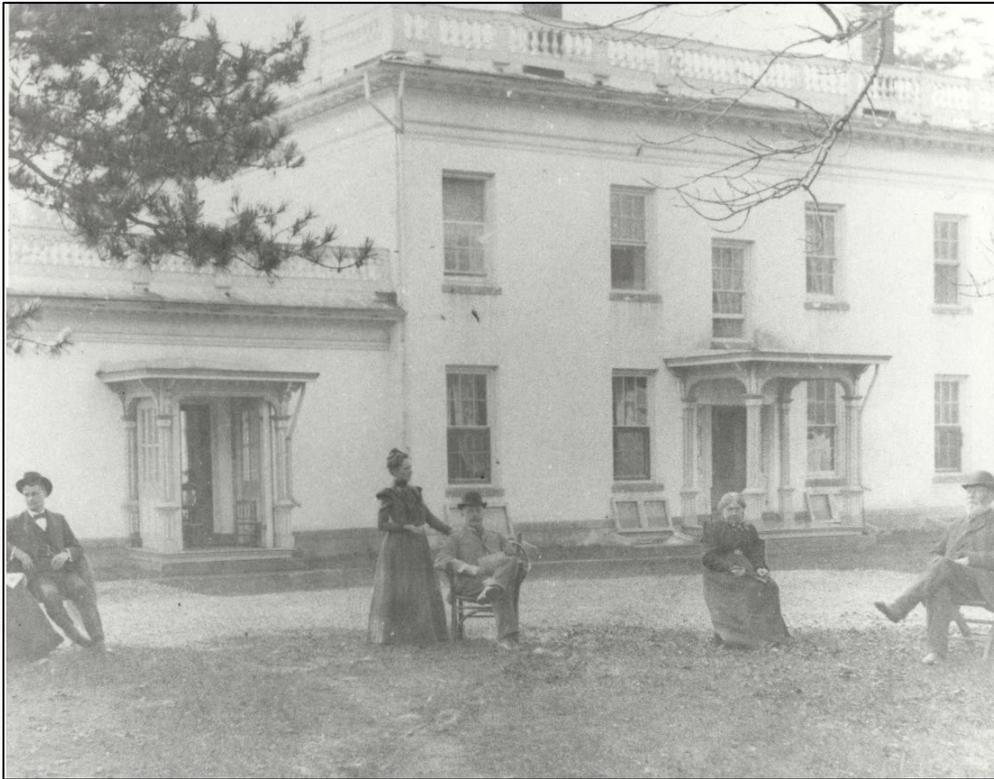
Figure 51. Late nineteenth, early twentieth century view of the north face of the Mansion (Fort Drum). Note gravel driveway or landscaping behind the Mansion guests.

included but is not limited to retrofit of a modern catering kitchen, a comprehensive heating and cooling system, a standing seam metal roof, replacement of two failing columns, installation of a dry pipe sprinkler system, re-plastering, and repair of plaster walls throughout the Mansion, and repair and restoration of chimneys, in addition to exterior improvements like stone steps and walkways. In 2015, the Command Group became concerned about the safety of the stone walkway leading to the formal guest entrances to the structure on the north side after a guest was observed getting a spiked heel stuck in a crack in the limestone. At that point, the walkway consisted of historic limestone blocks approximately 3 ft wide, 4 in. long and 8-12 in. thick. These blocks closely match limestone blocks located in portions of the original basement floor and were assumed to have been quarried from sources of Trenton limestone on the estate. Since that time, thanks to donation of the Harold Remington archives, we have learned that Colonel Harold Remington also salvaged landscape features from an estate in the Mohawk Valley that was being demolished. According to a late nineteenth or early twentieth century photo, prior to installation of the limestone walkway, the north entrance appears to be landscaped with gravel or is serviced by a gravel road so we know that the massive limestone block walkway was not part of the original early nineteenth century LeRay Mansion landscape design plan (Figure 51).

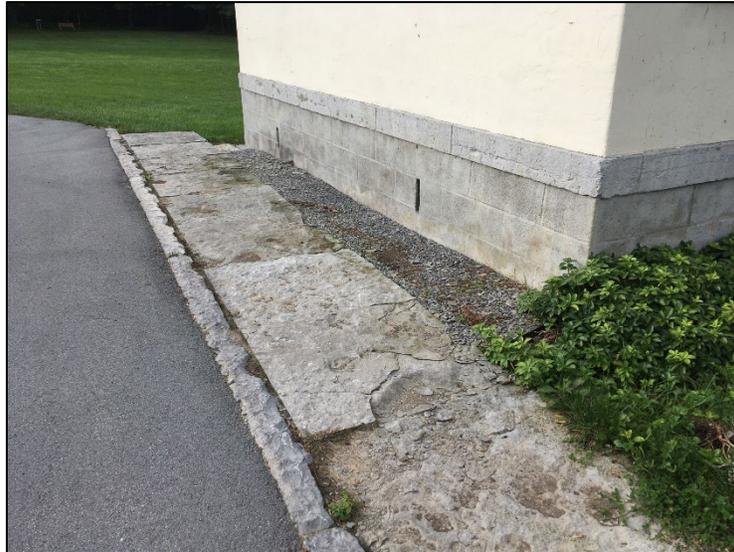
Figure 52. Photograph of Trenton Limestone walkway (Fort Drum). It is clear that the walkway pavers are a good match for the original construction stone of the Mansion. For example, compare the pavers with the run of stone just below the pargeting. In retrospect, the historic limestone blocks we were attempting to replace may have been from a different source. The curbing adjacent to the pavers in this image is made from pieces of the walkway we removed, and the two types of stone are clearly not a perfect match. The curbing has also proven to be extremely durable and is cut stone rather than spalled stone.

It was decided that new walkways would be included in a larger Mansion exterior restoration project that would also include new stone steps for the three north entrances, and a decorative iron railing for the handicapped accessibility ramp. This project was a DB project. The CRM worked with the Preservation Architect to specify that the new walkway should be a replacement in kind of the Trenton limestone blocks that were beginning to crack and that were not perfectly fitted, leaving gaps.

The material provided and installed was indeed Trenton limestone, but unfortunately, it was not a replacement in kind (Figure 52). The limestone pavers were spalled rather than cut and were only approximately two inches thick. They did match the local limestone perfectly, but they began to fail immediately upon installation (Figure 53).

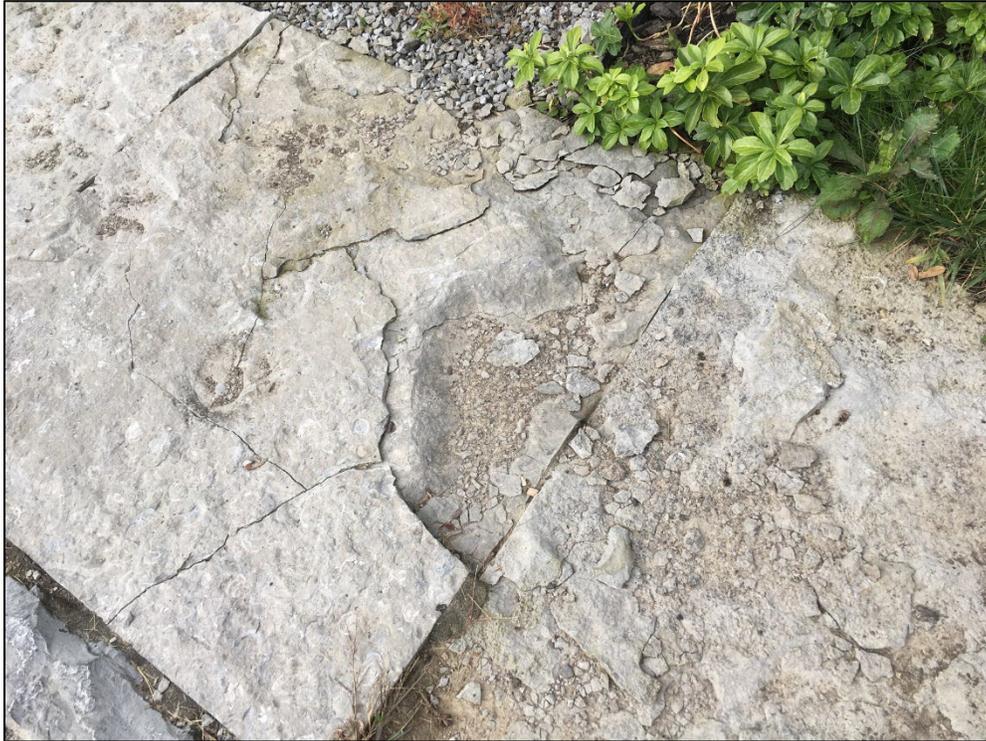
Figure 53. Photograph showing the deteriorating Trenton Limestone pavers (Fort Drum). This material does match our local limestone, but in this form, it is too friable to serve as a walkway. Some of the pavers cracked during installation, others began to deteriorate during the first freeze thaw cycle after installation. Deterioration was exacerbated dramatically by use of de-icing material, but the walkway was too dangerous to be cleared by using only manual snow and ice removal methods.

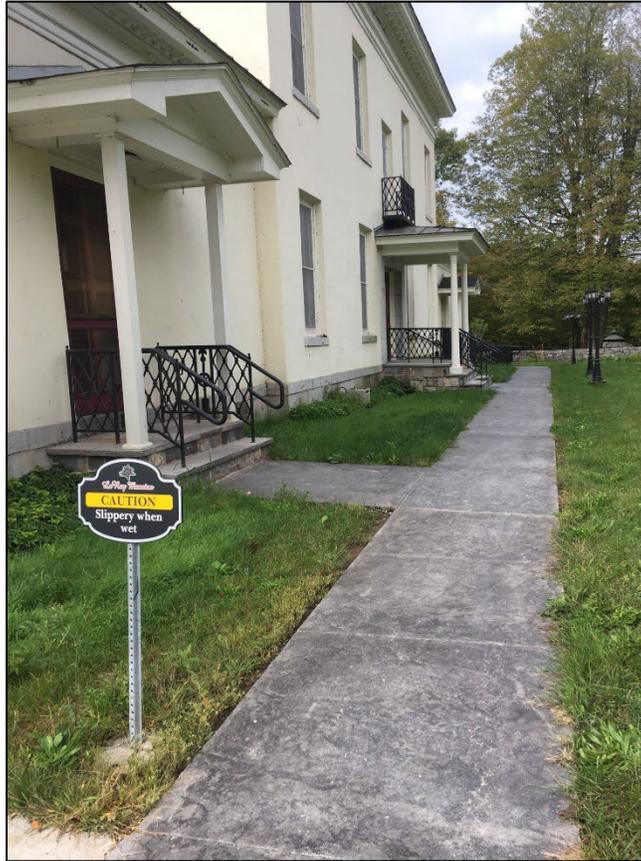
Figure 54. Photograph of stamped concrete walkway (Fort Drum).

Ultimately, it was necessary to remove the spalled pavers, and the decision was made to use stamped concrete. Every effort was made to match the concrete to what an historic limestone walkway is supposed to look like. The stamped concrete was compatible with the surrounding landscape. It is the philosophy of Fort Drum that an historic district requires visitation, use, and appreciation in order to stay alive. One component of that recognition is to make every effort to ensure that visitors are safe and comfortable. As you can see from the sign, the only downside of the stamped concrete is that it is indeed slippery when wet (Figure 54).

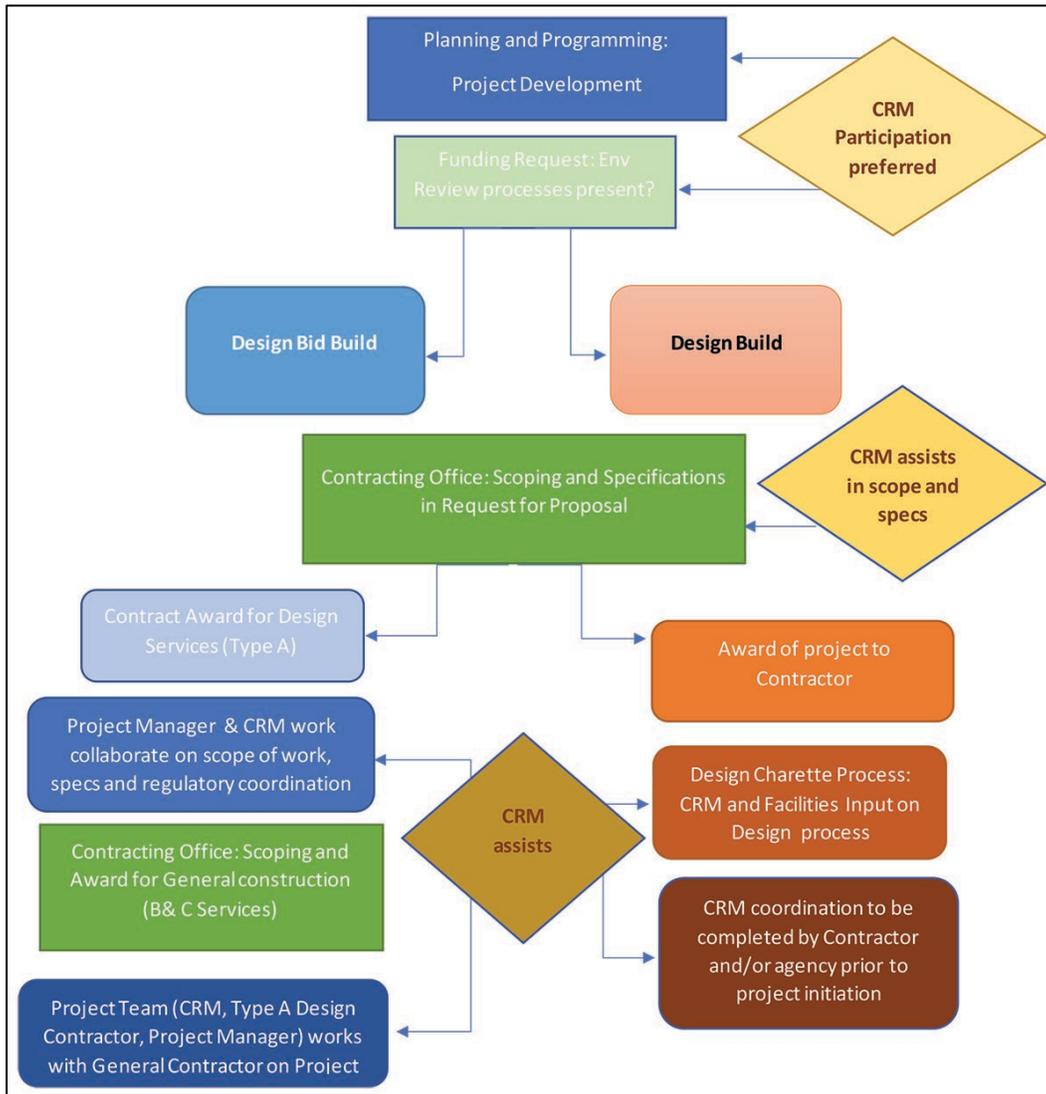
Figure 56. Flow chart of best practices.

Both DB and DBB have their place in military rehabilitation and construction projects, but the installations and the services need to be cognizant that each method has its flaws and holes in regard to the consultation process. Below is a flowchart showing the best steps for the construction process (Figure 40). Nevertheless, for all this to work, everyone at all levels has to be included in the process. The construction organization and the contracting organization cannot work without the CRM. In addition, the CRM needs to work with the contracting officer. The contracting office should never let out a contract that may affect historic properties without consulting the CRM. In addition, the construction and maintenance project managers need to notify and work with the CRM when dealing with historic structures and districts, not only from the compliance perspective under NHPA but also to implement the best solutions to preservation projects.
