USS *Arizona* Memorial

Legacy Resources Managment Fund Project No. 02-170
2002 Annual Report

Submerged Resources Center Technical Report No. 14

Long-Term Management Strategies for the USS *Arizona*: A Submerged Cultural Resource in Pearl Harbor, Hawaii
National Park Service
Submerged Resources Center and USS *Arizona* Memorial
Legacy Resources Management Fund Project No. 02-170
2002 Annual Report

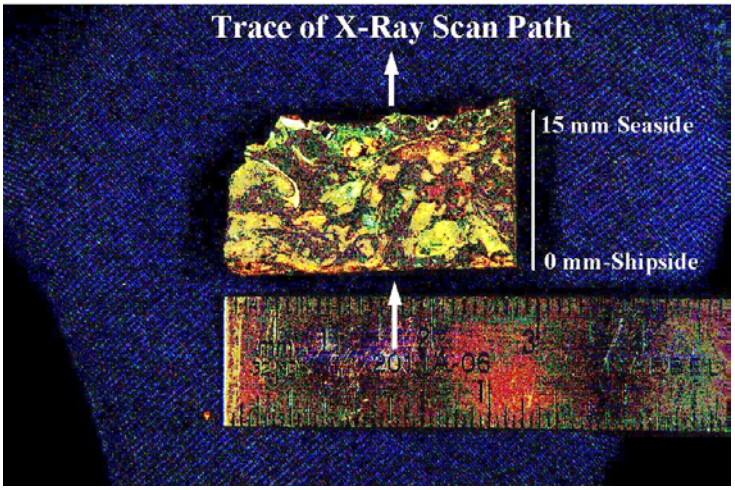
Robert De Angelis from the Air Force Research Laboratory, Eglin Air Force Base, conducted the X-ray diffraction. The thin slice sectioned from the concretion was mounted in a Seimens X-ray diffractometer. The diffractometer was outfitted with a tube containing a copper anode and a graphite beam diffracted beam monochromator. The beam size at sixty degrees two theta was two millimeters by one centimeter. X-Ray patterns were collected over the angular range of 10 to 80 degrees two theta. A measurement was made every millimeter through the thickness of the specimen. The various phases present in the XRD patterns were determined with the aid of Seimens search-match software. Excellent fits to the observed XRD patterns were obtained with the combination of three phases: aragonite, siderite and magnetite. It is apparent that the siderite was the major component in the concretion in the 13 mm of thickness near the ship surface. Aragonite, which was almost absent in the first 13 mm near to the ship, exists in the two millimeters of the concretion to the ocean-side. These were the two major crystalline components found in the concretion. Magnetite was also observed to be present in the concretion. The distribution of magnetite was uniformly low in concentration through the 13-mm thickness from the ship's surface. The magnetite concentration increased in the last two millimeters of thickness.

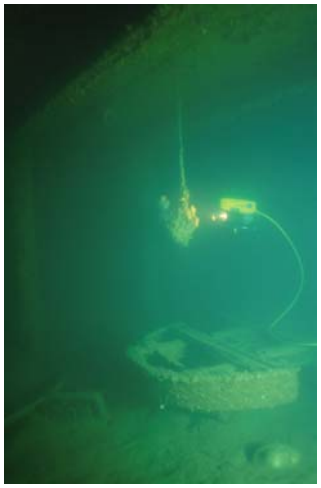
VideoRay ROV investigating the Admiral's cabin

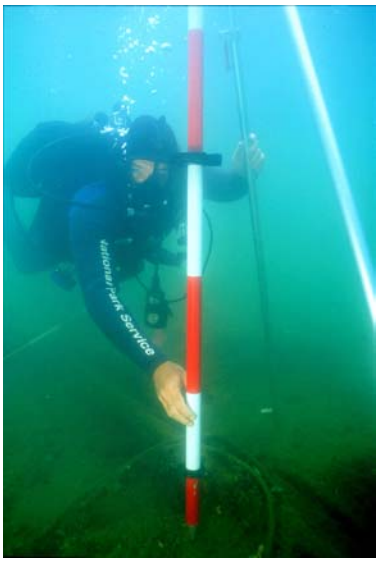
Physical changes to USS *Arizona*'s hull are being monitored using a series of high-resolution GPS points collected on the vessel during June 2001. SRC archeologists partnered with the US Army's 29th Engineer Battalion Survey Platoon, who provided state-of-the-art dual-frequency GPS receivers, to set a series of monitoring points across the *Arizona*. Archeologists set stainless steel studs in selected locations, then leveled a large, underwater tripod, designed by SRC, over each point. Extension poles set on top of the tripod extending above the water's surface allowed the GPS antenna to be placed precisely over the desired point. Using advanced survey techniques, the Army surveyors were able to collect points with sub-centimeter accuracy in three dimensions. These points will be re-surveyed periodically to determine if, and how, the ship is moving, shifting, and settling. In addition to these high-tech methods, structural changes are being monitored using a series of crack monitors normally employed in measuring how cracks are widening on historic building walls. These plastic monitors were affixed over numerous cracks in areas where *Arizona*'s hull seems to be experiencing the most change. The crack monitors are checked periodically to see if the cracks are widening or shifting.

NPS archeologists collecting GPS data with a US Army survey platoon

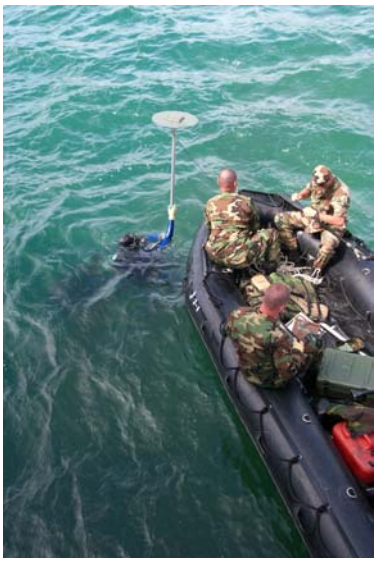
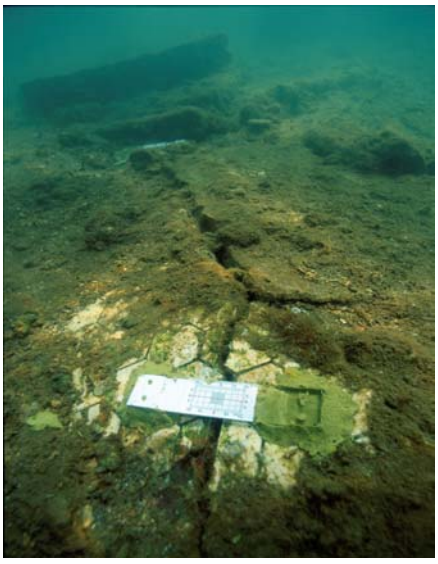
Crack monitors on *Arizona*'s deck
