Long-Term Management Strategies for USS ARIZONA, A Submerged Cultural Resource in Pearl Harbor

NATIONAL PARK SERVICE
SUBMERGED RESOURCES CENTER

SEPTEMBER 2008
THIS REPORT IS APPROVED FOR PUBLIC RELEASE

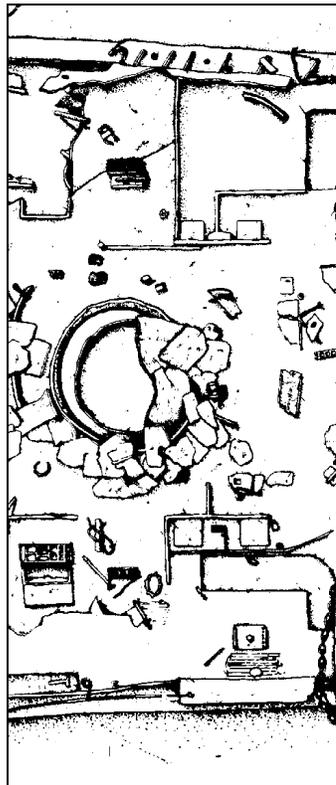
Acting *Arizona* Commander Homann (1942a:2, 1942b:2) who relied on survivors' interviews states in correspondence to the Chief, Naval Operations that "an early bomb hit down the stack and disrupted the fire main and bilge pumps." This is also listed by McClung in a report to the Salvage Engineer (McClung n.d.:1). One of the survivors was Lt CDR S.G. Fuqua, who reported a bomb had gone down the stack, and that it was not known "whether a torpedo hit the face plate of No. 4 turret indirectly" (Fuqua 1941:2). Divers investigating the uptake armor grating in the main deck as far as the wreckage would permit, and the grating was believed to be intact (Paine 1943:5), indicating no bomb went down the stack. Again, like the search for torpedo damage, no damage has been observed by NPS or Navy divers in the deck area around the stack. Based on material evidence, a bomb did not go down the stack and the fire pumps were disabled by the magazine explosion (Figure 3.7).

Figure 3.7. Detail of archeological map of *Arizona* depicting the stack area, with bow to the left (Drawing by NPS-SRC).

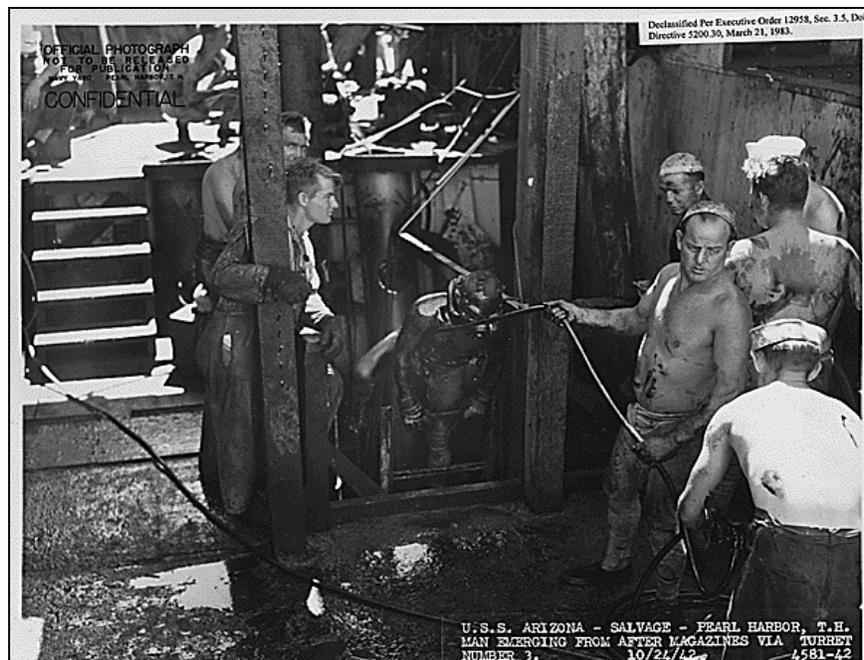
Figure 3.10. Diver emerging from after magazine through turret No. 3 (USS *Arizona* Memorial Archive Photo).

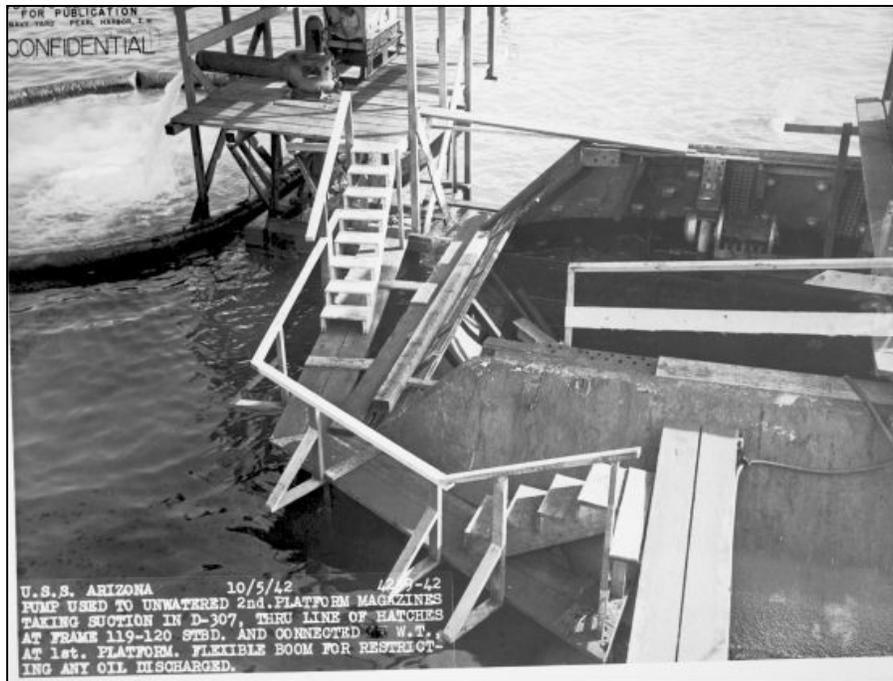
Figure 3.12. Pump and platform used to unwater second platform magazines, Space D-307, Frame 119-120, October 5, 1942 (USS Arizona Memorial Photo Archive).

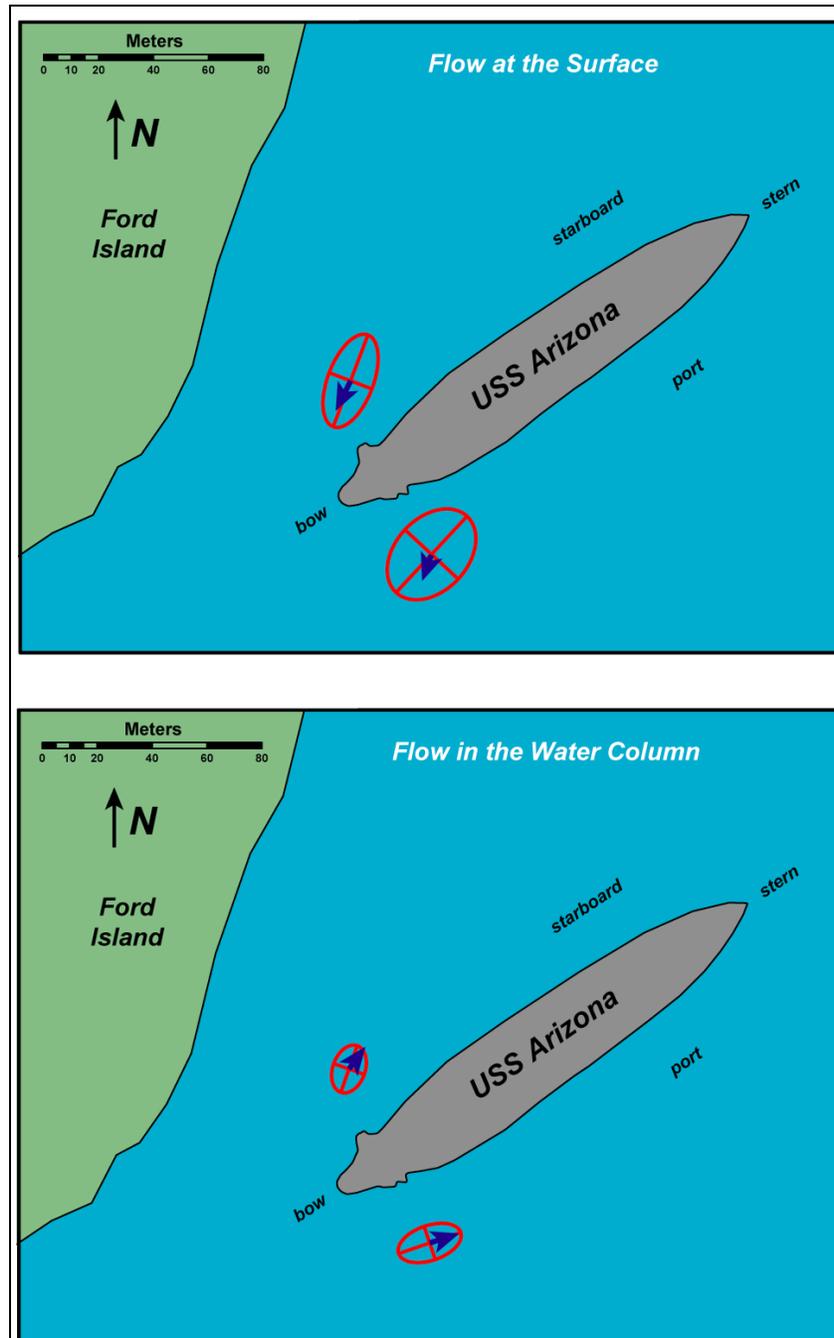
northeast or south-southwest, roughly parallel Ford Island's shoreline in the vicinity of the USS *Arizona*. Off the port side, however, the flow is predominantly oriented east-northeast or west-southwest, roughly parallel to the main trend of the East Loch of Pearl Harbor. These differences in orientation imply steering, not only by the bathymetry, but also by the USS *Arizona*'s hull (Figure 4.6).

Figure 4.6. The orientation of mean flow and its variability in the water column adjacent to the *Arizona*. **TOP:** Flow at the surface. **BOTTOM:** Flow in the water column. The red ellipses denote the magnitude of major and minor axes of variability in flow; the blue vectors denote the magnitude and direction of mean flow. Note that surface flow is stronger and oriented to the southwest while flow within the water column is weaker and is oriented to the northeast. Off the starboard side, the flow is predominantly oriented north-northeast or south-southwest, roughly parallel Ford Island's shoreline; off the port side, however, the flow is predominantly oriented east northeast or west-southwest, roughly parallel to the main trend of the East Loch of Pearl Harbor.

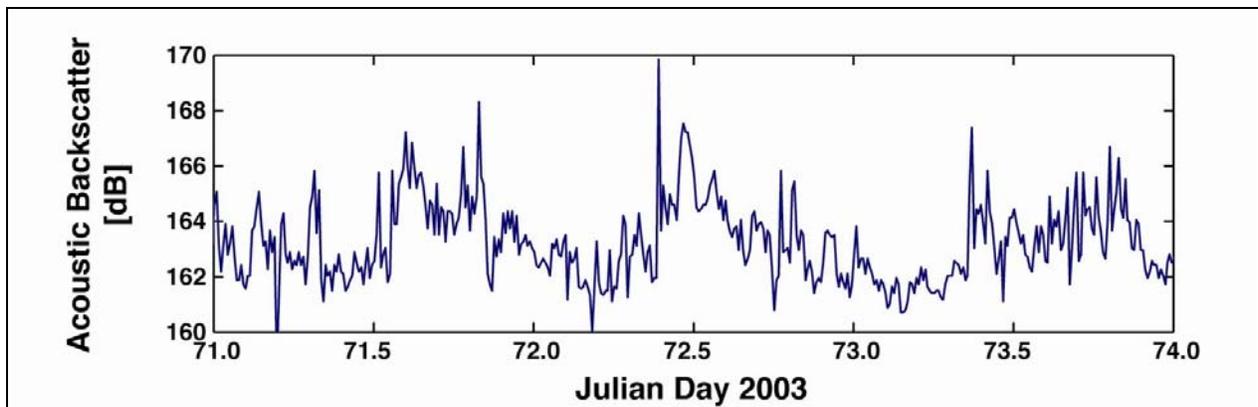
and the lowest during the summer months. This peak in acoustic backscatter suggests that wintertime phenomena causes increased particulate matter concentrations in the area around USS *Arizona*. Potential reasons for this increase in backscatter include: precipitation and runoff in other regions of Pearl Harbor that would introduce fine-grained particulate matter into the harbor that is advected into the area around *Arizona*, or nutrients introduced into Pearl Harbor from runoff might cause algal blooms that increase acoustic backscatter.

Acoustic backscatter was generally higher when the flow was to the south, likely caused by fine particulate matter being drawn down from the shallow regions of the northern half of the harbor. Acoustic backscatter also appeared to slightly increase during the early to mid-afternoon and decrease through the night (Figure 4.8); this suggests that either: (a) daily insolation-induced Trade wind intensification during the day creates larger Trade wind-driven waves that suspend more fine-grained sediment that is then advected by the sensor, or (b) more vessel traffic and prop wash during the day in the harbor tends to suspend more of the fine-grained bed sediment, which settles during the evening and night when vessel traffic subsides. We do not have information at this time that indicates which process or combination of processes is responsible for the observed intensification of acoustic backscatter during either the wintertime or in the afternoons and evenings.

Figure 4.8. Typical acoustic backscatter data from USS *Arizona*.

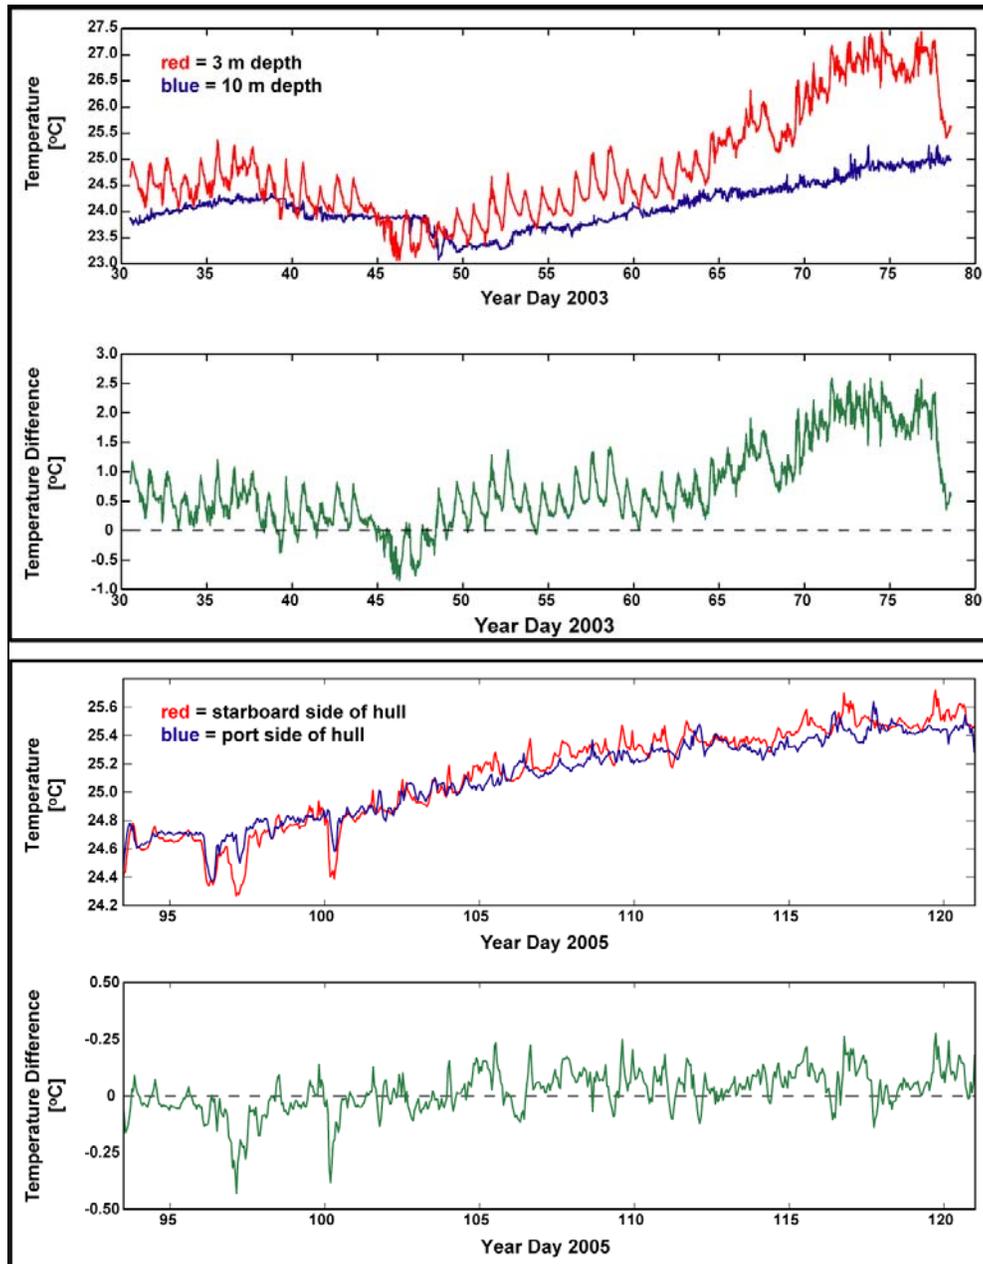
Along the 10-m isobath, the variability in water temperature was greater off the starboard (northwestern) side of the hull between the USS *Arizona*'s hull and Ford Island. In general, the near-bed water off the starboard (northwestern) side of the hull was slightly (0.02 ± 0.10 °C) warmer than off the port (southeastern) side of the hull (Figure 4.10). The greater stability off the port (southeastern) side of the USS *Arizona*'s hull is likely caused by greater mixing due to currents, which act to minimize temperature fluctuations caused by insolation or submarine groundwater discharge. We do not have information at this time that indicates that these processes are the cause of the temperature differences between the two sites.

Figure 4.9. Differences in water temperature around the USS *Arizona*. TOP: Near-bed (10 m) and near-surface (3 m) temperatures and the resulting thermal stratification. BOTTOM: Concurrent water temperatures off the port and starboard sides of the hull and the resulting thermal gradient. While both the port and starboard temperatures both follow the same long-term trends, note the greater fluctuations in water temperature off the starboard side; this likely results from less mixing of the water column off the starboard side.

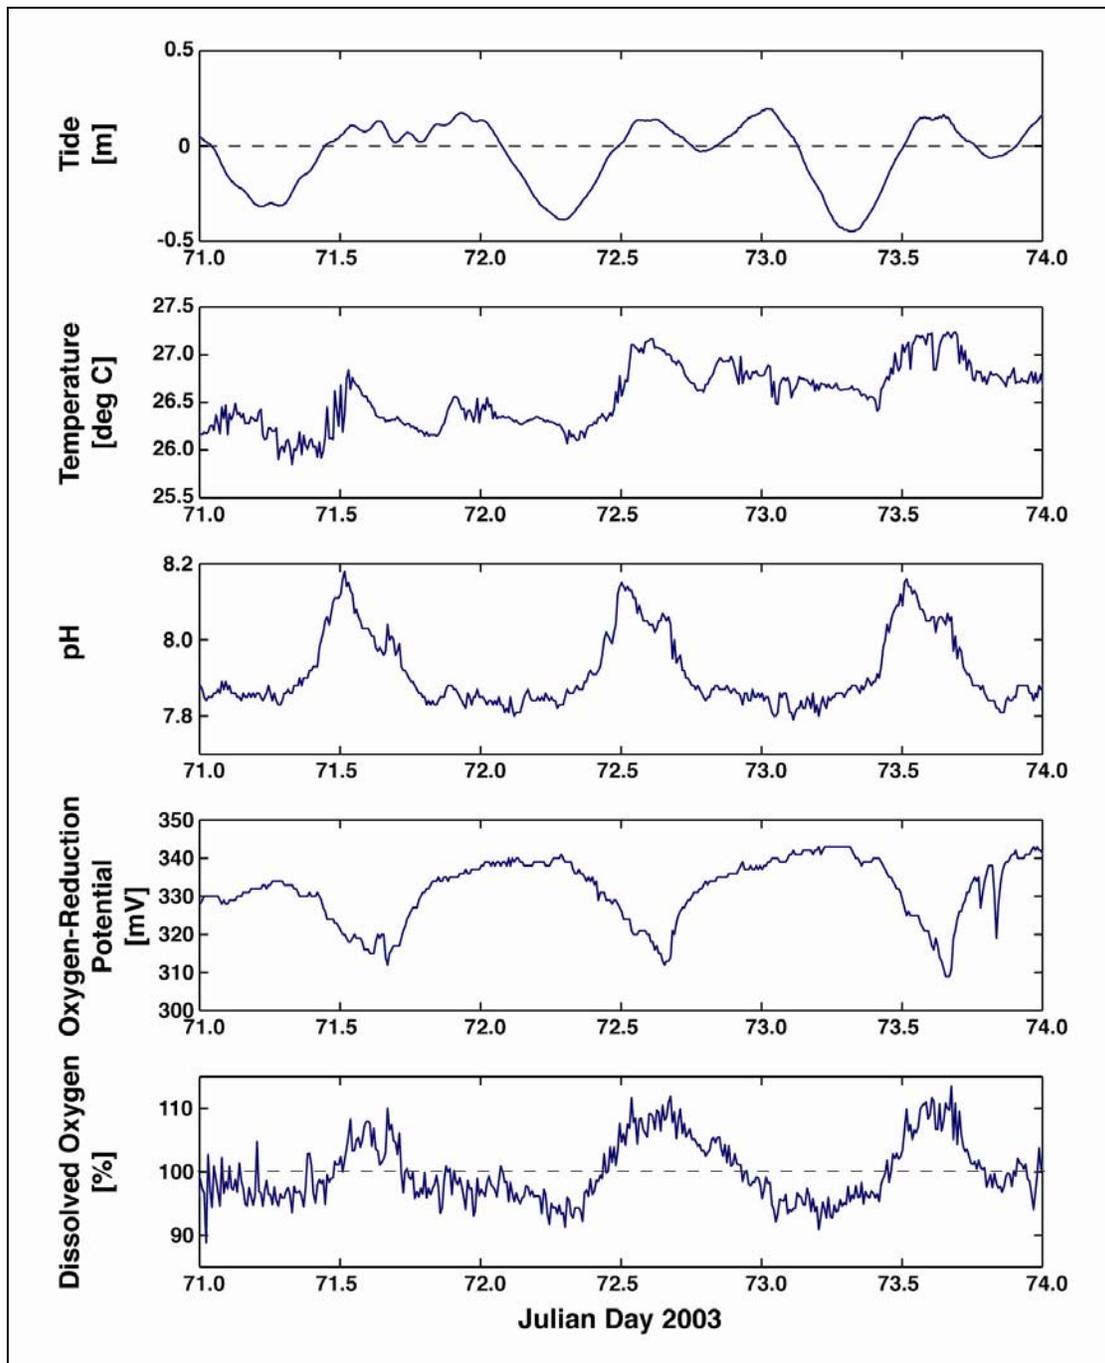
Over the period of study, the oxygen-reduction potential at the site along the 3-m isobath ranged between 150.0 mV and 397.2 mV, with a mean oxygen-reduction potential \pm one standard deviation of 289.2 ± 50.6 mV. Oxygen-reduction potential had an *inverse* relationship with pH and the percentage of dissolved oxygen during the summer months, with oxygen-reduction potential decreasing during the daytime and increasing into the night, attaining its greatest values just before sunrise. However, during the winter months when temperature and salinity were more variable, oxygen-reduction potential had more variable *positive* relationship with pH and the percentage of dissolved oxygen, suggesting that changes in salinity due to precipitation and/or submarine groundwater discharge might be impacting the data (Figures 4.10 and 4.11).

Figure 4.10. Graphic illustrating positive correlation between tide, temperature, ph, and dissolved oxygen; and an inverse correlation with oxygen reduction potential on the USS *Arizona* over a several day period.

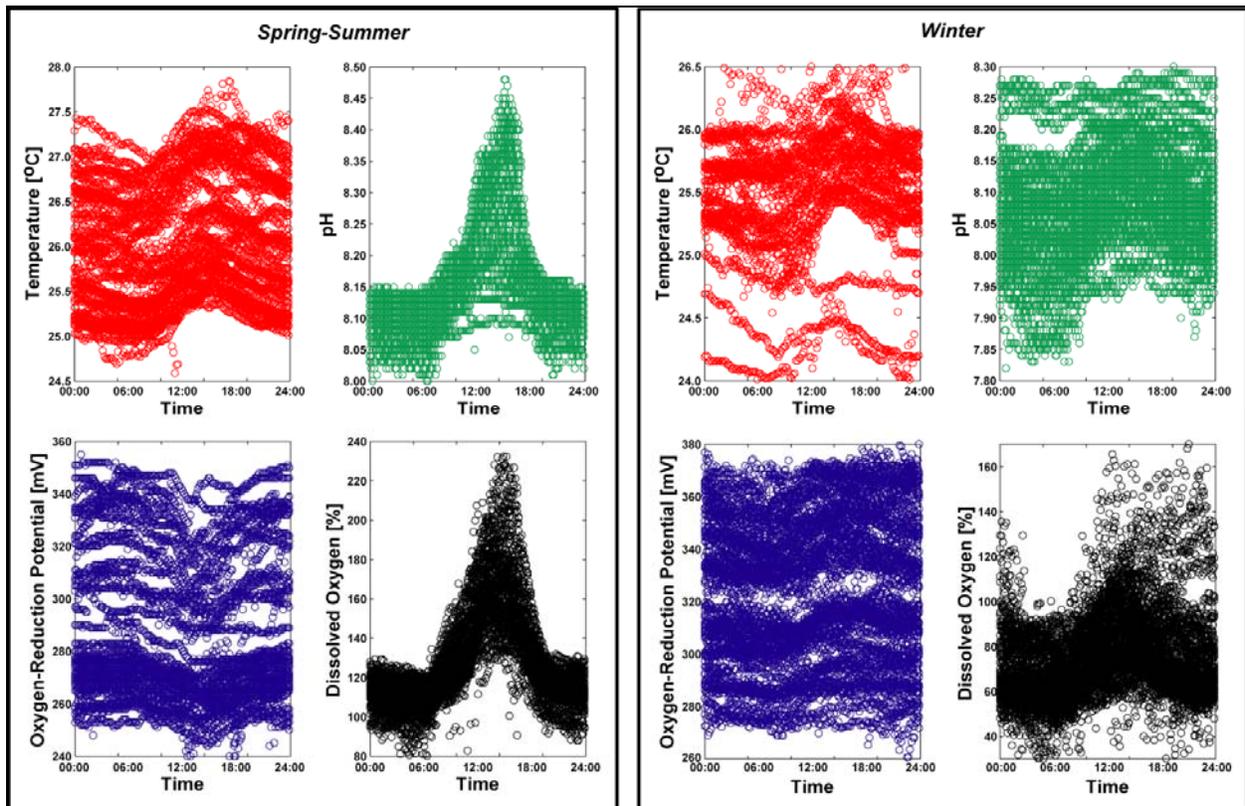
Over the period of study, the dissolved oxygen levels in the water at the site along the 3-m isobath ranged between 0% and 288.5%, with a mean dissolved oxygen level \pm one standard deviation of $69.5 \pm 58.8\%$. Similar to the pH levels, most variability in dissolved oxygen levels is at daily timescales; dissolved oxygen tends to rapidly increase at roughly 09:00 each morning, peak around 13:00, then decrease down to nominal levels by 21:00 (Figures 4.10 and 4.11). This daily increase of 5-20% suggests that dissolved oxygen levels at *Arizona* are related to daily

Figure 4.11. Phasing of pH, oxygen-reduction potential and dissolved oxygen relative to the time of day. These plots show how pH, dissolved oxygen and oxygen-reduction potential increase towards early afternoon and decline through the night into the early morning.

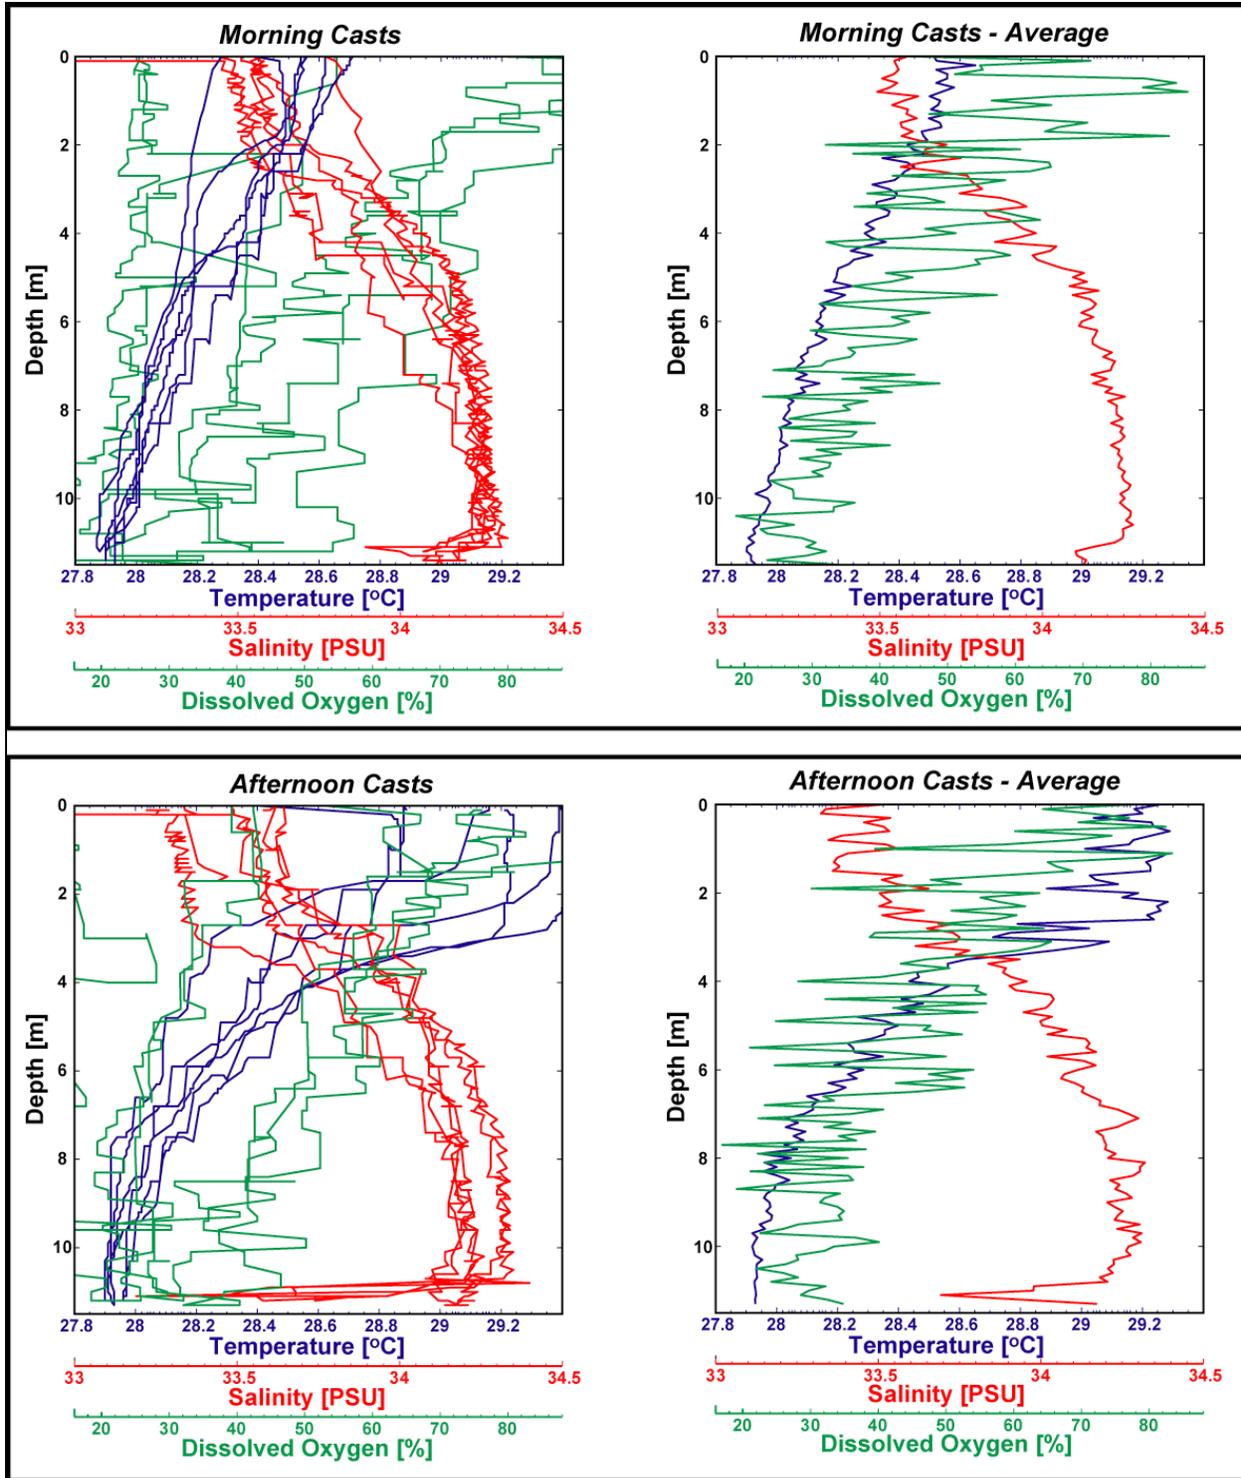
The temperatures during the vertical profiles taken in the early morning varied between 27.83 °C and 28.72 °C, with the near-surface temperatures on average roughly 0.74 °C warmer than the near-bed temperatures. The salinities during these profiles varied between 33.47 PSU and 34.38 PSU, with the near-surface temperatures roughly 0.79 PSU less saline on average than the near-bed salinities. The dissolved oxygen levels during these profiles varied between 15.3% and 91.2%, with the near-surface dissolved oxygen levels on average roughly 41.1% higher on average than the near-bed dissolved oxygen levels (Figure 4.12). The temperatures during the

vertical profiles taken in the late afternoon varied between 27.85 °C and 29.51 °C, with the near-surface temperatures roughly 1.32 °C warmer on average than the near-bed temperatures. The salinities during these profiles varied between 33.21 PSU and 34.35 PSU, with the near-surface temperatures roughly 0.91 PSU less saline on average than the near-bed salinities. The dissolved oxygen levels during these profiles varied between 11.7% and 104.4%, with the near-surface dissolved oxygen levels roughly 46.6% higher on average than the near-bed dissolved oxygen levels (Figure 4.12).

Figure 4.12. Vertical profiles of temperature, salinity and dissolved oxygen off the USS Arizona dock. These plots show how these parameters vary vertically from just below the water’s surface down to the sea floor and how the vertical variation in these parameters changes over the course of a day.

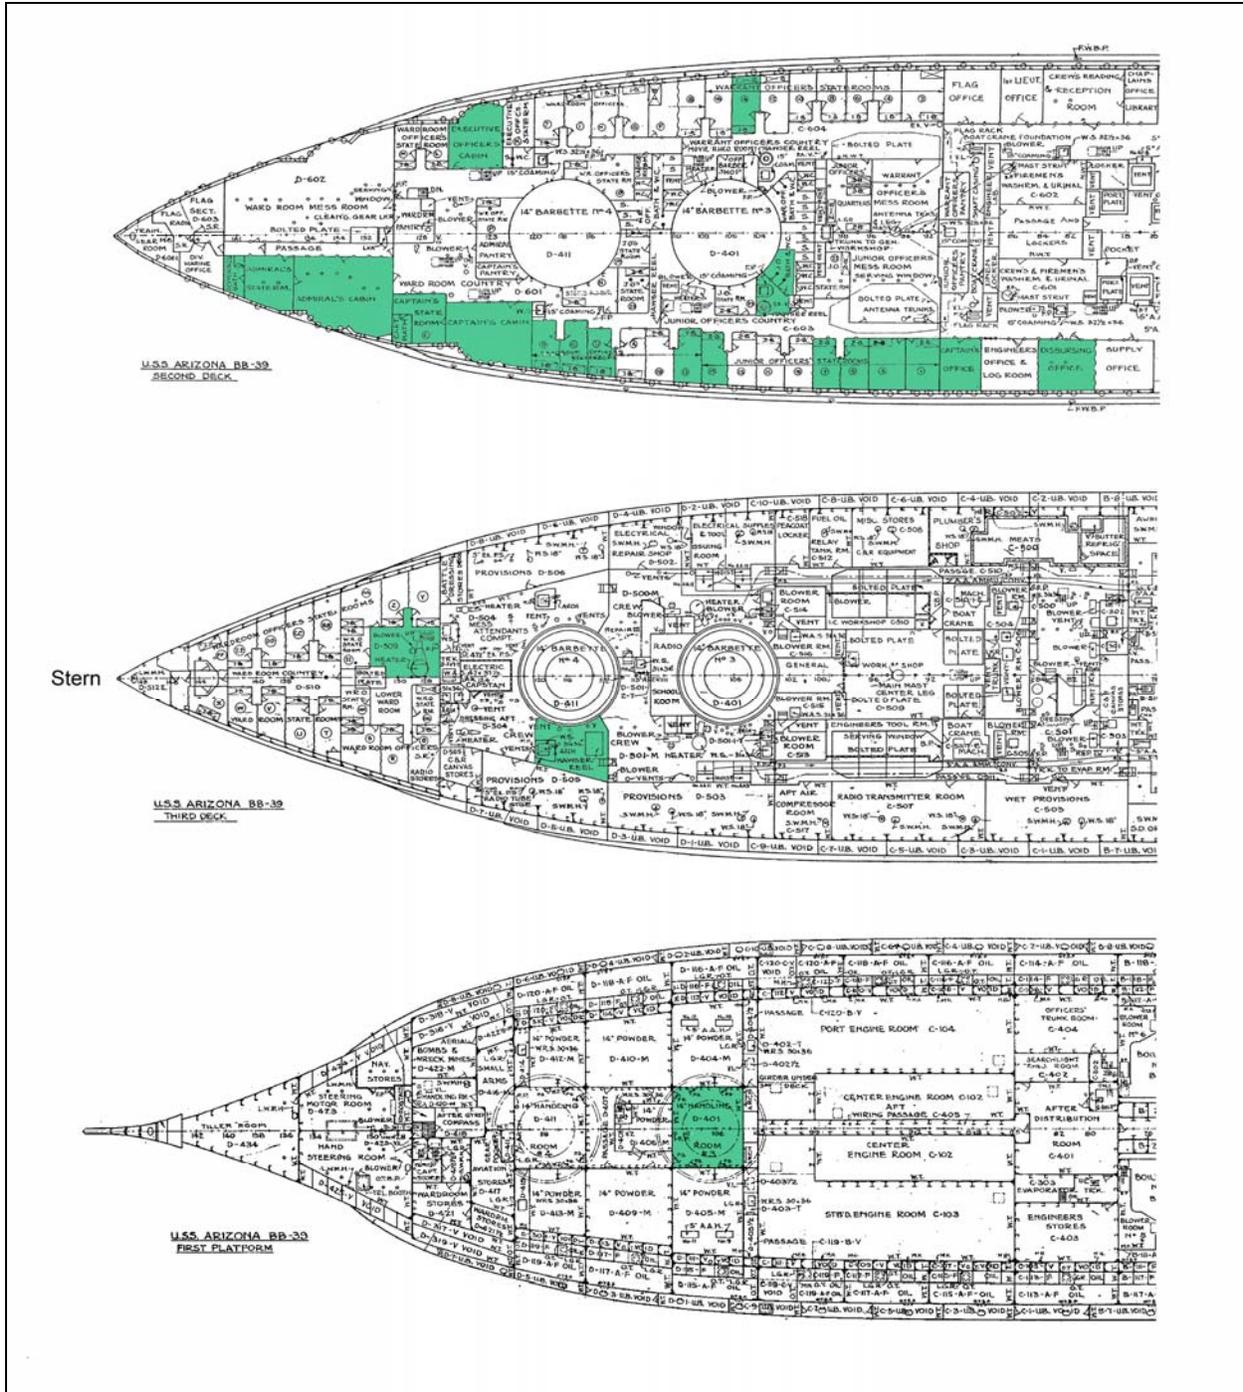
In total, 23 separate interior spaces were measured using the YSI Sonde-equipped VideoRay ROV. These spaces included 20 cabins and hallways on the Second Deck accessible through a combination of open portholes, exterior hatches, and accessible bulkheads; two interior spaces on the Third Deck that are only accessible via vertical hatches, including one that can only be reached after a long run down a Second Deck hallway; and the interior of Barbette No. 3, which reaches down to the First Platform level (just below the Third Deck) (Figure 4.15).

Figure 4.15. Interior spaces measured using the YSI Sonde-equipped VideoRay ROV.
