# **DoD Ergonomics Working Group NEWS**

### Issue 113, February 2011

## Navy Southwest Regional Maintenance Center: Ergonomics + NAVFAC = A Tight Ship

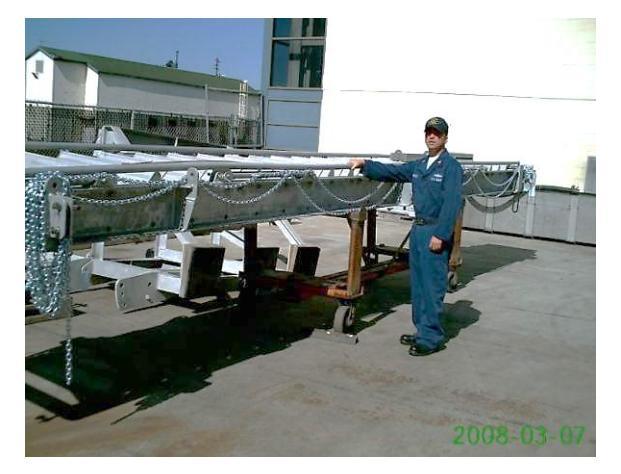
Fully assembled accommodation ladder staged after repair.

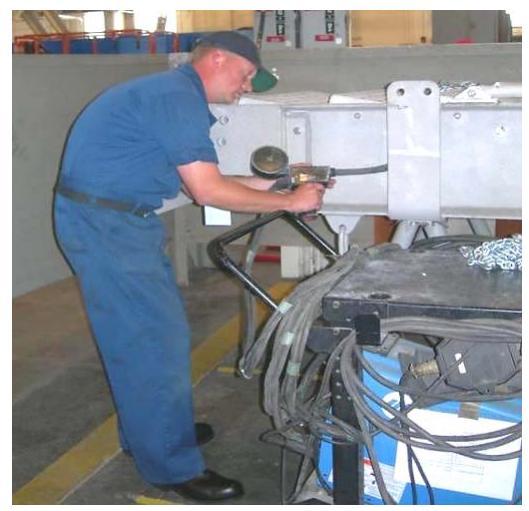
Before: Non-neutral working posture was quite common during welding tasks on the ACCOM ladders.

Personnel were required to bend, stoop, twist, and kneel during the preventive maintenance (PM) process to access all sides of the ACCOM ladder. Short, infrequent exposure to non-neutral postures are typically tolerated by the workforce where long exposures can cause injury.

The combination of heavy lifting and sustained non-neutral postures placed those working on ACCOM ladders at an increased risk of developing work-related musculoskeletal disorders (WMSDs) of the spine or shoulder. These disorders can be caused by exerting high forces that can contract muscles to their maximum capability, leading to fatigue and possible damage to the muscles and other soft tissues. Lifting outside of one's power zone (e.g., from knees to shoulders) increases stress on the spine. SWRMC personnel noted these postures when turning the heavy ACCOM ladders.

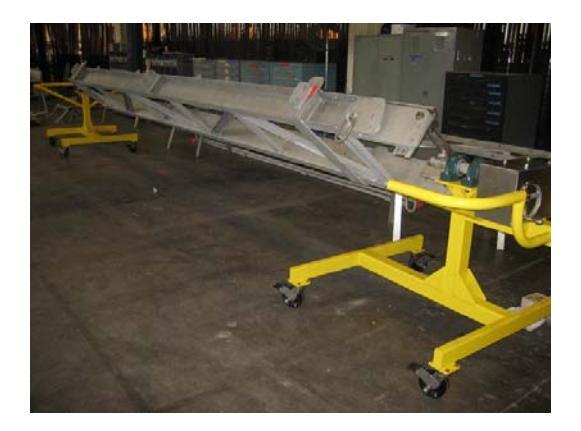
After: Rotating ladder fixture orients easily into the position that best suits the worker and the task whether it be welding or bolt removal, continually fitting the task to the person.

The NAVFAC MP/HA Team assessed the ACCOM operation, discussed potential resolutions with SWRMC personnel, and generated a detailed report. An MP/HA project was subsequently developed, submitted, and funded in April of 2009. The funding was used to design and fabricate a rotating ladder fixture, which eliminated the need to man-handle the ACCOM ladders, and greatly reduced the requirement for sustained nonneutral postures.

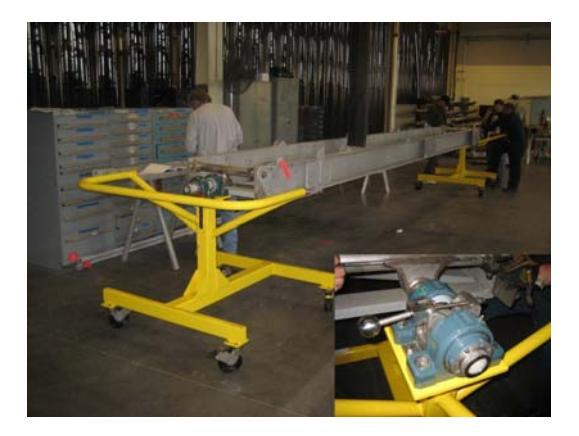
After: Rotating ladder fixture allows one worker to safely turn the ladder and lock it into place. The ladder system saves time and effort, and reduces the risk of injury and equipment damage.

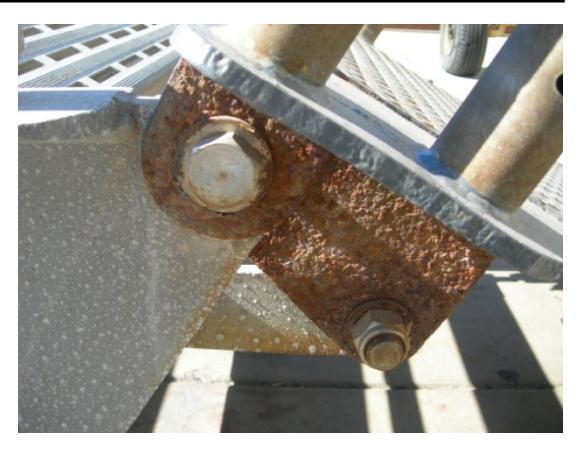
Previously seized bolts/bushings/pins were removed with an impact hammer or by manually hammering them out. Blunt impact, both first aid and lost workday injuries, occurred from the manual method.

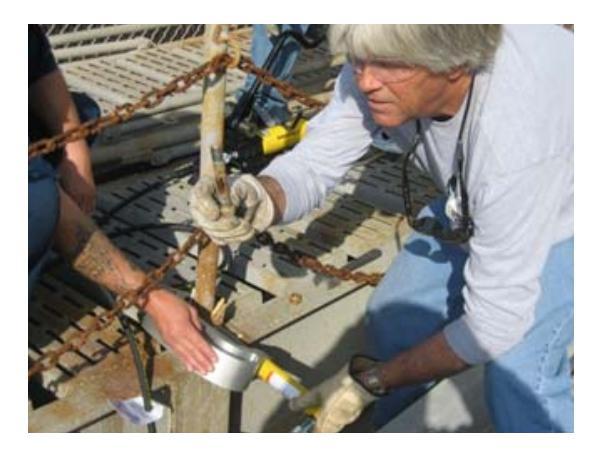
After: The stanchion removal tool effortlessly pushes the bolts free and eliminates the manual method.

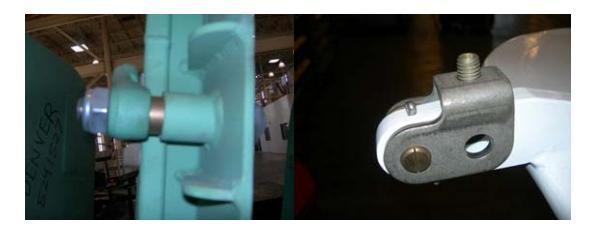
Examples of brass bushing (left) and hinge (right) on a watertight fitting reworked during repair process.
