Online Library of Selected Images:

-- EVENTS -- The 1960s -- 1965

Operation "Sailor Hat" Explosive Tests, February-June 1965

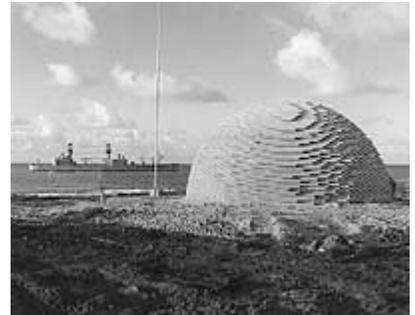
Photo #: KN-10831

The 500-ton TNT explosive charge for Shot "Bravo", first of a series of three test explosions, is ready for detonation on the southwestern tip of Kahoolawe Island, Hawaii, circa early February 1965. It is 17 feet high and 34 feet in diameter.

Weapons effects test ship *Atlanta* (IX-304) is moored in the background. Note that her bow is facing right and that a large SPS-37/SPS-43A type radar antenna is mounted on a pedestal amidships.

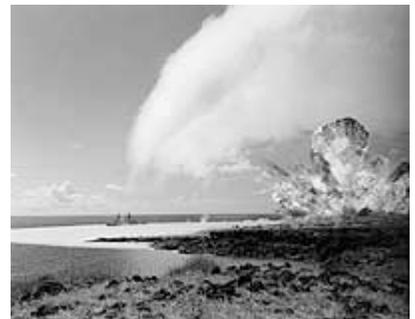
Photo #: KN-11352

Detonation of the 500-ton TNT explosive charge for Shot "Bravo", first of a series of three test explosions on the southwestern tip of Kahoolawe Island, Hawaii, 6 February 1965. Weapons effects test ship *Atlanta* (IX-304) is moored in the left center.

Note the shock wave spreading over the water just beyond the ship, and the shock condensation cloud lifting overhead.

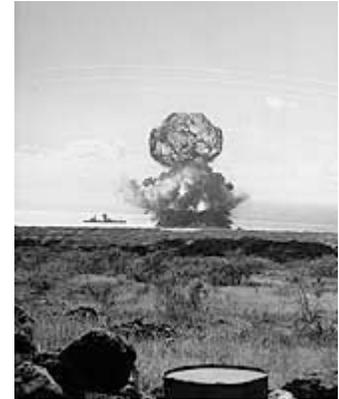
Photo #: NH 98886

"Sailor Hat" Shot "Bravo"'s 500 tons of high explosive are detonated on Kahoolawe Island, Hawaii, 6 February 1965, with the test ship *Atlanta* (IX-304) moored nearby. Note smoke or dust around the ship's foremast, and the shock wave perimeter expanding on the water beyond the ship.

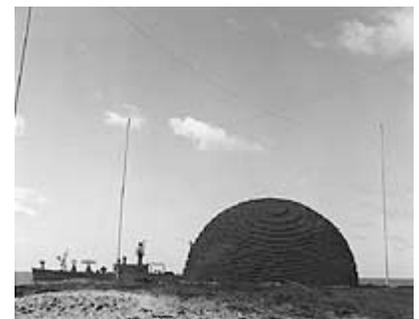
Photo #: USN 1110434

The 500-ton TNT explosive charge for Shot "Charlie", second of a series of three test explosions, ready for detonation on the southwestern tip of Kahoolawe Island, Hawaii, April 1965.

USS *Atlanta* (IX-304) is moored in the background, with her bow facing left. A large SPS-37/SPS-43A type radar antenna is mounted on a pedestal on her foredeck, immediately in front of an ASROC launcher. An SPS-30 type radar antenna is on the pedestal at her extreme bow. Both of these antennas were relocated after the February 1965 Shot "Bravo".

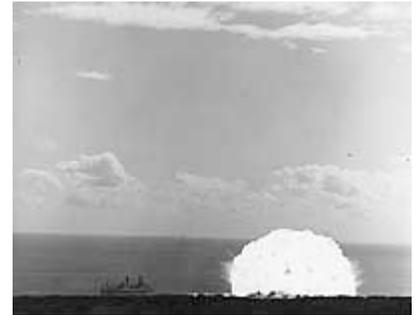
Photo #: USN 1110440

500-ton TNT explosive charge is detonated in Shot "Charlie", April 1965. This was the second of three Operation "Sailor Hat" test explosions conducted on Kahoolawe Island, Hawaii, in February-June 1965. USS *Atlanta* (IX-304) is moored to the left of the blast, with her bow pointing to the left.
