Context Study of the UNITED STATES QUARTERMASTER GENERAL STANDARDIZED PLANS 1866 - 1942

Prepared for U.S. ARMY ENVIRONMENTAL CENTER ENVIRONMENTAL COMPLIANCE DIVISION Aberdeen Proving Ground Maryland

by U.S. ARMY CORPS OF ENGINEERS SEATTLE DISTRICT Technical Center of Expertise for Preservation of Structures and Buildings

**NOVEMBER 1997**

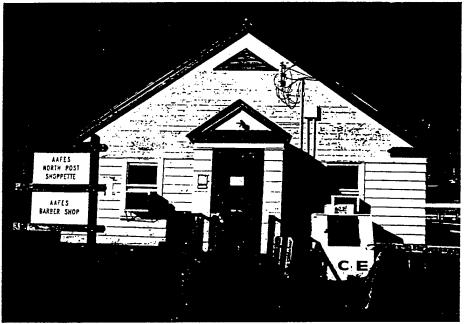
Figure 2. Arctic entry added to Nurses Quarters at Ladd Field (now Fort Wainwright) near Fairbanks, Alaska.

Climate also had an influence on the appearance of buildings built from standardized plans. Army barracks constructed from 1918 Quartermaster Corps standardized plans in the nation's southern states varied from those built for the colder, northern climate. (See Figure 1.) Practically identical, the interior walls and ceilings of those buildings in the northern states were finished with a single layer of wall board (either 3/16" fiber or 3/8" gypsum). Soldiers living in barracks in southern areas had to be content with interior wall surfaces showing open studs. In more extreme conditions, standardized buildings at Ladd Field, near Fairbanks, Alaska, received Arctic entries (cold weather vestibules) and some were built several feet above ground to avoid melting "permanently" frozen ground.<sup>13</sup> (See Figure 2.)

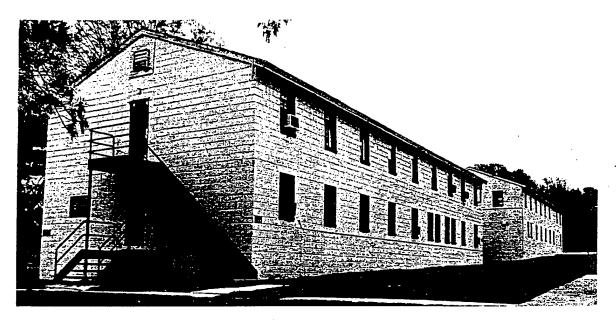
Figure 3. Building 424, barracks built from 800 series standardized plans at Bolling Field, now Bolling Air Force Base, District of Columbia. Note that the walls are laid up in concrete masonry blocks instead of being wood-framed. (US Army Corps of Engineers, Seattle District, 1997)

of standardized barracks built of masonry, steel and hollow tile.<sup>14</sup> Eventually, wood was chosen as the most cost-effective and easily obtained material. Yet another series of barracks, generally built of wood, were occasionally built of concrete masonry blocks, as at Bolling AFB (See **Figure 3**.).

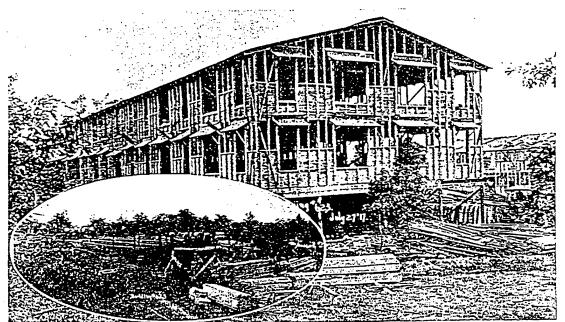
Figure 5. A typical barracks at Camp Devens at Ayer, Massachusetts. The insert (July 20<sup>th</sup> 1917) shows pre-cut lumber. Seven days later, in the larger view, the building is framed and nearly enclosed. (Peter F. O'Shea, "The Human Side of Cantonment Building", *American Builder*, October 1917, Volume 24, No. 1, 41)

the Army's Spanish Mission style buildings have a reserved character and are devoid of gaudy ornamentation. An example of efficiency of cost was achieved through the purchase of materials in bulk, as in the construction of Camp Devens in Ayer, Massachusetts in 1917 where

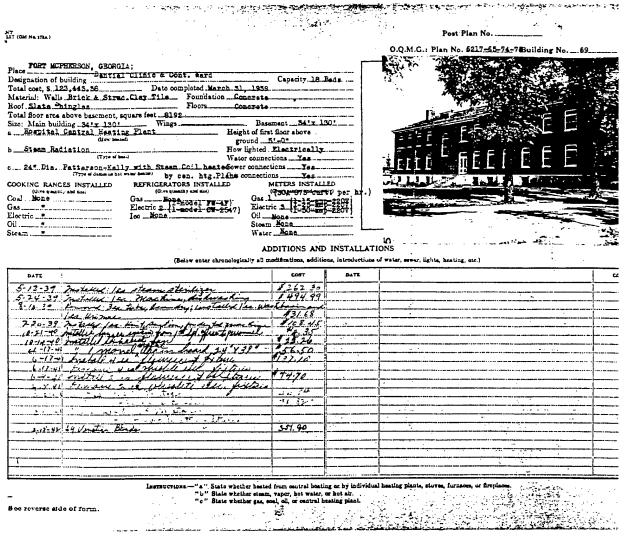
Figure 7-Example of War Department QMC Form 117 (inventory sheet) Fort McPherson, Georgia. The Dental Clinic was completed on March 31, 1939 using the O.Q.M.G. standardized plan number 6217-65-74-78.

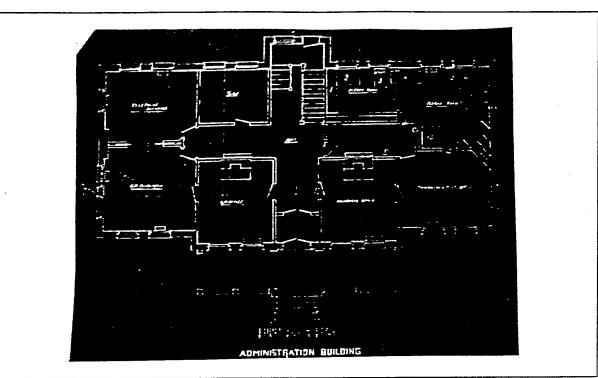
Figure 10--Plans by the Department of the Dakota for an Administration Building, based on Quartermaster General Meigs plans.

variations on Meigs 1872 plans."<sup>42</sup> (Figure 10.) There is evidence that builder's handbooks, also known as pattern books, were used as source books by the Quartermaster design staff.

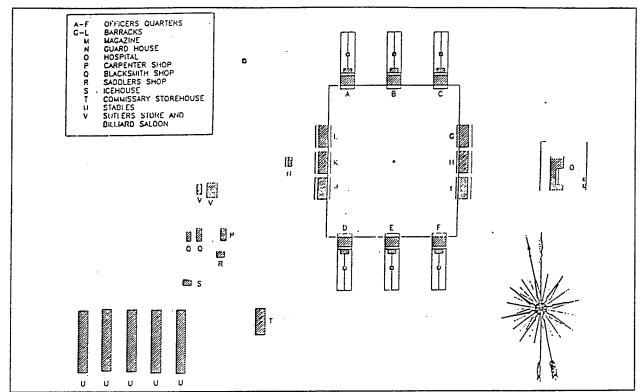
Figure 12--Layout of Fort Riley, Kansas, showing the typical arrangement of buildings at western frontier posts.

After the frontier moved west of the Mississippi, the spatial arrangement of frontier posts evolved. Gradually the palisade disappeared as a protective fortification. The parade ground became more pronounced as the center of the post with barracks, officers' housing, and administrative buildings surrounding the parade ground. Various service areas were located apart from the central parade ground: an infirmary or hospital; guardhouse; agricultural fields; and, shops. Stables for cavalry troops were located close to the barracks, while corrals and storage facilities were located apart from main parade ground area."<sup>44</sup> Fort Riley, Kansas is a good example of a typical frontier post plan (Figure 12.)

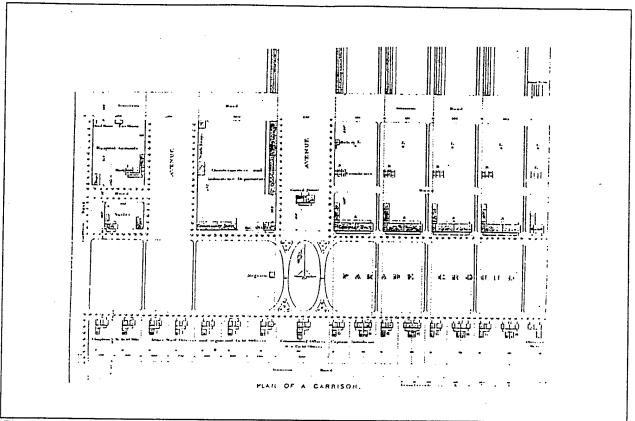
Figure 13--Proposed plan for a typical garrison, 1860. (From U.S. War Department, Regulations Concerning Barracks and Quarters for the Army of the United States, 1860 [Washington, DC: George Bowman, Printer, 1861.])

To date, the only evidence of efforts to standardize Army post plans during the Frontier Post era are found in unofficial 1860 regulations. These regulations suggested the following arrangement of a four company garrison (Figure 13):

Plan of a Garrison. Officers' quarters, chaplain's quarters, and officers' mess on one line, facing a parade ground open at both ends and varying in breadth at different posts, according to the ground and other circumstances, from 250 to 400 feet; all other buildings on the other side from the officers' line, and in positions to be presently described. On that side an avenue 220 feet wide extending outward perpendicularly from the parade ground, will separate the troops from the supplying departments another avenue 200 feet wide, parallel to the first, and 300 feet from it, will separate the supplying departments from the sutler's establishment and the hospital ground...<sup>45</sup>

Landscape character-defining features depicted on the 1860 proposed standardized plan include overall organization (site plan-buildings, roads, parade ground), land use areas (quarters, administration, supply areas, medical, etc.), building clusters, and vegetation (trees line several roads and the perimeter of the parade ground.

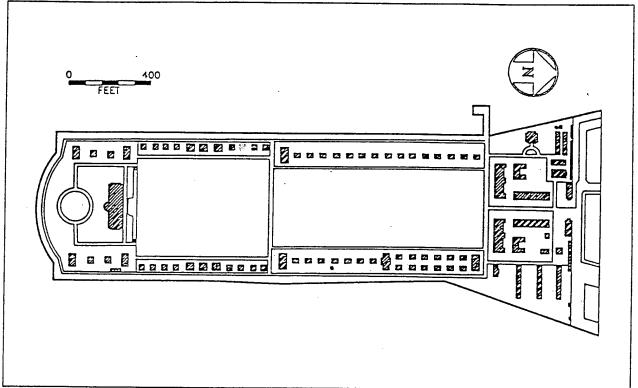
Figure 14--Charles McKim, of McKim, Mead and White, designed the Army War College and Engineers Post.

Army design efforts as military planners worked to improve living conditions for personnel. Design precedents from the Beaux Arts movement such as the formal site plans and classicallyinspired architecture were introduced by civilian architects; some of whom, for the first time, were employed by the Quartermaster Department rather than being hired under contract. At the War College at Washington Barracks (now Ft. McNair in Washington, D.C., and the U.S. Military Academy at West Point, New York, private architectural firms prepared comprehensive site plans which exemplified the Beaux-Arts planning principles such as formal symmetrical building layouts arranged around axes (Figure 14).
