**UNACCOMPANIED PERSONNEL HOUSING (UPH)  
DURING THE COLD WAR  
(1946-1989)  
UNRESTRICTED**

**U.S. ARMY ENVIRONMENTAL COMMAND  
ABERDEEN PROVING GROUND, MARYLAND 21010-5401**

**January 2007**

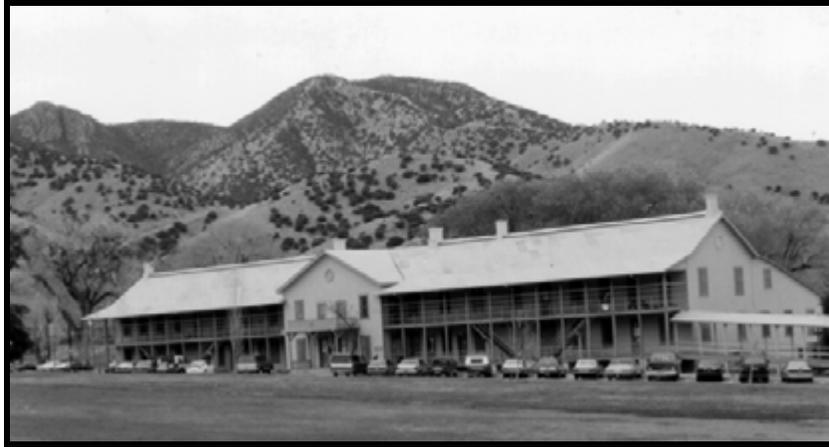
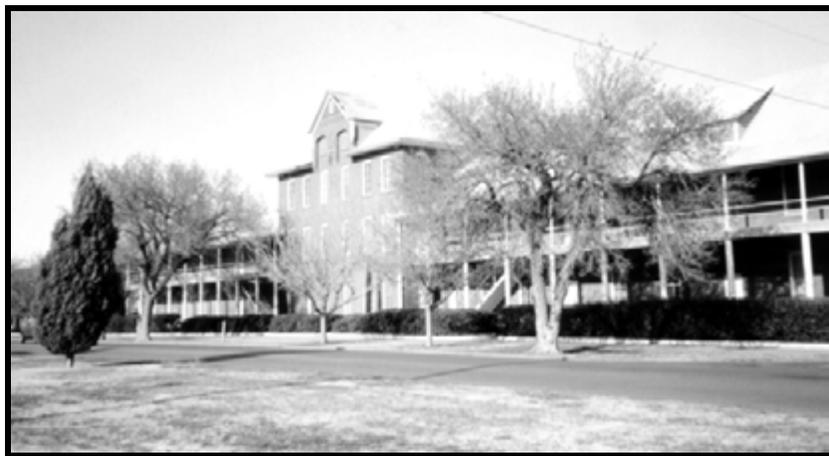
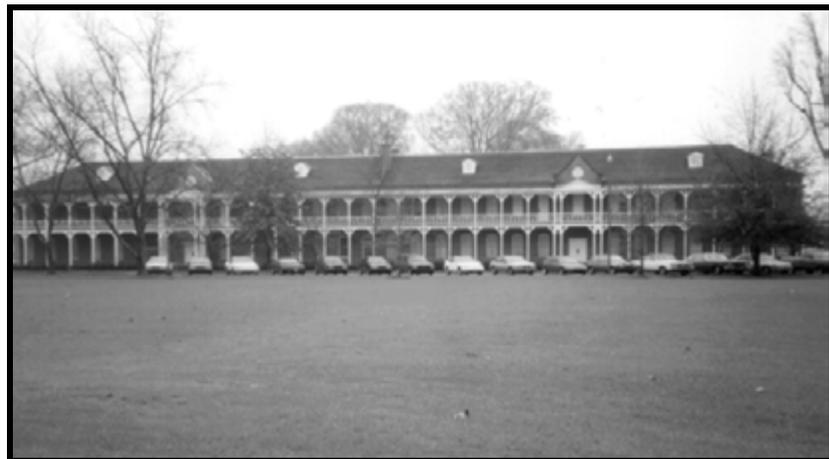
Figure 3.3 1883 wood-frame barracks (Ft. Huachuca, Arizona), *above*. 1893 multi-company barracks (Ft. Bliss, Texas), *middle*. 1891 barracks with simplified Queen Anne and Stick style detailing (Ft. McPherson, Georgia), *below*. (RCG&A)

The Army constructed new posts with greater attention to planning and to architectural design. Barracks traditionally were located along one edge of the central parade ground, facing the officers’ quarters, which were located along the opposite side of the parade ground. This location allowed easy access to training activities held on the parade ground and to duty stations. Because of their prominent location, barracks were important elements in the installation plan and often were impressive buildings that defined the architectural character of the installation as a whole (Figure 3.3). During this era, the Army built larger, two-company barracks. Barracks typically featured a central block flanked by wings with two-tiered porches. Porches served as corridors and provided ventilation. A second type of two-

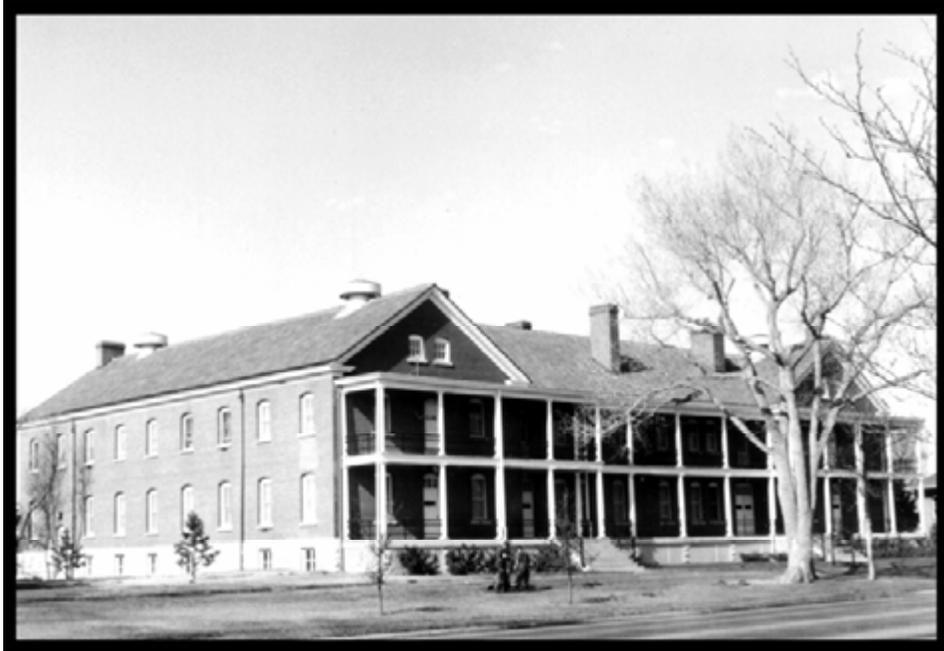
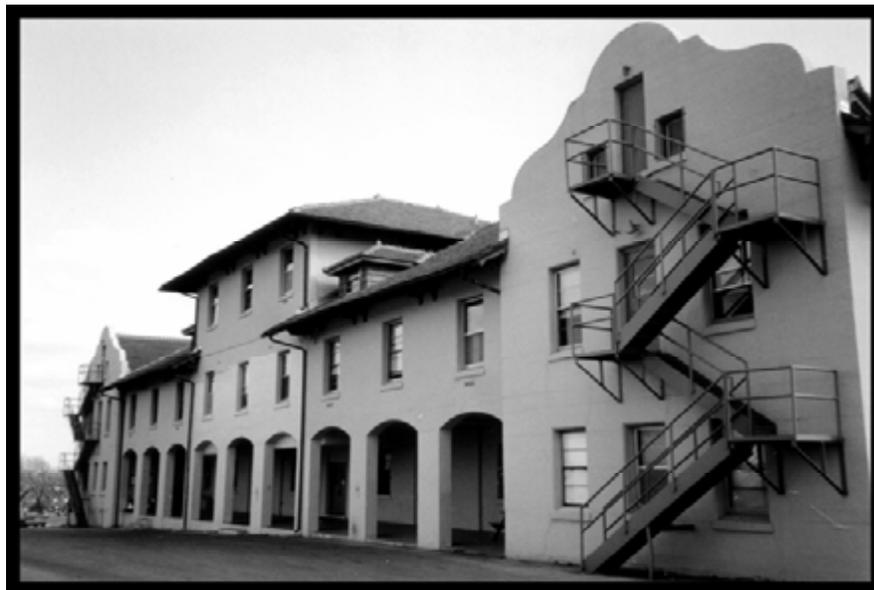
Figure 3.4 1910 Cavalry barracks, Quartermaster standardized plan no. 75-M (F.E. Warren AFB [Formerly Ft. D.A. Russell], Wyoming), *above*. 1911 barracks designed in the Spanish Colonial Revival style (Ft. Sill, Oklahoma), *below* (RCG&A).

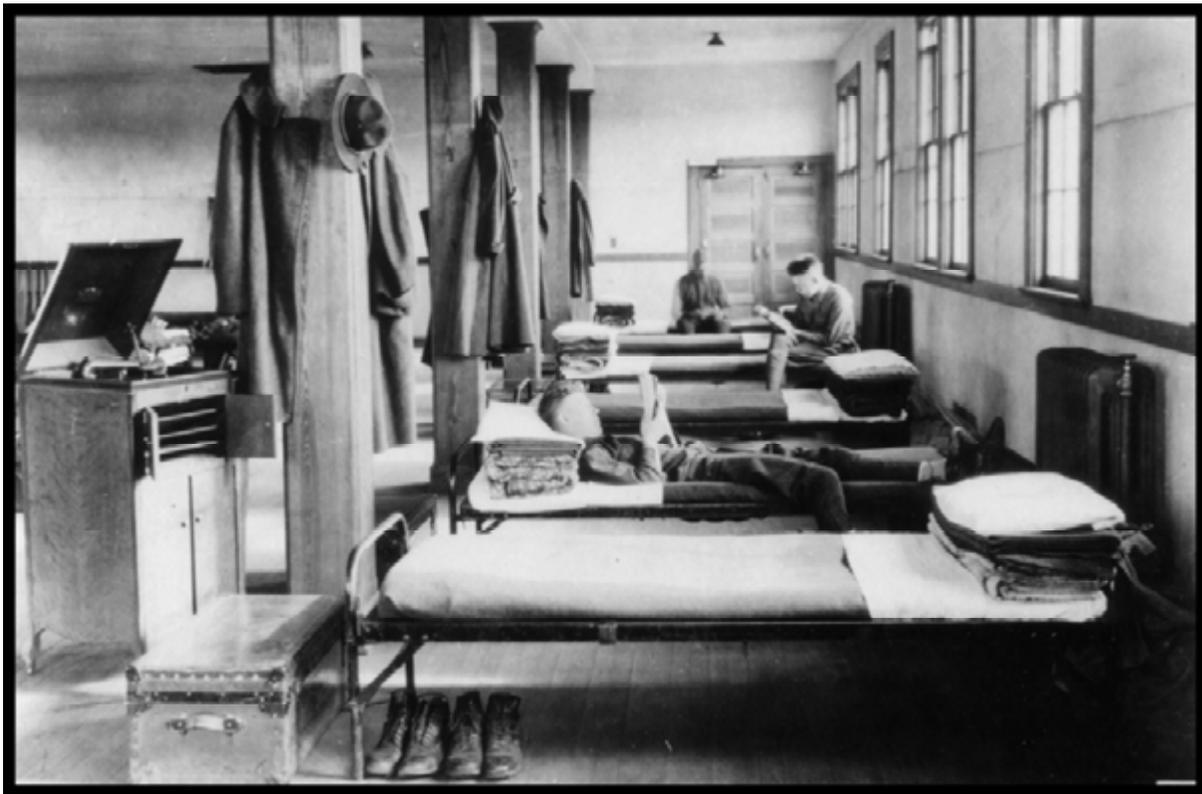
Figure 3.5 Typical World War I mobilization barracks complex (Aberdeen Proving Ground, Maryland), *above*. Interior of World War I mobilization barracks (Aberdeen Proving Ground, Maryland), *below* (RCG&A).

After World War I, military spending slowed dramatically. Thousands of troops continued to live in temporary World War I mobilization barracks (Figure 3.5), which were deteriorating rapidly. The National Defense Act of 1920 redefined the organization of the U.S. Army. This organization comprised the permanent Army, National Guard, Officers Reserve Corps, and Enlisted Reserve Corps. The law established the geographic limits for nine Army corps within the continental United States. Each corps area was to contain one active Army division, plus one Reserve and two National Guard divisions. The Act further defined the combatant arms of the Army as the Corps of Infantry, Cavalry, Field Artillery, Coast Artillery; the Air Service; the Corps of Engineers; and, the U.S. Army Signal Corps. During peacetime, the personnel numbers for the standing Army was raised from 175,000 to 280,000 enlisted men and raised from 11,673 to 17,717 officers (Ganoe 1964:479; War Department Annual Report 1920).

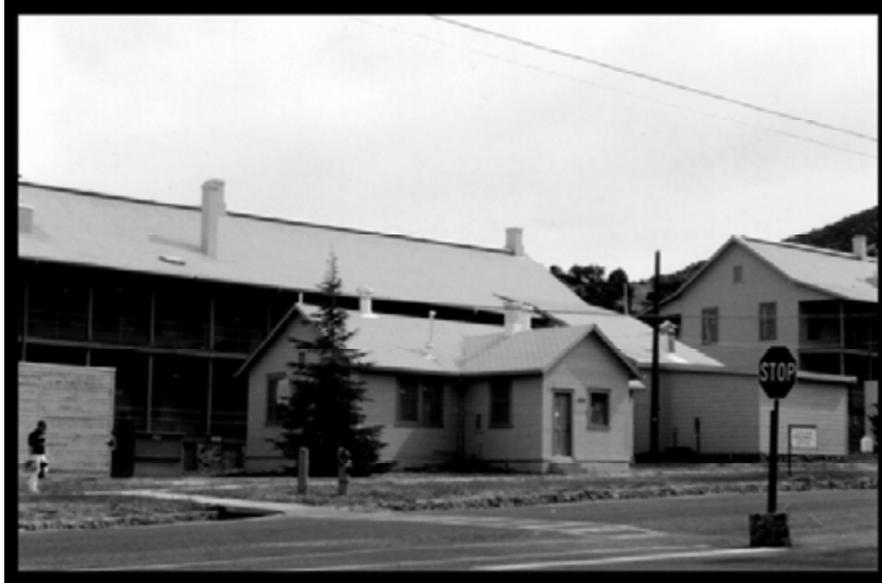
Figure 3.7 1903 detached lavatory (Ft. Huachuca, Arizona), *below* (RCG&A).

Communal detached latrines and bathhouses became prevalent for barracks, particularly in the West at such installations as Forts Huachuca, Bliss, and Riley, during the late nineteenth and early twentieth centuries (Figure 3.7). These buildings contained indoor plumbing for toilets and bathing facilities. Support buildings were located behind the barracks, and often served the residents of two barracks. On some western posts, permanent detached lavatories were not constructed until World War I. By the 1930s, indoor bathrooms and toilets were included in all barracks designs.

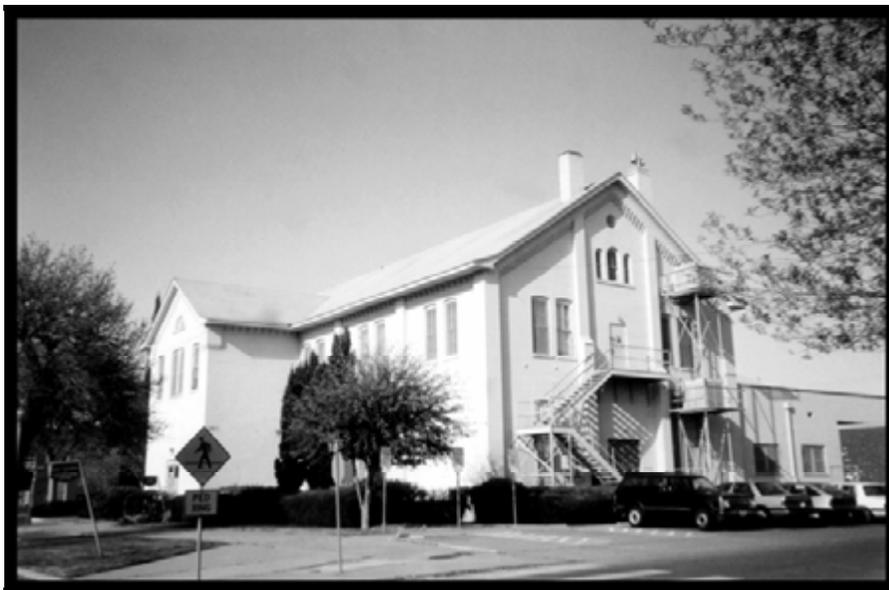
Figure 3.8 1893 consolidated mess (Ft. Bliss, Texas) (RCG&A).

As the Army consolidated troops onto larger, permanent posts during the 1880s and 1890s, the Quartermaster Department experimented with plans for a single mess for all enlisted personnel. The Army constructed its first consolidated mess at the recruiting depot at David's Island, New York, in 1888 (Risch 1962). Common mess halls were adopted at a number of larger posts by 1893, including: Ft. Bliss, Ft. Brady, Davids Island, Jefferson Barracks, Ft. McPherson, Plattsburgh Barracks, Ft. Riley, Ft. Sam Houston, Ft. Sheridan, and Ft. Thomas (Figure 3.8). In addition, consolidated messes were established at Ft. Myer, Key West Barracks, Ft. Schuyler, Ft. Warren, and Willets Point (War Department Annual Report 1893).

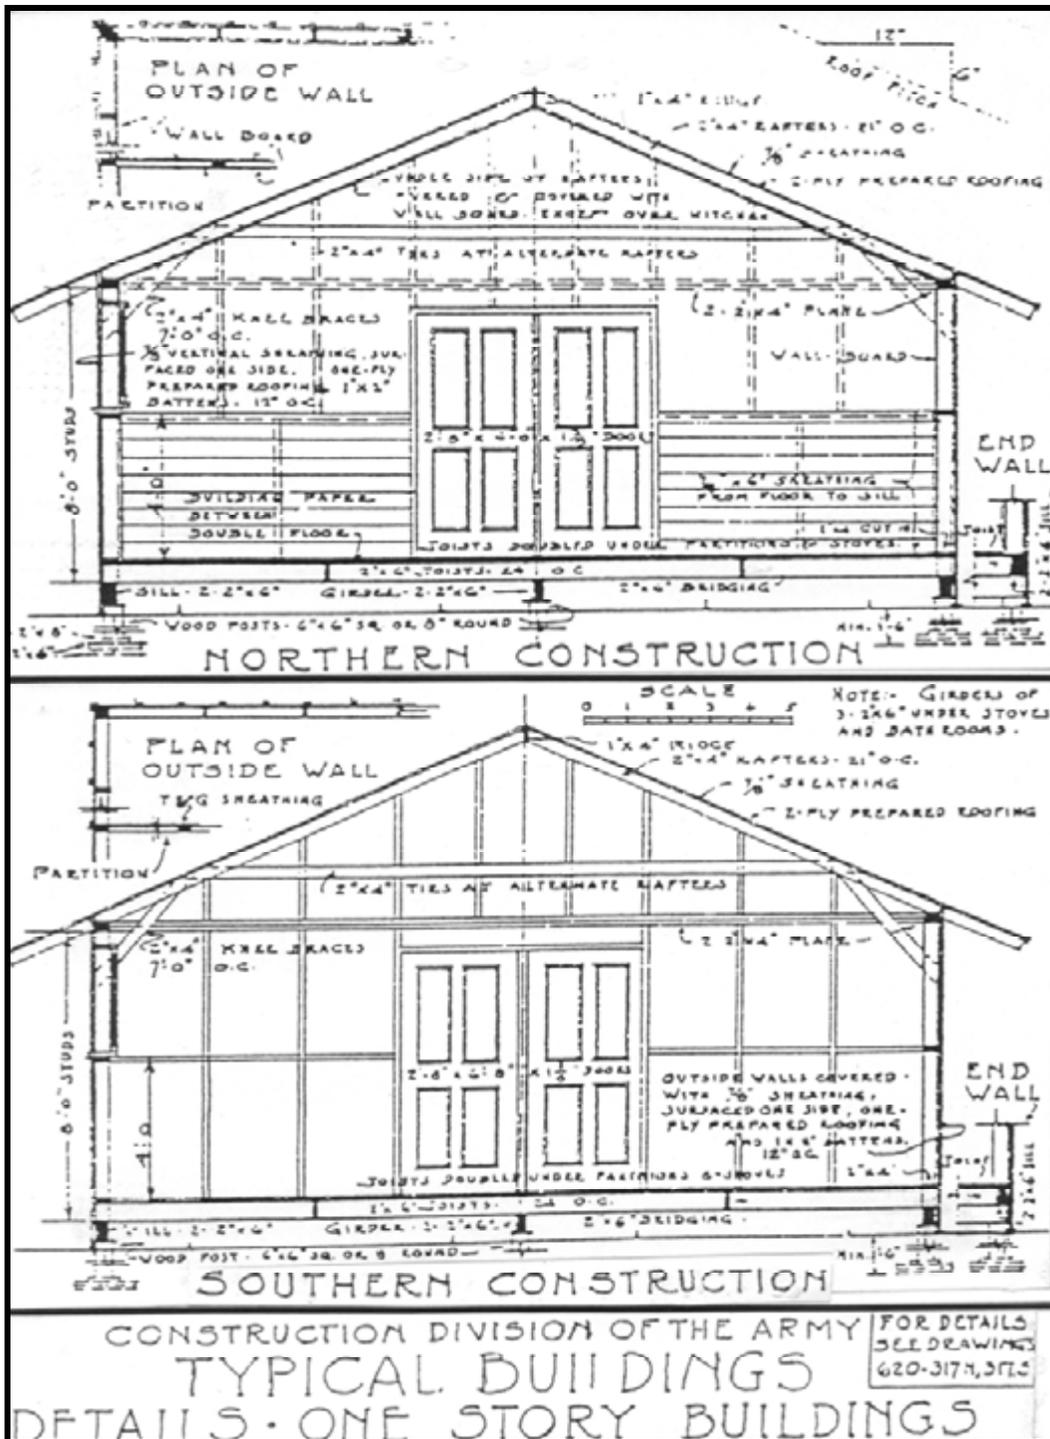
Figure 3.11 600 Series Mobilization Construction Plans used in World War I (From John S. Garner, *World War II Temporary Military Buildings*. Champaign, Illinois: U.S. Army Construction Engineering Research Laboratory, 1993).

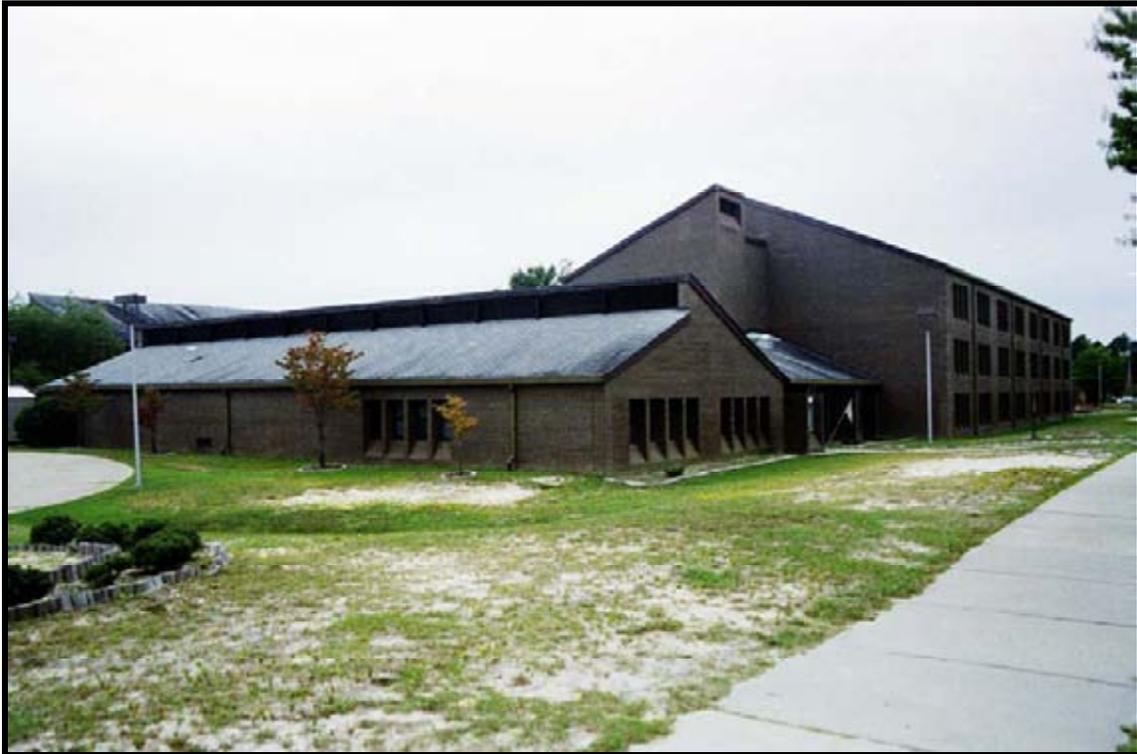
Figure 3.12 Quadrangle barracks, Ft. Bragg (RCG&A).

Quadrangle barracks were designed to meet the “2+2” standards issued in 1983. The flexibility allowed by this approach was apparent in the resulting buildings. Quadrangle barracks are two- or three-story, brick barracks featuring an overlapping gable roof. Troops are housed in principal blocks defined by central corridors with four-person rooms or suites along both sides. Each room/suite features living/sleeping units, individual closets, and a bath. Barracks were built singly, combined with another barracks to create an L-shaped building, or combined with perpendicular wings containing administration and supply facilities to create C-shaped buildings (Figure 3.12).

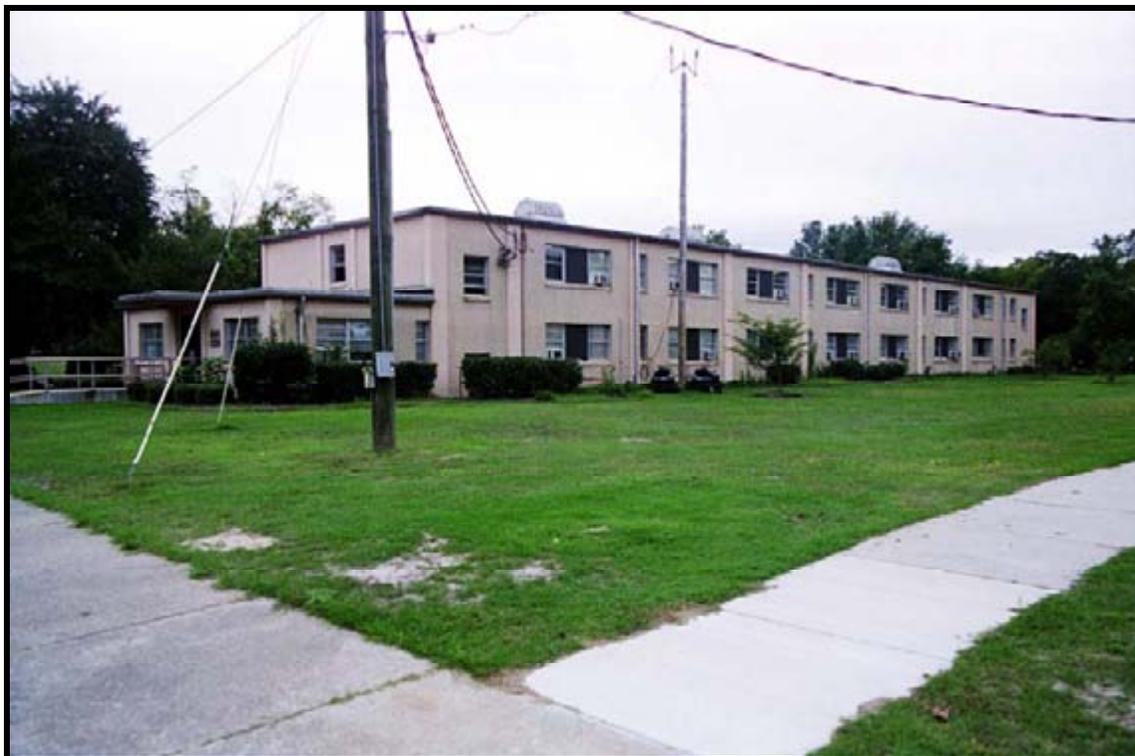
Figure 3.13 Two-story, hammerhead BOQ converted to offices, Ft. Bragg (RCG&A).

The designs of BOQs built in the early 1950s were derived from hammerhead barracks plans. Depending on the needs of the base, the buildings were either two or three stories tall. General Hardin's description of the hammerhead barracks also applied to the design for hammerhead BOQs. The buildings were utilitarian, constructed of reinforced concrete, devoid of ornamentation, and very durable (Figure 3.13). The entrances to these rectangular buildings were located at the end elevations of the buildings. The BOQs differed from hammerhead barracks in two important respects. First, hammerhead BOQs did not include a kitchen and mess hall wing. Second, officers were housed in suites with living/bedroom areas, closets, and a shared bathroom. Character-defining features consist of the building's exposed reinforced concrete frame, exposed concrete block walls, window placement, and interior plan.

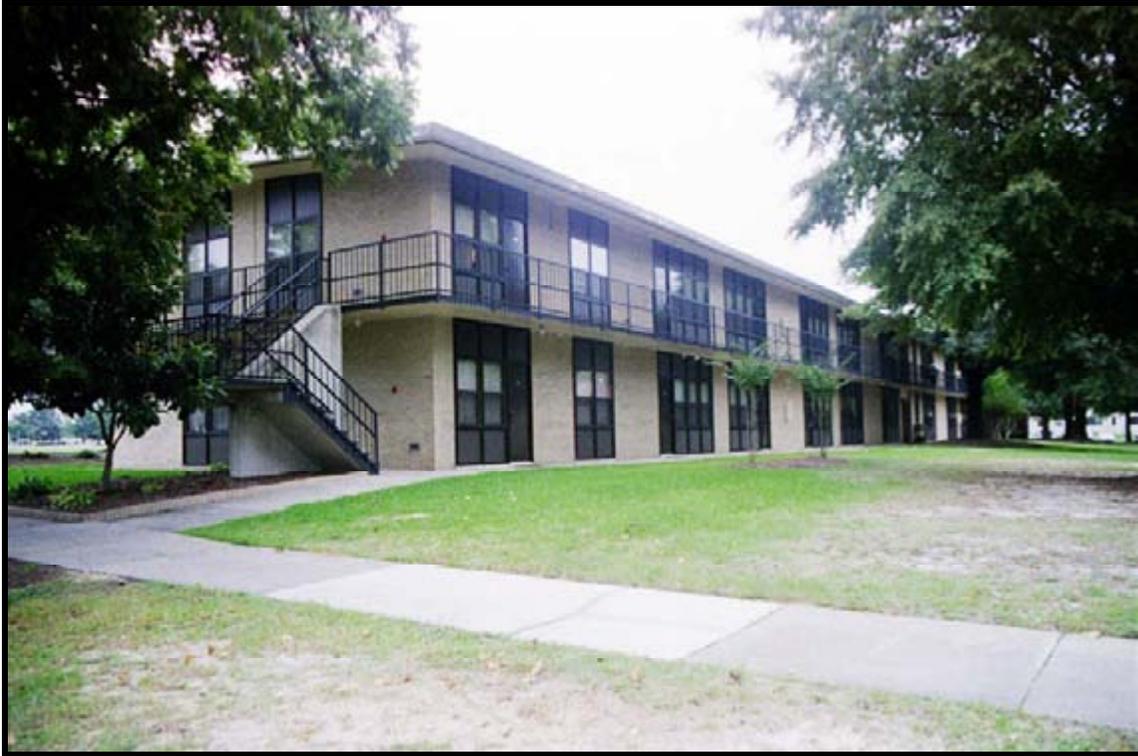
Figure 3.15 120-man motel-type BOQ, Ft. Bragg (RCG&A).

The Army began constructing motel-type BOQs by 1968. Character-defining features of these two-story, brick buildings included the exterior entrances, wide eaves, and wrap around balconies (Figure 3.15). Fort Bragg featured several plans. Some rooms were arranged with a living room, bedroom, bathroom, and a kitchen, while other units had a combined living room/bedroom and bathroom. Some of these latter rooms also included kitchenettes. The BOQs at Fort Polk had two-person suites. Each suite included living room/bedrooms, private bathrooms, and a common kitchen.

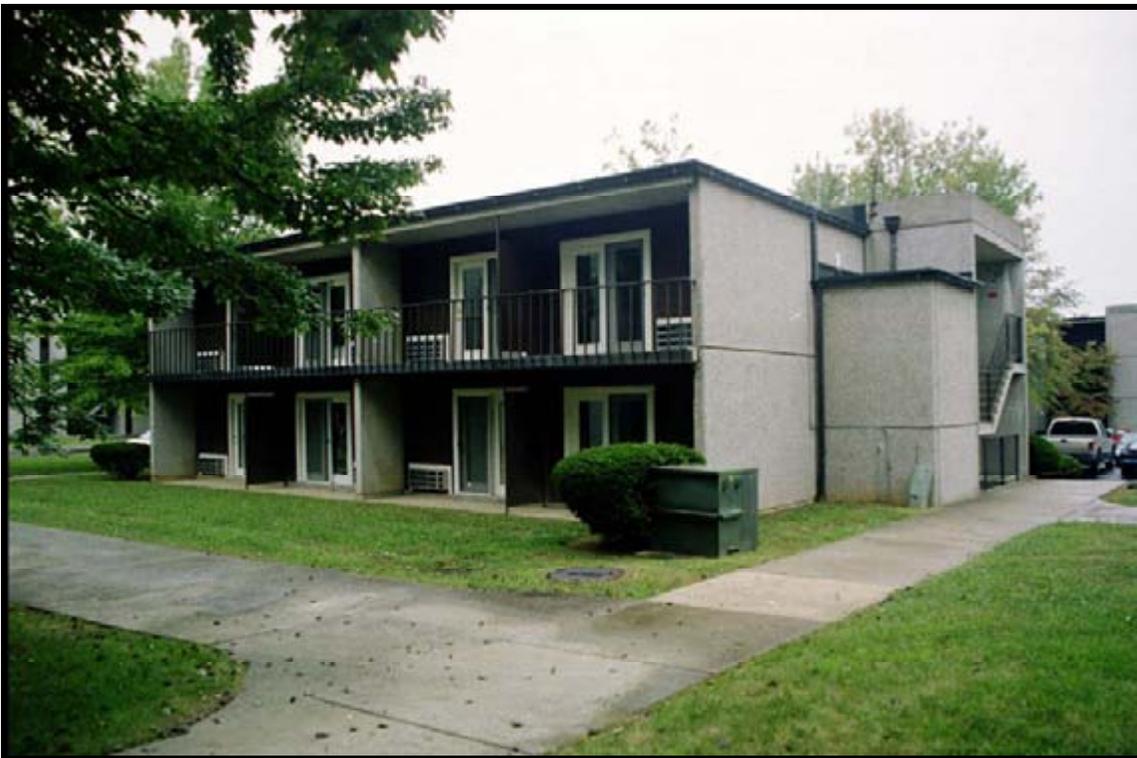
Figure 3.17 Apartment-type BOQ, Ft. Knox (RCG&A).

The campus environment created by the Lyles, Bissett, Carlisle, and Wolff barracks was carried over into BOQs. In 1974, the Army constructed an apartment campus for bachelor officers at Fort Knox, Kentucky. The campus included seven buildings for bachelor officers and a community center. The most striking feature of the campus was the variety in scale, mass, and proportion of the individual buildings. The two- to three-story buildings were constructed of pre-cast concrete and featured exterior stairs, balconies, and flat roofs (Figure 3.17). Each room had its own private balcony accessed by a sliding glass door.

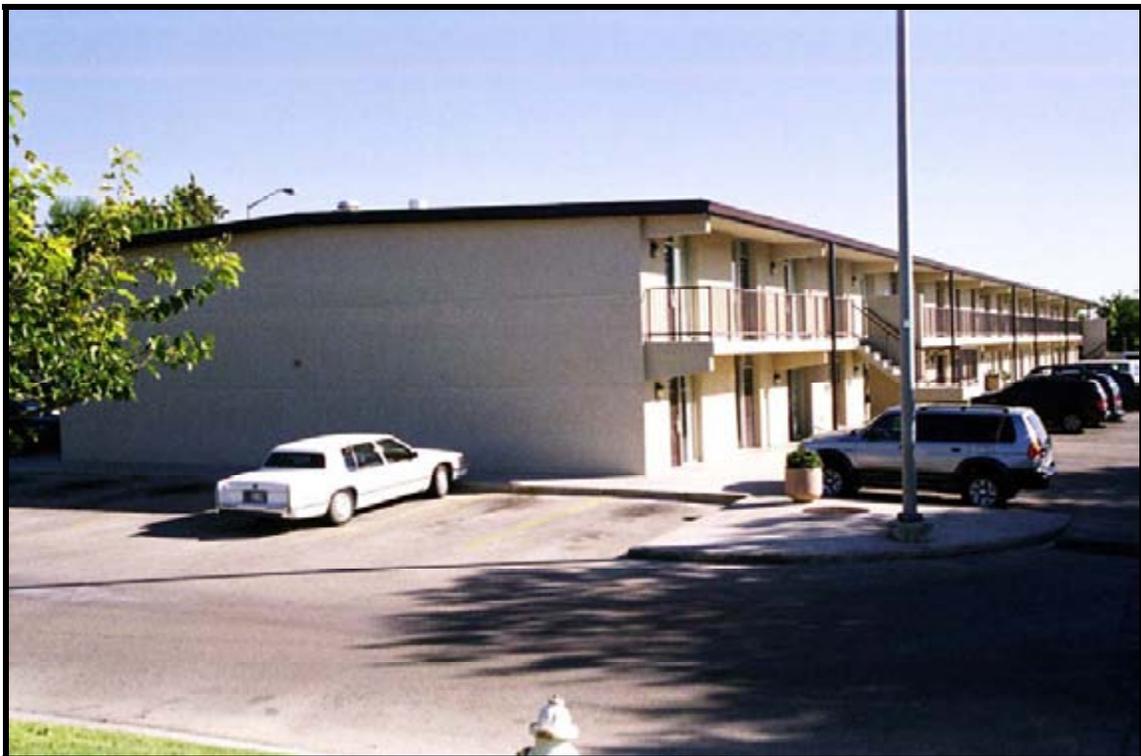
Figure 3.19 Transient quarter, Ft. Hood (RCG&A).

Transient quarters built during the period were designed with 27 or 33 rooms depending on the size of the post (AF Times 3 June 1970:20). They operated much like commercial motels or hotels with daily maid service, laundry facilities, and vending machines. Designs for larger transient quarters were quickly developed. Fort Bragg constructed an 88-unit guest house in 1971. The two-story reinforced concrete design featured exterior stairs and balconies along the sides of the building that were protected by overhanging eaves. Fort Hood utilized the design in 1973 (Figure 3.19).

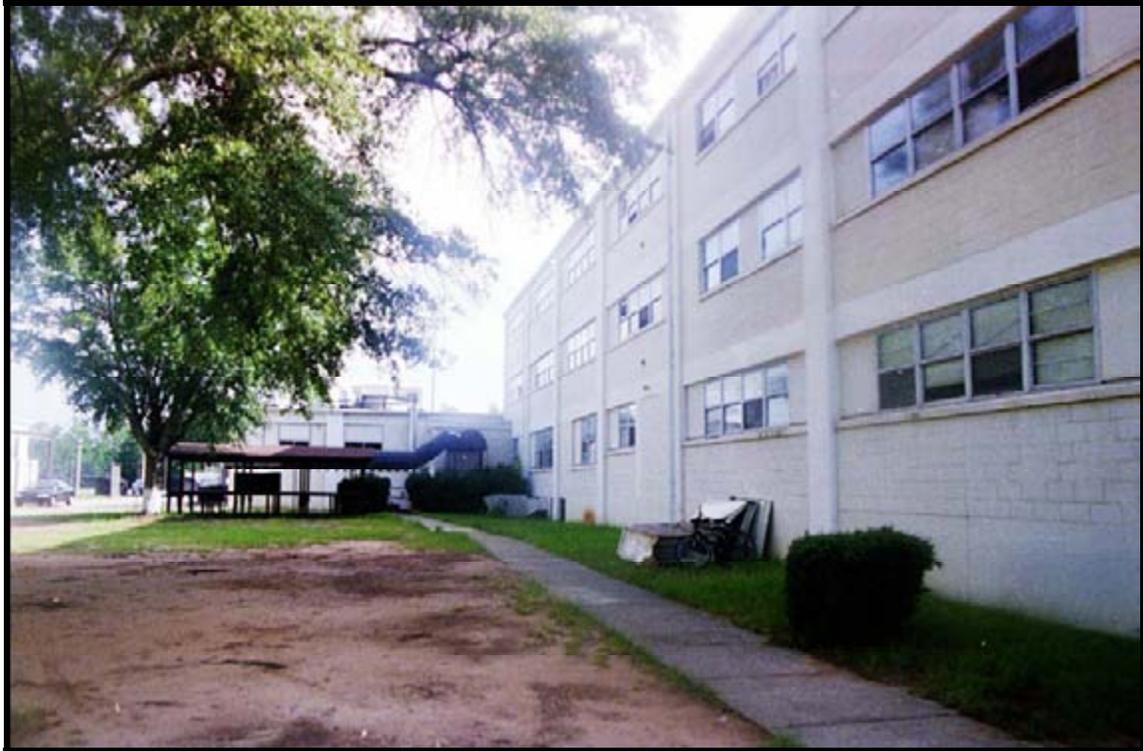
Figure 4.1 225-man hammerhead barracks, Ft. Benning (RCG&A).

Figure 4.1 illustrates a 225-man hammerhead barracks at Fort Benning, Georgia. The minimal landscaping of the hammerhead barracks is shown in Figure 4.2. In contrast, the landscaping is stark in the arid southwest at Fort Bliss (Figure 4.3). The mess wing is illustrated in Figure 4.4.

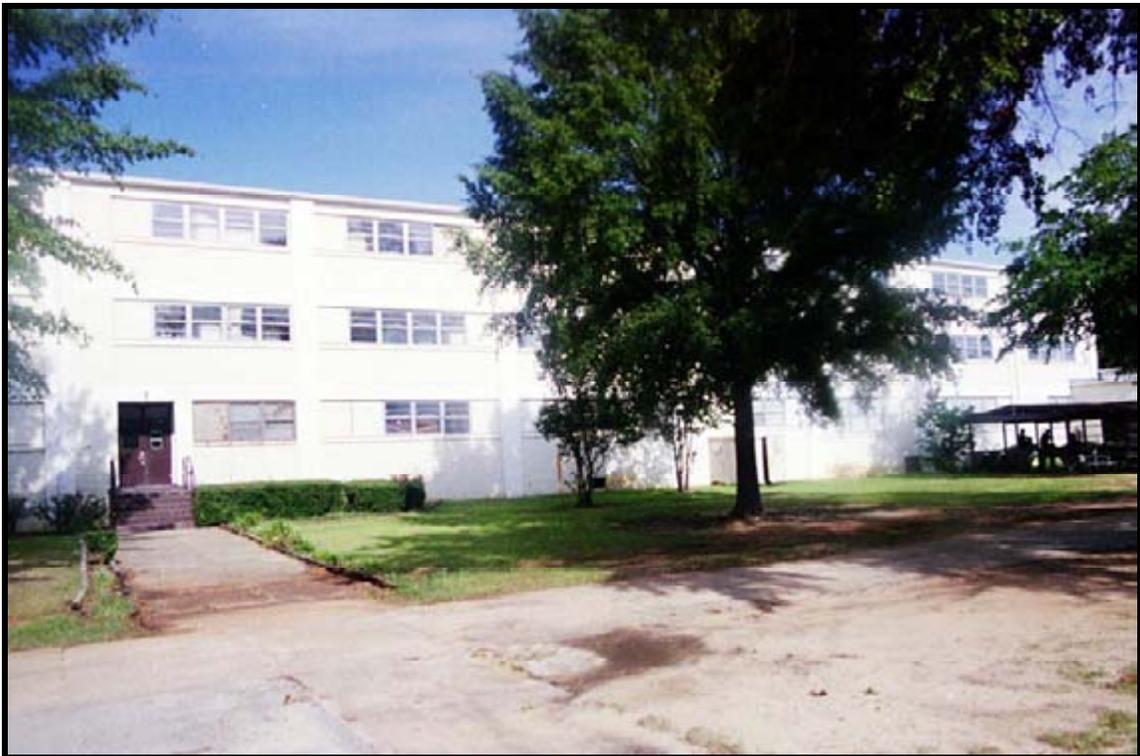
Figure 4.2 225-man hammerhead barracks, Ft. Benning (RCG&A).

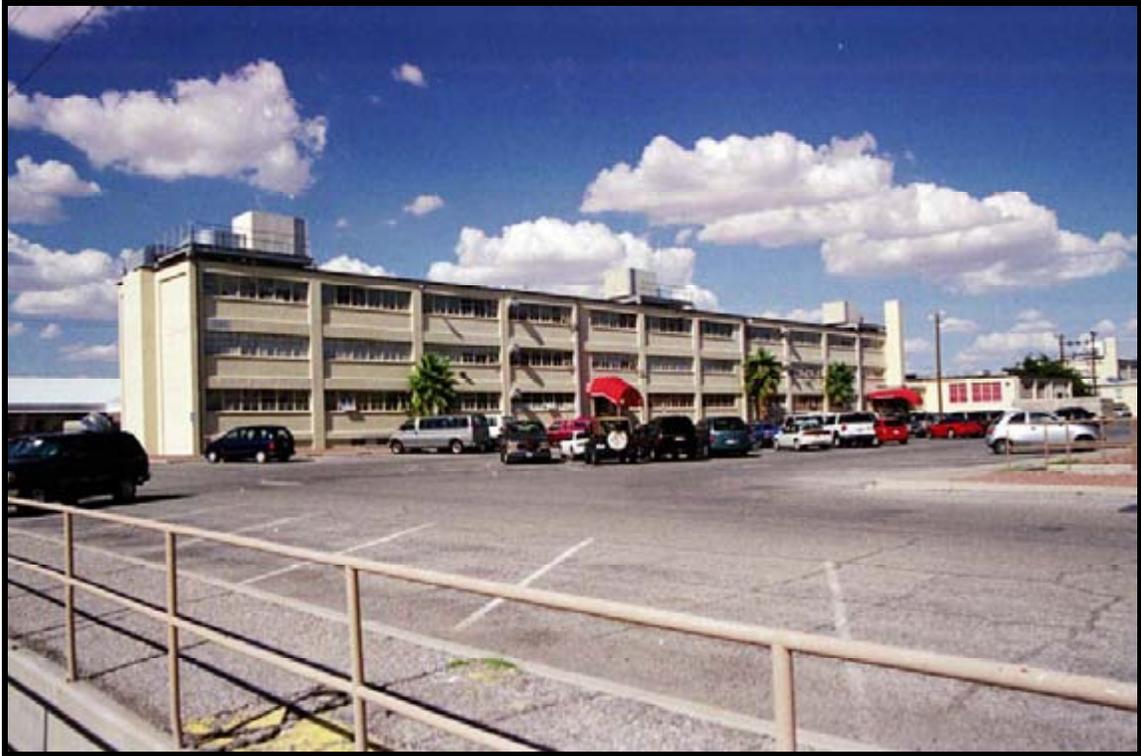
Figure 4.3 225-man hammerhead barracks, Ft. Bliss (RCG&A).

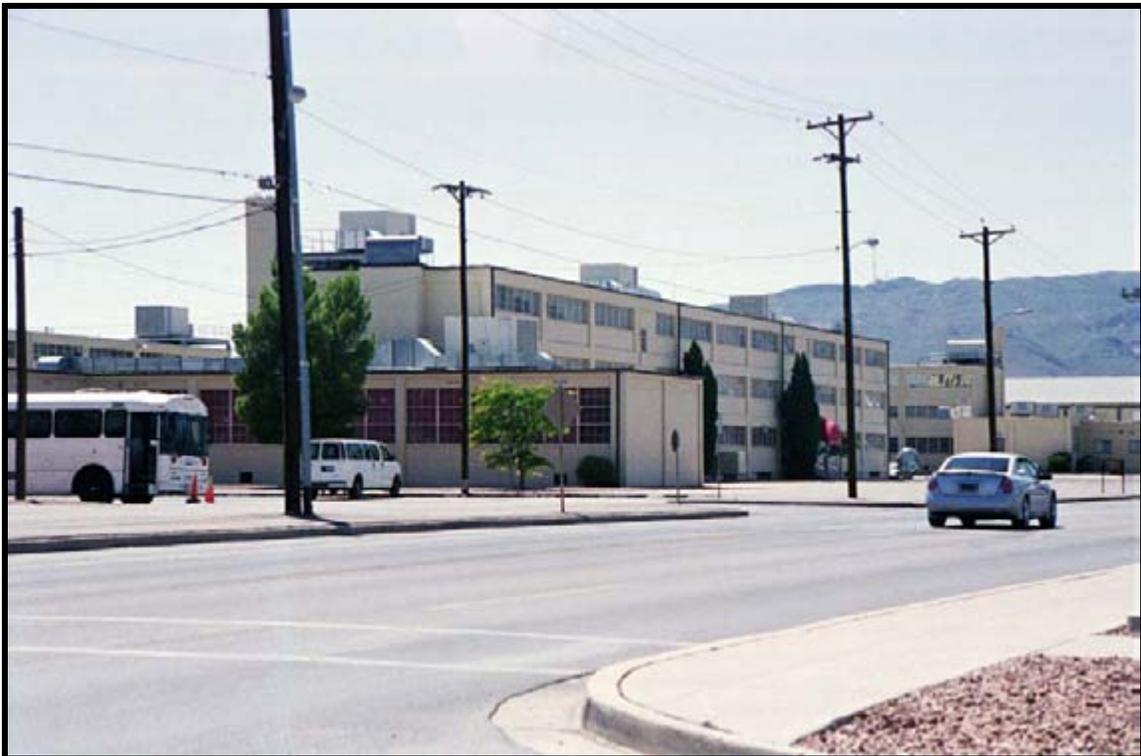
Figure 4.4 225-man hammerhead barracks, Ft. Bliss (RCG&A).

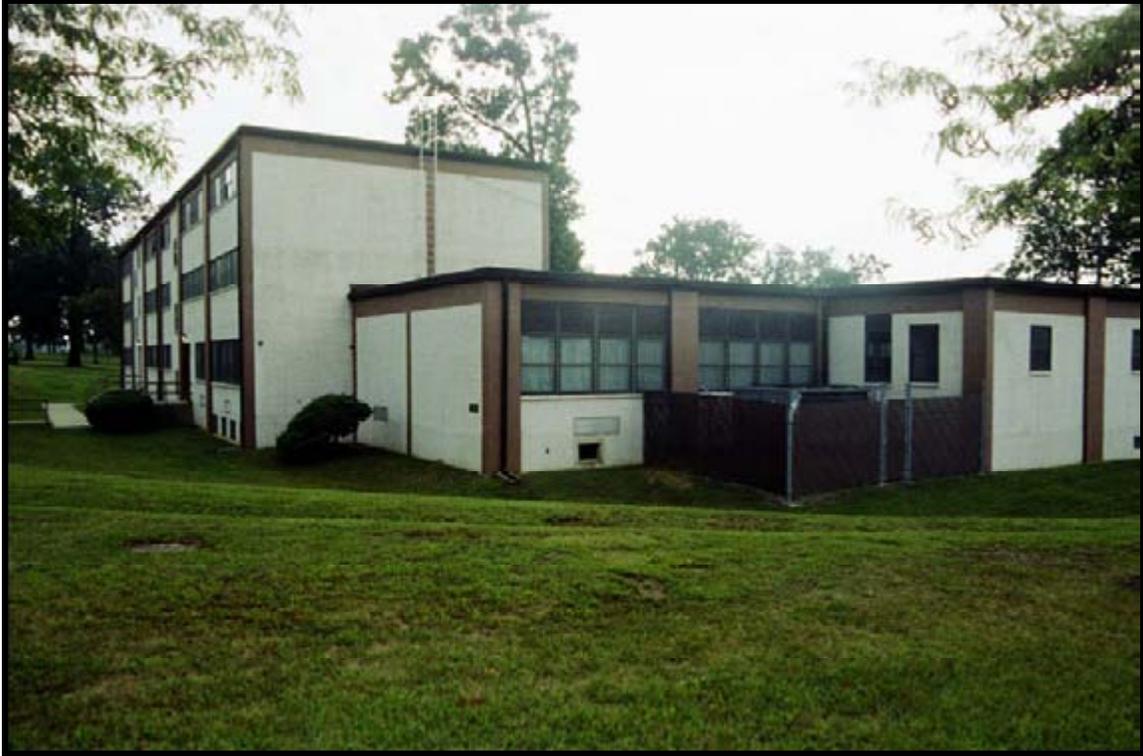
Figure 4.5 105-man hammerhead barracks, Ft. Knox (RCG&A).

The footprint of the 105-man barracks had a smaller kitchen wing. The 105-man barracks only contained one lavatory and small squad room on the second and third floors. Figure 4.5 illustrates 105-man hammerhead barracks.

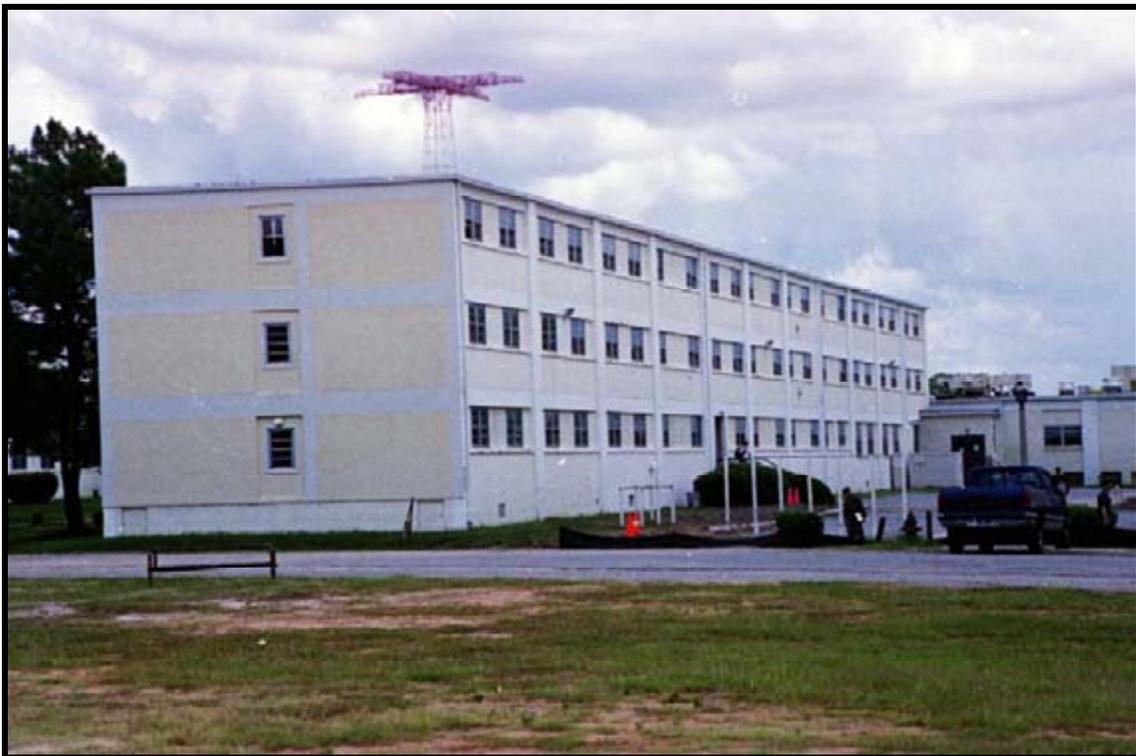
Figure 4.6 Double hammerhead barracks, Ft. Benning (RCG&A).

Fort Benning, Georgia, featured some double hammerhead barracks. In the double hammerhead barracks, the floor plans are the same as a 225-man hammerhead barracks. The buildings were rehabbed in the 1970s under the VOLAR program. Figure 4.6 illustrates a double hammerhead.

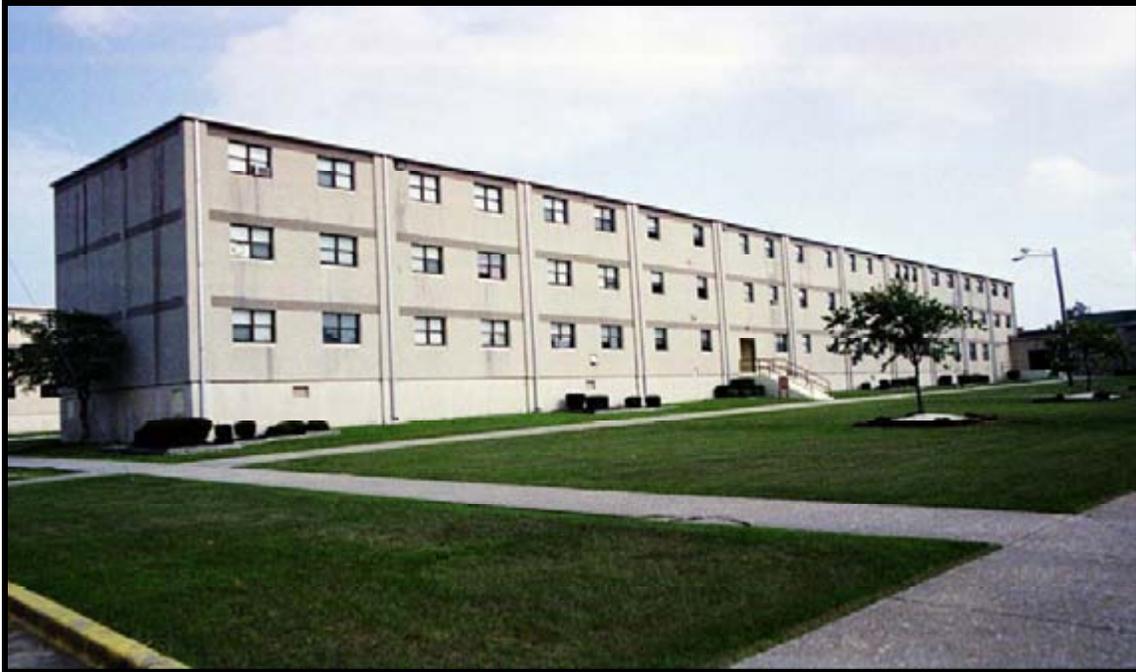
Figure 4.7 Alterations to hammerhead barracks include window replacements and new exterior materials, Ft. Bragg (RCG&A).

In the 1990s, a number of hammerhead barracks were renovated to meet the 2+2 standards and, later, the 1+1 standards, which required suites with one-person rooms. The renovation of these barracks often included stripping the building interiors to the reinforced concrete frame, adding balconies, constructing walls in modern materials, and the addition of gable roofs.

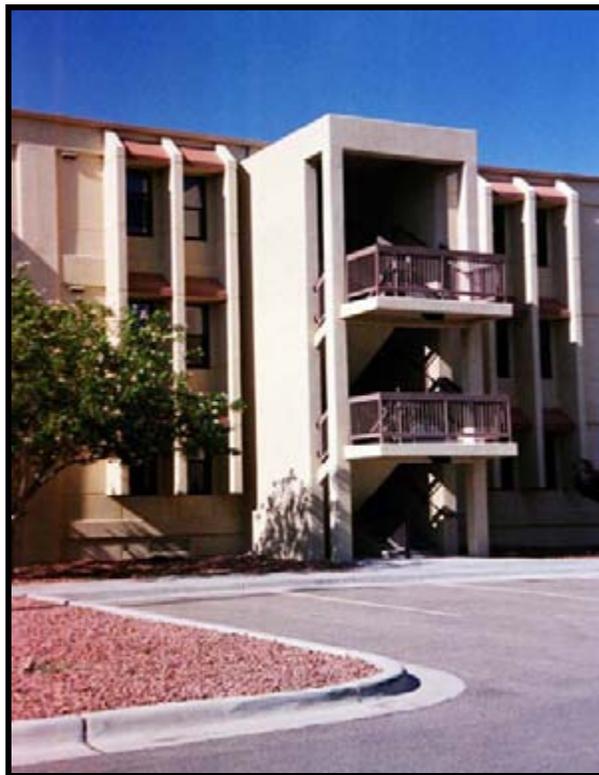
Figure 4.8 Detail of exterior renovation to hammerhead barracks, Ft. Bliss (RCG&A).

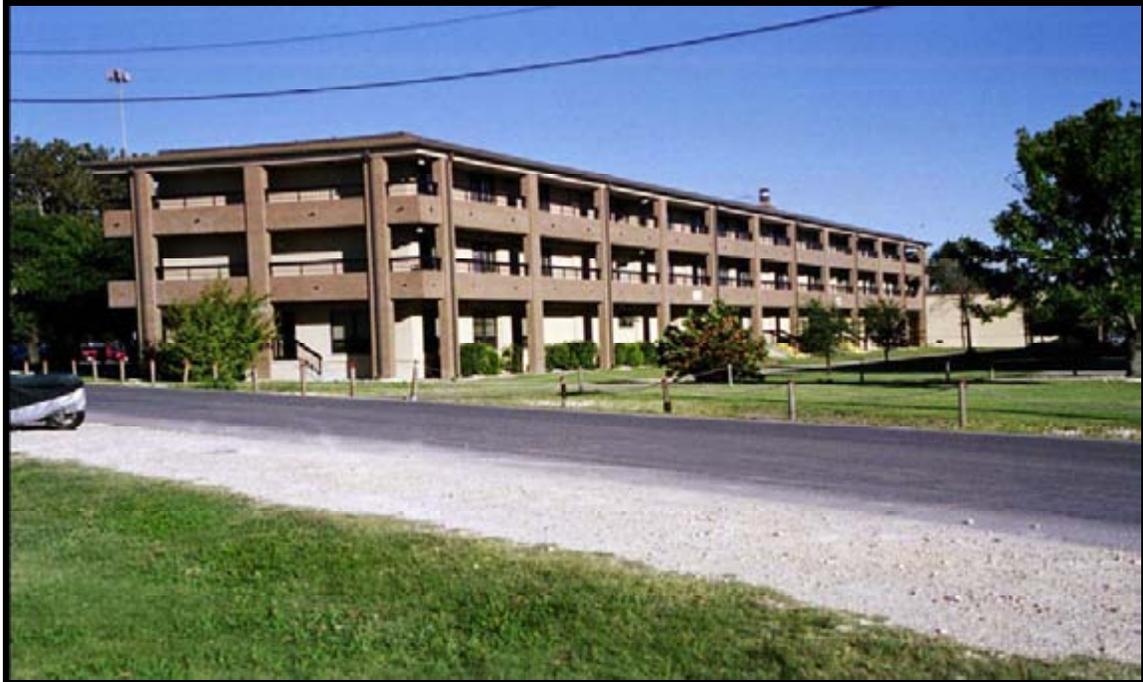
Figure 4.9 Rebuilt hammerhead barracks includes balconies and new exterior materials, Ft. Hood (RCG&A).

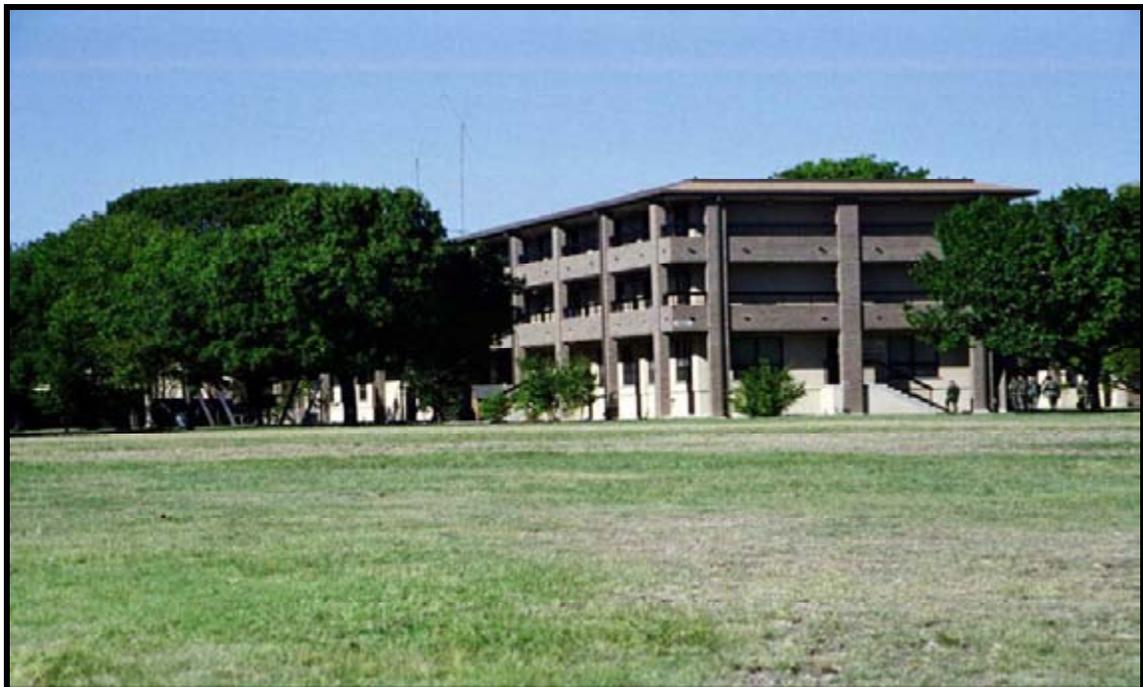
Figure 4.10 Rebuilt hammerhead barracks includes balconies and new exterior materials, Ft. Hood (RCG&A).

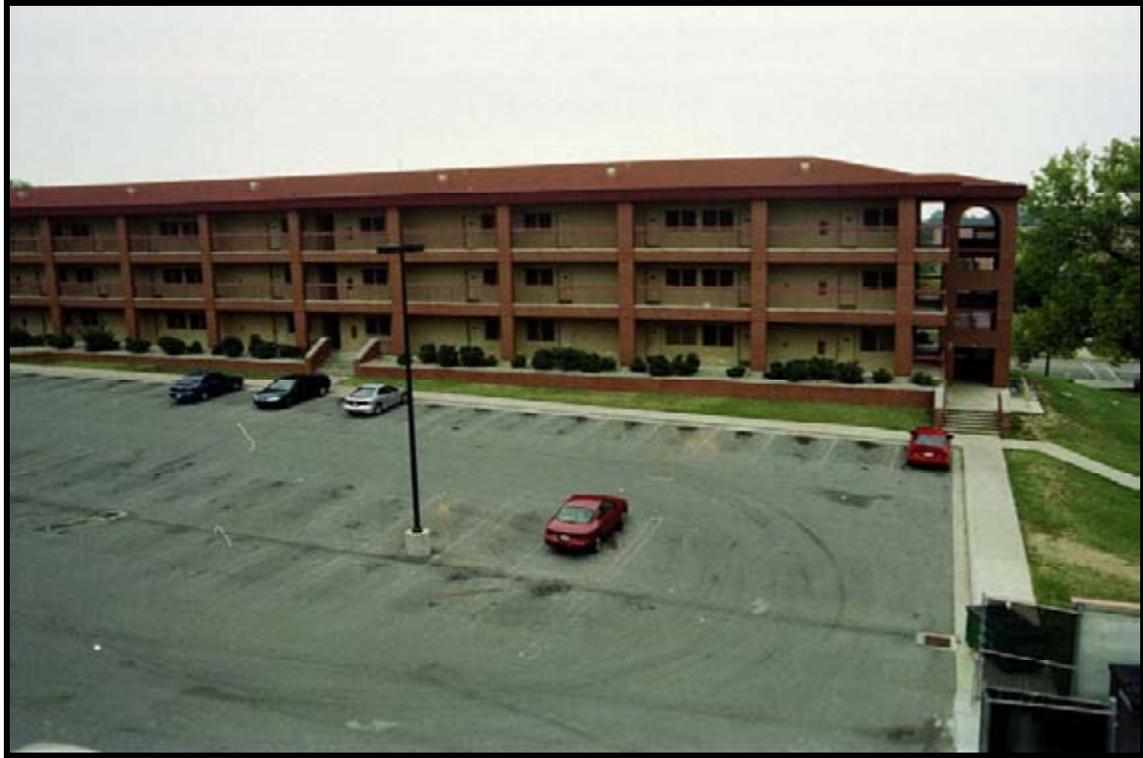
Figure 4.13 Totally renovated hammerhead barracks, Ft. Knox (RCG&A).

In the early 1990s, many hammerhead barracks were modernized to meet the new 2+2 standards, which required that barracks contain suites of two person rooms. In such cases, the buildings were gutted to the reinforced concrete frame and the interiors were rebuilt with modern materials including metal stud walls, new windows, and modern exteriors. A small number of the barracks also received exterior staircases, which freed interior space (Figure 4.8). In a small number of rebuilt hammerhead barracks, the interior hallways were removed and replaced with exterior balconies and doorways (Figures 4.9 and 4.10). Figure 4.11 illustrates a hammerhead complex at Fort Knox, Kentucky, which was the most extensively rebuilt barracks examined during the site visits. The kitchen and mess hall wing had a new plan and extensive exterior modifications (Figure 4.12). The barracks wing featured a hipped roof, wrap around balconies, exterior stairs, and an enlarged parking lot (Figures 4.13 and 4.14).

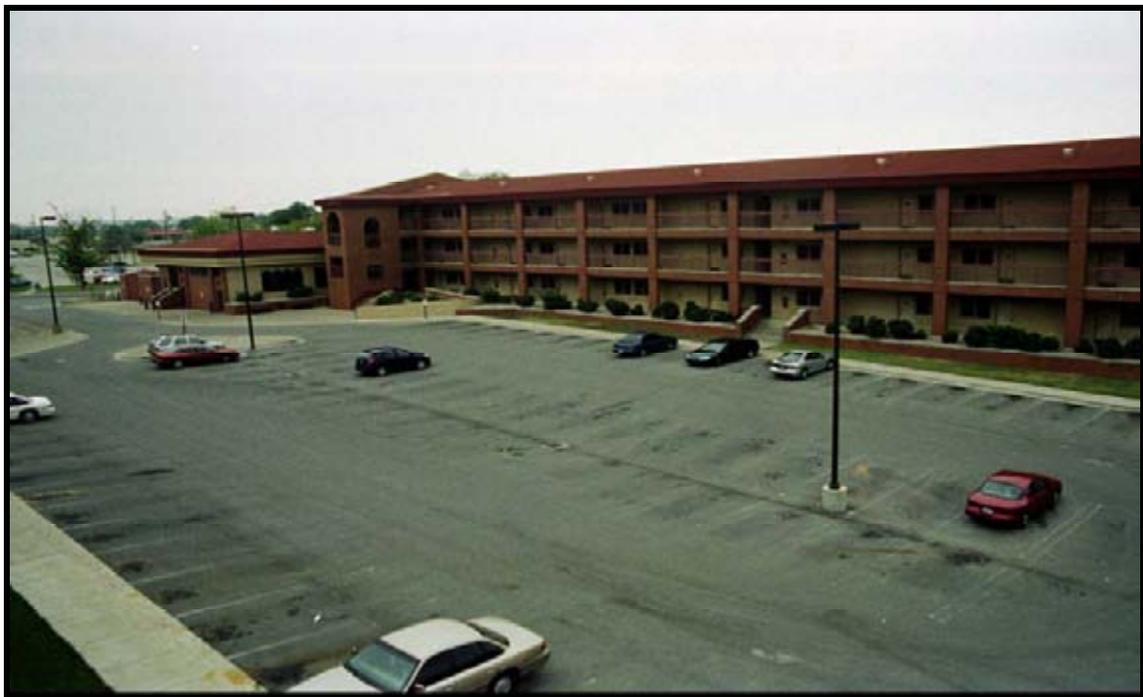
Figure 4.14 Totally renovated hammerhead barracks, Ft. Knox (RCG&A).
