**UNACCOMPANIED PERSONNEL HOUSING (UPH)  
DURING THE COLD WAR  
(1946-1989)  
UNRESTRICTED**

**U.S. ARMY ENVIRONMENTAL COMMAND  
ABERDEEN PROVING GROUND, MARYLAND 21010-5401**

**January 2007**

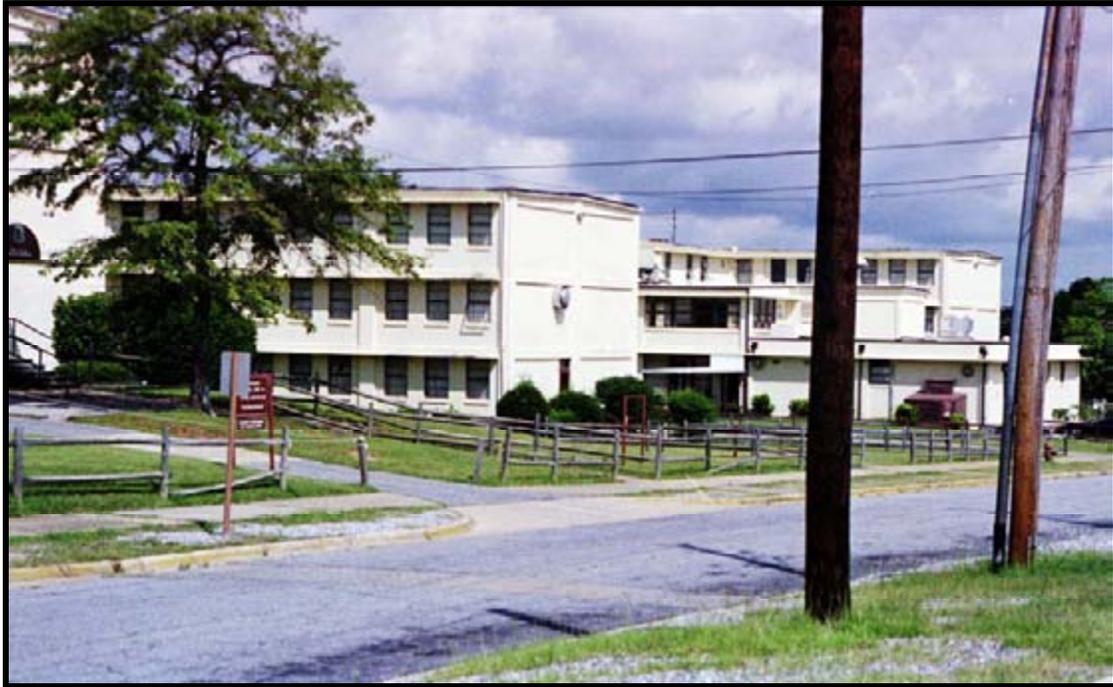
Figure 4.15 Detail of mess wing, H-style, two-company barracks, Ft. Benning (RCG&A).

A small variation in the exterior of H-style barracks was found. While most barracks had no sunshades, some buildings at Ft. Benning, Georgia, featured a brise soliel, a projecting concrete sunshade over the windows (Figure 4.15). The brise soliel shielded the windows from sun and rain, helping ventilation in inclement weather.

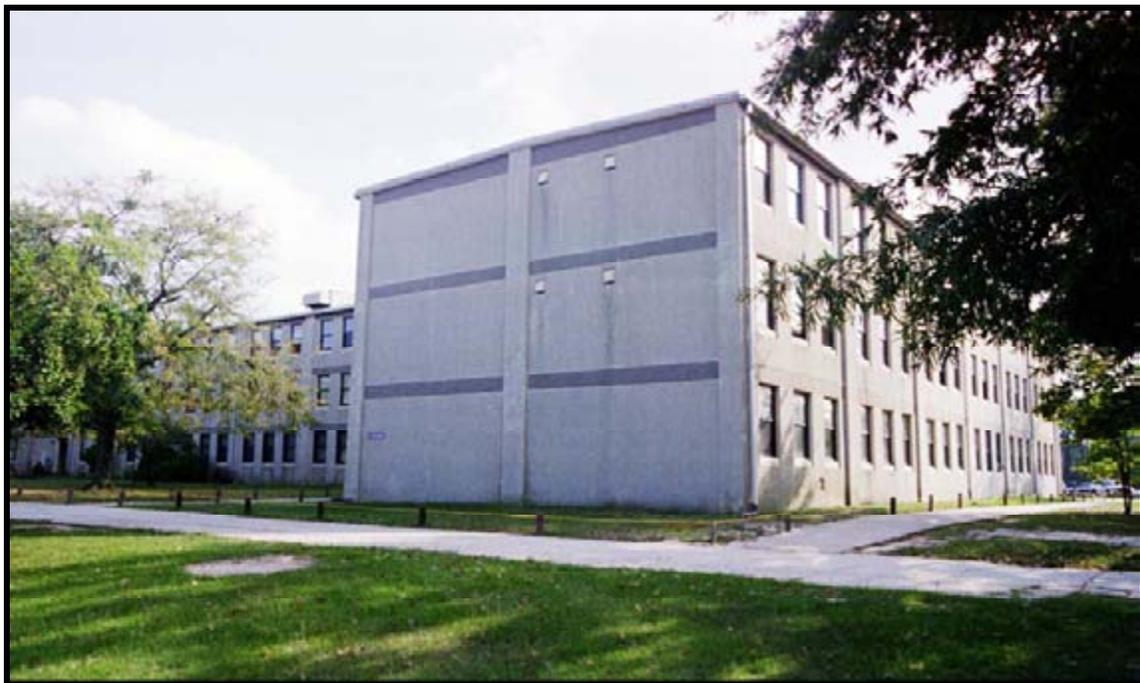
Figure 4.16 Alterations to H-style, two-company barracks include new windows and exterior materials, Ft. Bragg (RCG&A).

H-style barracks were modified with the introduction of the Volunteer Army (VOLAR) program in the 1970s. The most common change under the VOLAR program was the division of the squad rooms into two- and four-person enlisted man rooms. Additional modifications included the introduction of new exterior materials (Figures 4.16 and 4.17).

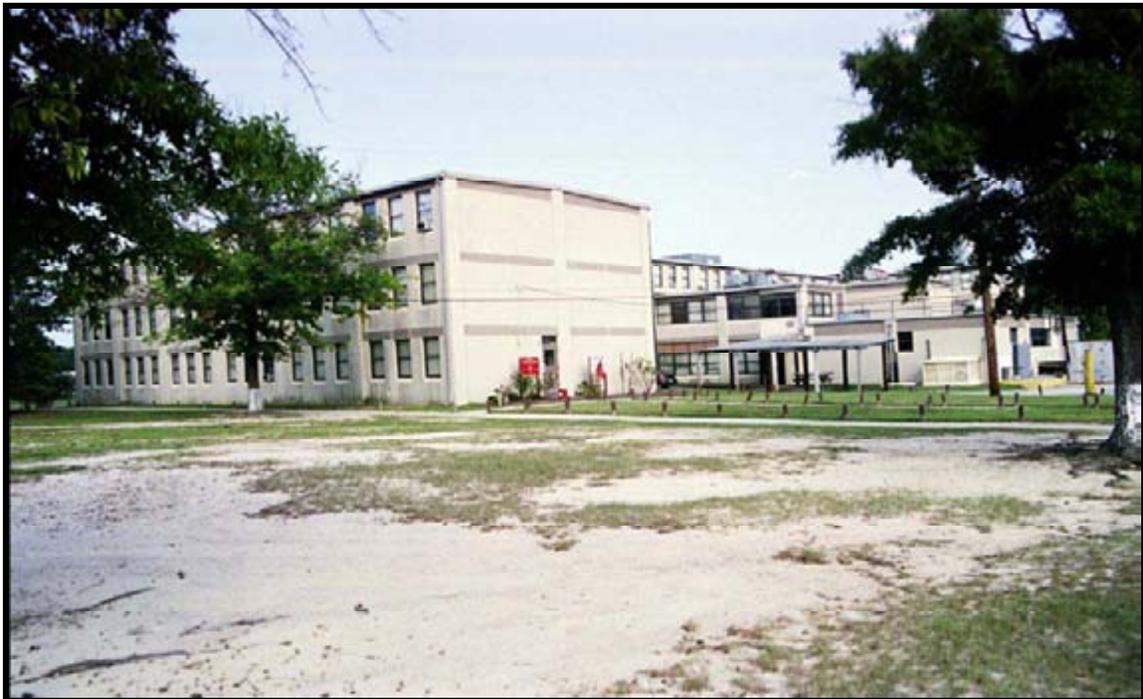
Figure 4.17 Alterations to H-style, two-company barracks include new windows and exterior materials, Ft. Bragg (RCG&A).

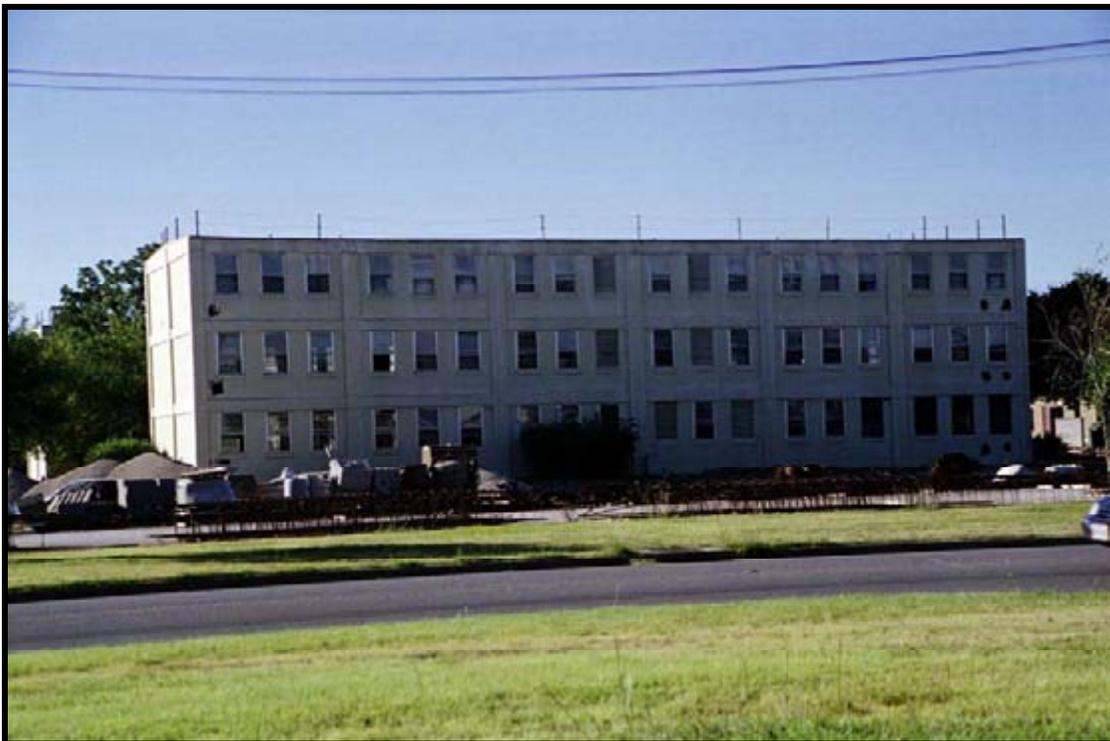
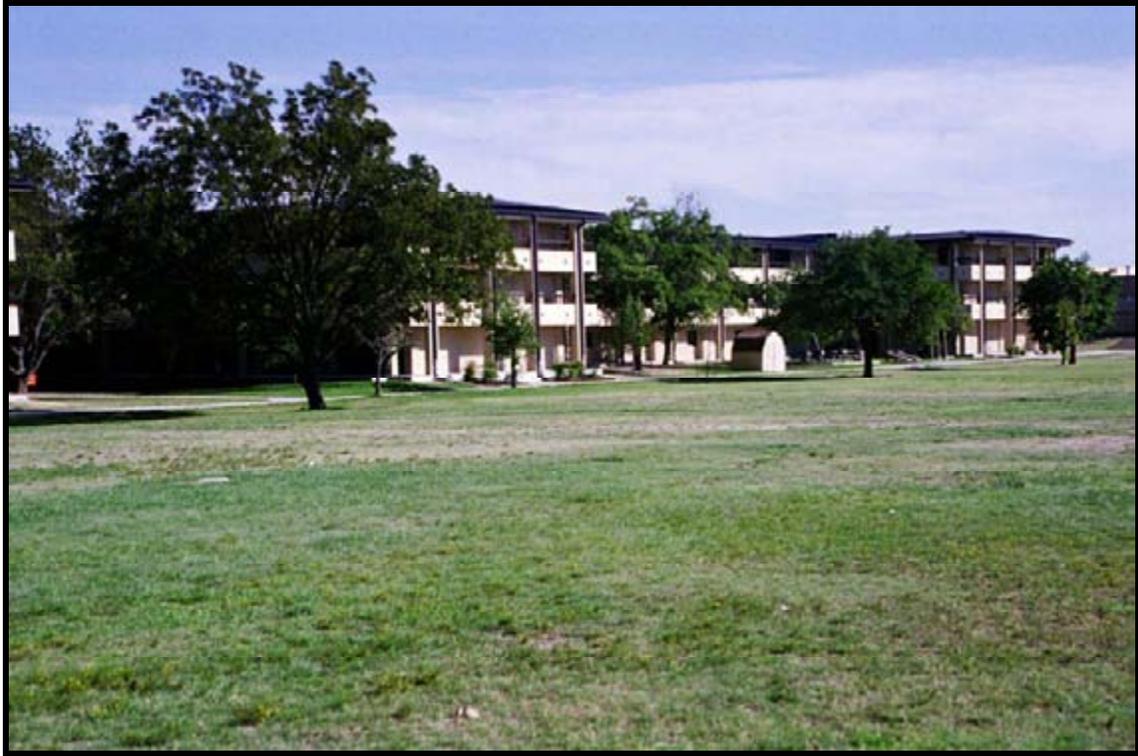
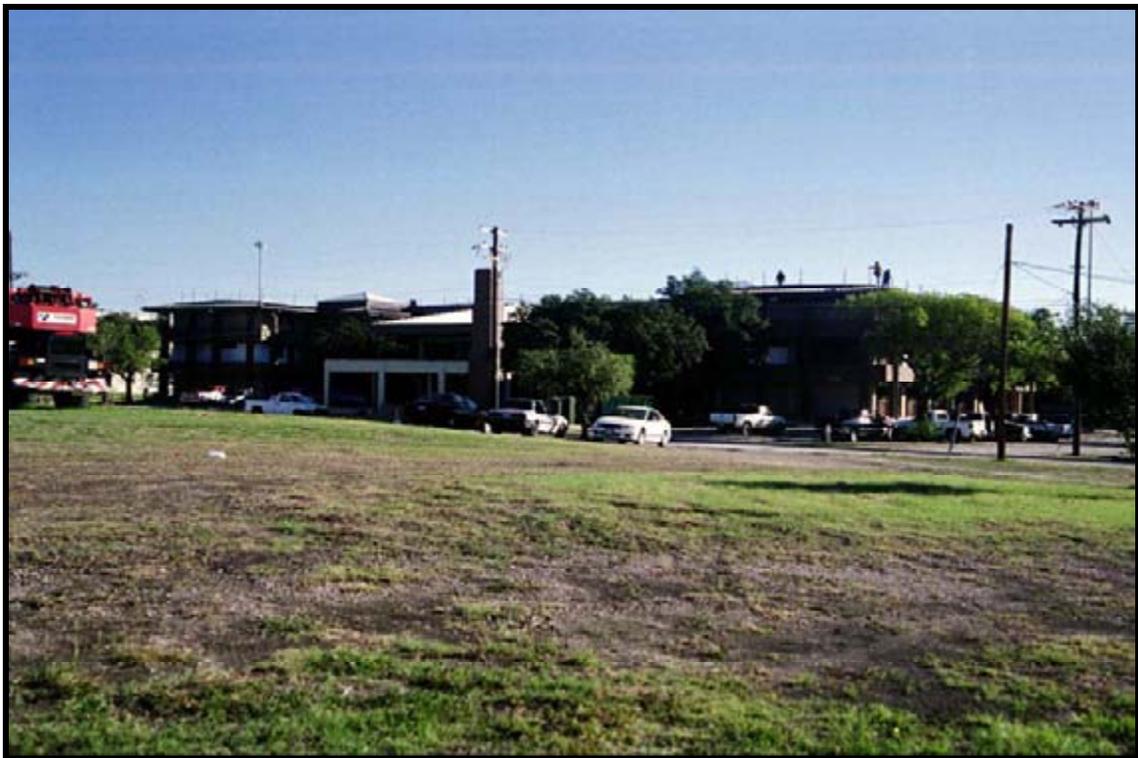
Figure 4.18 Renovated H-style, two-company barracks, Ft. Hood (RCG&A).

Figure 4.19 Renovated H-style, two-company barracks, Ft. Hood (RCG&A).

Figure 4.20 Renovated H-style, two-company barracks, Ft. Hood (RCG&A).

From the 1990s to the present, a number of H-style barracks have undergone complete renovation. The renovation of these barracks has included stripping the buildings to the reinforced concrete frames and adding balconies, gable roofs, and new walls utilizing modern materials. H-style

barracks that have undergone extensive renovation generally do not retain their original integrity of design, materials, workmanship, or feeling (Figures 4.18 through 4.20).

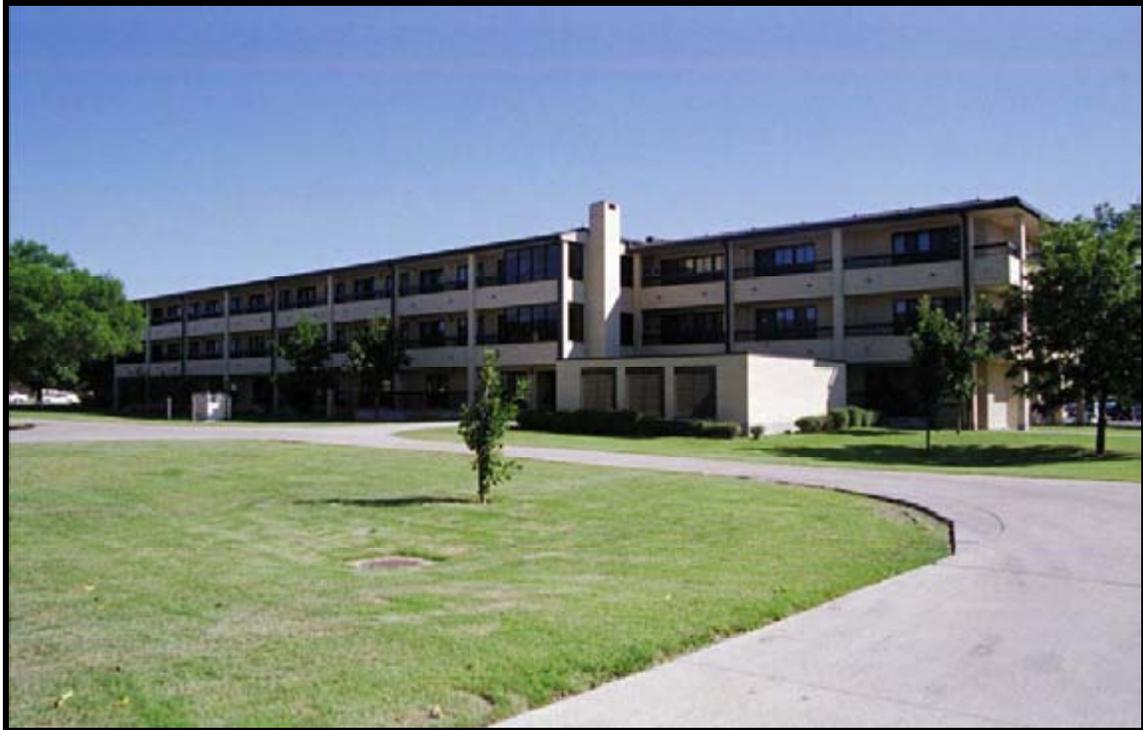
Figure 4.29 Renovated Rolling Pin, two-company barracks, Ft. Hood (RCG&A).

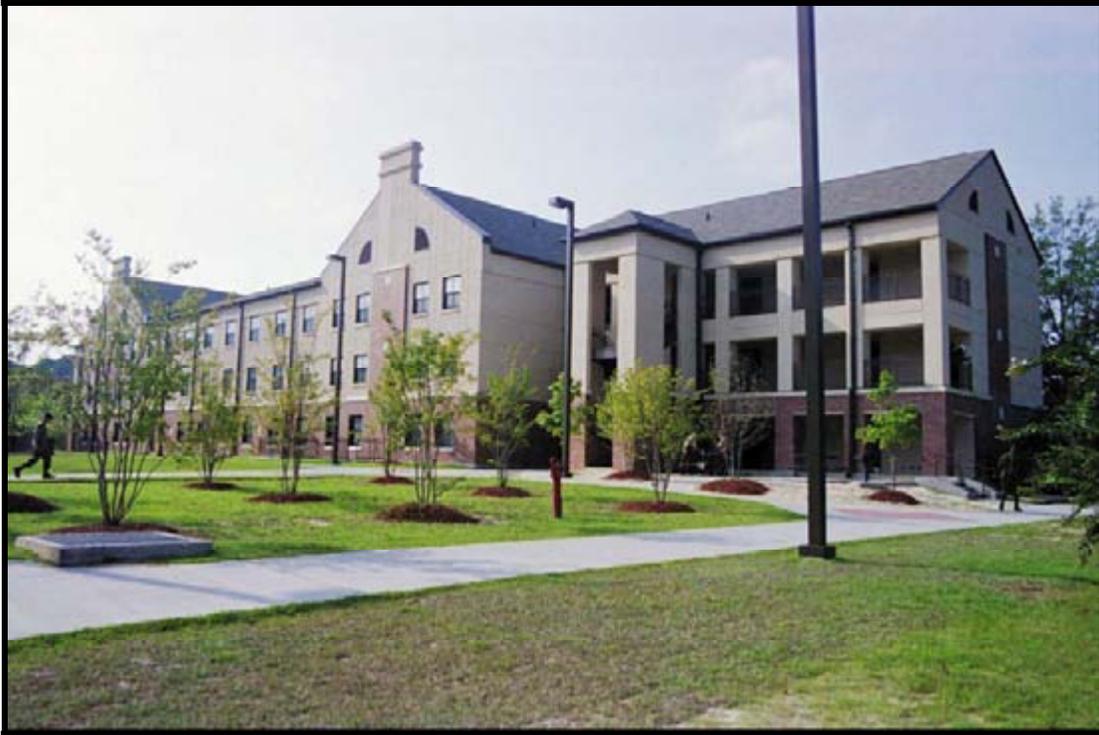
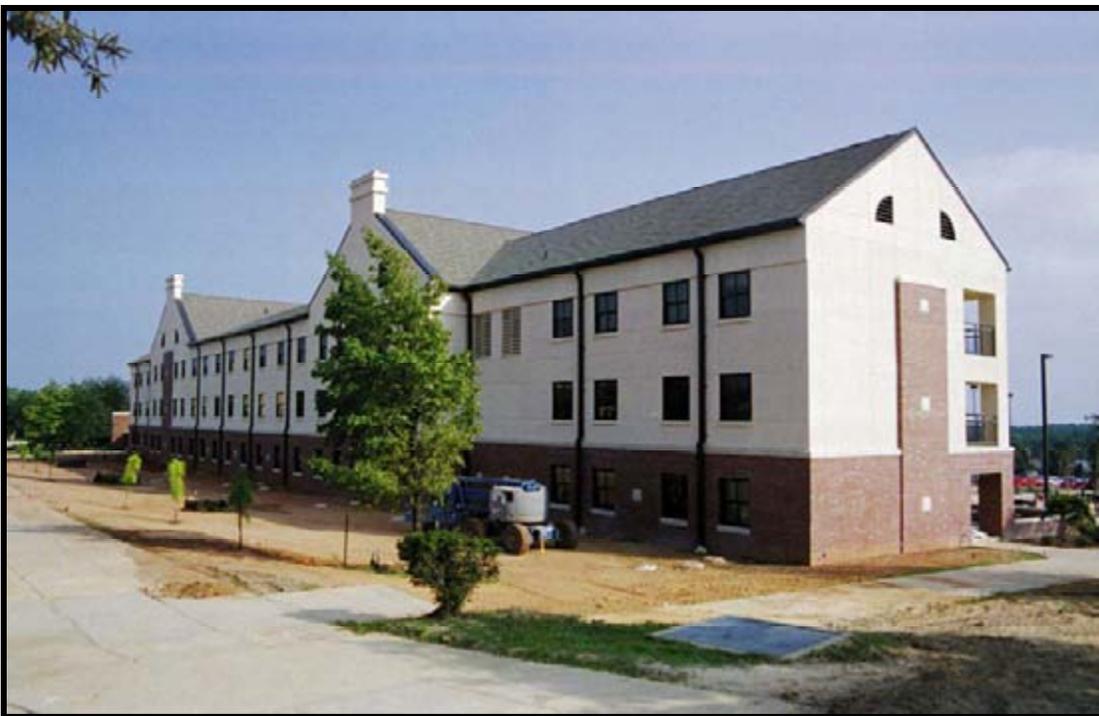
Figure 4.31 Renovated Rolling Pin, two-company barracks, Ft. Bragg (RCG&A).

The first rolling pin barracks underwent significant modifications in the 1990s. One group of rolling pin barracks has been renovated at Fort Hood. The renovations are similar to renovations undertaken to the hammerhead barracks and H-style barracks. Most notably, balconies and gable roofs have been added. In addition, walls were removed and rebuilt, and floor plans altered (Figures 4.29 and 4.30). This pattern of modification also was found in examples of the barracks type located at Fort Bragg. Changes include the addition of balconies and exterior stairs on the end wings, new exterior materials, and the addition of prominent cross gable roofs with faux chimneys on the cross gable-ends (Figures 4.31 and 4.32).

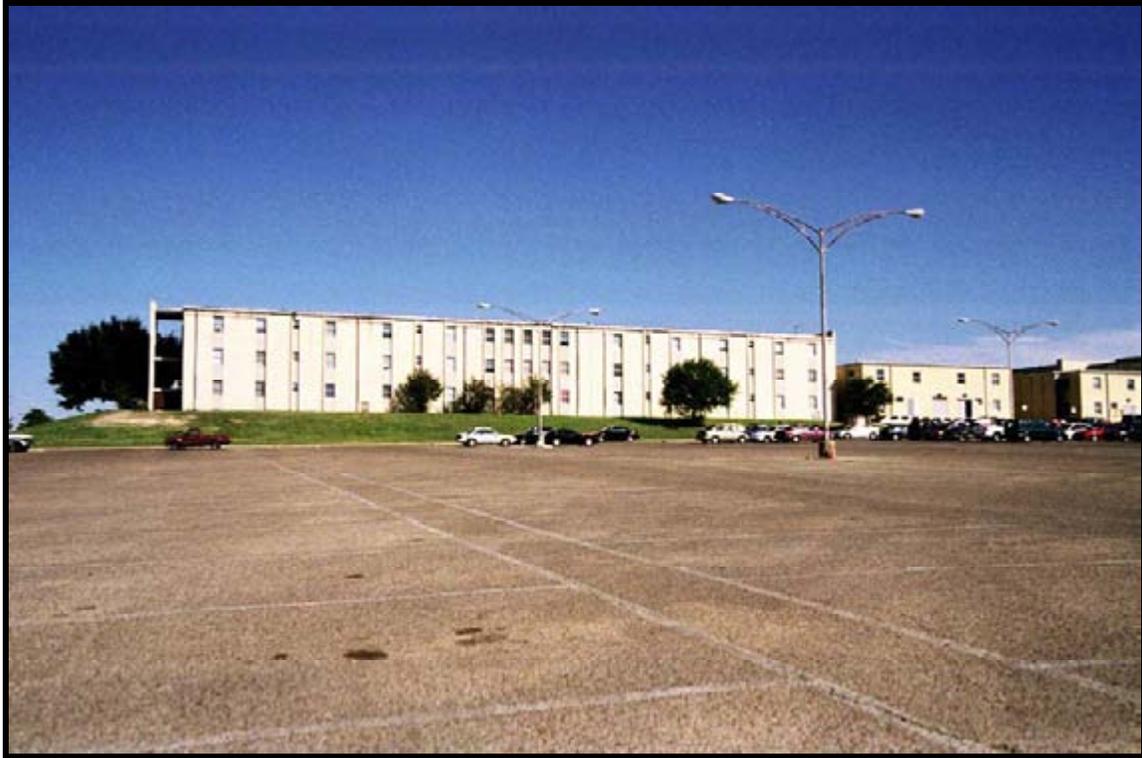
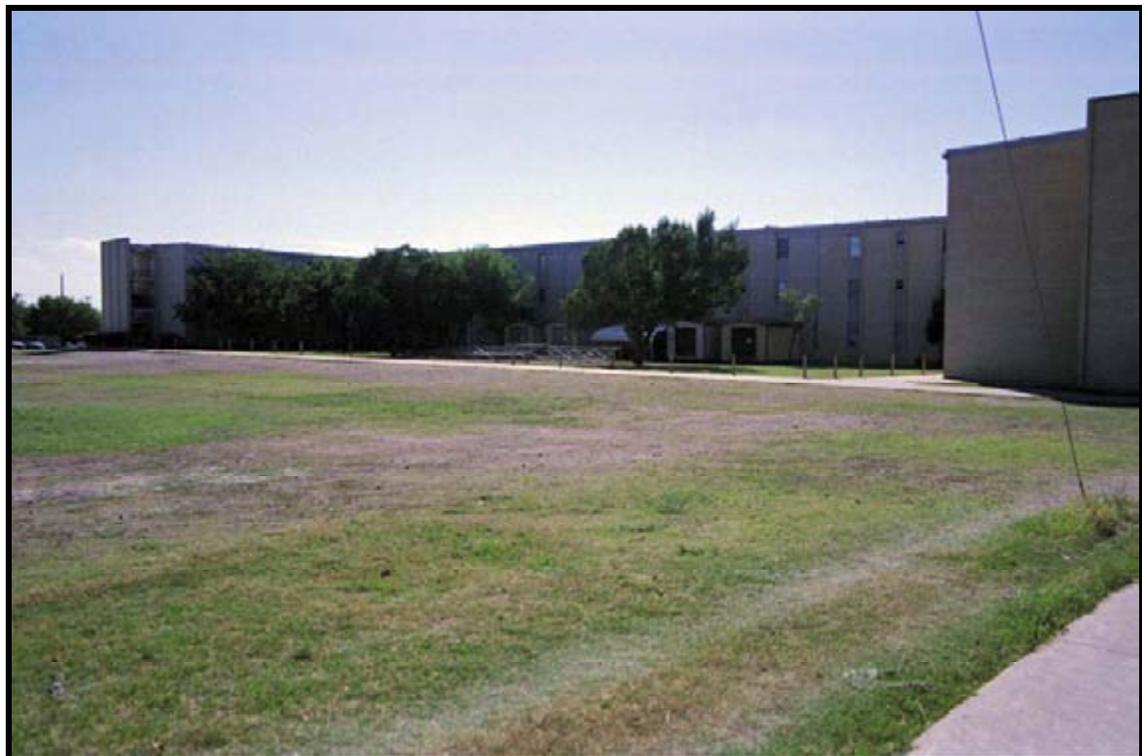
Figure 4.33 A-style barracks, Ft. Hood (RCG&A).

No modifications to the original design of the A-style barracks were noted during the field investigations (Figures 4.33 and 4.34). All examples survived intact and retained their original architectural design and materials (Figures 4.35 and 4.36).

The character-defining features of A-style barracks are distinctive floor plan, brick walls, mass, and scale. At the time of the site visit, the A-style barracks at Fort Hood retained integrity of location, design, setting, materials, workmanship, feeling, and association. The integrity was high since the barracks were only 30 years old and had not been modified.

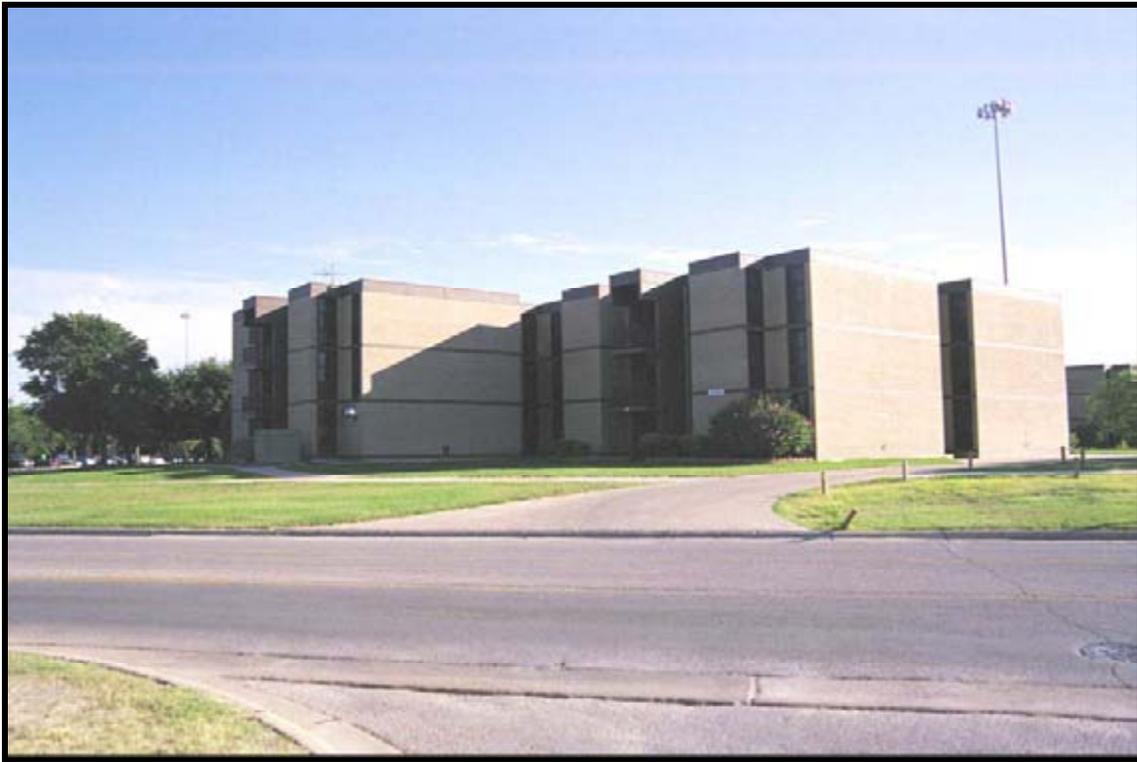
Figure 4.37 LBC&W barracks, Ft. Hood (RCG&A).

Figure 4.37 illustrates typical LBC&W barracks. LBC&W barracks have undergone some improvements. Examples at Fort Bragg have been fitted with a cross gable roof (Figures 4.38 and 4.39). At Fort Polk, the barracks underwent similar changes, but the roofs are done in a darker color scheme.

The character-defining features of the Lyles, Bissett, Carlisle, & Wolff barracks are the distinctive ground plan of the twelve-man four-bedroom modules, the three-story scale, and the brick materials. A number of LBC&W barracks have been upgraded through the installation of new cross gable roofs and energy efficient windows. The barracks and associated support buildings generally retain their overall architectural integrity.

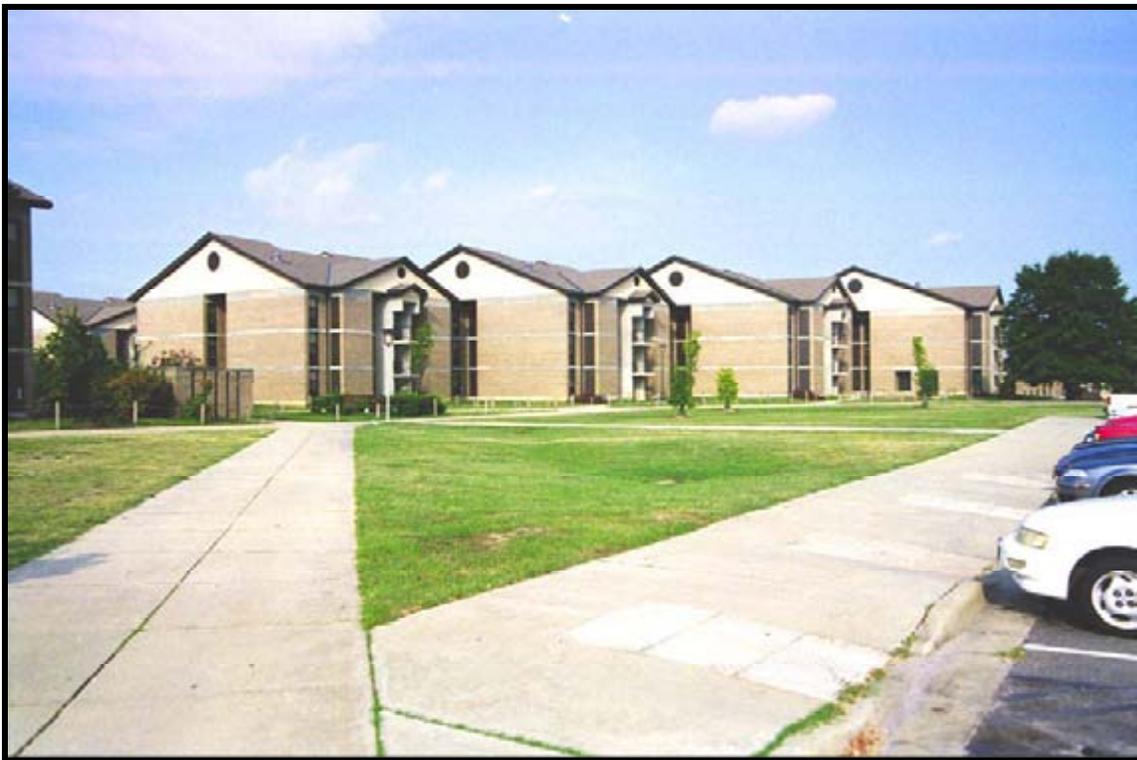
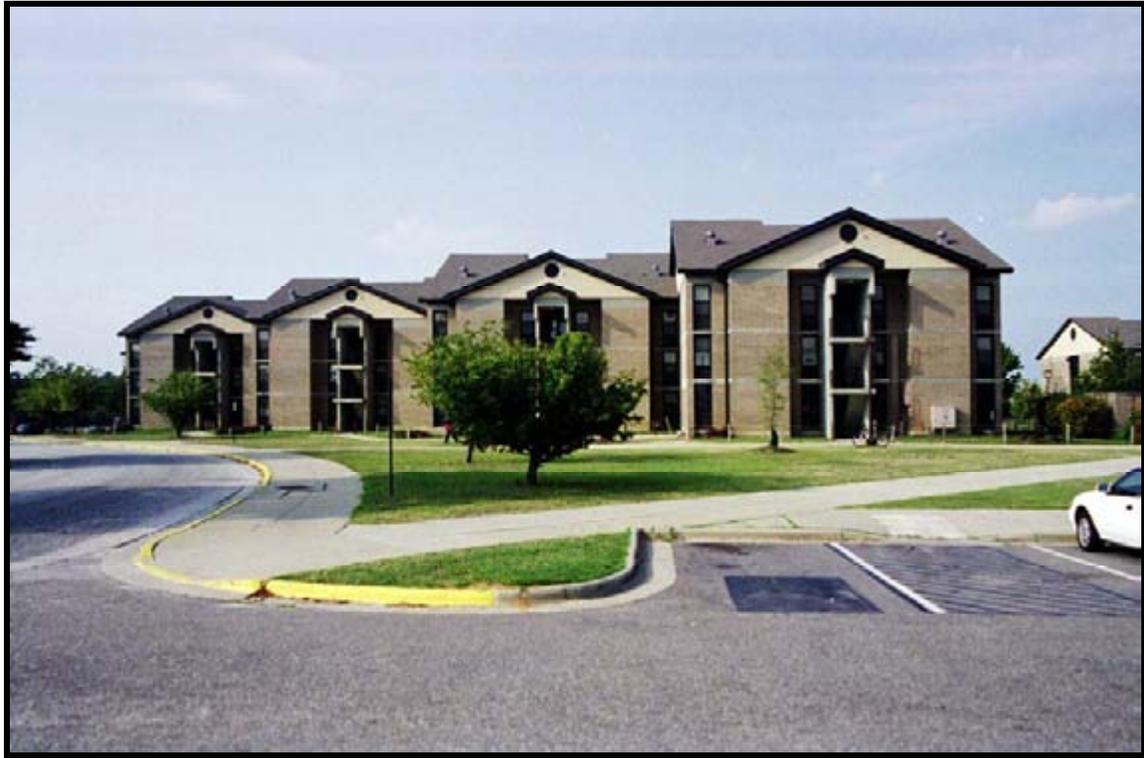
Figure 4.38 LBC&W barracks, Ft. Bragg (RCG&A).

The LBC&W barracks have undergone few changes. The most common modifications included the addition of cross gable roofs on the barracks and the replacement of original windows with energy-efficient units. The gable roofs concealed new heating and air conditioning equipment (Figures 4.38 and 4.39). A number of LBC&W dining facilities also included new cross gable roofs (Figures 4.40 and 4.41).

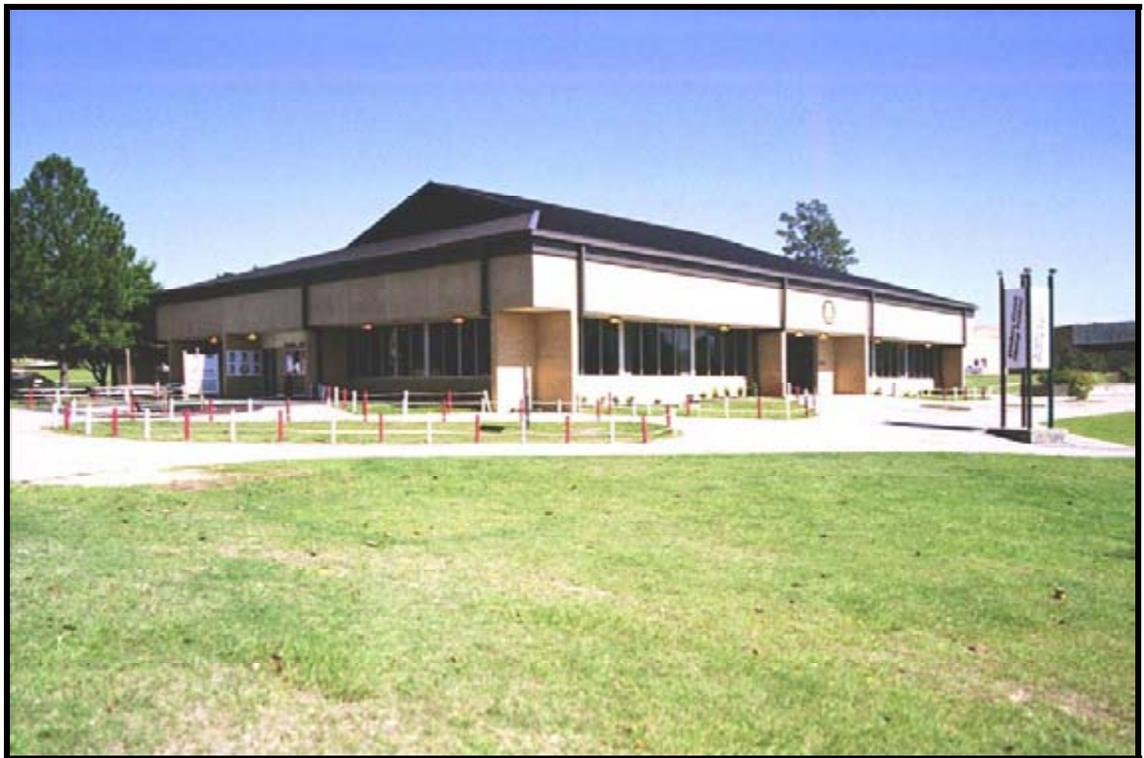
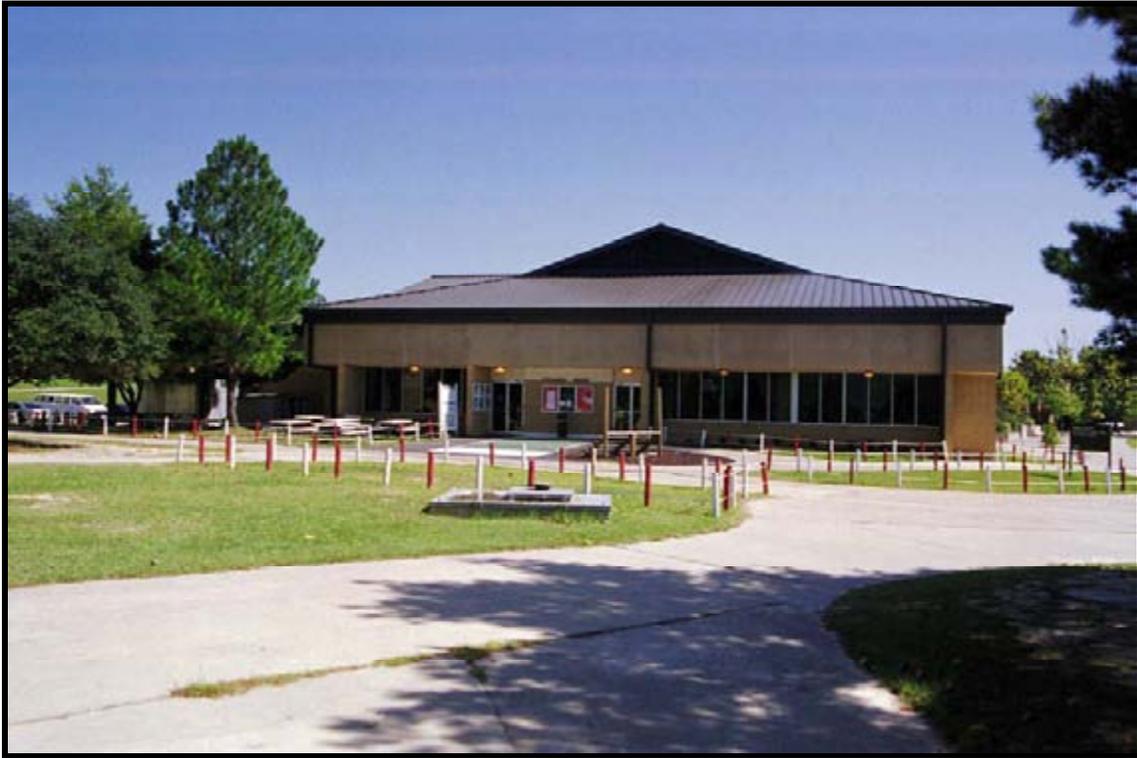
Figure 4.40 LBC&W dining facility, Ft. Polk (RCG&A).

The floor plans were consistent with earlier consolidated dining facilities. The kitchens were located at the rear of the buildings. The entrances provided direct access to the two serving areas. Large open dining rooms occupied the front of the buildings (Figures 4.40 and 4.41).

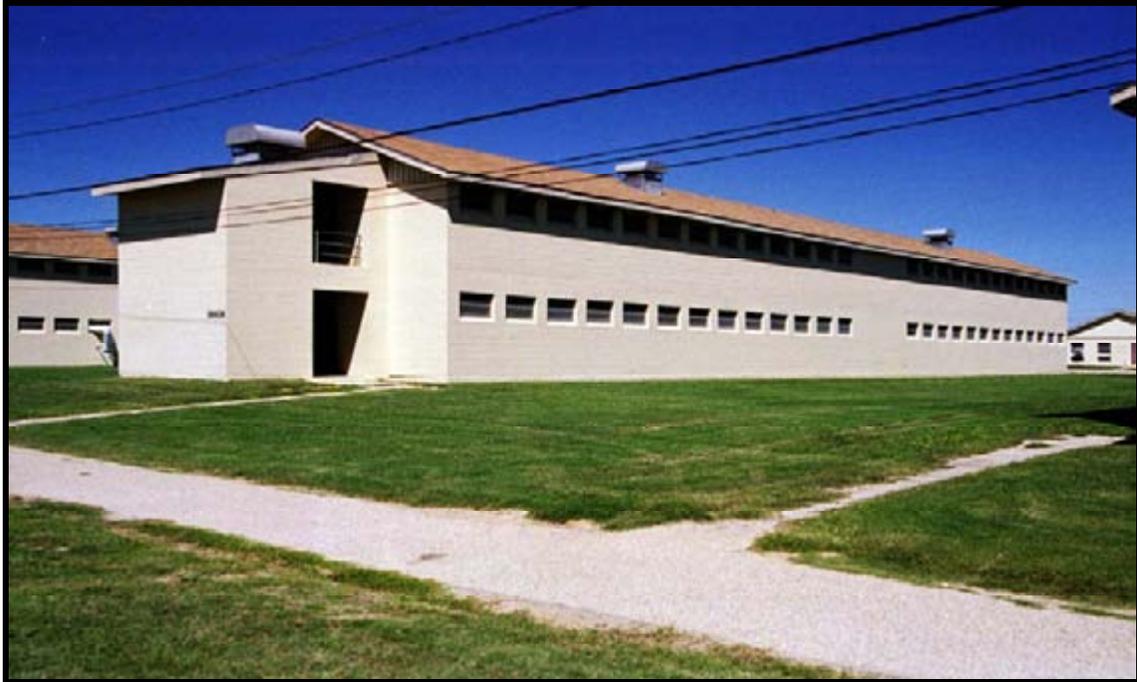
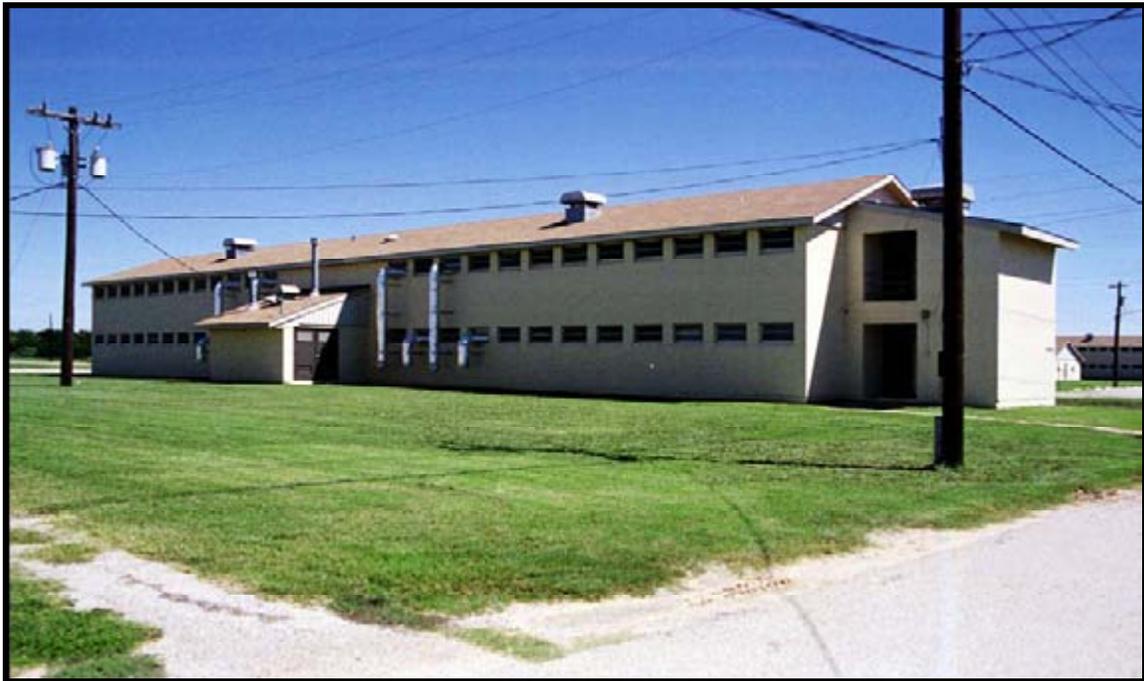
Figure 4.44 Two-story barracks, North Ft. Hood (RCG&A).

The Army Reserve annual training barracks were similar in overall design to earlier designs for semi-permanent and mobilization barracks. The type differs in materials. Two sub-styles of these simple Army Reserve annual training structures were developed: a one-story and a two-story design. Both versions were long, rectangular concrete-block buildings that terminate in front gable roofs sheathed in composition shingles. The gable-ends were clad with vertical siding. The entrances featured single-light metal doors and were located at the ends of the building. The buildings featured one-over-one-light, metal sash windows. The two-story designs featured exterior stairs at the both ends of the buildings. Both designs included open squad rooms located at the ends of the building and central latrines. Photographs of the one-story version show the simple ornamentation (Figures 4.42 and 4.43). The design of the two-story version incorporated stairs on the gable ends (Figures 4.44 and 4.45).

features of the Army Reserve annual training barracks are the rectangular footprint, exposed concrete block walls, the front gable roofs, the gable-ends clad with vertical siding, and the one-over-one-light, metal sash windows. The North Fort Hood examples retain their integrity of location, design, setting, materials, workmanship, feeling, and association from the period of their construction.

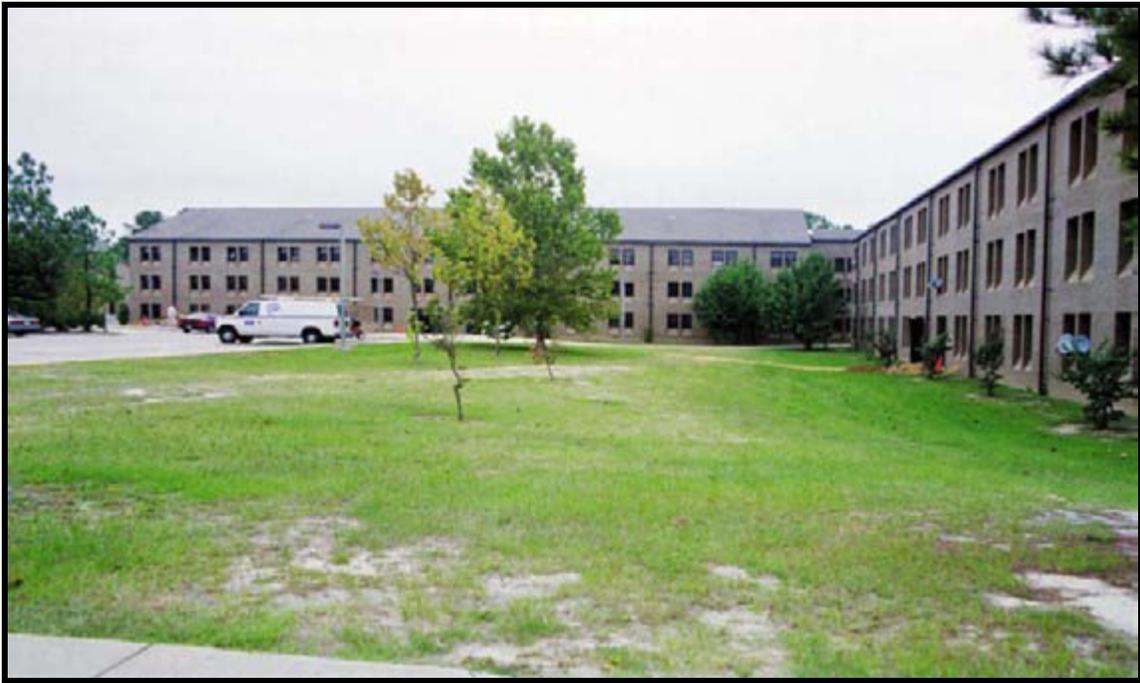
Figure 4.54 Double Quadrangle barracks, Ft. Bragg (RCG&A).

The L-shaped design consisted of two principal blocks sited perpendicular to one another and joined by a connector building. The three-story connector building featured a lobby, two day rooms, and a laundry room on each floor. Stairs were located in the connector building and at the outer ends of the principal blocks. The same floor plan was utilized on the second and third floors. Landscaping around the quadrangle barracks was sparse with small bushes along the elevations and trees near the entrance (Figure 4.54).

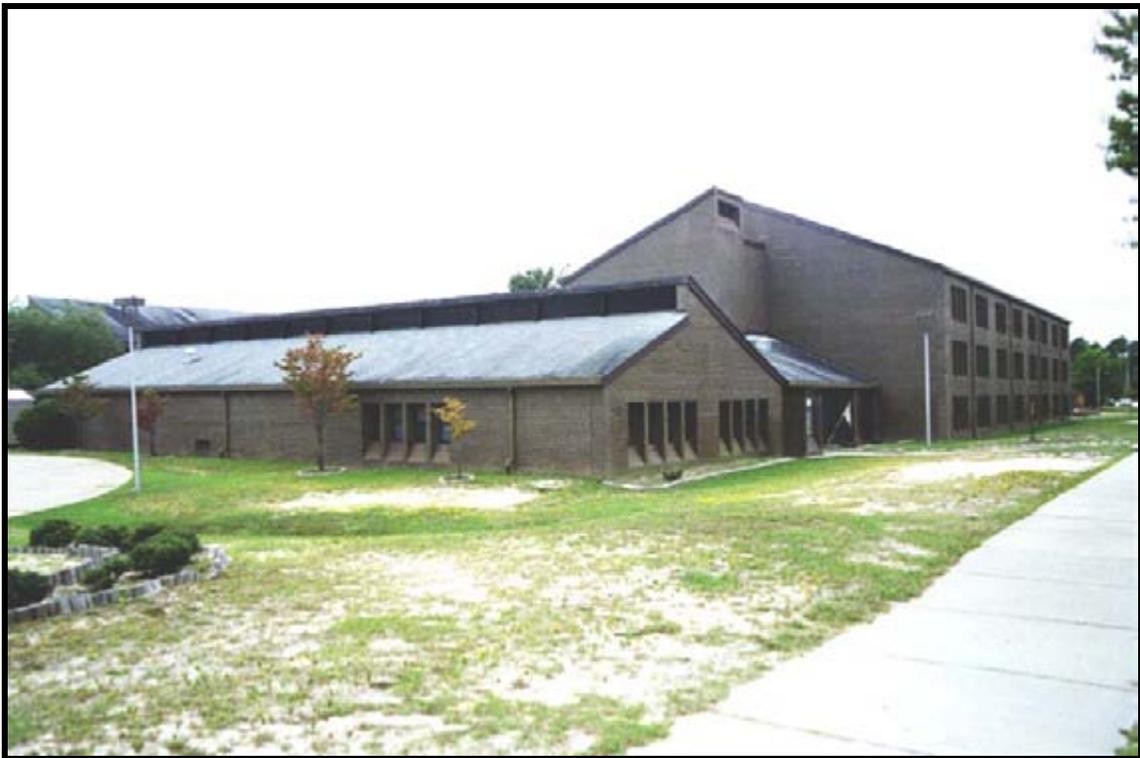
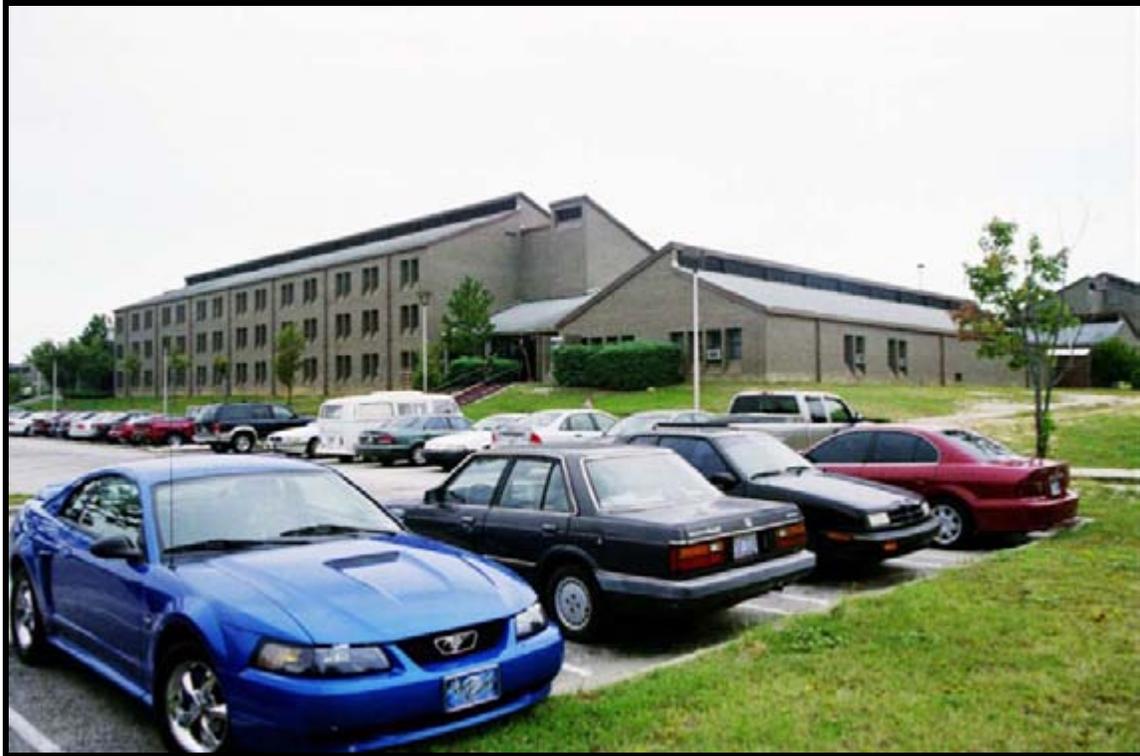
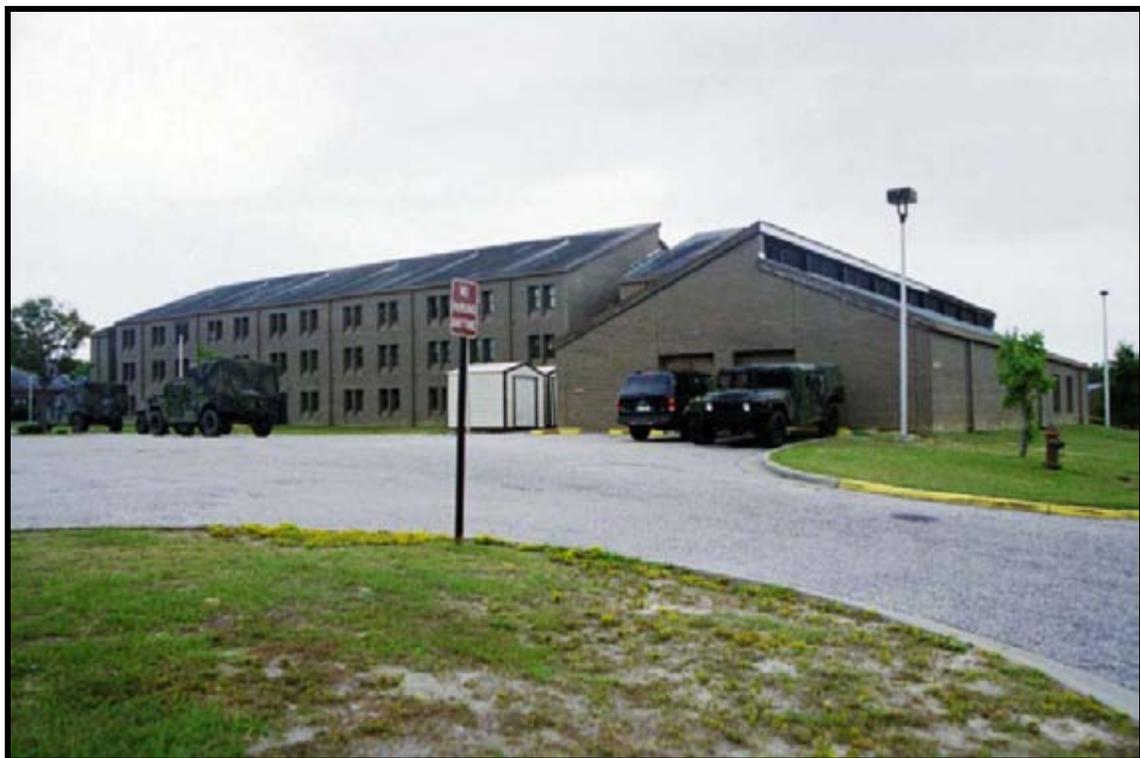
Figure 4.55 Quadrangle barracks, Ft. Bragg (RCG&A).

The character-defining features of the principal block were also found in the administration and supply wings. The wings featured brick construction, an overlapping gable roof, and grouped one-over-one-light, metal-sash windows. The administration offices were clustered near the principal block and unit storage was located at the ends of the “C”. Figures 4.55 and 4.56 show the quadrangle barracks complex, while Figure 4.57 is from the interior of the complex.

The character-defining features of the quadrangle barracks are brick construction, an overlapping gable roof, and one-over-one-light, metal-sash windows. No modifications to the buildings were documented due to their recent construction. The quadrangle barracks are anticipated to retain integrity of location, design, setting, materials, workmanship, feeling, and association.

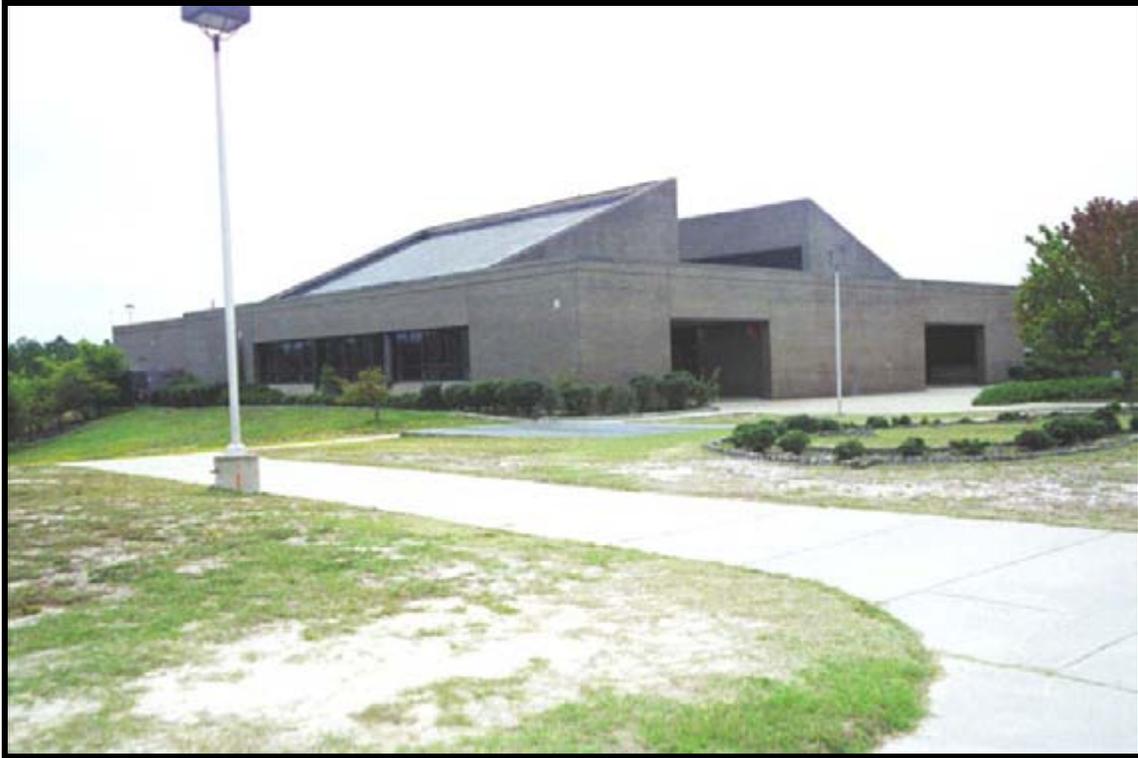
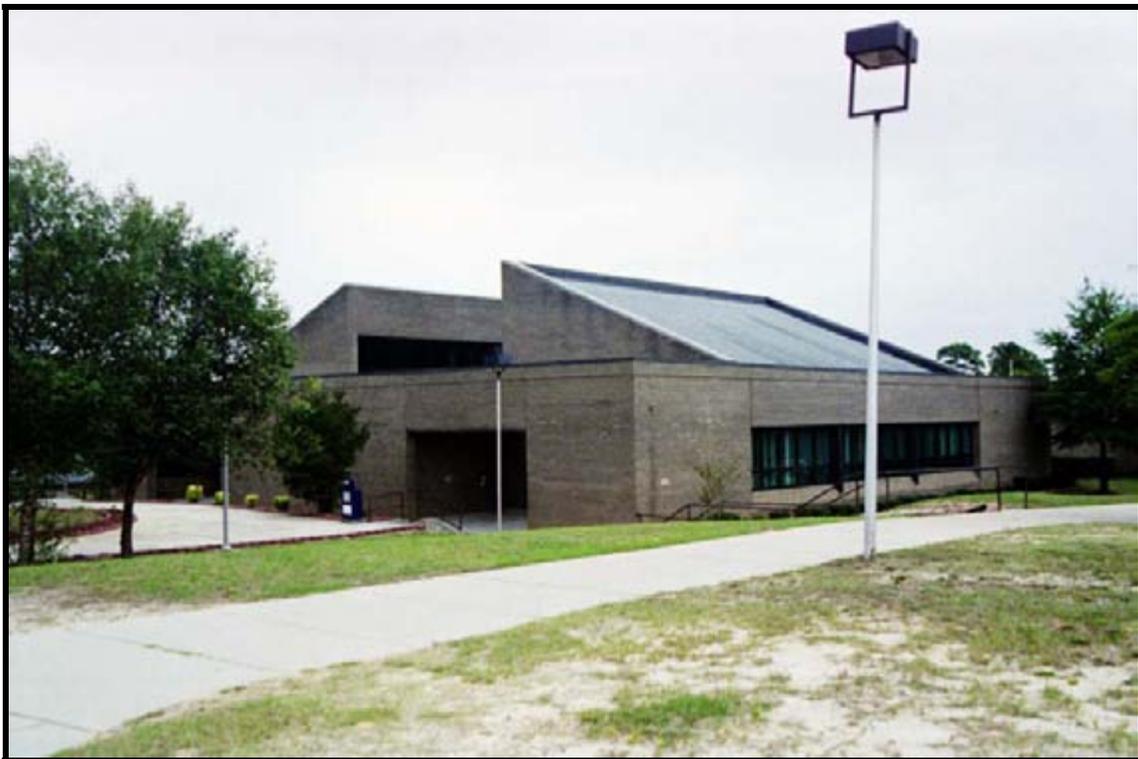
Figure 4.58 Quadrangle dining facility Ft. Bragg (RCG&A).

Large consolidated mess halls were constructed to support complexes of C-shaped barracks. The one-story brick mess halls featured a split gable roof and ribbons of fixed windows along the side elevations (Figures 4.58 and 4.59). Aisles along the perimeters of the dining rooms directed soldiers to the serving areas located in the front of the buildings. The kitchens occupied the rear of the buildings.
