**UNACCOMPANIED PERSONNEL HOUSING (UPH)  
DURING THE COLD WAR  
(1946-1989)  
UNRESTRICTED**

**U.S. ARMY ENVIRONMENTAL COMMAND  
ABERDEEN PROVING GROUND, MARYLAND 21010-5401**

**January 2007**

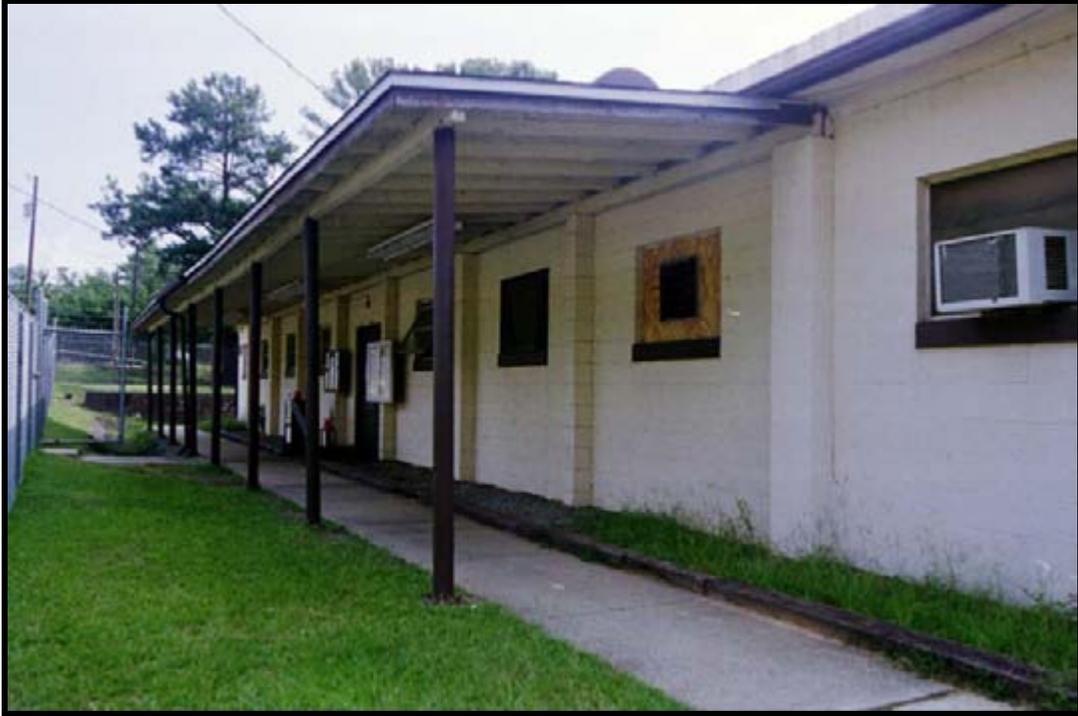
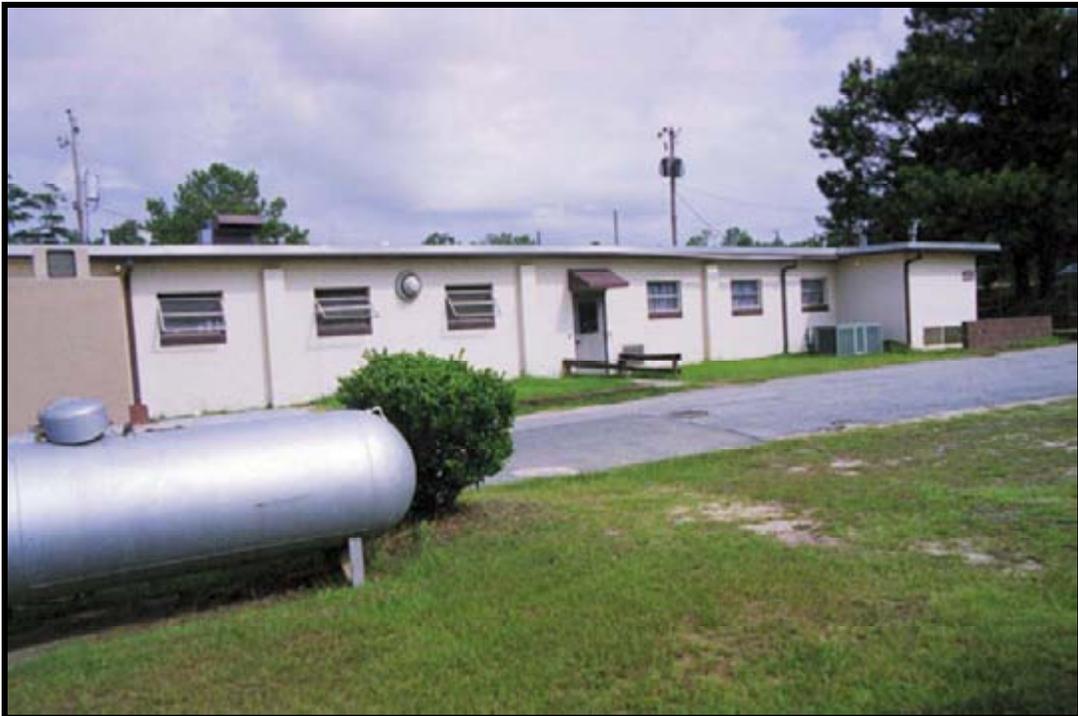
Figure 4.62 Semi-permanent dining facility, Ft. Benning (RCG&A).

Eight barracks were arranged in two rows with the open ends of the “U” oriented towards the center. Rectangular, one-story, concrete block buildings, which lined one side of the compound, contained the mess hall and lounge facilities. The dining hall also was built of concrete block (Figures 4.62 and 4.63). The lounge or dayroom was nearly the same size as the mess facility and featured the same construction techniques (Figure 4.64). An administration and supply facility was located at the end of the compound.

The character-defining features of the U-shaped barracks are the distinctive ground plan, the exposed concrete block walls, gable roofs, and one-over-one-light, metal-sash windows with concrete sills. Minimal modifications were identified in the archival record or through site inspections of representative examples. The barracks complex appeared to retain integrity of location, design, setting, materials, workmanship, feeling, and association.

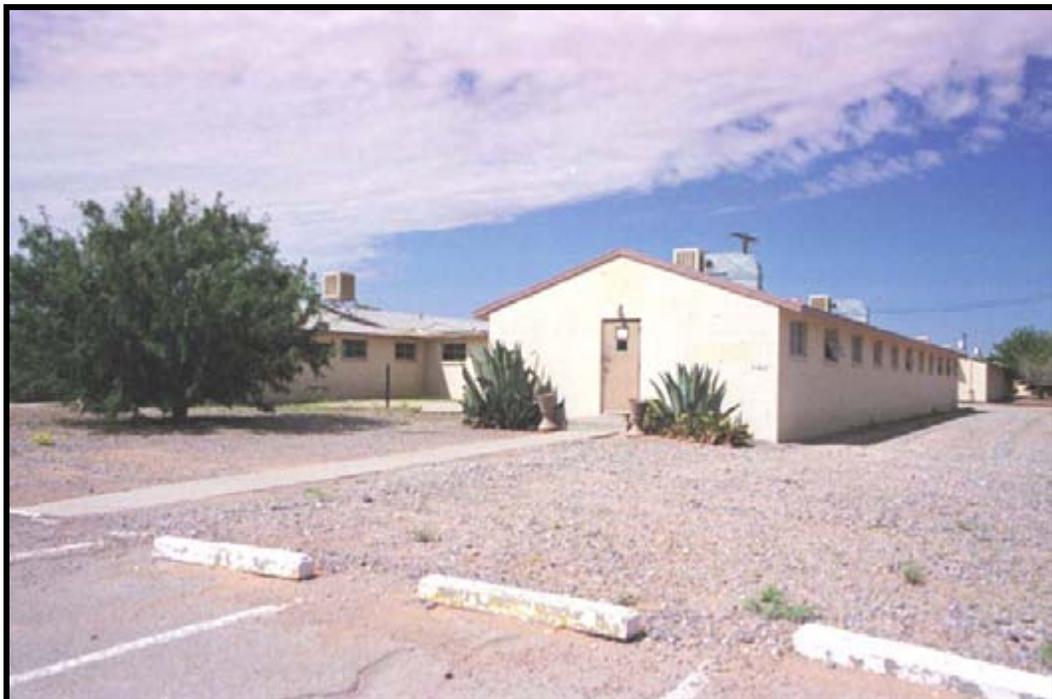
Figure 4.66 Semi-permanent 80-man “H” barracks, McGregor Range, Ft. Bliss (RCG&A).

“H” barracks with shed roofs were identified at the Oro Grande Range, Fort Bliss (Figure 4.65). Built in 1961, these barracks featured a simple entry vestibule to provide protection from the wind. Gable roof examples were found at McGregor Range (Figure 4.66). A small number of the barracks on McGregor Range retain the open squad bays typical of the 1959 design (Figure 4.67). A majority of the barracks were modernized in the late 1970s. Interior changes included the redesign into one and two-person rooms, hallways, and new bathrooms for the upper ranking enlisted men. Exterior changes included new entrances necessitated by the insertion of the hallway (Figures 4.68 and 4.69).

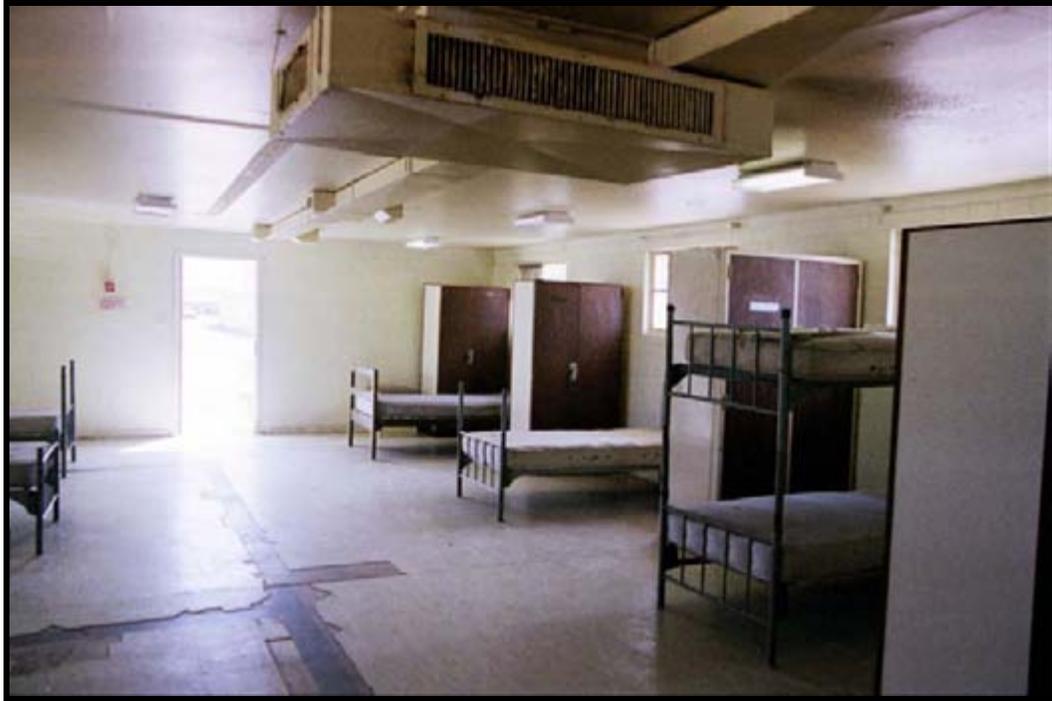
Figure 4.67 Squad room, Semi-permanent 80-man “H” barracks, McGregor Range, Ft. Bliss (RCG&A).

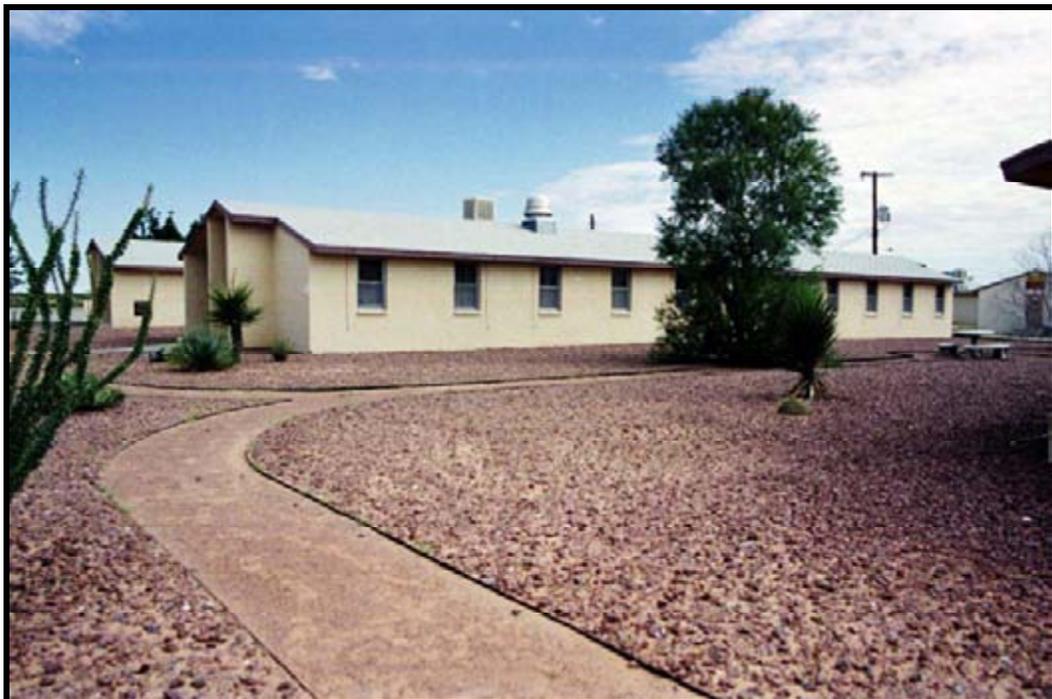
Figure 4.68 Renovated Semi-permanent 80-man “H” barracks, McGregor Range, Ft. Bliss (RCG&A).

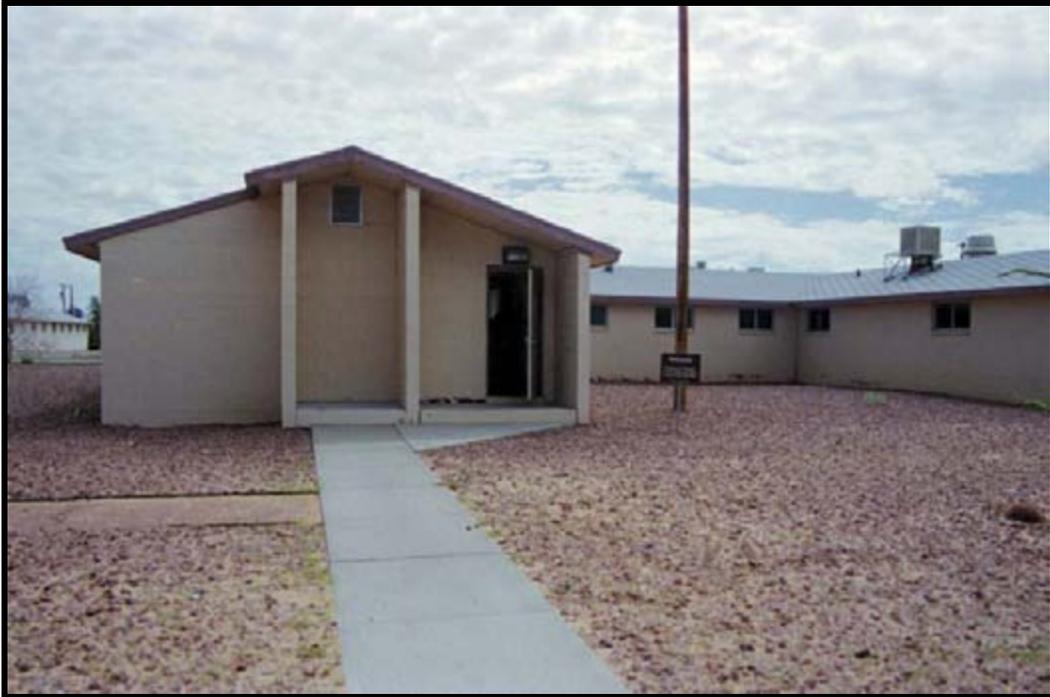
Figure 4.69 Entrance detail, renovated Semi-permanent 80-man “H” barracks, McGregor Range, Ft. Bliss (RCG&A).

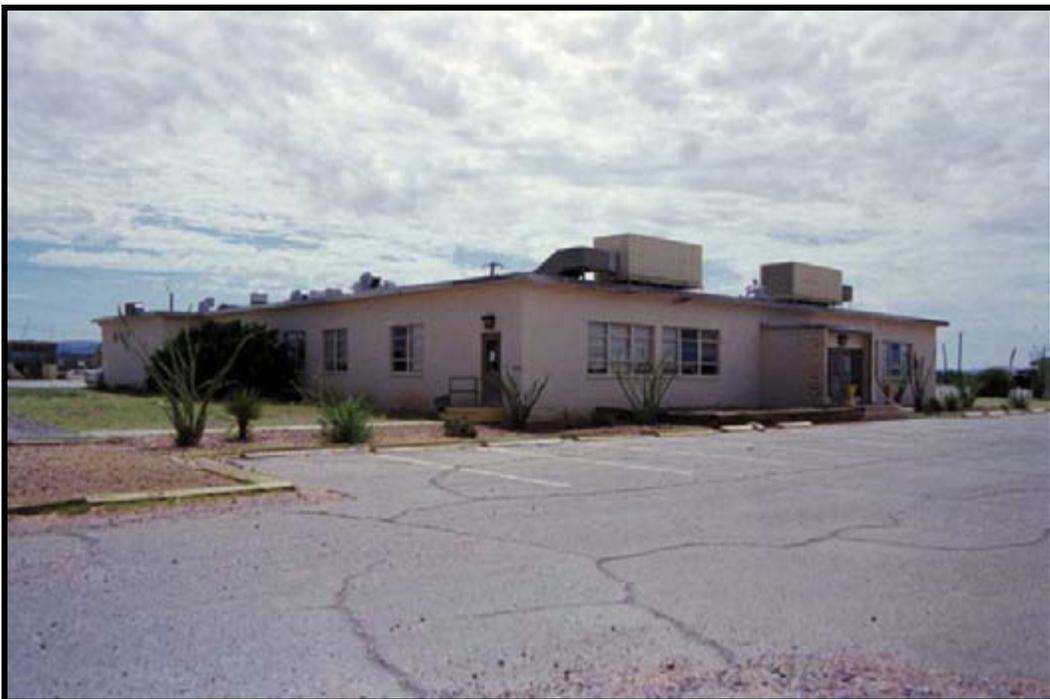
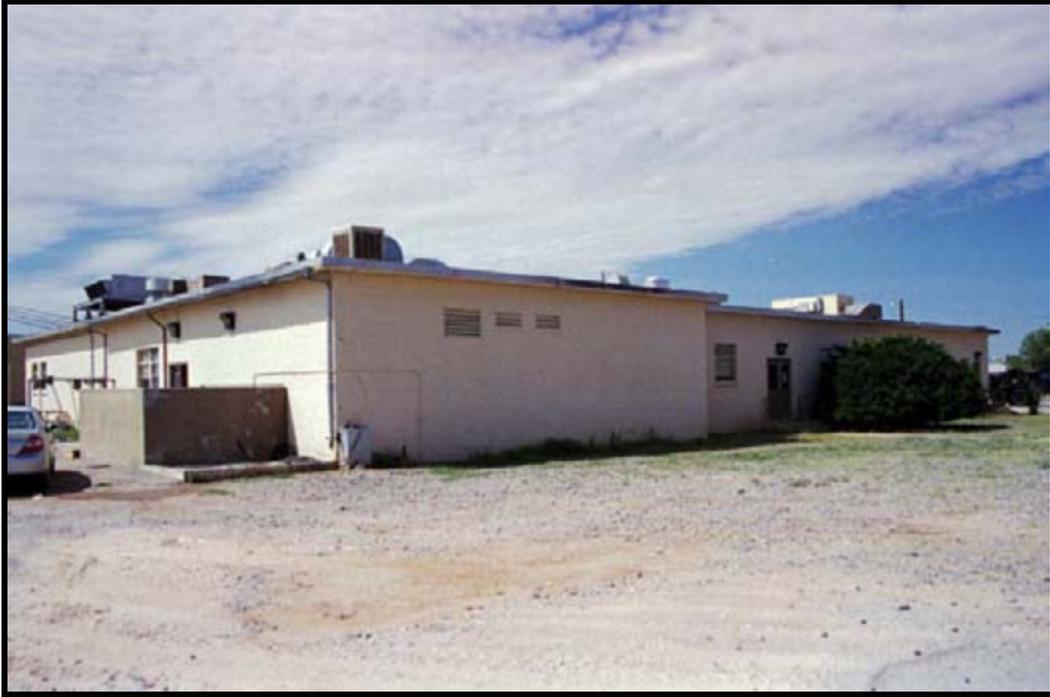
Figure 4.70 Semi-permanent dining facility, McGregor Range, Ft. Bliss (RCG&A).

Figure 4.71 Semi-permanent dining facility, McGregor Range, Ft. Bliss (RCG&A).

The barracks complex also contained mess, administration, supply, and recreation buildings including a 12,396 sq. ft. mess facility. The rectangular, concrete block support buildings featured concrete foundations and floors. The mess facility included a front dining area and rear kitchen areas. Small groupings of windows provided light to the dining areas while the rear featured a small loading area (Figures 4.70 and 4.71). The building terminated in a flat roof sheathed with built-up composition roofing.

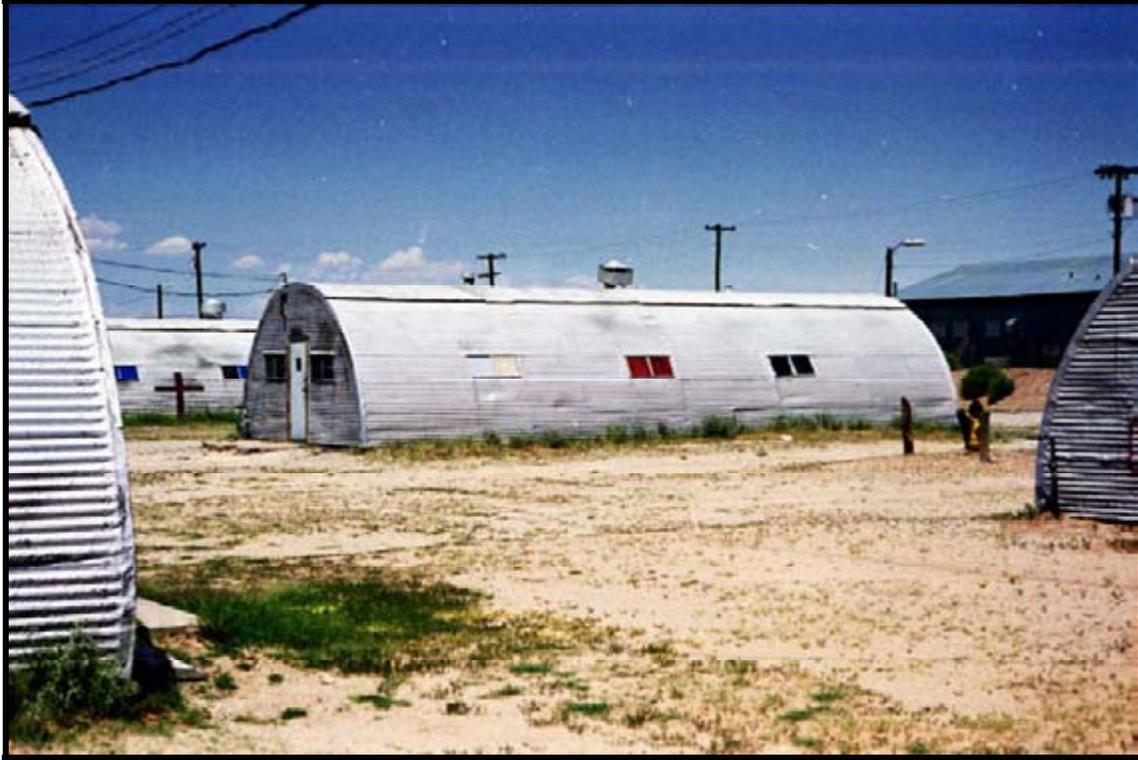
Figure 4.72 Quonset hut, Oro Grande Range, Ft. Bliss (RCG&A).

Quonset huts are characterized by their unique design that includes a semi-cylindrical roof of galvanized corrugated sheet metal supported by steel ribs. Quonset huts are generally sited in a grid plan. The semi-circular ends of the building are simple symmetrical designs with a central door flanked by two-over-two-light windows (Figure 4.72).

The character-defining features of Quonset huts are their semi-cylindrical metal roofs and the central metal door flanked by two-over-two-light windows. The character defining features of straight-sided Quonset huts are the arched metal roof, metal straight walls, and central metal door. Minimal modifications were identified in the archival record or through site inspections of representative examples. The complex of Quonset huts appeared to retain their integrity of location, design, setting, materials, workmanship, feeling, and association.

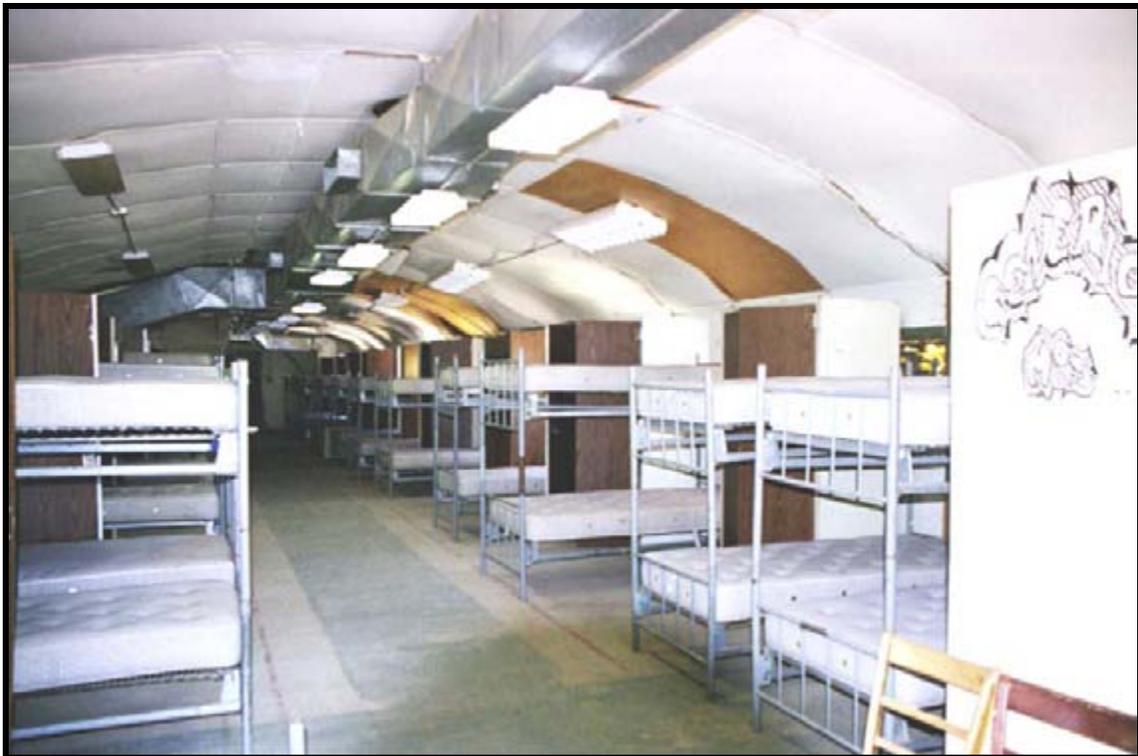
Figure 4.73 Squad room in straight-sided Quonset hut, Oro Grande Range, Ft. Bliss (RCG&A).

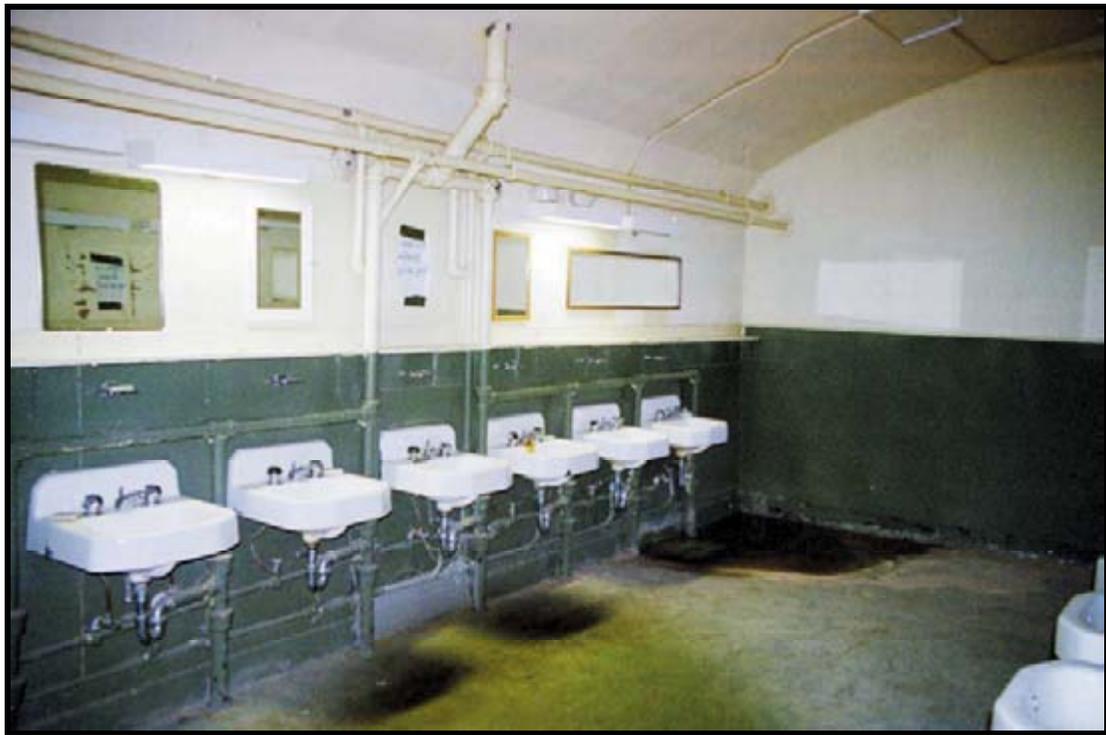
Figure 4.74 Latrine in straight-sided Quonset hut, Oro Grande Range, Ft. Bliss (RCG&A).

During the Korean War, the Army developed a straight-sided version of the Quonset hut to maximize interior space. These were also sited in a grid plan. Straight-sided Quonset huts featured the characteristic roof form, but included straight walls. The ends of the building housed a central door. Ribbon windows were located along the sides of the building. The interiors were open squad rooms with the beds lined along the walls (Figure 4.73). Latrines were separate from the barracks and utilized the same construction. The building was separated by function – showers, toilets, and sinks (Figure 4.74).

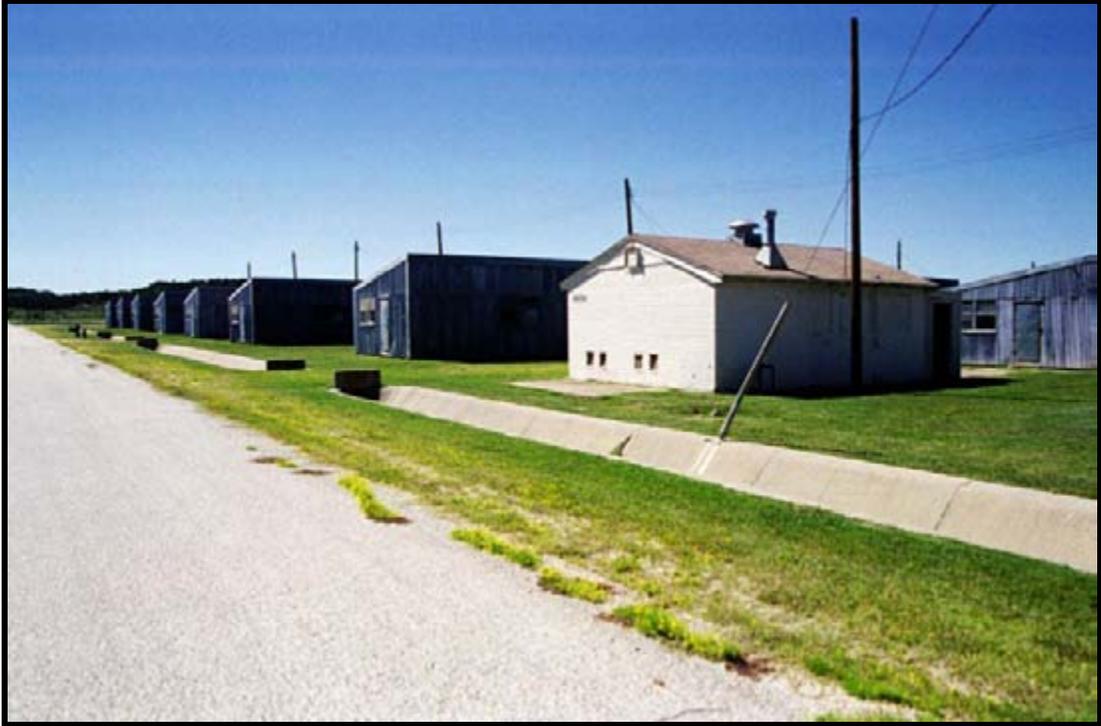
Figure 4.78 C-hut dining facility, North Ft. Hood (RCG&A).

Meals for soldiers stationed in the C-huts at North Fort Hood were supplied from centrally located, semi-permanent, rectangular, concrete block kitchens (Figure 4.78). The buildings terminated in a side gable roof sheathed with composition shingles. A double metal door provided access. Windows on the front and rear elevations were likely used for serving.

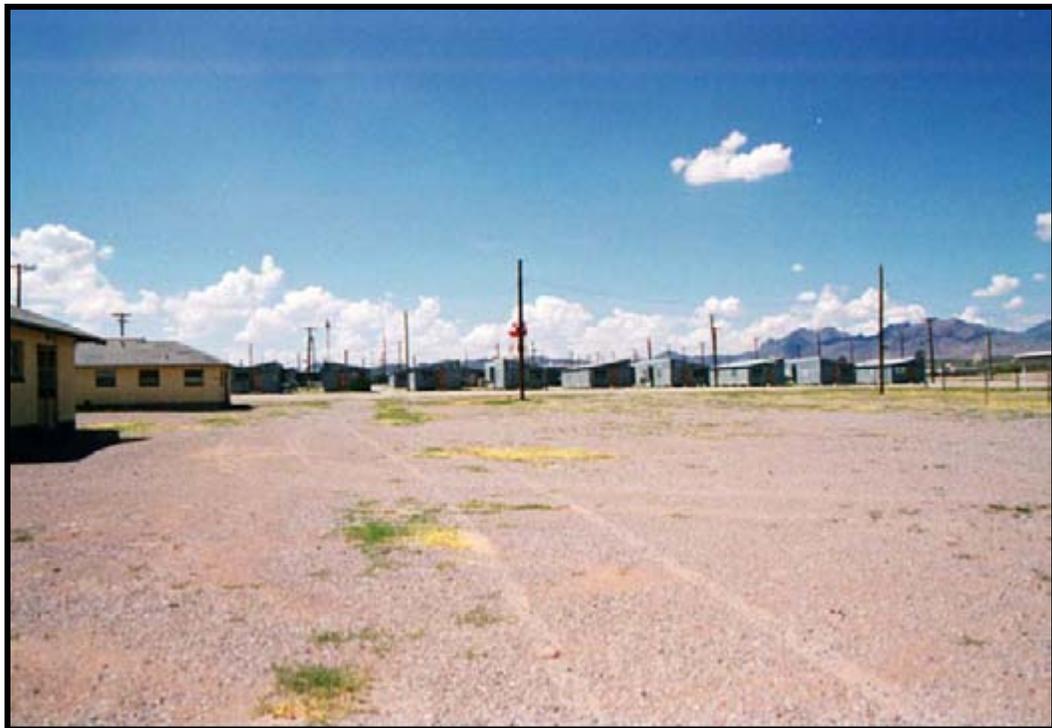
Figure 4.79 Overview of C-huts, Dona Ana Range, Ft. Bliss (RCG&A).

While the C-huts at North Fort Hood are not listed in the Army IFS database, the C-huts at Fort Bliss' Dona Ana Range were. The same building plan was used for barracks and BOQ construction. Its use differed by the number of men it housed. The C-huts were sited in rows (Figure 4.79). The C-huts at Fort Bliss differed from those at North Fort Hood. The Fort Bliss examples include a single light door and air conditioning.

The character defining features of C-huts are the simple modular construction, basic rectangular structure, shed roof, metal door, and two-over-two-light, metal-sash windows. Minimal modifications identified included the replacement of doors with single light windows and the addition of air conditioning. The C-huts retain their integrity of location, design, setting, materials, workmanship, feeling, and association.

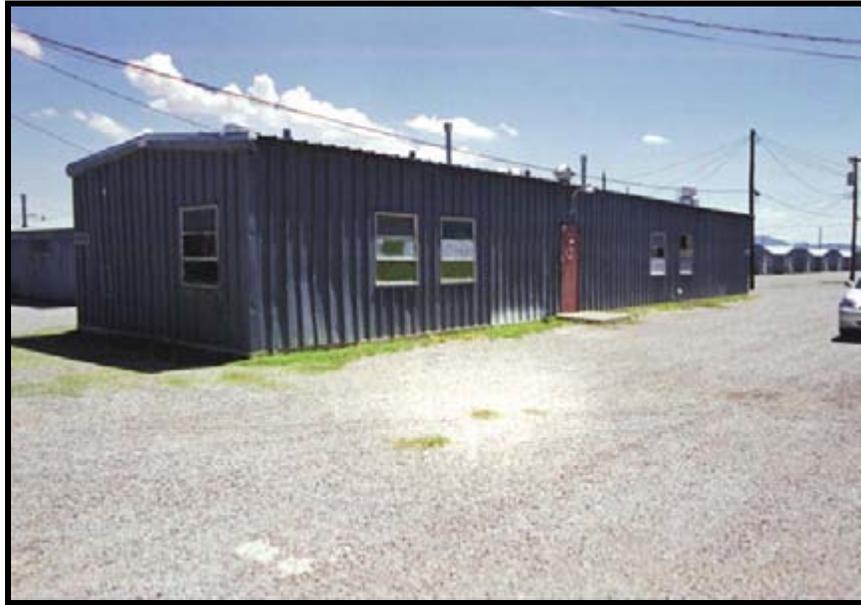
Figure 4.80 Mobilization latrine, Dona Ana Range, Ft. Bliss, (RCG&A).

A similar rectangular, metal building was used as a central bathhouse and latrine. The structure featured two lavatory facilities divided by a central heating room. The building utilized the same metal construction as the dining facility (Figure 4.80). The interior was spartan and featured gang latrines (Figure 4.81).

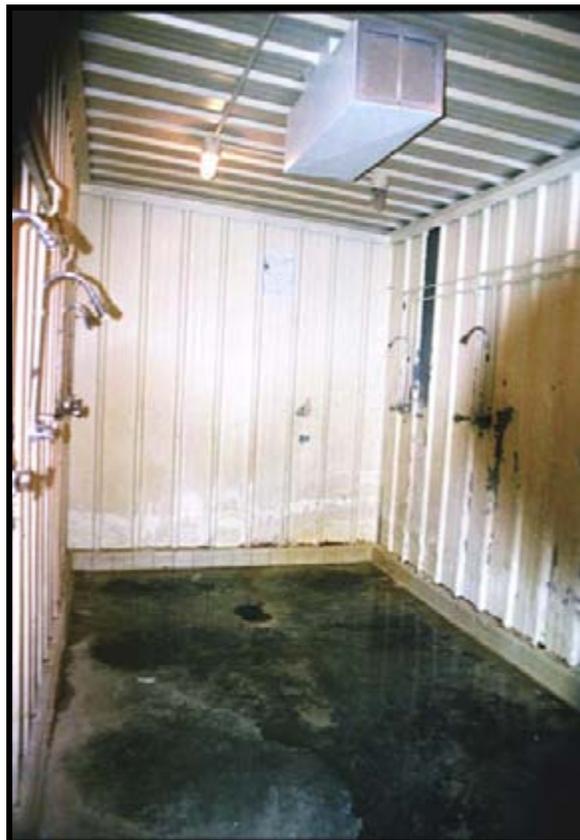
Figure 4.81 Showers in mobilization latrine, , Dona Ana Range, Ft. Bliss (RCG&A).

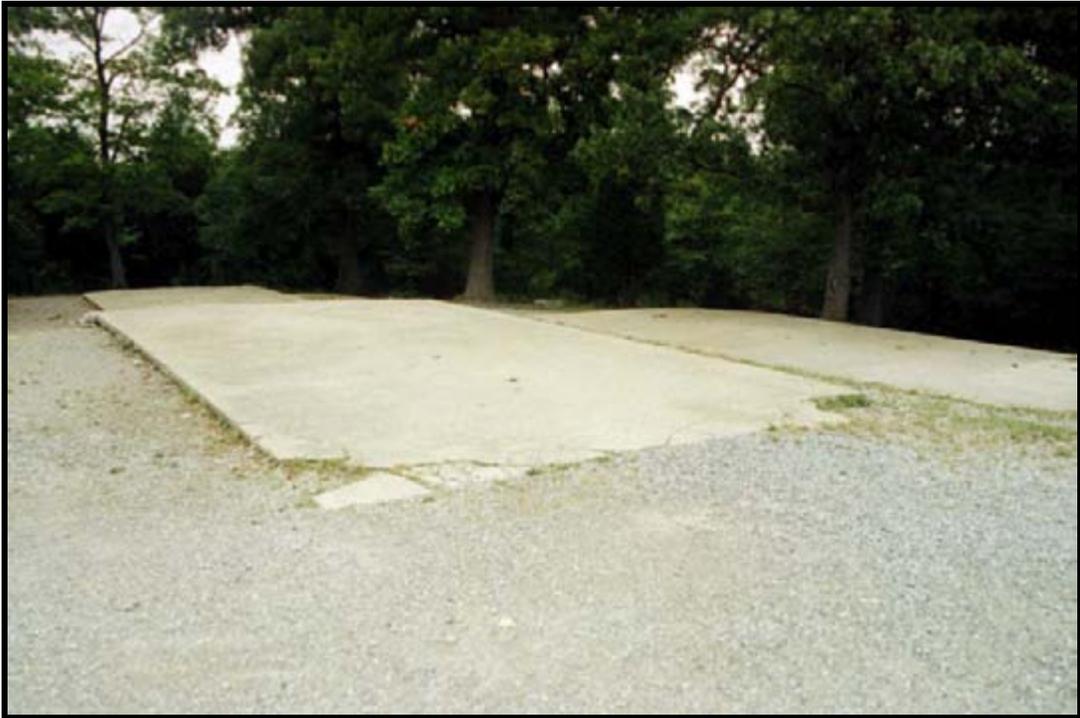
Figure 4.82 Tent Pad, Ft. Knox (RCG&A).

The tent pads identified during the site visits generally were deteriorated and no longer in use. The examples examined did not retain their integrity of design, materials, or workmanship as built resources.

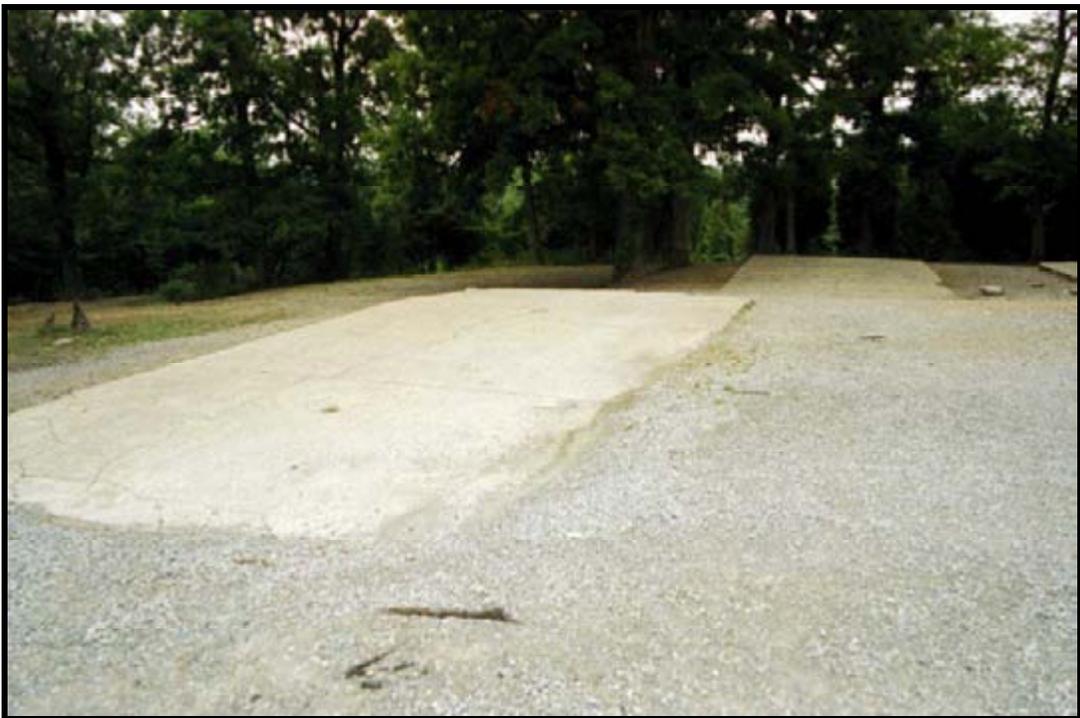
Figure 4.83 Tent Pad, Ft. Knox (RCG&A).

Tent pads typically are permanent concrete pads over which tents are placed (Figures 4.82 and 4.83). Either a metal or wood frame is used to support the tent (Figures 4.84 and 4.85)

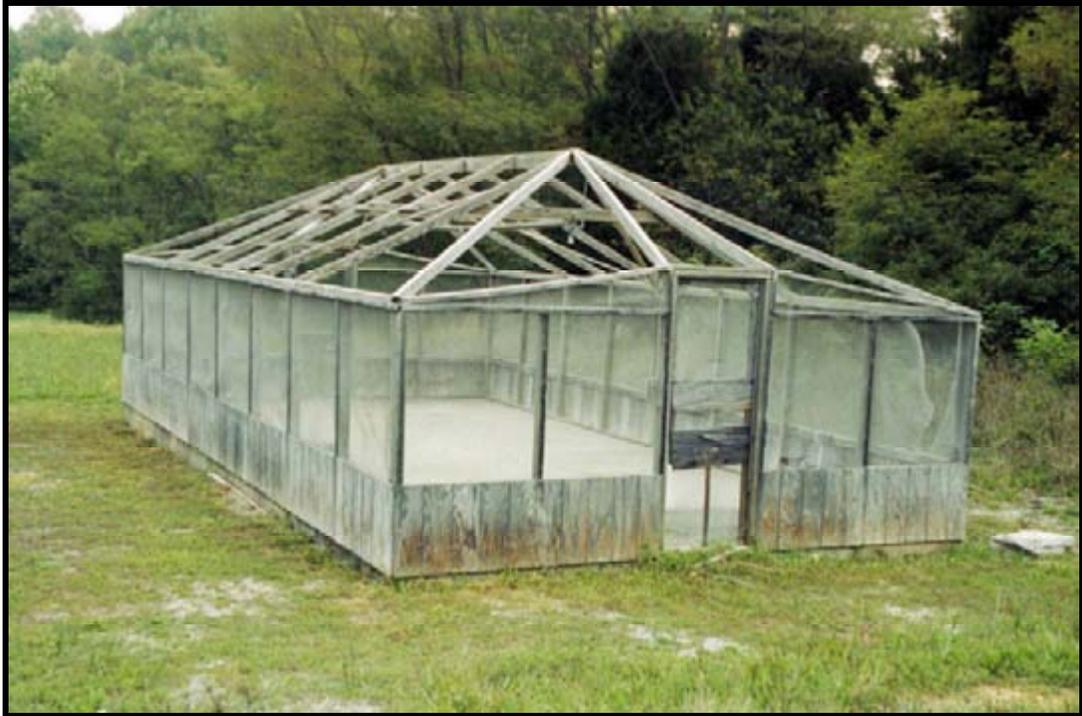
Figure 4.84 Tent Pad with wood tent frame, Ft. Knox (RCG&A).

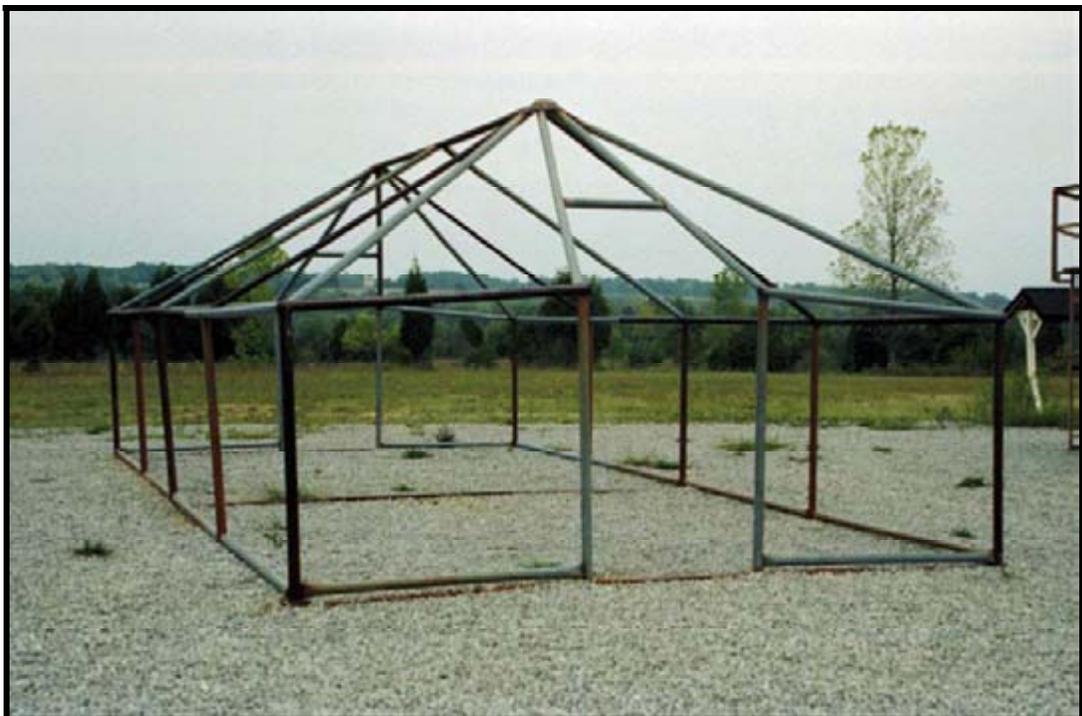
Figure 4.85 Metal tent frame, Ft. Knox (RCG&A).

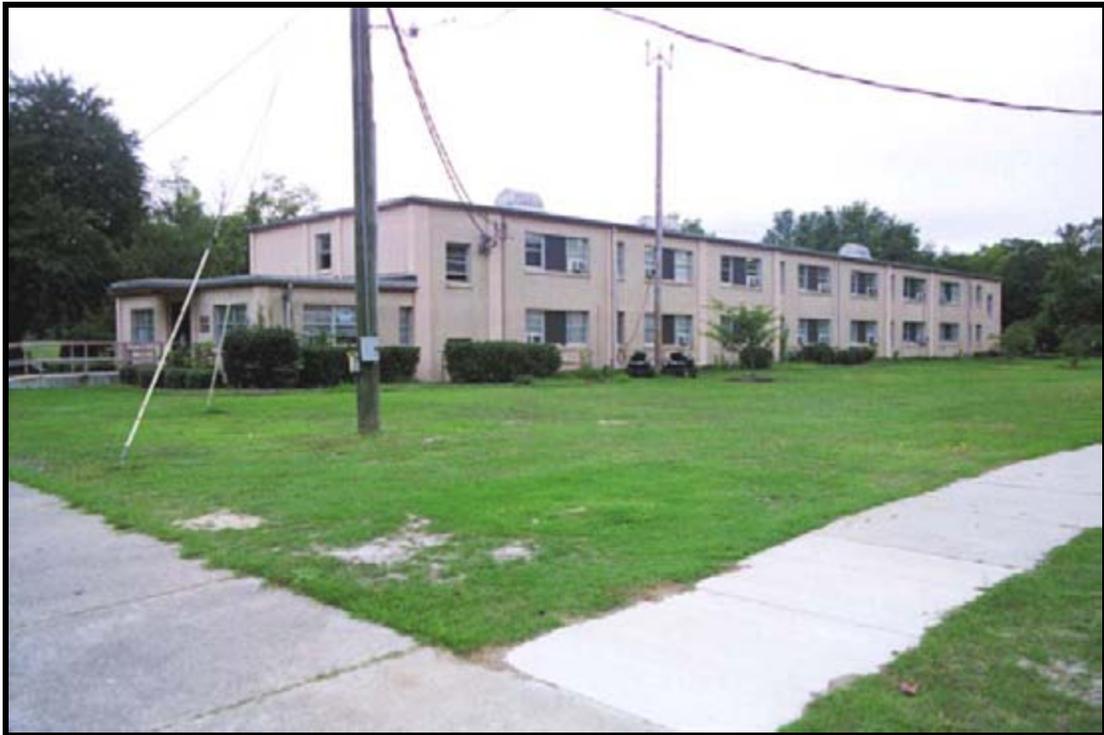
Figure 4.86 Two-story, hammerhead BOQ converted to offices, Ft. Bragg (RCG&A).

Most hammerhead BOQs have been modified and redesigned over time. Many were converted into offices (Figure 4.86). The replacement of windows and doors were common modifications to buildings in use as BOQs (Figures 4.87, 4.88, and 4.89). More extensive changes to hammerhead BOQs included gable roofs, new brick and stucco exteriors, modern replacement windows, and remodeled interiors. At Fort Bragg, the exteriors of the buildings were faced in stucco and brick veneers (Figures 4.90 and 4.91). In the most extensive renovations, the buildings were stripped to the reinforced concrete frames and rebuilt with modern materials including metal stud

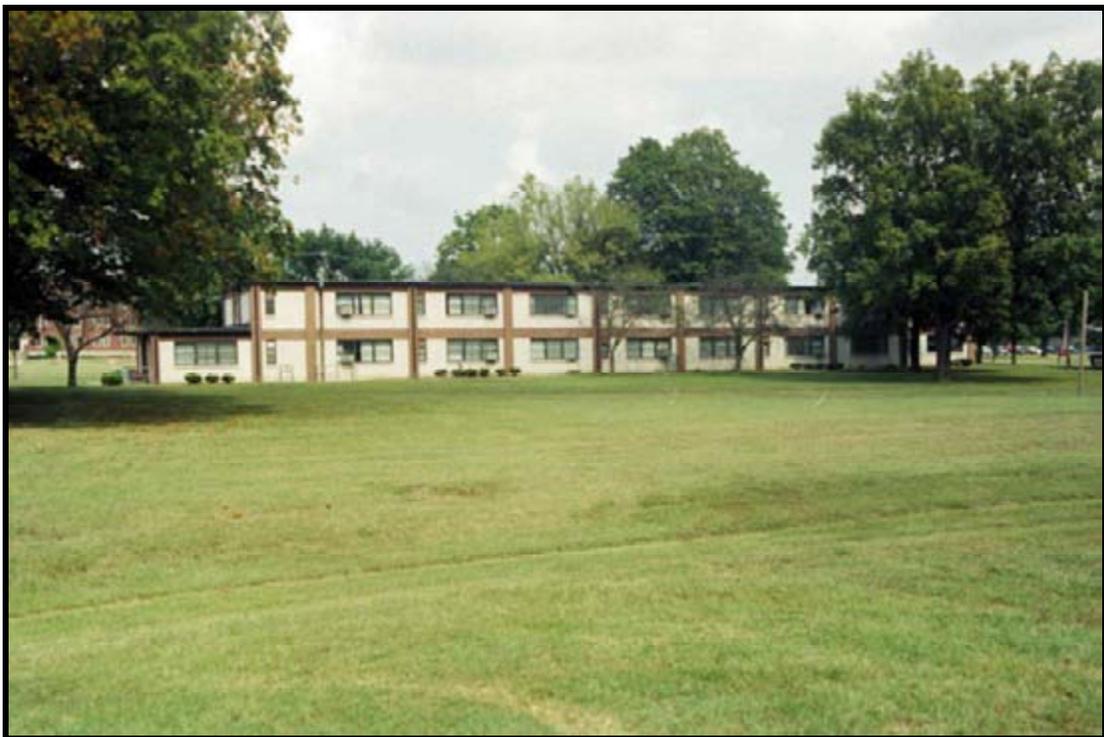
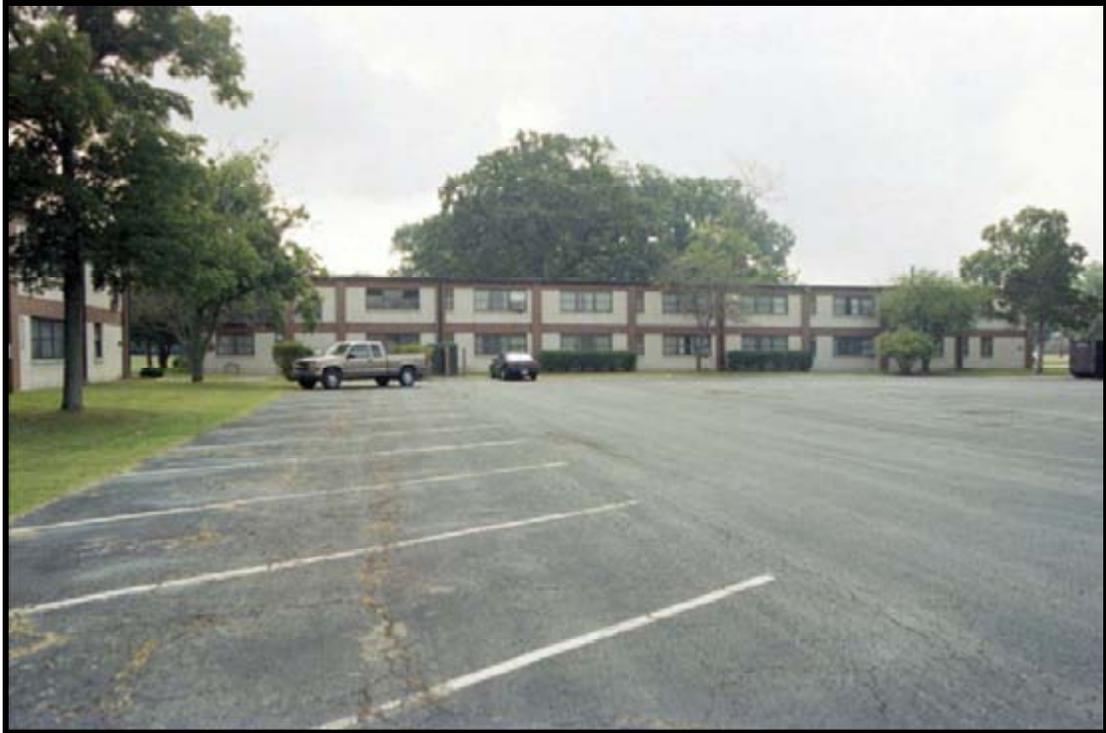
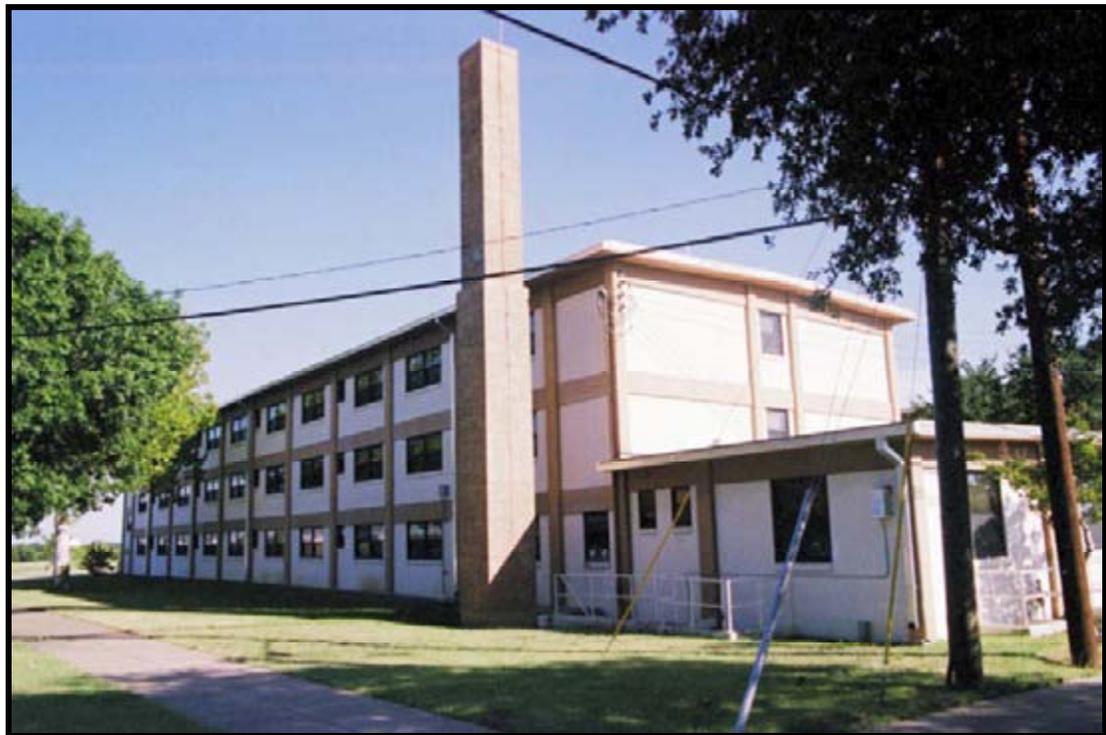
Figure 4.87 Two-story, hammerhead BOQ Ft. Knox (RCG&A).

Figure 4.88 Two-story, hammerhead BOQ, Ft. Knox (RCG&A).

Figure 4.89 Three-story, hammerhead BOQ, Ft. Hood (RCG&A).

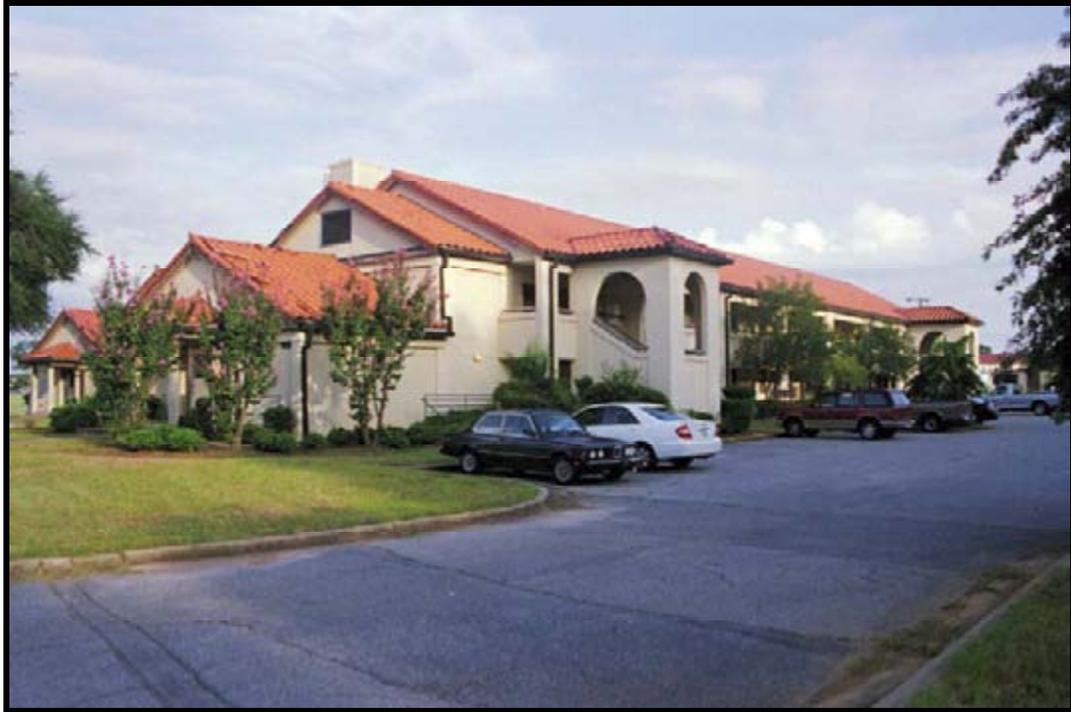
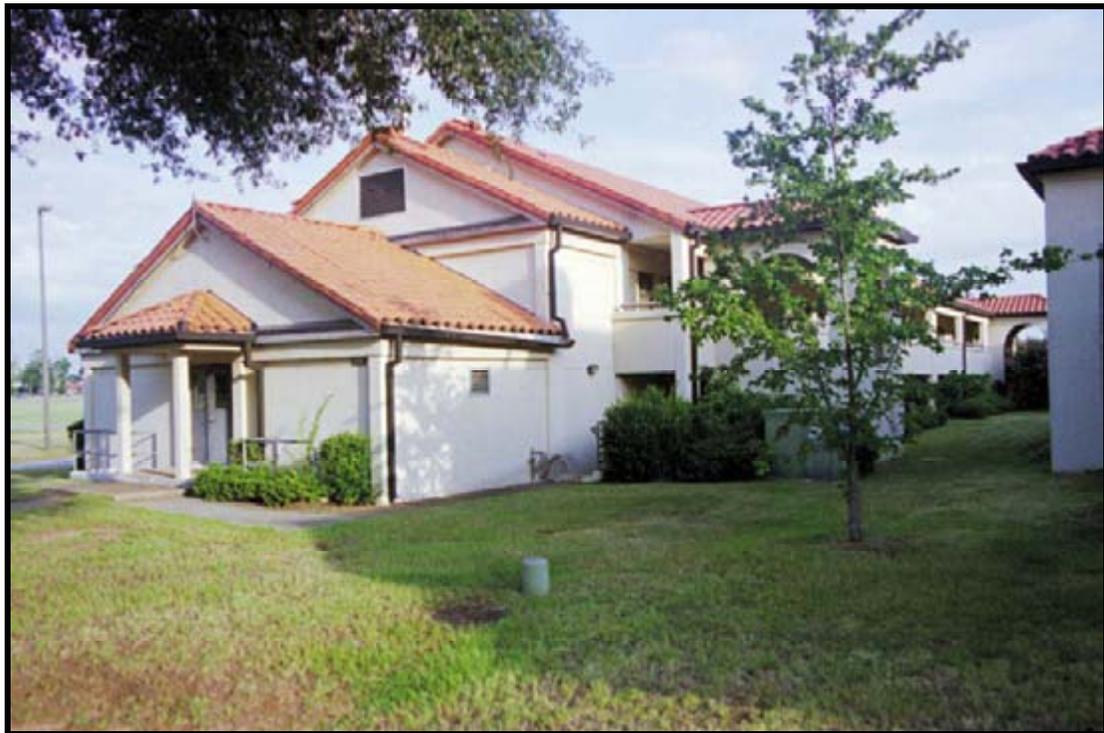
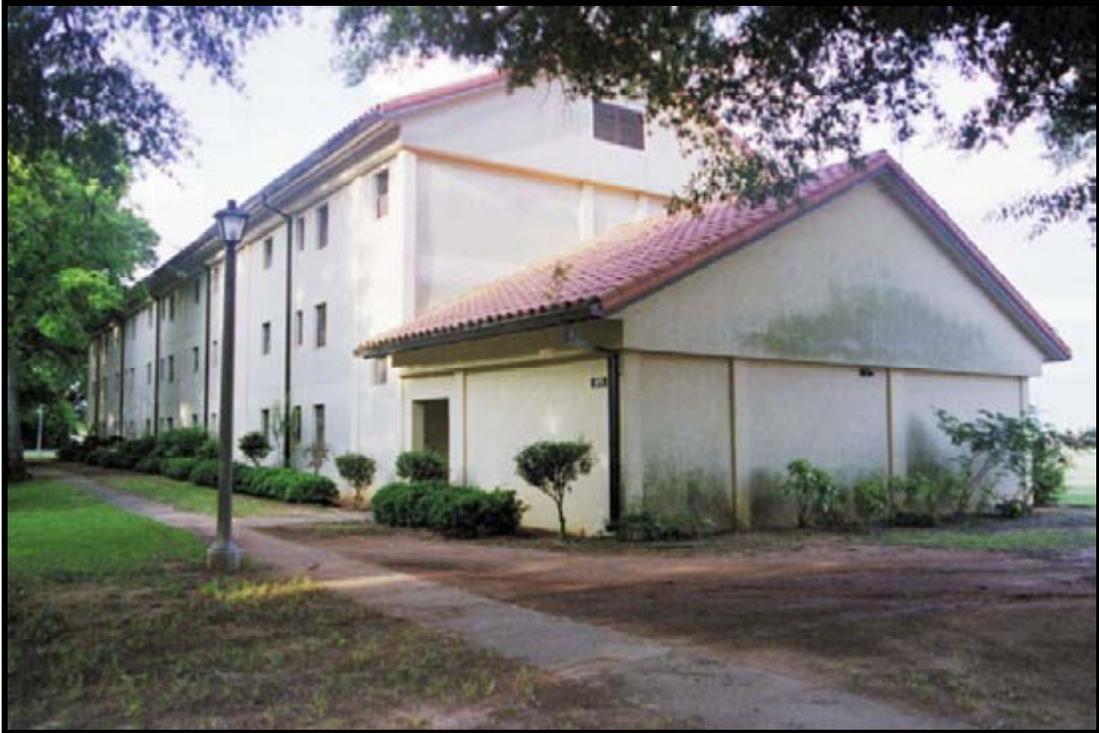
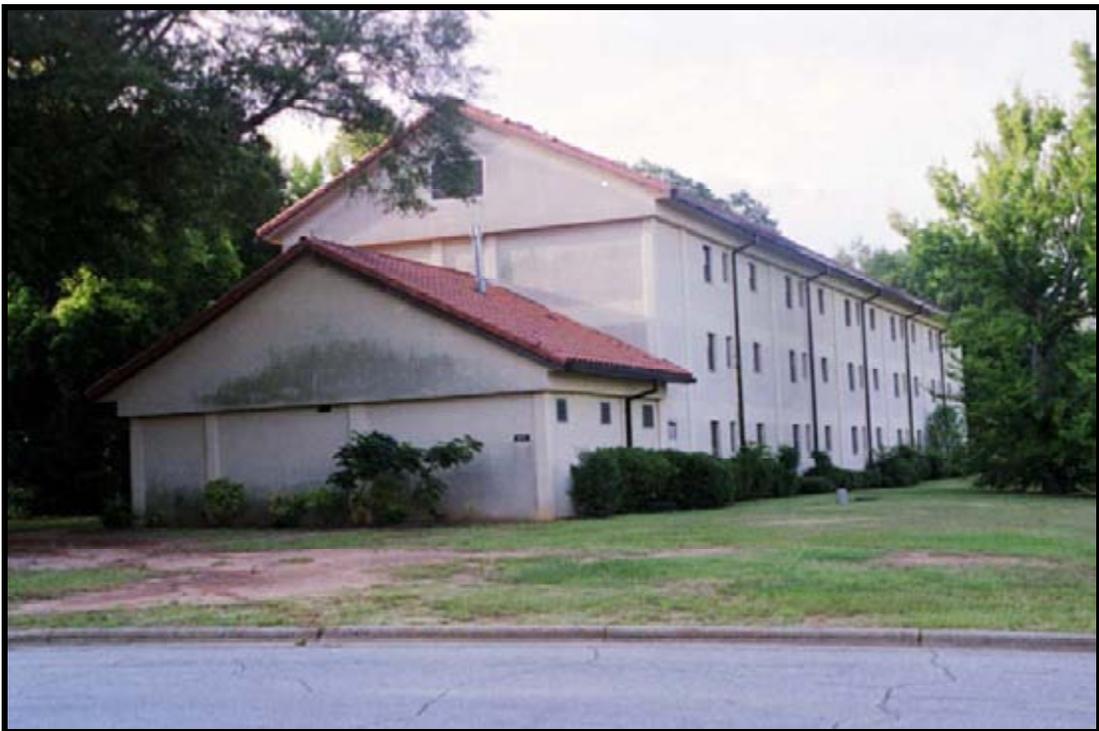
Figure 4.92 Renovated two-story, hammerhead BOQ, Ft. Benning (RCG&A).

Figure 4.93 Renovated two-story, hammerhead BOQ, Ft. Benning (RCG&A).

Figure 4.94 Renovated three-story, hammerhead BOQ, Ft. Benning (RCG&A).

Figure 4.95 Renovated three-story, hammerhead BOQ, Ft. Benning (RCG&A).

walls, new windows, and foam insulation. In some cases, the interior hallways were removed and replaced with exterior balconies and doorways. At Fort Benning, the BOQs were remodeled in a Spanish Colonial Revival style (Figures 4.92 through 4.95). Some hammerhead BOQs were reclassified as transient quarters.
