**UNACCOMPANIED PERSONNEL HOUSING (UPH)  
DURING THE COLD WAR  
(1946-1989)  
UNRESTRICTED**

**U.S. ARMY ENVIRONMENTAL COMMAND  
ABERDEEN PROVING GROUND, MARYLAND 21010-5401**

**January 2007**

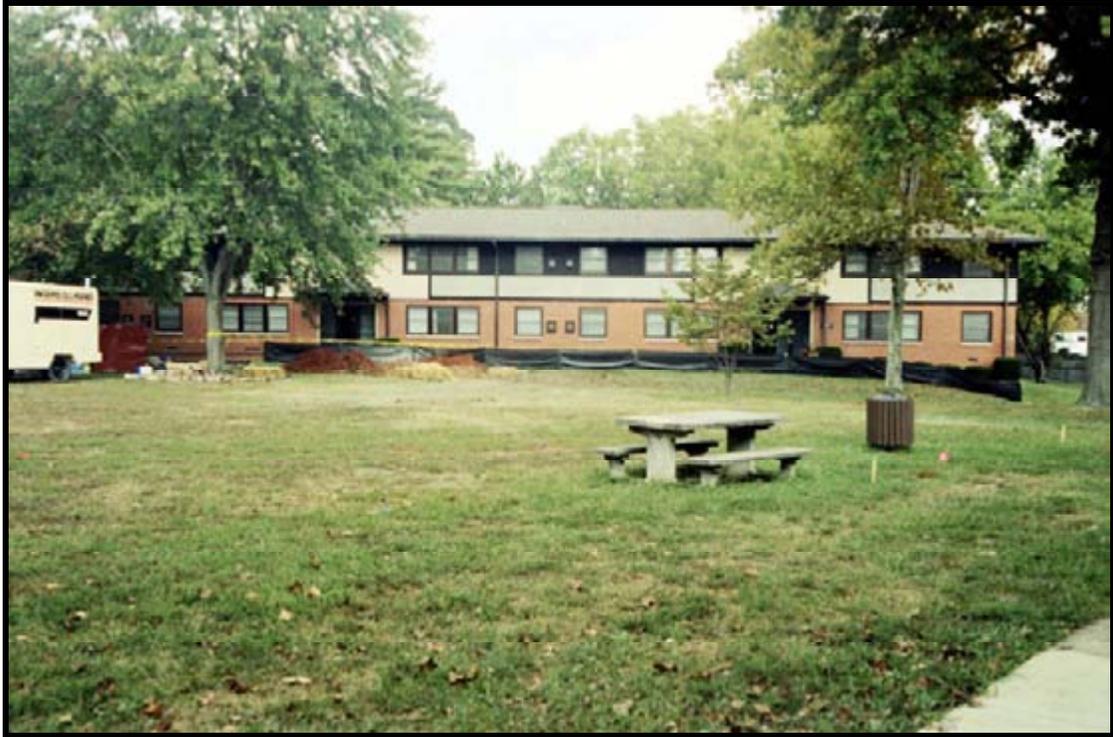
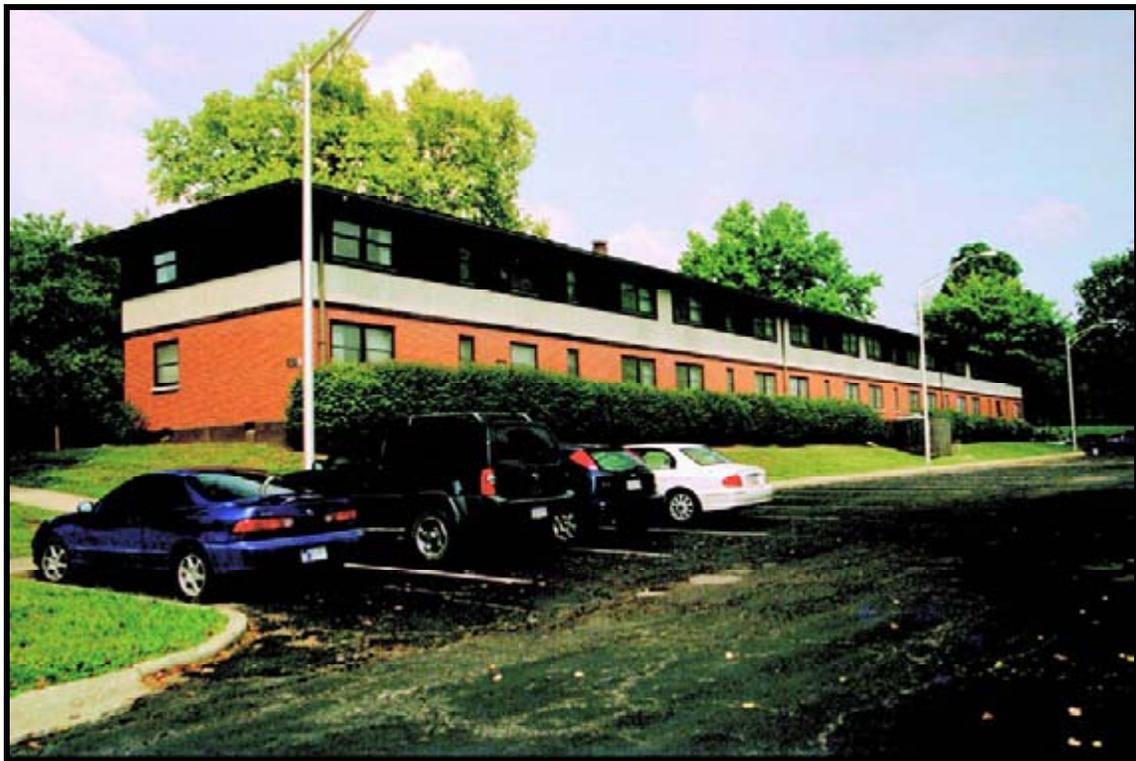
Figure 4.96 Two-story, apartment type women's BOQ, Ft. Knox (RCG&A).

Figure 4.97 Two-story, apartment type women's BOQ, Ft. Knox (RCG&A).

At Fort Knox, these brick and wood frame BOQs were built on a reinforced concrete slab and incorporated three primary entrances. The women's BOQs faced a park area, which is bounded by the buildings. Parking areas were arranged on the perimeter of the complex (Figures 4.96 and 4.97). The men's BOQs featured a different wood trim than the women's quarters and also incorporated a louvered gable dormer above each entrance (Figure 4.98). At Fort Bliss, walls were constructed of concrete block and the buildings had four primary entrances (Figures 4.99 and 4.100). The Fort Bliss examples also had flatter roofs than the Fort Knox examples and featured large ventilation units on the roofs. In all examples, each entrance provided access to four apartments – two upstairs and two downstairs. Each apartment contained a kitchen, bedroom, bathroom, and living room. The complex did not include formal landscaping.

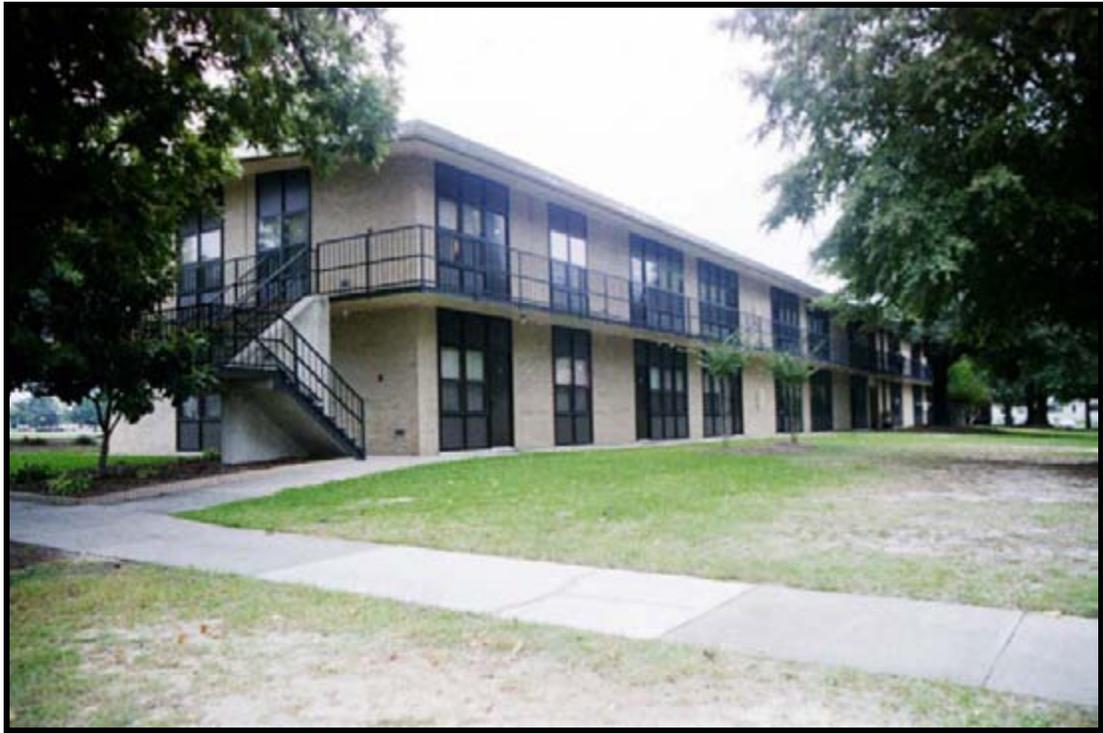
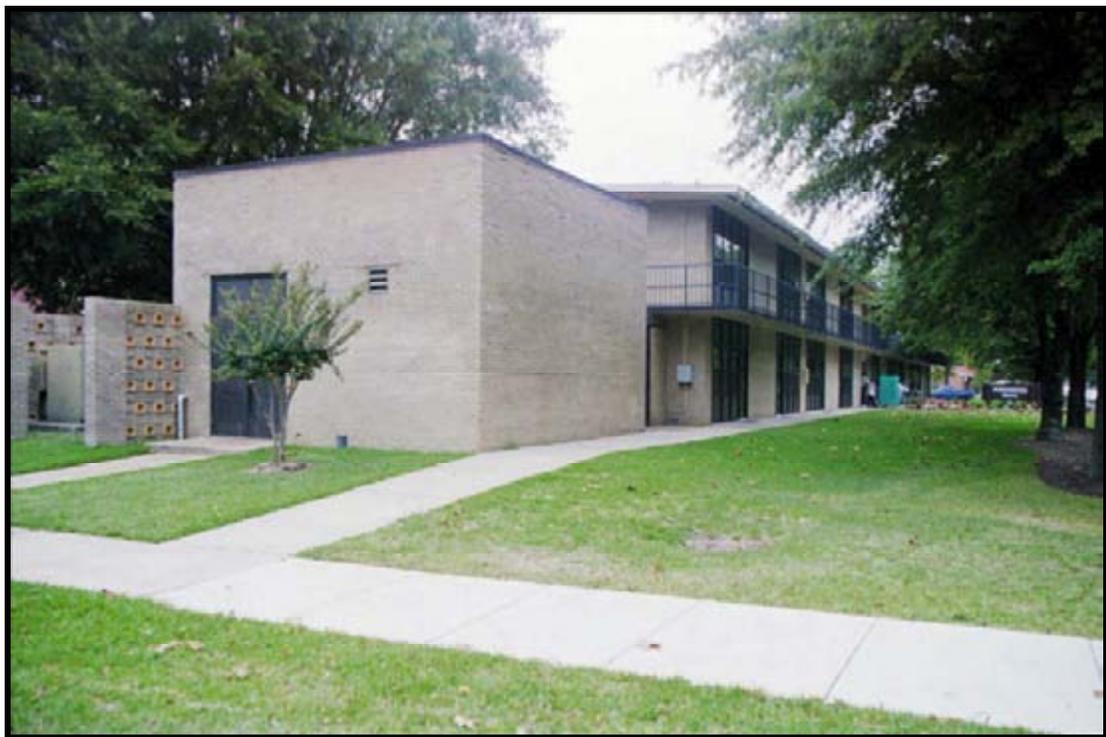
Figure 4.101 120-man motel type BOQ, Ft. Bragg (RCG&A).

Figure 4.102 120-man motel-type BOQ, Ft. Bragg (RCG&A).

Motel designs were first employed for BOQs in the late 1960s. Loewenstein-Atkinson Architects of Greensboro, North Carolina, designed an early example constructed at Fort Bragg. This 120-man, two-story, rectangular, brick structure featured a second floor balcony, exterior entrances, and a flat roof. The building had large fixed windows and glass doors. Exterior stairs accessing the balconies were located at the ends of the buildings (Figures 4.101 and 4.102). The west end units featured a living room, kitchenette, bedroom, and bathroom for field officers. The remainder of the units were studios for company officers and combined living/bedroom and bathrooms.

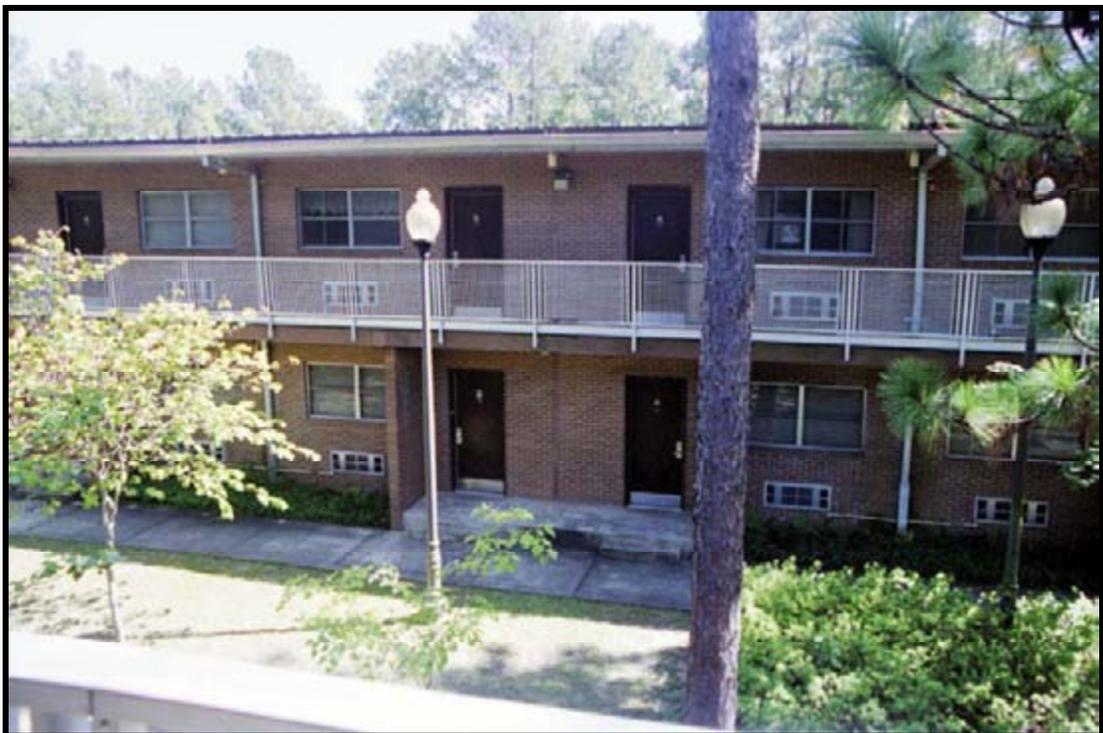
Figure 4.106 Motel-type BOQ, Ft. Polk (RCG&A).

The examples of motel-type BOQs identified at Fort Polk were similar in design to those at Fort Bragg. The Fort Polk BOQs differed in plan; an interior corridor extended through the width of the buildings. A small laundry room and a storage room were accessed from the corridor. The buildings also included a handicapped ramp to the first floor (Figure 4.103). Exterior stairs accessed the second floor (Figure 4.104). The units included metal doors and paired two-over-two-light windows (Figures 4.105 and 4.106). Each room included a combined living/bedroom area and a bathroom. Adjoining rooms shared a kitchen.

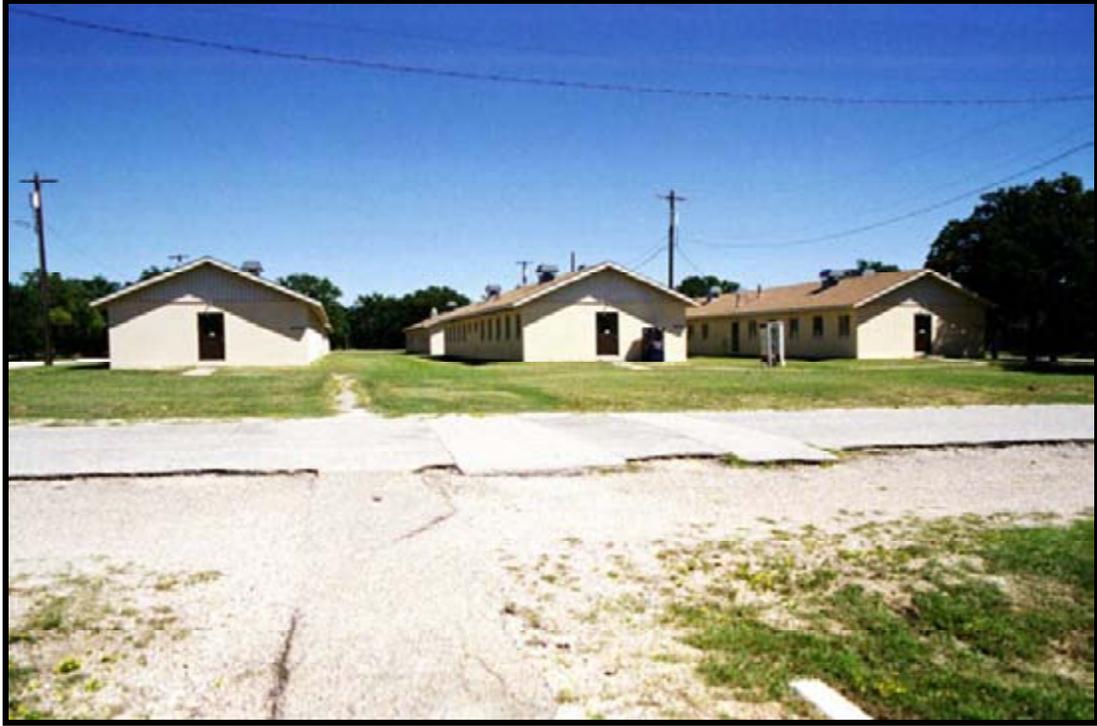
Figure 4.113 Army training BOQs, Ft. Hood (RCG&A).

The Army Reserve Training BOQs were similar in design to the semi-permanent and mobilization BOQs employed elsewhere. The BOQs are long, rectangular, concrete-block buildings that terminate in front gable roofs sheathed in composition shingles (Figure 4.113). The gable-ends are clad with vertical siding. The entrances feature single-light metal doors and are located at the gable-ends of the buildings. The buildings feature one-over-one-light, metal sash windows. Living units were located off of a central double-loaded corridor (Figure 4.114).

The character-defining features of Army Reserve annual training BOQs are exposed concrete-block walls, front gable roofs, gable-ends clad with vertical siding, and one-over-one-light, metal-sash windows. No modifications were identified in the archival record or through site inspections of representative examples. The Army Reserve training BOQs appeared to retain integrity of location, design, setting, materials, workmanship, feeling, and association.

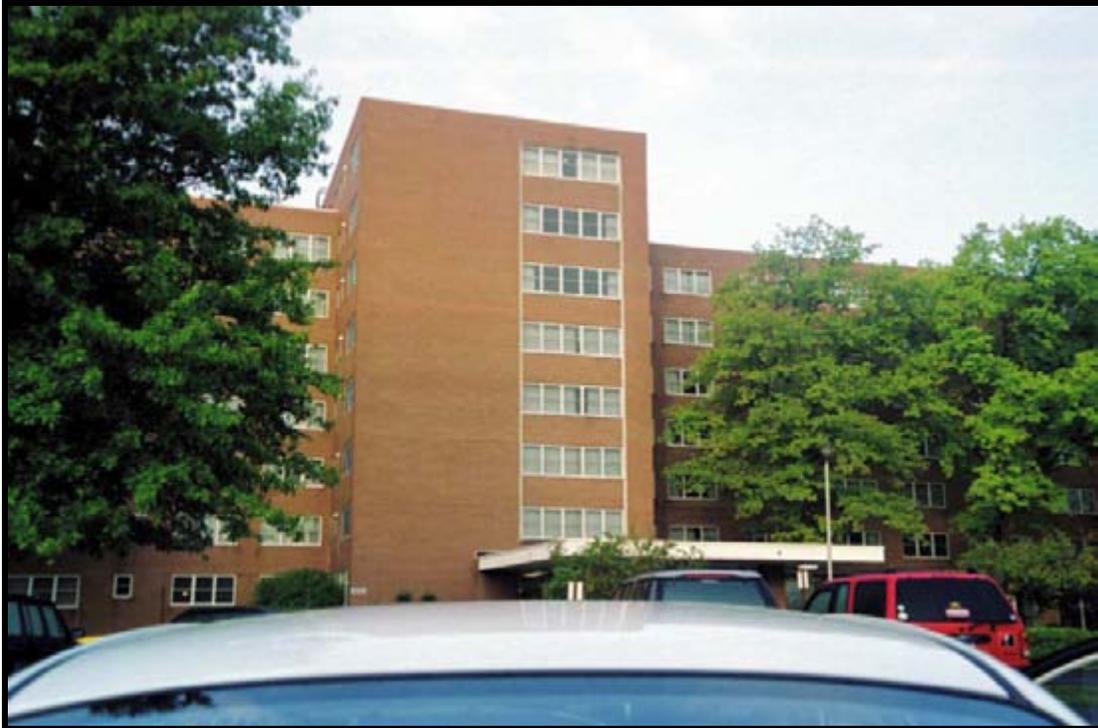
Figure 4.115 High Rise BOQ, Ft. Knox (RCG&A).

The first eight-story apartment building authorized under the Wherry Act was constructed at Fort Knox. Midwest Mortgage Company and its affiliate, Fort Knox Construction Company, designed the \$2 million dollar cross-shaped, brick building. Construction was completed in 1958. The building contained 180 efficiency apartments and 20 one-bedroom apartments (ENR 17 July 1952:26). Although built as family housing, the apartments were used to house unaccompanied officers and as transient quarters (Ft. Knox real property records). The cross-shaped, brick building featured ribbons of one-over-one, metal-sash windows. The main entry had a small, flat roofed, porte cochere (Figure 4.115). Small parking lots are located around the building (Figure 4.116).

The character-defining features of the Fort Knox apartment building complex are the distinctive ground plans, brick construction, elevators, scale, and mass. The buildings retain their integrity of location, design, setting, materials, workmanship, feeling, and association.

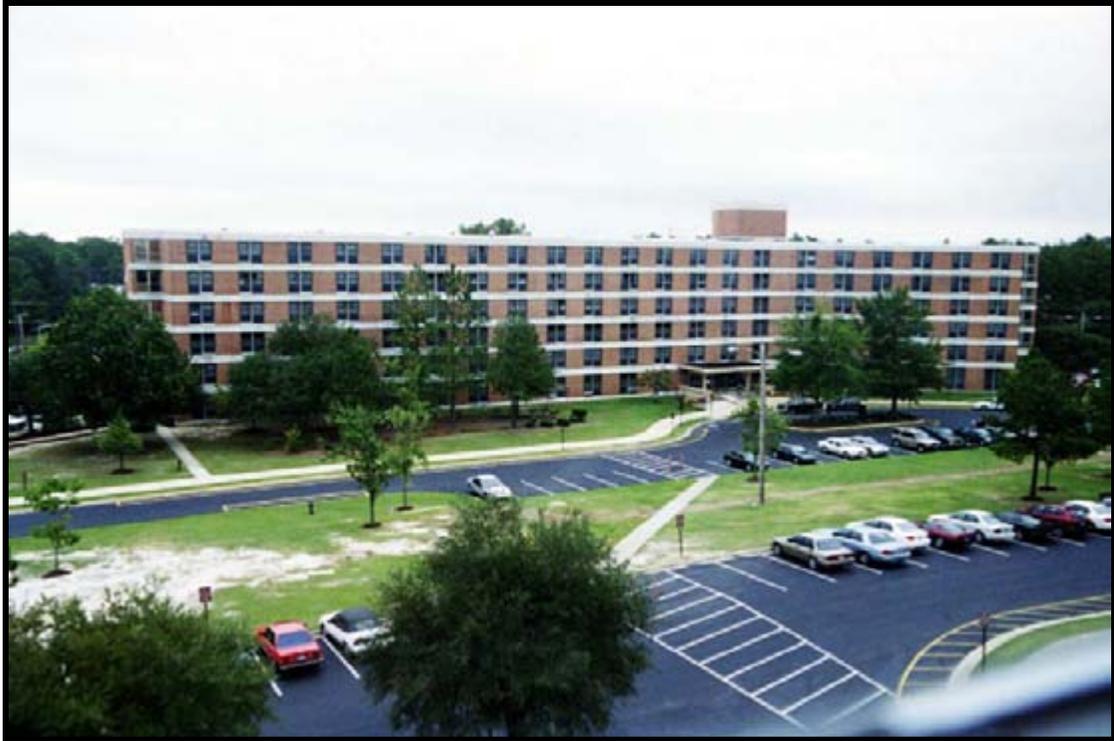
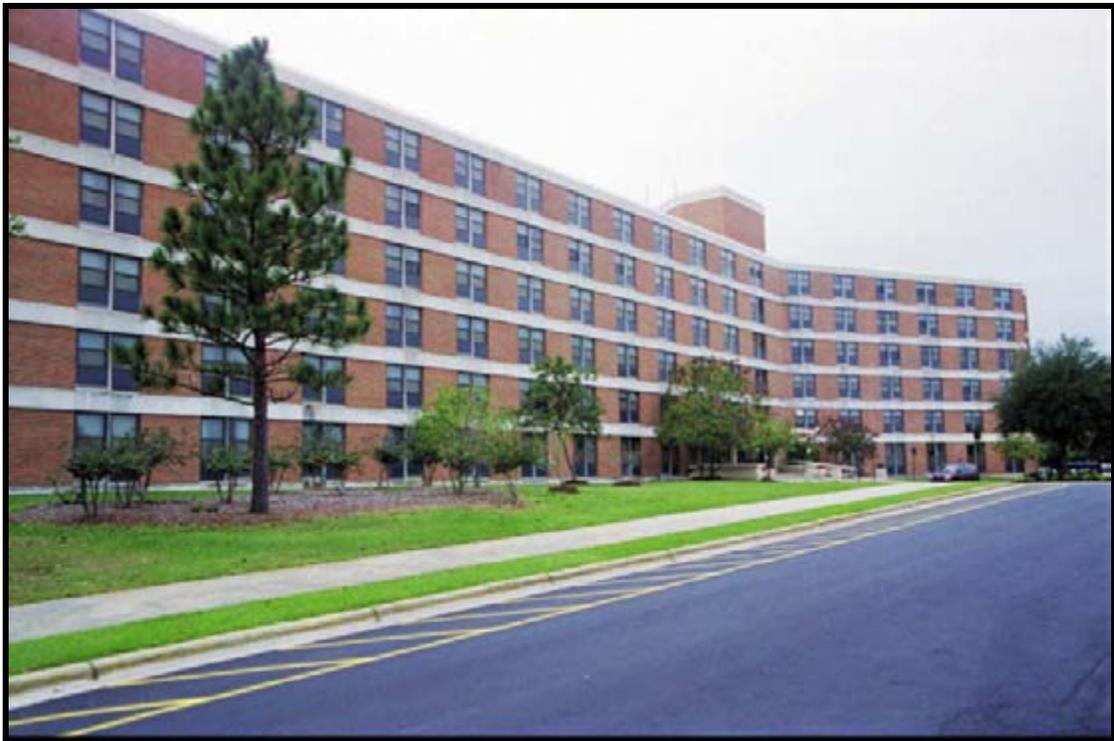
Figure 4.119 High Rise BOQ, Ft. Bragg (RCG&A).

Forts Bragg and Hood constructed 300-man, eight-story, Y-shaped, brick BOQs in the late 1960s. The BOQs at Fort Bragg featured horizontal concrete bands and paired, three-light, metal sash windows. Fort Hood's BOQ featured a brick façade divided by concrete framed window bays. Each window bay featured two, one-over-one-light, metal sash windows. Fort Hood's BOQ was adapted to the site by Howard R. Meyer and Leo L. Landauer & Associates, Architect-Engineers, of Dallas, Texas. The firm also designed a one-story, brick dining facility. The Y-shaped buildings featured a central first-floor lobby located at the intersection of the "Y." A bank of elevators provided access to the upper floors from the lobby. Exterior stairs located at the end of each wing provided additional access to the upper floors. Two apartment plans were developed. One wing of the first floor was reserved for distinguished visitors and featured units containing a bedroom, living room with kitchenette, and bathroom. Most units in the buildings featured a combined bedroom/living room with kitchenette, and bathroom. Although the buildings are similar in plan, examination of the buildings reveals striking differences in the exterior treatments. The Fort Hood example has a wide, overhanging eave to provide sun protection and open stairwells (Figures 4.117 and 4.118). In contrast, examples at Fort Bragg have minimal eaves and enclosed stairwells (Figures 4.119 and 4.120).

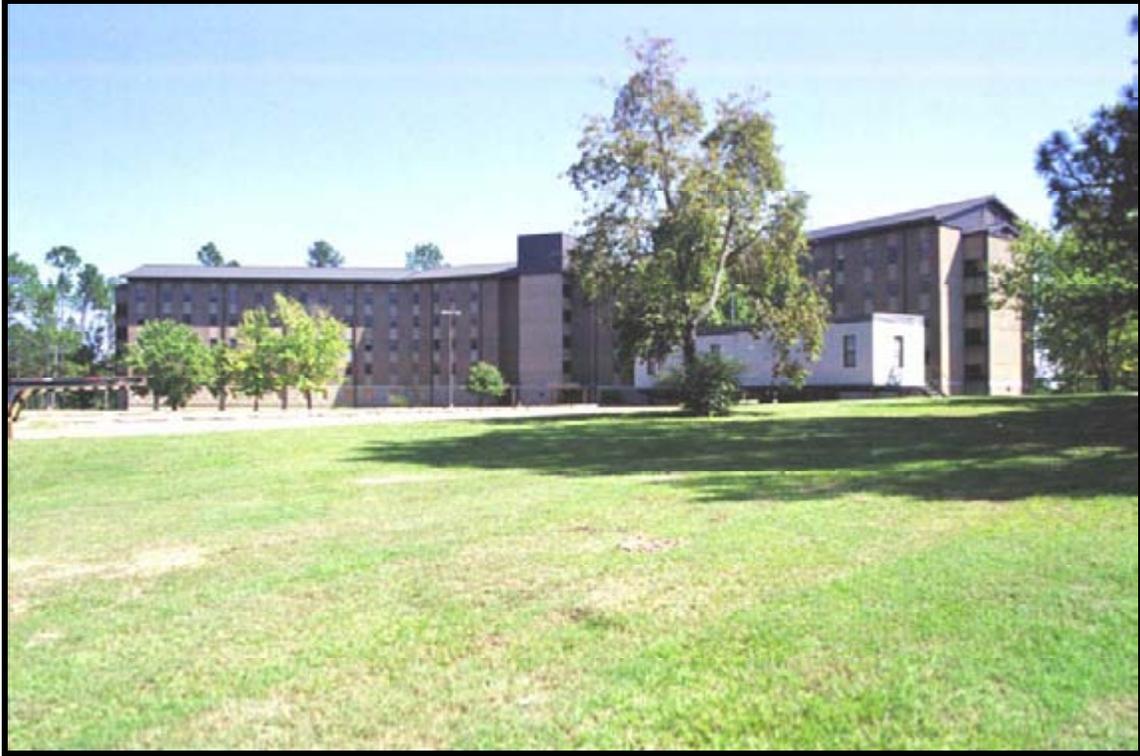
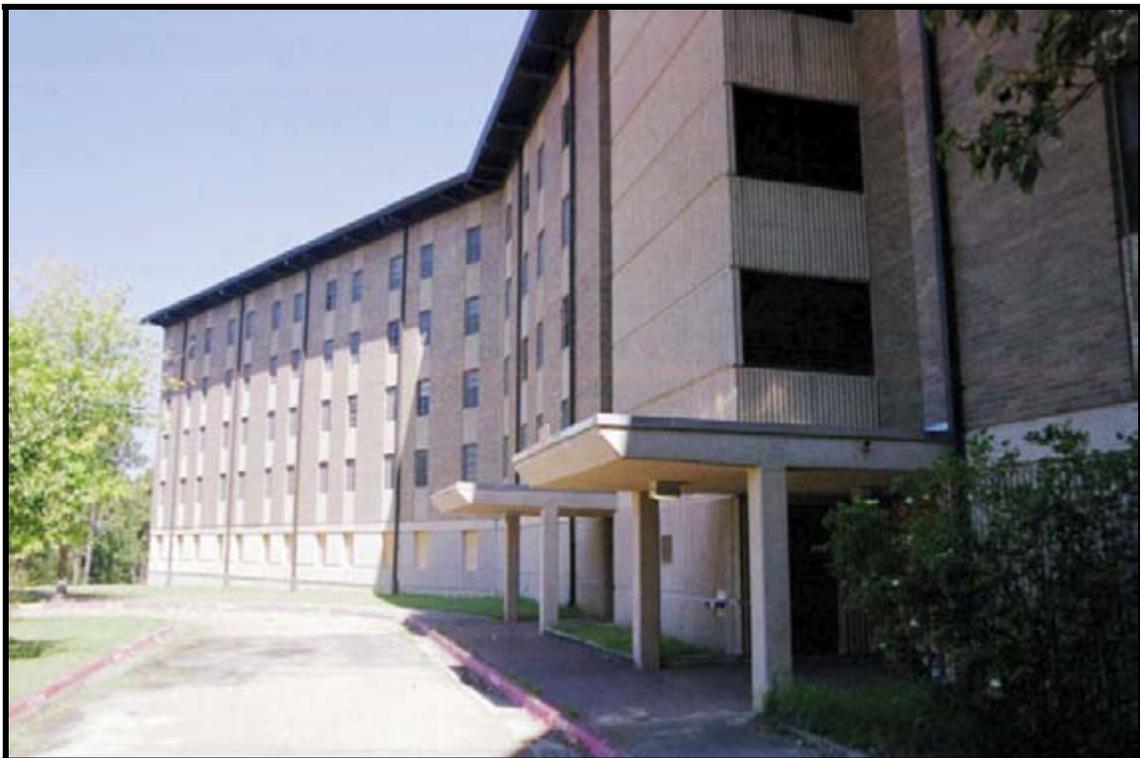
Figure 4.121 High Rise BOQ, Ft. Polk (RCG&A).

Fort Polk's BOQ included simple landscape features consisting of a small grouping of trees on islands in the parking lots and bushes to the side of the front entrance (Figures 4.121 and 4.122). All parking was located in one lot in front of the building (Figure 4.123). The landscape to the rear of the building was left in its natural state except for a few bushes that accented building entrances (Figure 4.124).

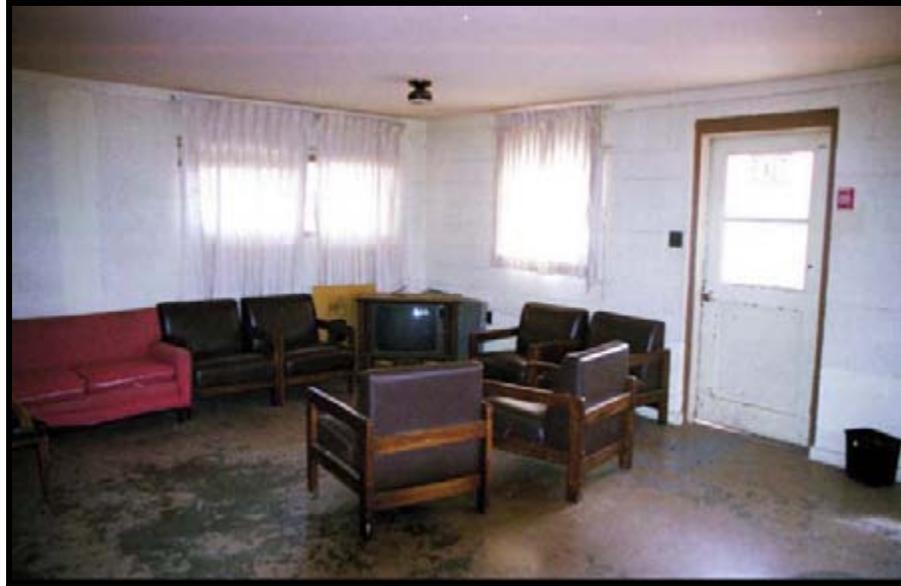
Figure 4.125 Semi-permanent "U" BOQ dayroom, McGregor Range, Ft. Bliss (RCG&A).

Reinforced concrete slabs supported the buildings. The uprights of the “U” were lined with one-man rooms on the interior of the “U” and two-man rooms on the exterior. Each room was equipped with individual closets. Day rooms were located at the base of the uprights (Figure 4.125). Lavatory facilities were located in the cross member of the “U”.

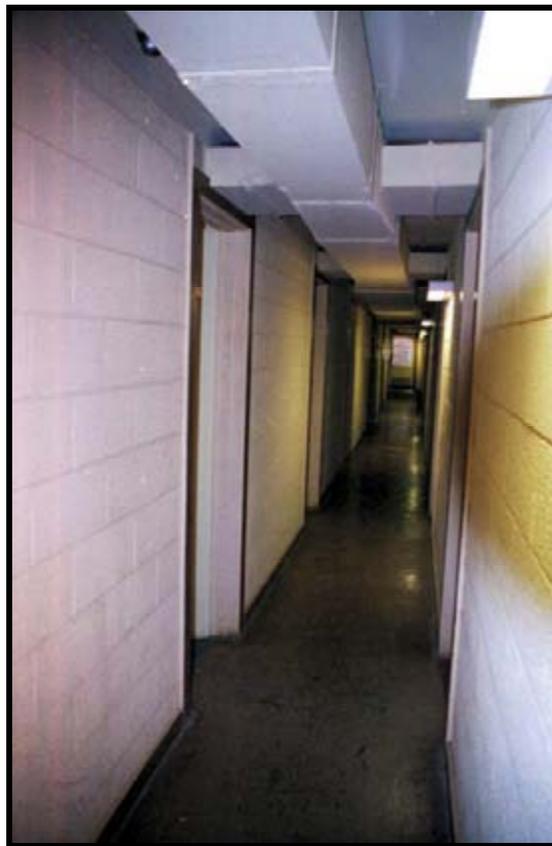
Figure 4.126 Semi-permanent "U" BOQ hallway, McGregor Range, Ft. Bliss (RCG&A).

The only modification to the original design and construction of the BOQs was the addition of air conditioning (Figure 4.126).

The character defining features of the U-shaped BOQs are the exposed concrete block walls, distinctive ground plan, and four-light, metal-sash windows with concrete sills. The only modification to the buildings identified in the archival record or through site inspections of representative examples was the addition of air conditioning. The BOQs appeared to retain integrity of location, design, setting, materials, workmanship, feeling, and association.

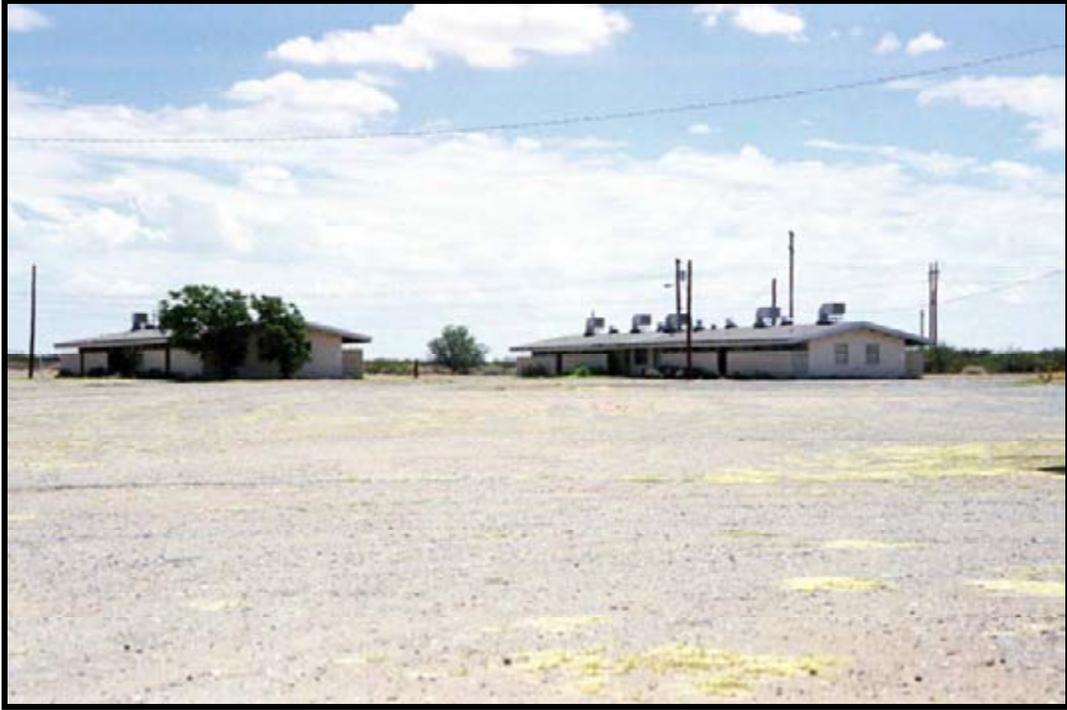
Figure 4.127 Semi-permanent 16-man BOQ, Oro Grande Range, Ft. Bliss (RCG&A).

Two, semi-permanent, 16-man BOQs were identified at the Oro Grande Range at Fort Bliss. The rectangular, concrete block buildings terminated in side gable roofs with overhanging eaves (Figure 4.127). Swamp coolers located on the roofs provided air conditioning. Concrete lattice privacy walls provided protection from the wind and sun (Figure 4.128). Each building featured four suites at each end of the building with a lounge, storage room, and boiler room located in the center. The suites featured two bedrooms, closets, and a common bathroom. Suites opened onto the sidewalks from either the front or rear elevations.

The character-defining features of the semi-permanent 16-man BOQs are the exposed concrete-block walls, the side gable roof with overhanging eaves, and the concrete lattice privacy walls. No modifications were identified in the archival record or through site inspections of representative examples of the semi-permanent 16-man BOQs at Oro Grande Range. The BOQs appeared to retain integrity of location, design, setting, materials, workmanship, feeling, and association.

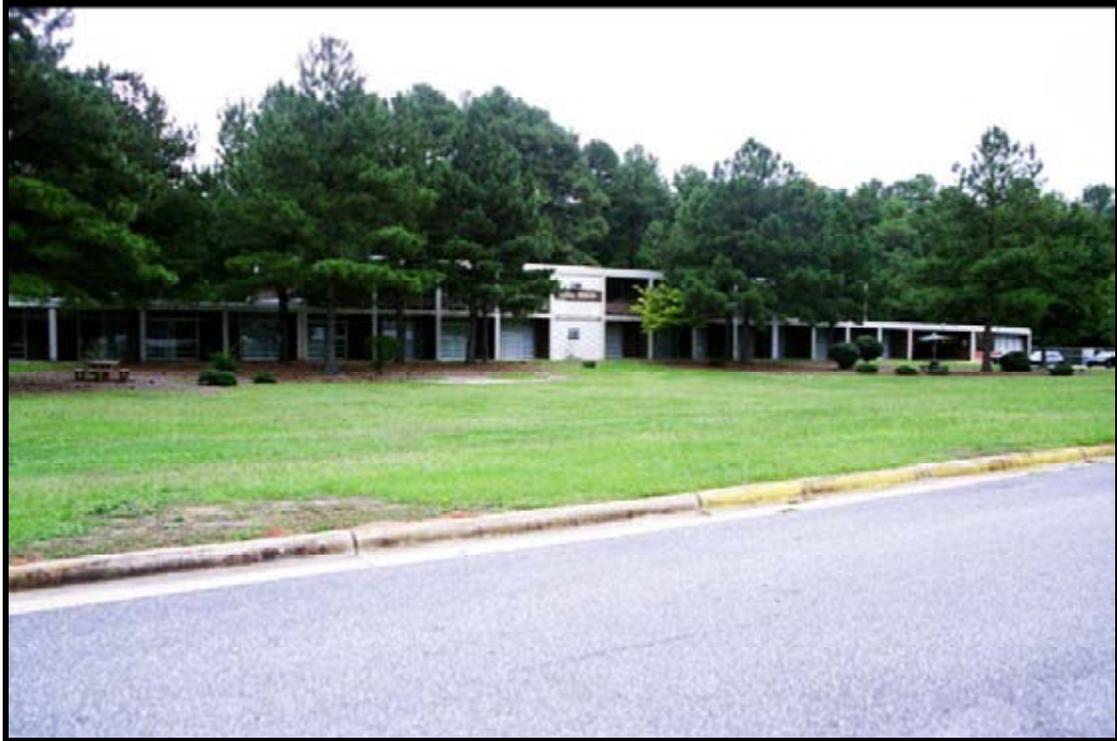
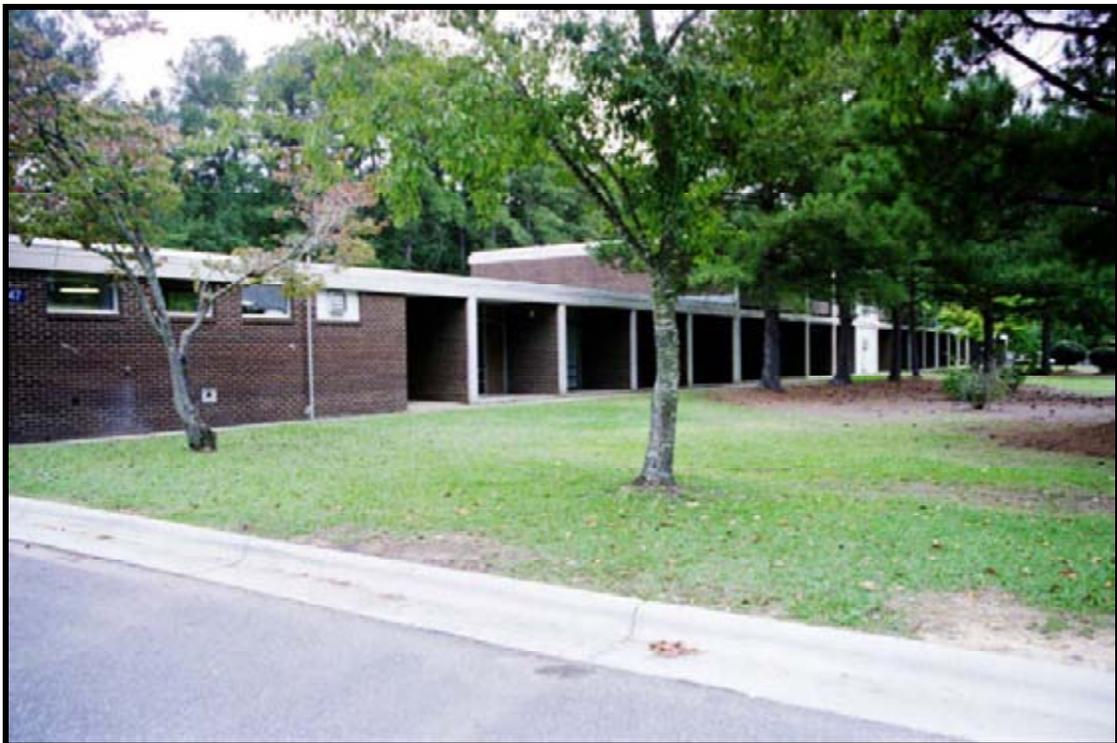
Figure 4.129 Transient quarter, Ft. Bragg (RCG&A).

NCO motels utilized contemporary motel construction techniques. The rectangular-shaped NCO motel at Fort Bragg featured a two-story center block with flanking one-story wings (Figures 4.129 and 4.130). The brick non-commissioned officers motel was built in 1967 on a concrete slab and terminated in a flat roof sheathed with built-up tar and gravel. An office was located at the end of the south ell; housekeeping facilities were located at the end of the north ell.

Minimal modifications were identified in the archival record or through site inspections of the representative example. The NCO motel at Fort Bragg appeared to retain integrity of location, design, setting, materials, workmanship, feeling, and association.

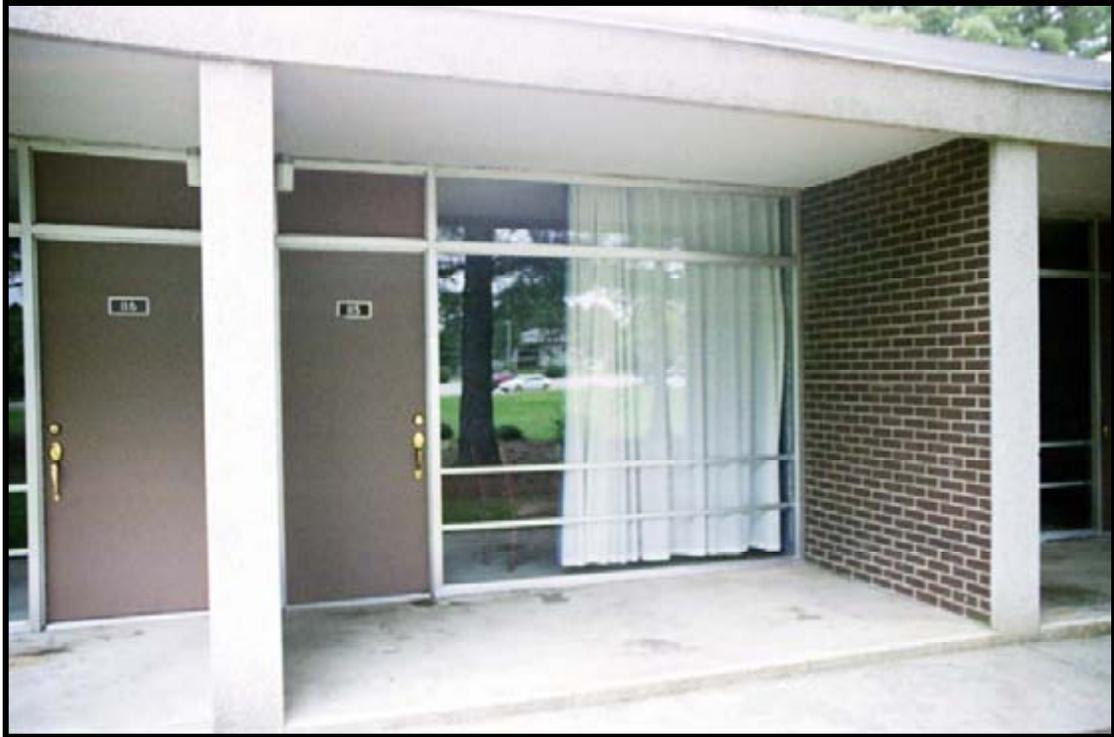
Figure 4.131 Transient quarter, Ft. Bragg (RCG&A).

Each unit was recessed from the front façade for privacy. The front elevation of each unit featured a fixed glass, floor-to-ceiling window with an offset metal door (Figure 4.131). The rear entrance to each unit consisted of a metal door. An exterior stair located next to the rear parking lot provided access to the second-floor rooms (Figure 4.132). Each unit combined a bedroom/living room and a bathroom.

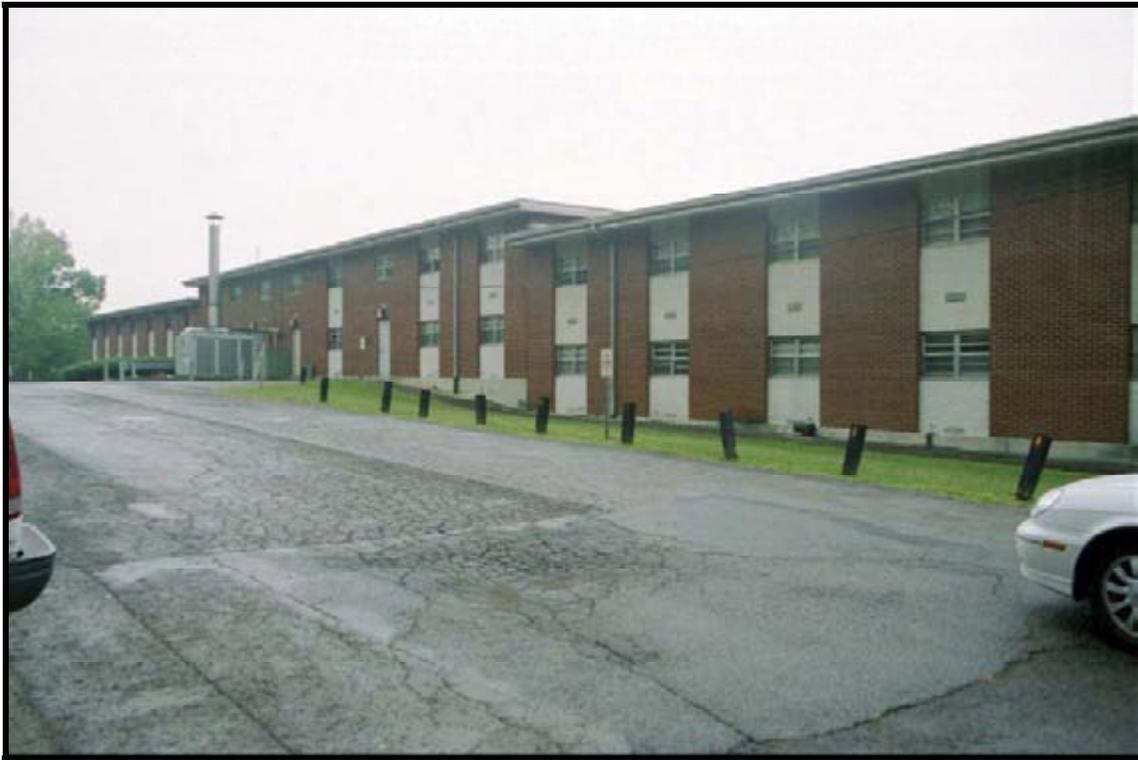
Figure 4.135 Transient quarter, Ft. Knox (RCG&A).

The first guest houses were built with 27 or 33 units. Each unit was fitted with bedroom and bathroom facilities sufficient to house individuals or up to four family members. The first guest house was completed at Fort Knox in 1970. The two-story brick guest house terminated in a flat roof. The building featured a center block slightly higher than the two wings. A concrete canopy sheltered the primary entrance on the front of the central block (Figure 4.133). The building featured paired, two-over-two-light windows (Figure 4.134). Textured concrete defined the window sills and heads. Parking was located in front and rear lots (Figure 4.135).

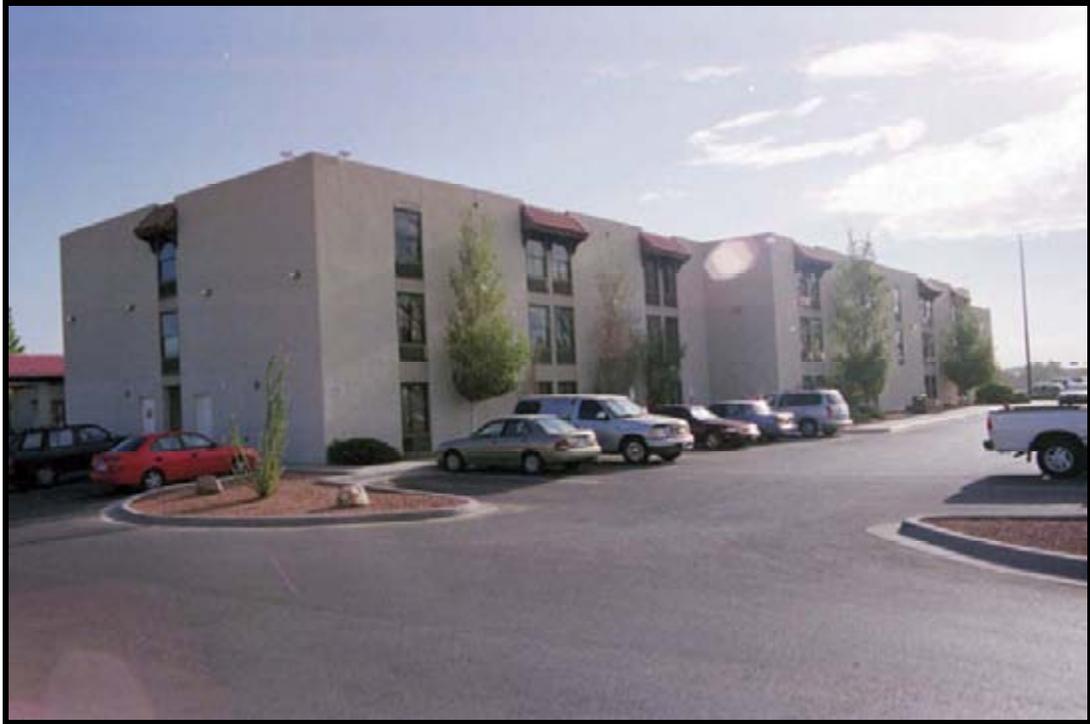
Figure 4.141 Transient quarter, Ft. Bliss (RCG&A).

Inns were larger facilities than guest houses and included additional amenities, including swimming pools and restaurants. The inn at Fort Bliss is a three-story building configured like a rolling pin barracks. The brick building was stuccoed and terminated in a flat roof (Figure 4.141). The inn featured single and paired one-over-one-light, fixed metal-sash windows. Single-light, metal doors on the front, rear, and side elevations provided access to the building.

The inn at Fort Bliss has undergone a major expansion and renovation, which has impacted the building's integrity of design, setting, and workmanship.
